**ARBORICULTURAL REPORT  
AND  
ARBORICULTURAL IMPACT ASSESSMENT  
to BS 5837:2012  
at  
Former Higher Birch School  
Marland Fold  
Rochdale  
Lancashire  
OL11 4RA**

Greenstone Construction Ltd

21778/TT

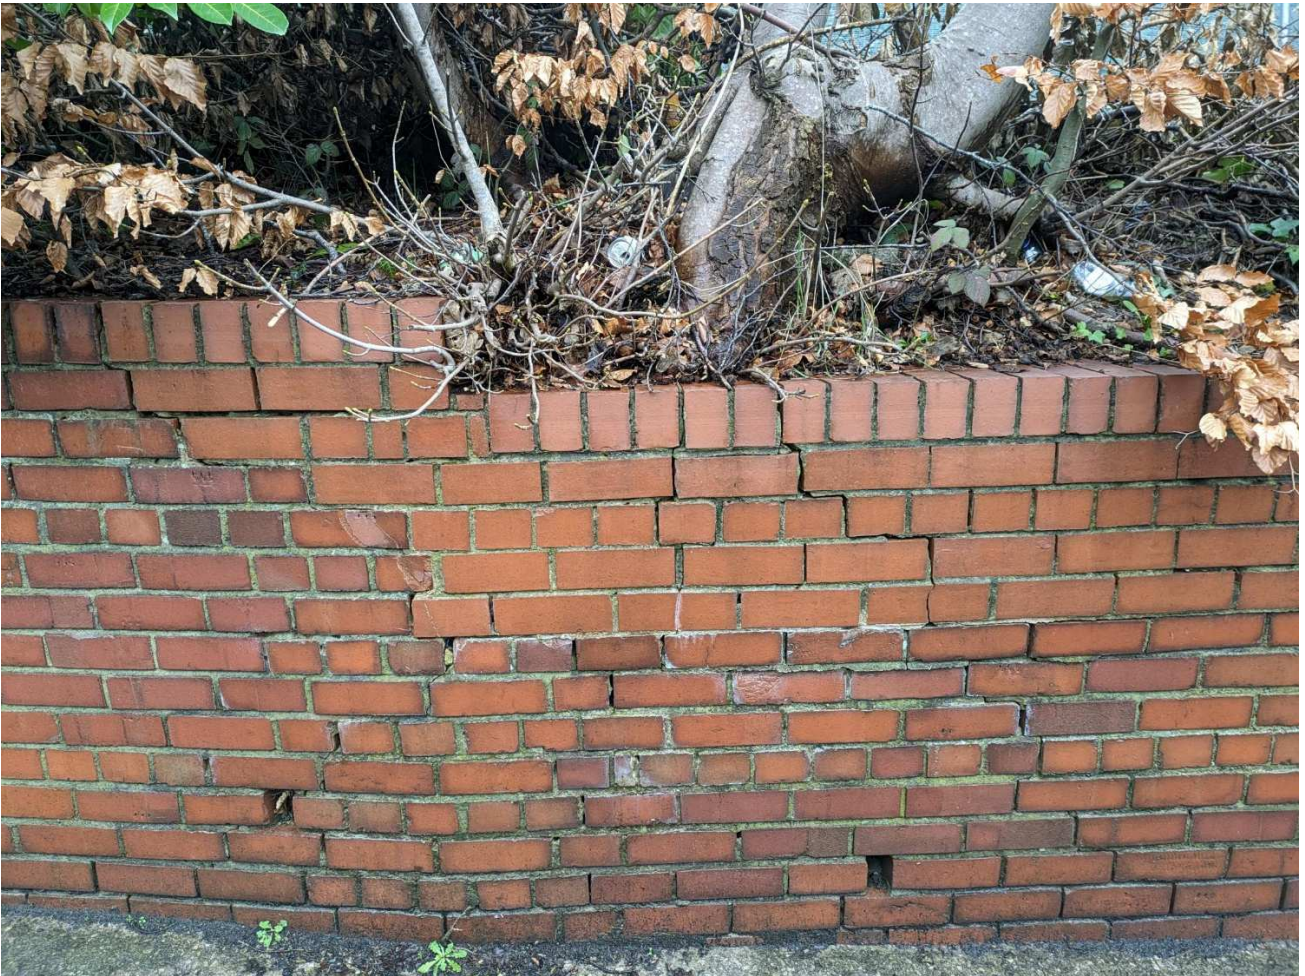
| Tree Ref. | Age<br>Common Name<br><i>Botanical Name</i> | Height (m) | Crown Height (m) | Height (m) and Direction of the Lowest Branch | Diameter (cm) | Crown Spread<br>N<br>W E<br>S | Observations | Arboricultural Recommendations | Recommendations to accommodate the Proposals | Physiological Condition | Structural Condition | Amenity Value | NHBC Water Demand | Life Expectancy (yrs) | Retention Category |
|---|---|---|---|---|---|---|---|---|---|---|---|---|---|---|---|
| T 4 | Semi Mature<br>Sycamore<br><i>Acer pseudoplatanus</i> | 7 | 1 | n/a<br>n/a | 14<br>17 | 2<br>0 4#<br>2.5 | Twin-stemmed at ground level with an unbalanced crown. Overhanging the road. Decay observed at the base. Damage observed to the adjacent retaining wall. | No action required. | <b>Remove.</b> | GOOD | FAIR | LOW | MOD | 10+ | C 1 |

Damage to the wall adjacent to T4.

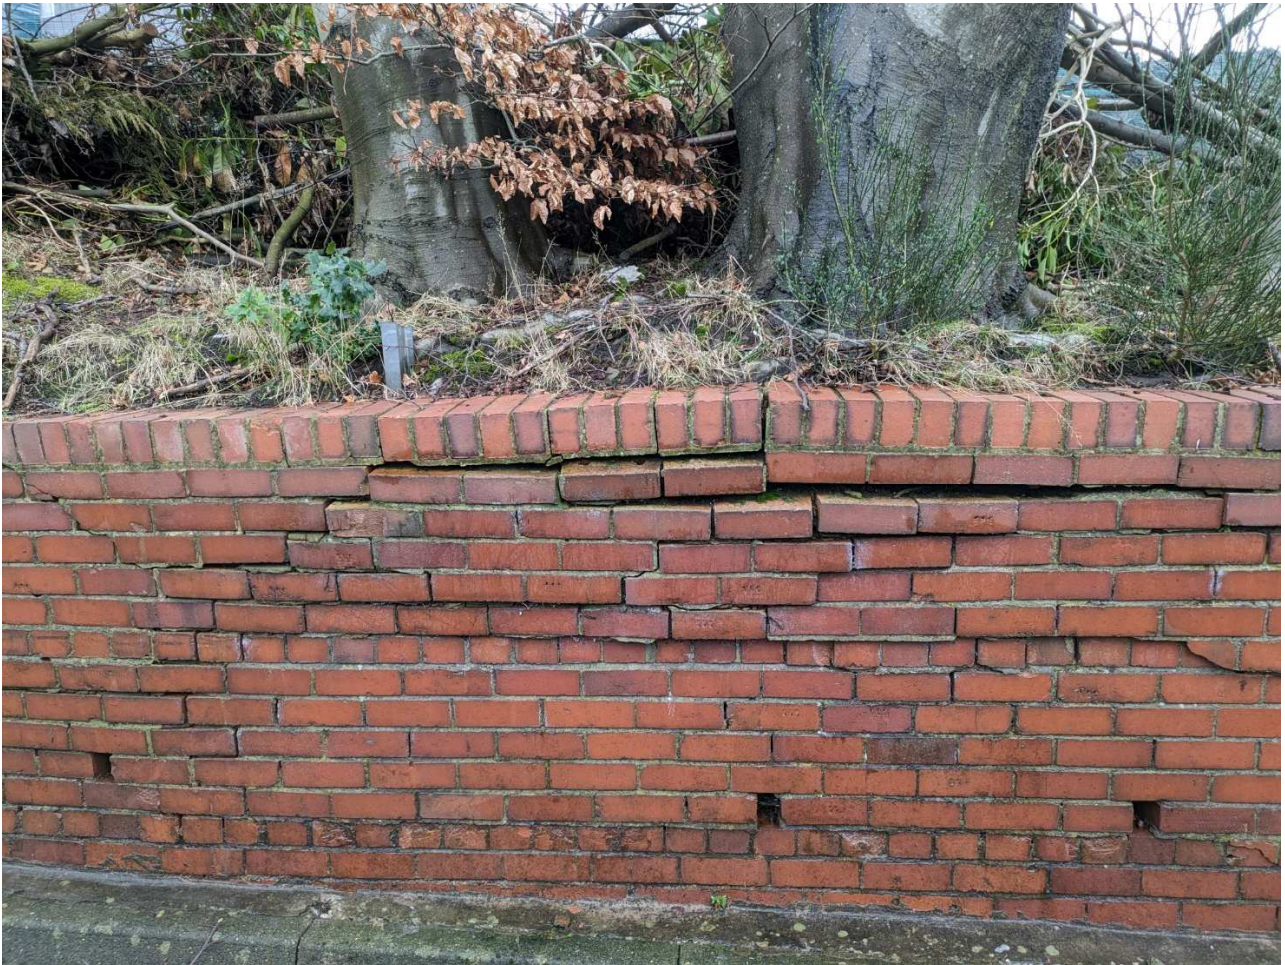
| Tree Ref. | Age<br>Common Name<br><i>Botanical Name</i> | Height (m) | Crown Height (m) | Height (m) and Direction of the Lowest Branch | Diameter (cm) | Crown Spread<br>N<br>W E<br>S | Observations | Arboricultural Recommendations | Recommendations to accommodate the Proposals | Physiological Condition | Structural Condition | Amenity Value | NHBC Water Demand | Life Expectancy (yrs) | Retention Category |
|---|---|---|---|---|---|---|---|---|---|---|---|---|---|---|---|
| T 6 | Mature<br>Common Beech<br><i>Fagus sylvatica</i> | 17 | 1.5 | 2<br>S | 56<br>53 | 7.5#<br>3 7<br>8 | Twin-stemmed at 1m with a slightly unbalanced crown. Overhanging the road. Occasional pruning wounds and branch stubs due to crown lifting. Deadwood noted. The northern side of the stem could not be assessed due to dense vegetation. Damage observed to the adjacent retaining wall. | No action required. | <b>Remove.</b> | GOOD | GOOD | HIGH | MOD | 40+ | B 1 |
| T 7 | Mature<br>Common Beech<br><i>Fagus sylvatica</i> | 17 | 2 | 4.5<br>W | 46 | 7.5#<br>2 1<br>7 | Single-stemmed with a slight lean and an unbalanced crown. Overhanging the road. Occasional pruning wounds and branch stubs due to crown lifting. Deadwood noted. The northern side of the stem could not be assessed due to dense vegetation. Damage observed to the adjacent retaining wall. | No action required. | <b>Remove.</b> | GOOD | FAIR | HIGH | MOD | 40+ | B 1 |

Damage to the wall adjacent to **T6** and **T7**.

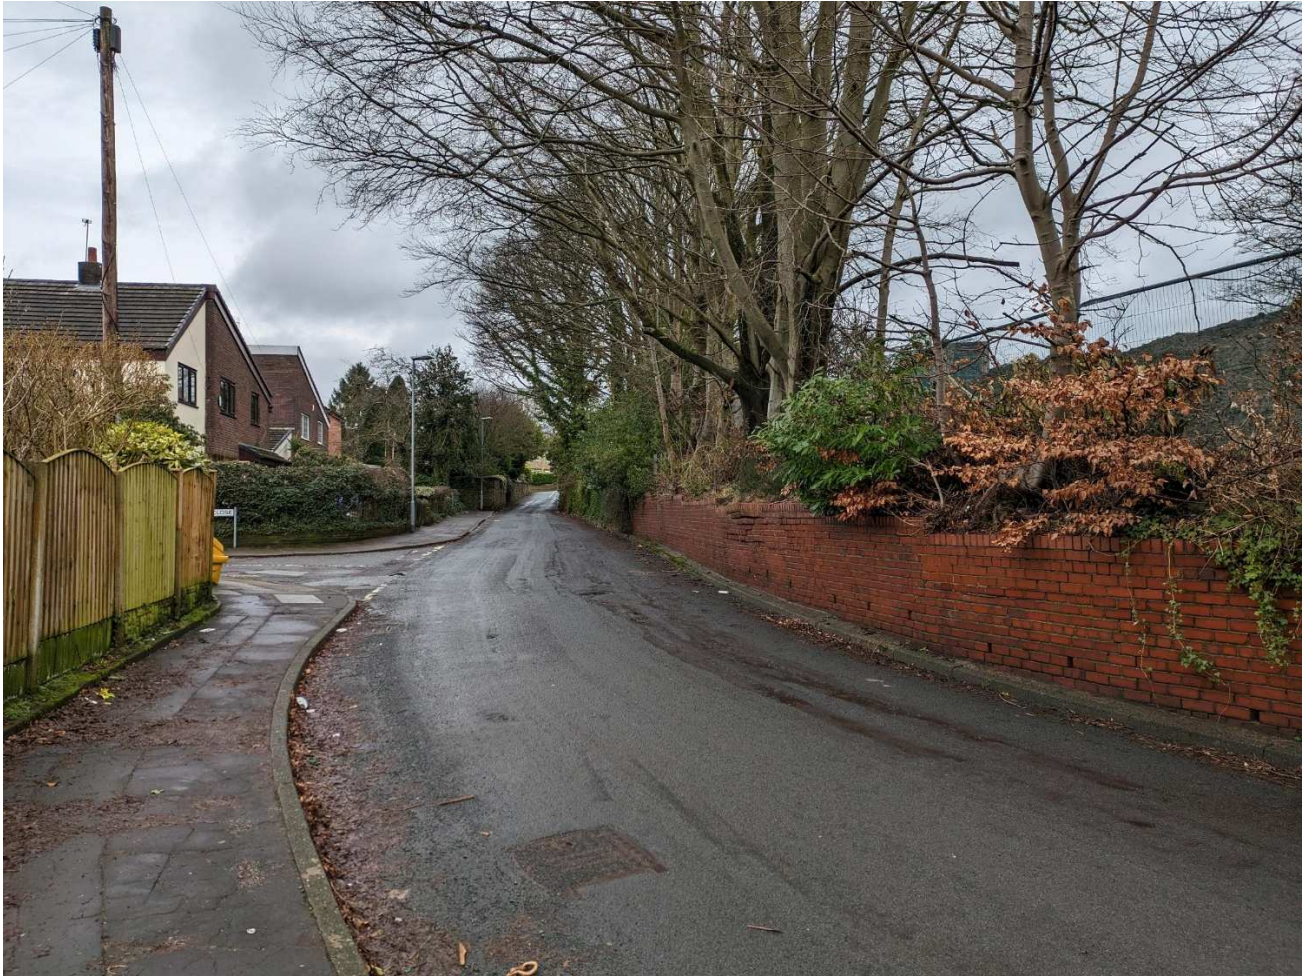
- 4.2.1 The trees are located close to the retaining wall on a higher elevation than Marland Old Road and have grown to a size where they are now damaging the wall (please refer to the photographs at **Appendix 7**). The trees are likely to become unstable when the wall is demolished.
- 4.2.2 We have been advised that for safety reason, and to allow the retaining wall to be re-constructed, it will be necessary to first remove the adjacent trees.
- 4.2.3 Based on the section of the retaining wall that is to be demolished and re-built, the following trees will need to be removed:

A view of the retaining wall and the trees along Marland Old Road.

- 4.1.1 It is proposed to demolish a damaged section of the retaining wall (adjacent to Marland Old Road) and rebuild this.
- 4.1.2 We have been supplied with **Drawing No. 1859.10k - proposed site plan**, which details the section of the retaining wall that is to be demolished and repaired.
- 4.1.3 The tree data has been overlaid onto the proposed designs to create the Arboricultural Implications Plan, which can be found at **Appendix 6**. This provides the basis for which this Arboricultural Impact Assessment has been prepared.
- 4.1.4 All tree works required to accommodate the proposals are detailed in *italics* in the recommendation columns of the tables at **Appendix 1**. Please note that any required Arboricultural works recommended during the initial survey are also listed in these tables in non-italics.
