**E3P**

Ref: 14-768-L3-2  
Date: 13th March 2023

## **GEOENVIRONMENTAL ASSESSMENT PUBLIC OPEN SPACE – HEYWOOD ROAD, CASTLETON**

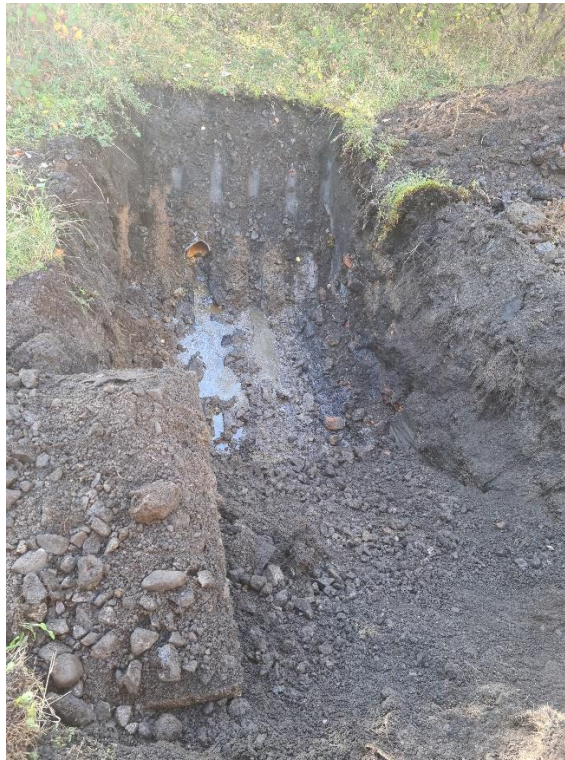
PLATE 1      TP312 EXCAVATION

A concrete obstruction was encountered within WS204 resulting in a shallow refusal. Hydrocarbon odours were noted within TP311 and TP312 at depths of 0.60 m and 0.80 m bgl respectively, with an oily sheen noted within the groundwater seepage at 1.50m bgl.

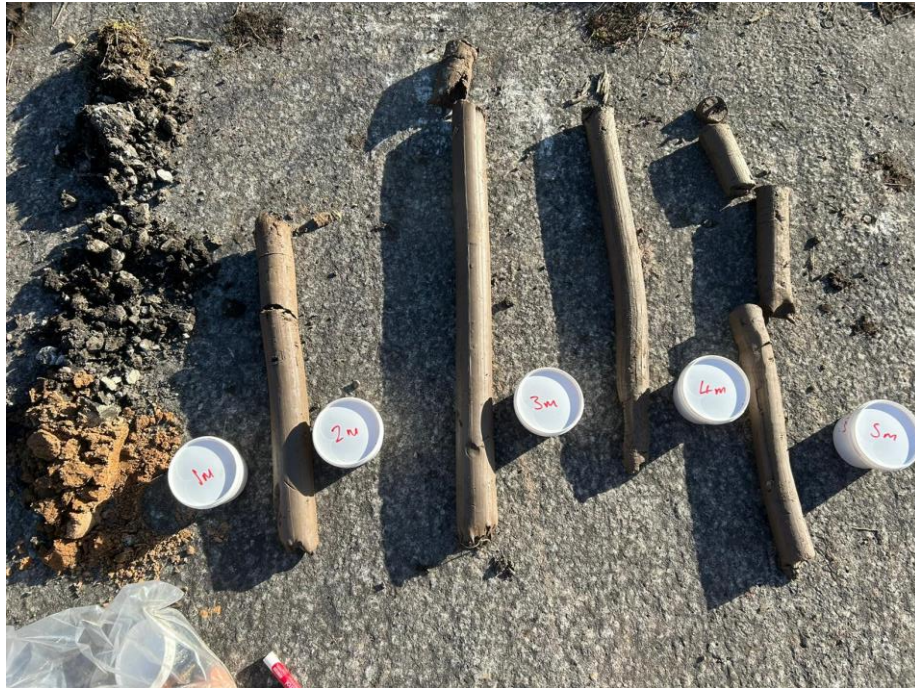
PLATE 3

WS205 ARISINGS

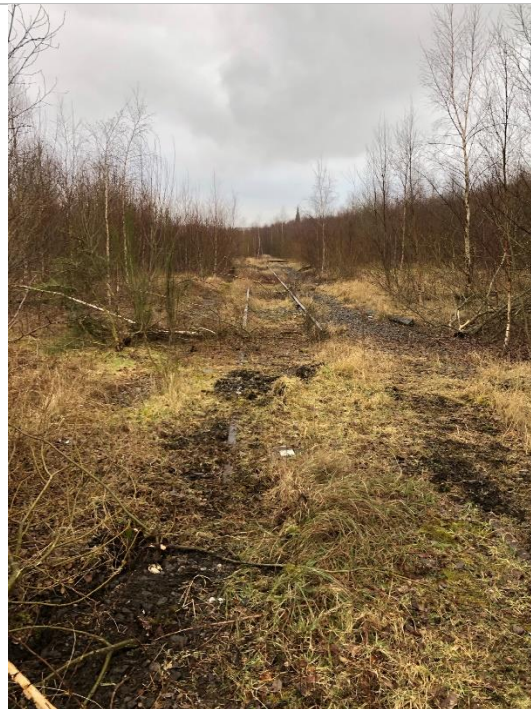
PLATE 4

RAILWAY SIDINGS THROUGH POS AREA

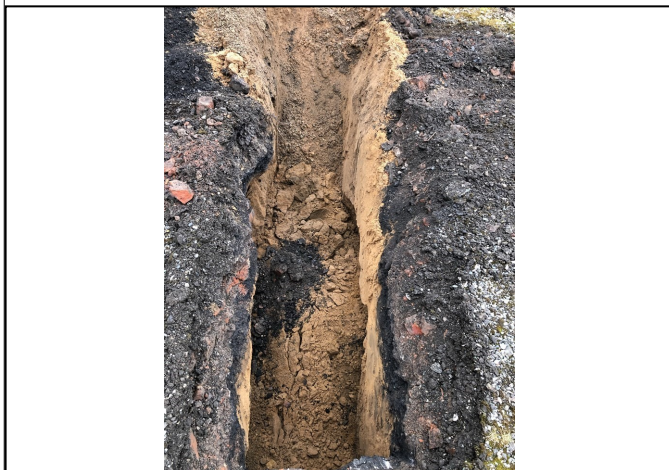
Trial Pit 104

Remarks: 1. Terminated due to side wall collapse within Made Ground. 2. Water strike encountered at 1.50m bgl.

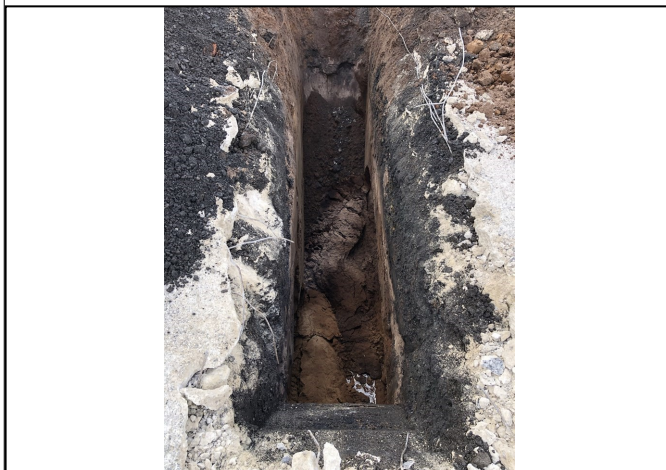
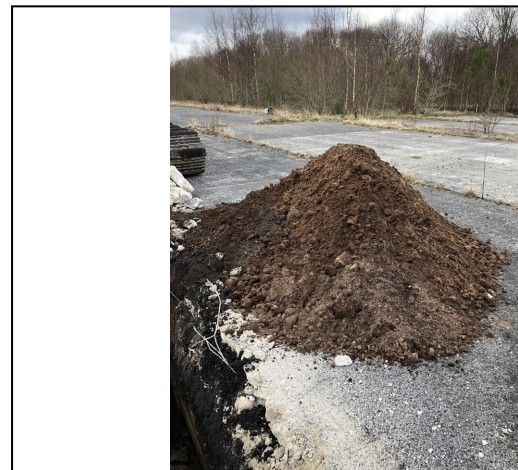
Trial Pit 109 Spoil

Remarks: 1. Terminated due to side wall collapse within Made Ground. 2. Water strike encountered at 2.70m bgl.

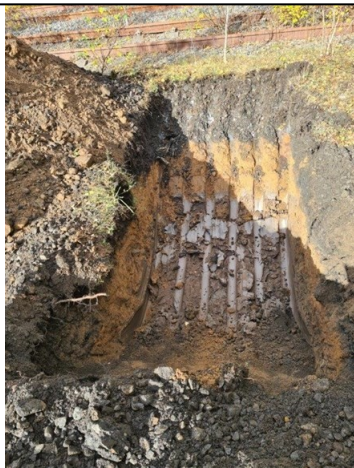
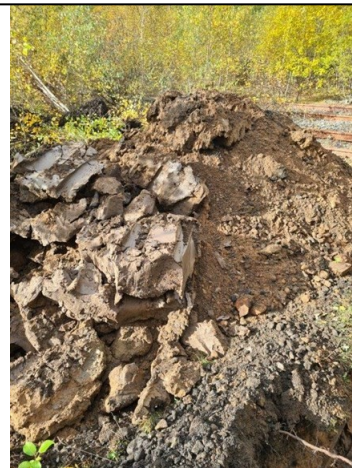
TP310 spoil

Remarks: 1. Complete.

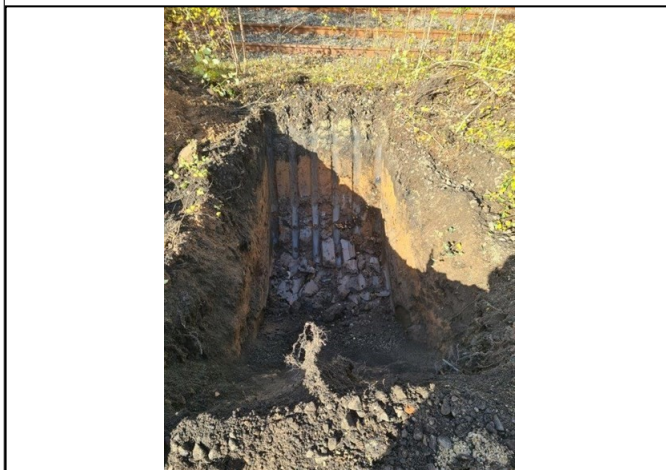
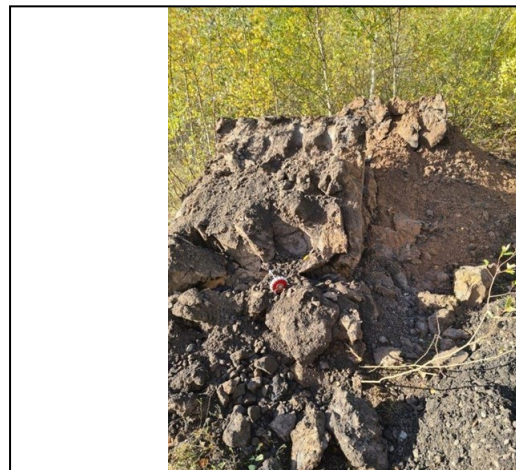
TP311 spoil

Remarks: 1. Complete. 2. Slight hydrocarbon odour at 0.60m bgl.

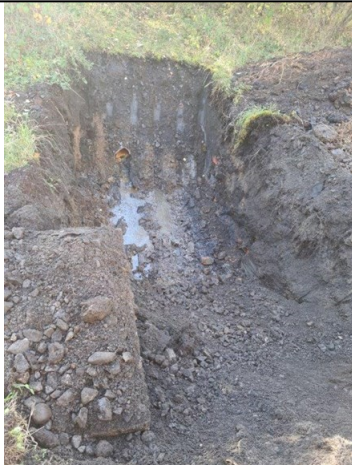
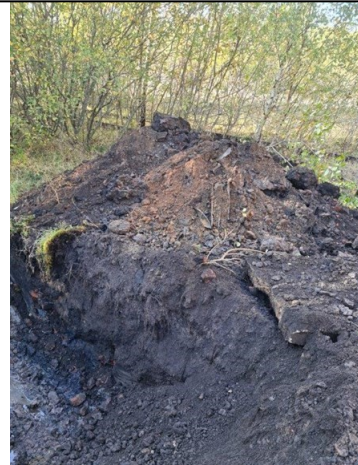
TP312 spoil

Remarks: 1. Complete 2. Land drain encountered at 0.80m bgl and oily sheen encountered on water ingress. 3. Strong hydrocarbon odour encountered between 0.40m and 1.00m bgl. 4. Water strike encountered at 1.50m bgl- seepage.
