## **GEOENVIRONMENTAL GROUND INVESTIGATION**

**M400 Heywood Distribution Park  
Pilsworth Road  
Heywood, Manchester**

**5986-JPG-XX-XX-RP-G-0605-S2-P03**

**January 2022**

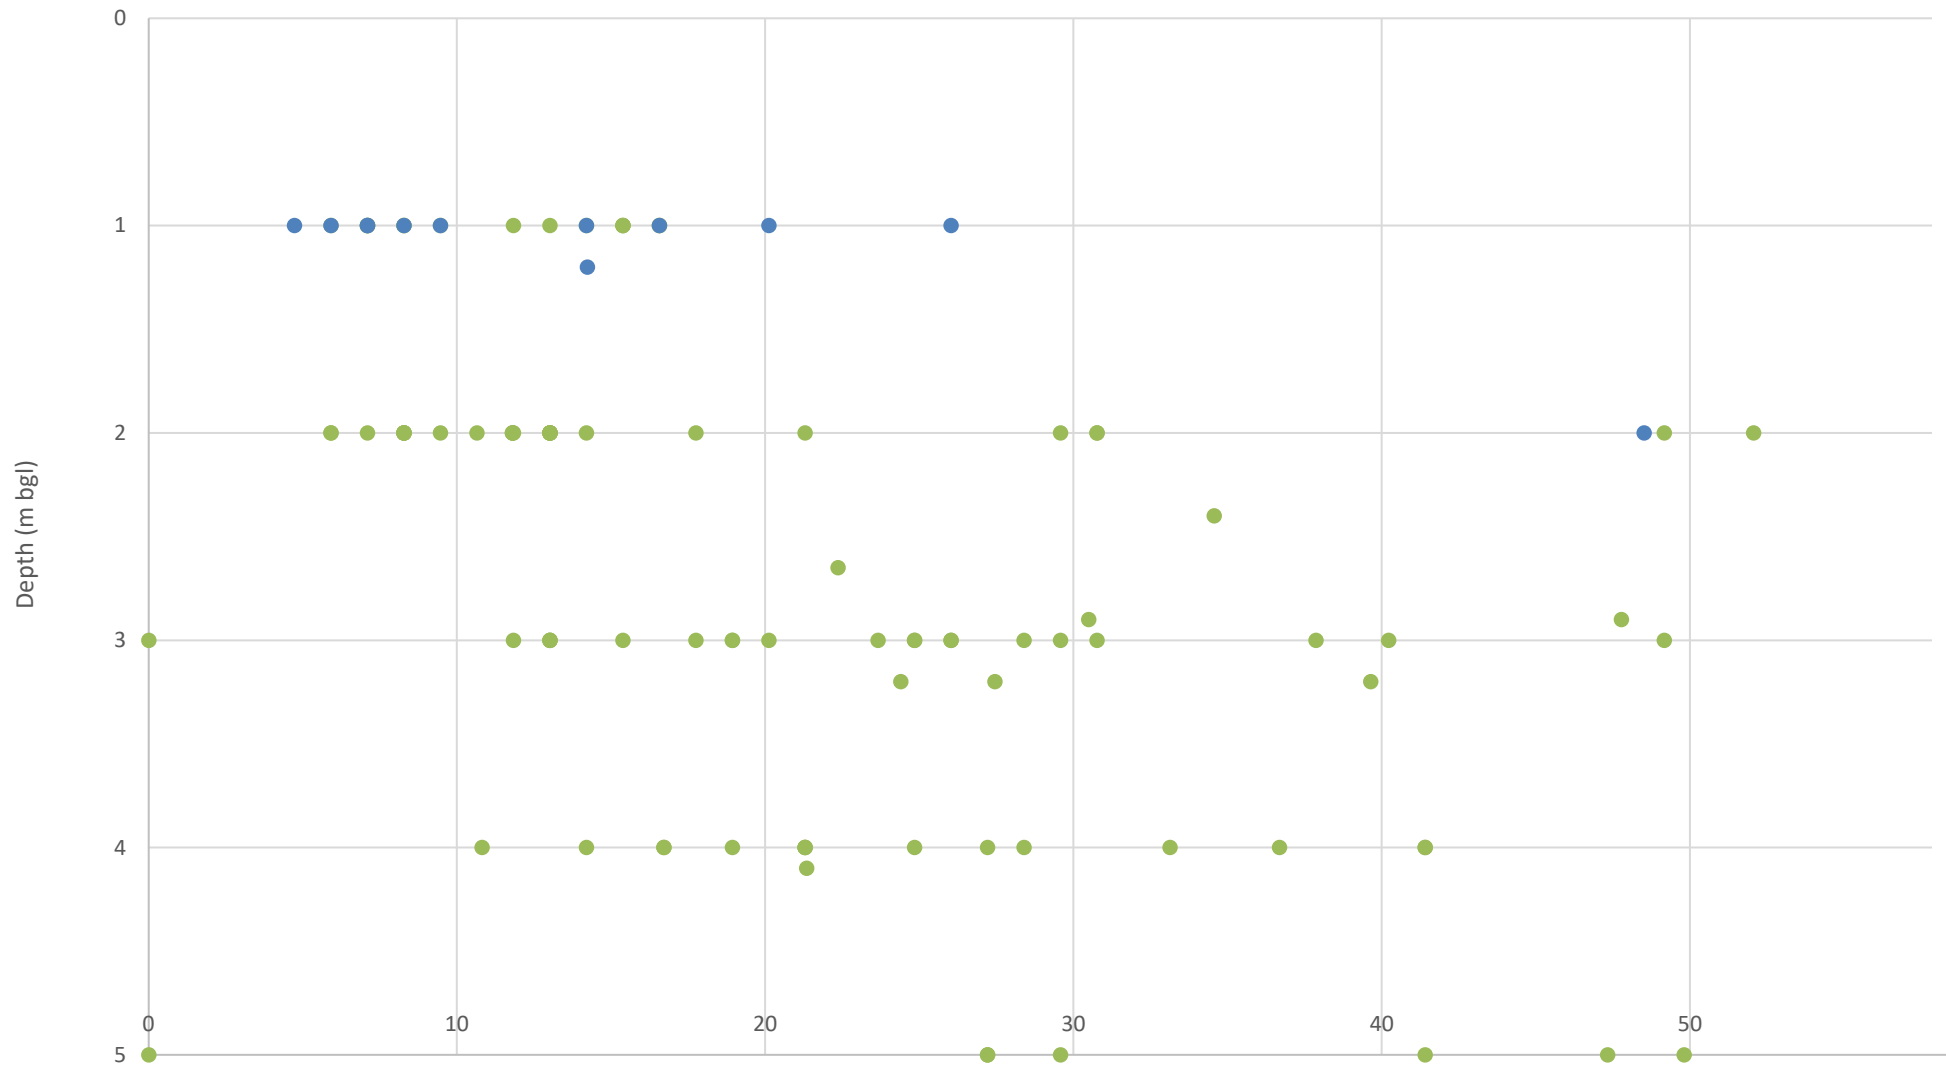
Figure 3: SPT N Value vs Depth (m bgl)

The SPT data generally indicates increasing strength/density with depth with N values of greater than 10 recorded below 3.00m bgl with some lower N-values recorded in the upper 2.50m bgl. It should be noted that an anomalous N-value of 0 was recorded in WS109 at 3.00m bgl. This may be due to the presence of extremely soft soils or a void at this location.

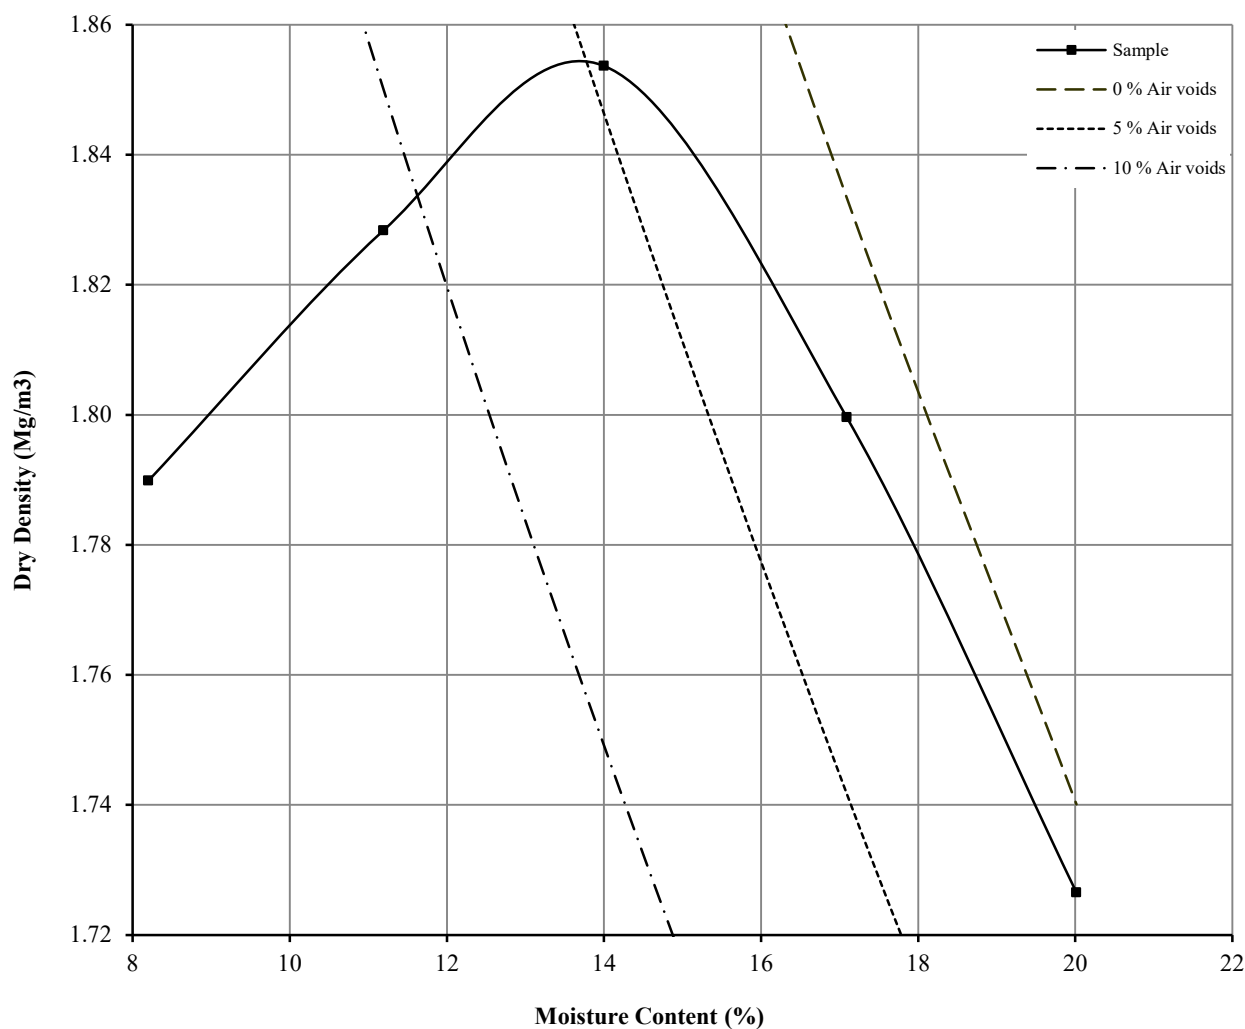
| Initial Moisture Content: | 17 | Method of Compaction: | 2.5kg | Separate Samples |
| Particle Density (Mg/m <sup>3</sup> ): | 2.67 | Measured | Material Retained on 37.5 mm Test Sieve (%): | 0 |

Three soil samples of cohesive made ground, one of granular made ground and three samples of natural cohesive glacial till were submitted for dry density/moisture content relationship testing. The compaction tests were carried out using both a 2.5kg and a 4.5kg rammer. The results are summarised in Table 4.5.3.

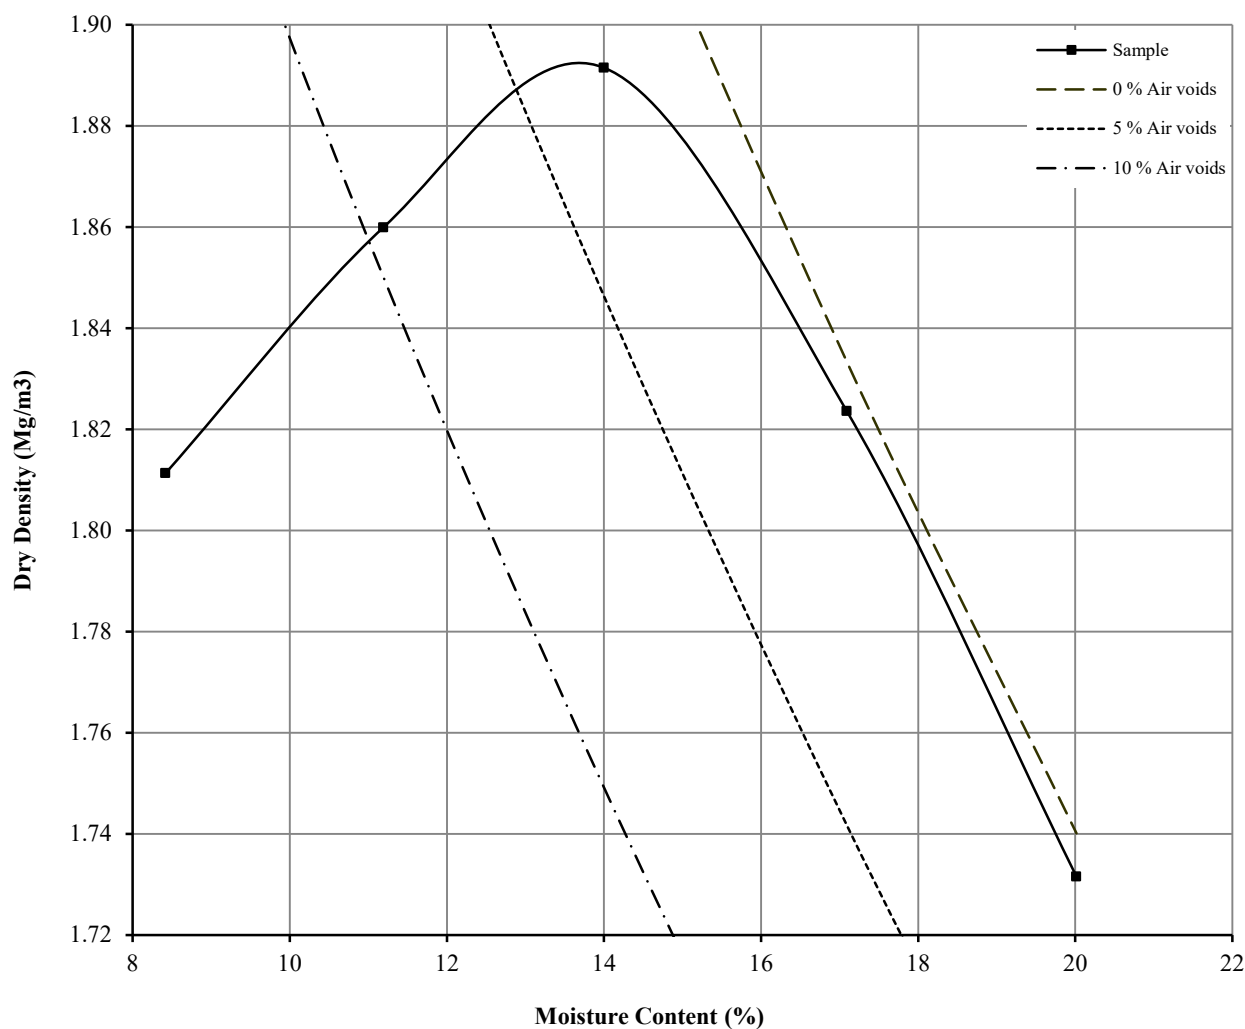
| Initial Moisture Content: | 17 | Method of Compaction: | 4.5kg | Separate Samples |
| Particle Density (Mg/m <sup>3</sup> ): | 2.67 | Measured | Material Retained on 37.5 mm Test Sieve (%): | 0 |

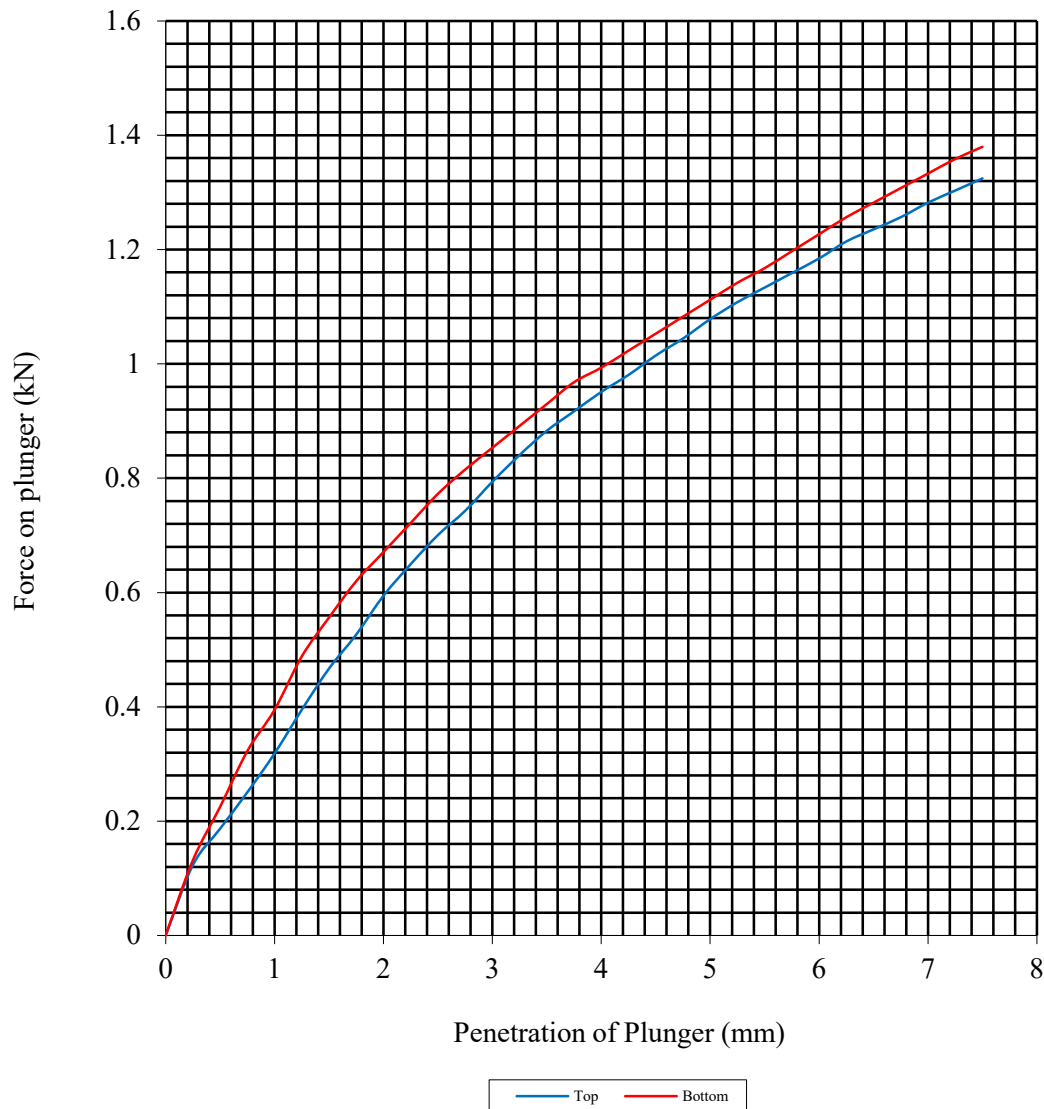
| Initial Sample Conditions | | Sample Preparation | | Final Moisture Content % | | C.B.R. Value % | |
| Moisture Content: | 17 | Surcharge Kg: | 4.00 | Sample Top | 17 | Sample Top | 5.4 |

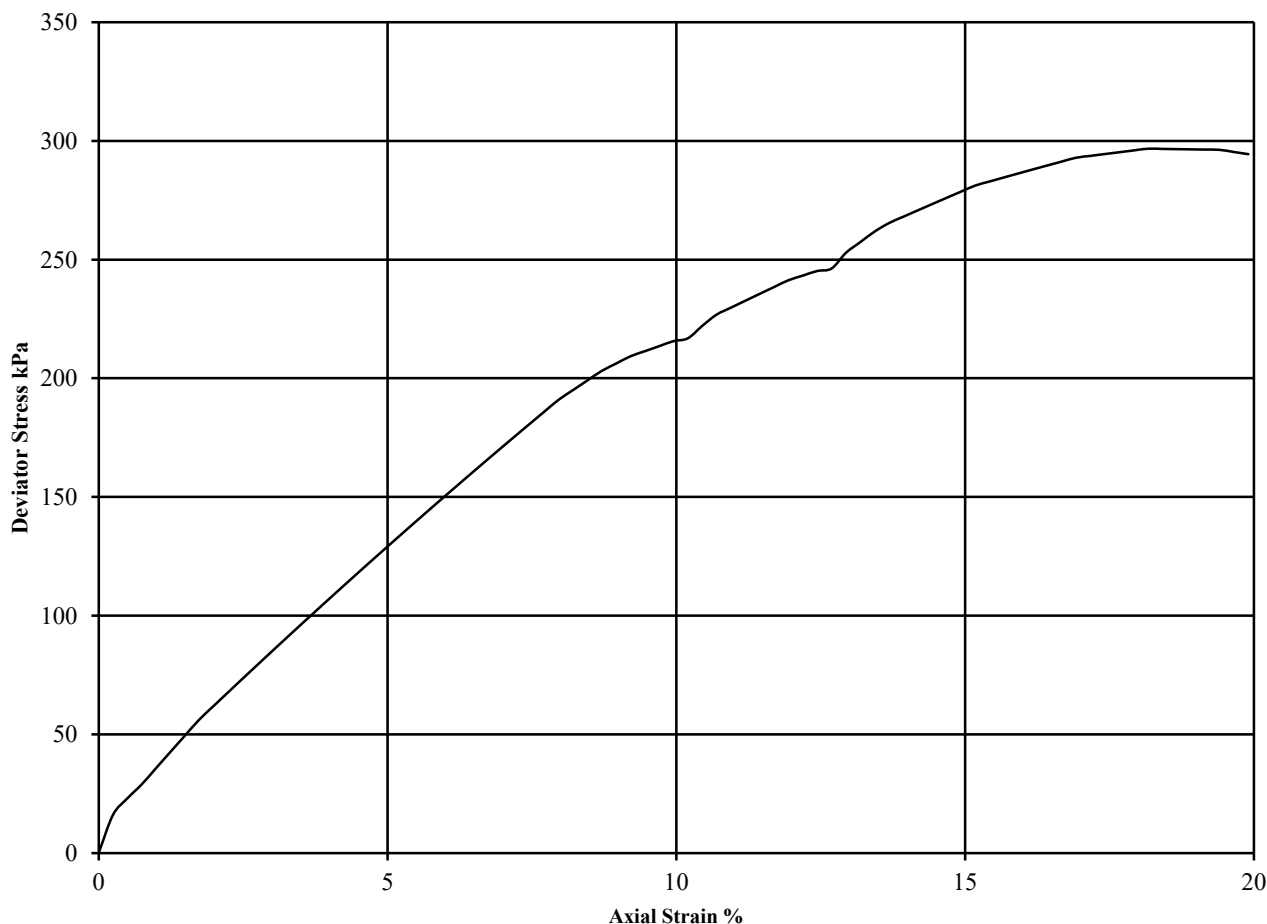
| Diameter (mm): | | 103 | Height (mm): | | 207 | Test: | UU Multistage | | Remarks |
| Specimen | Moisture Content (%) | Bulk Density (Mg/m3) | Dry Density (Mg/m3) | Cell Pressure (kPa) | Corr. Max. Deviator Stress (kPa) | Shear Strength Cu (kPa) | Failure Strain (%) | Mode of Failure | Undisturbed Sample<br>Sample taken from top of tube<br>Rate of strain = 2 %/min<br>Latex Membrane used 0.2 mm thick<br>Membrane Correction applied (kPa)<br>0.35      0.34      0.33<br>See summary of soil descriptions |
