## LAND AT CROMPTON AVENUE, ROCHDALE

### Site Investigation & Ground Assessment

Report Ref: BEK-22081-2 Rev C

April 2023

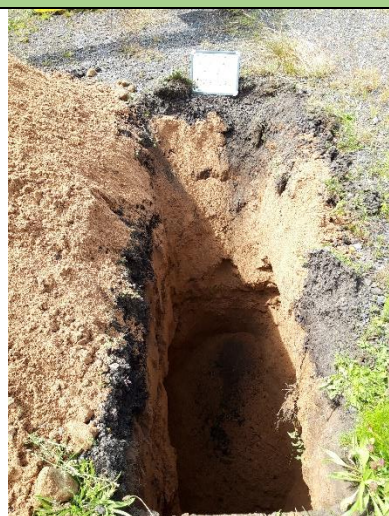
**P11: TP8**

- 4.5.2 In Trial Pit No TP8, where relict brick footings were observed near the access gate, the Made Ground comprised compact grey-black sandy fine to coarse angular gravel of mixed lithologies to a depth of 0.15 m bgl.

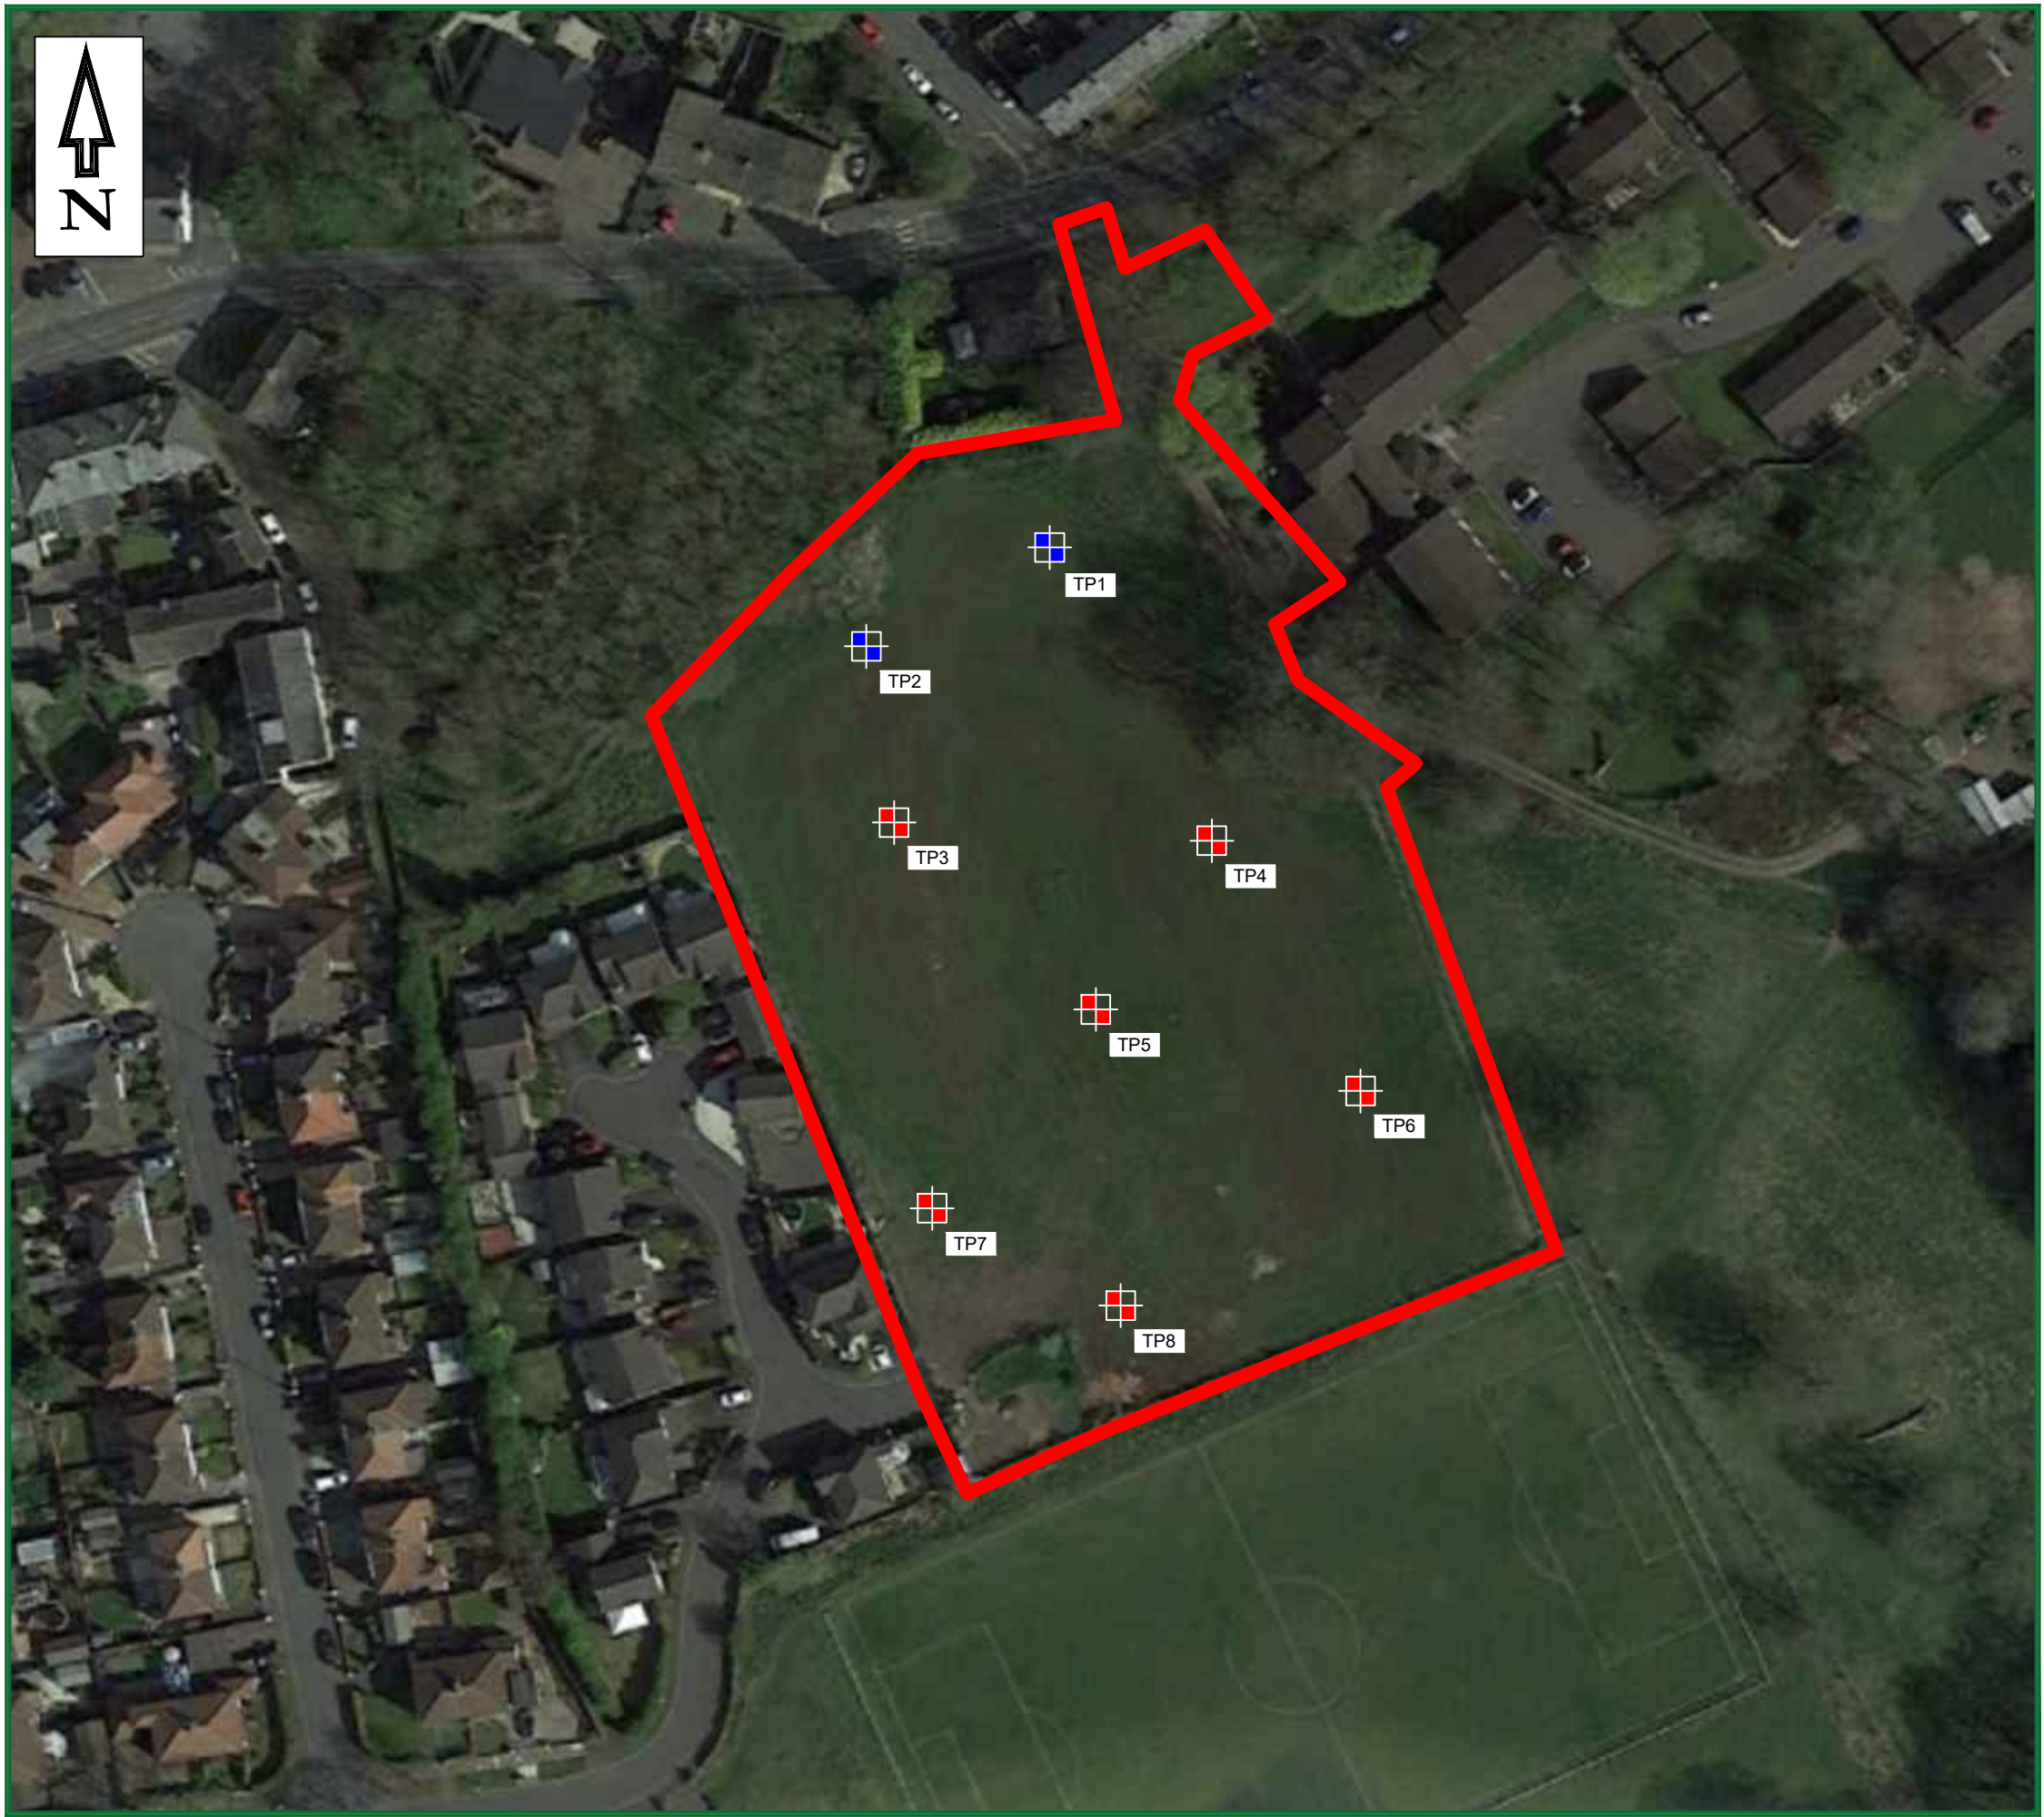
| DRAWING No. | 22081-3 | REV. | A |

- Eight machine excavated trial pits (TP1 to TP8) to depths of up to 4.0 m bgl, using a JCB 3CX, to provide information on the site wide ground conditions and to target potential areas of potential contamination.
- The recovery of representative soil samples from the trial pits for laboratory chemical analysis, to assess potential contamination levels.
- Infiltration tests undertaken in two trial pits, to assess the permeability of the shallow ground to assist soakaway design.
