# ARBORICULTURAL IMPLICATIONS ASSESSMENT

PROPOSED DEVELOPMENT

CRIMBLE COTTAGE  
CRIMBLE LANE  
ROCHDALE

Author: C. Salisbury  
Date: 8 June 2023  
Ref: TRE/CCCL

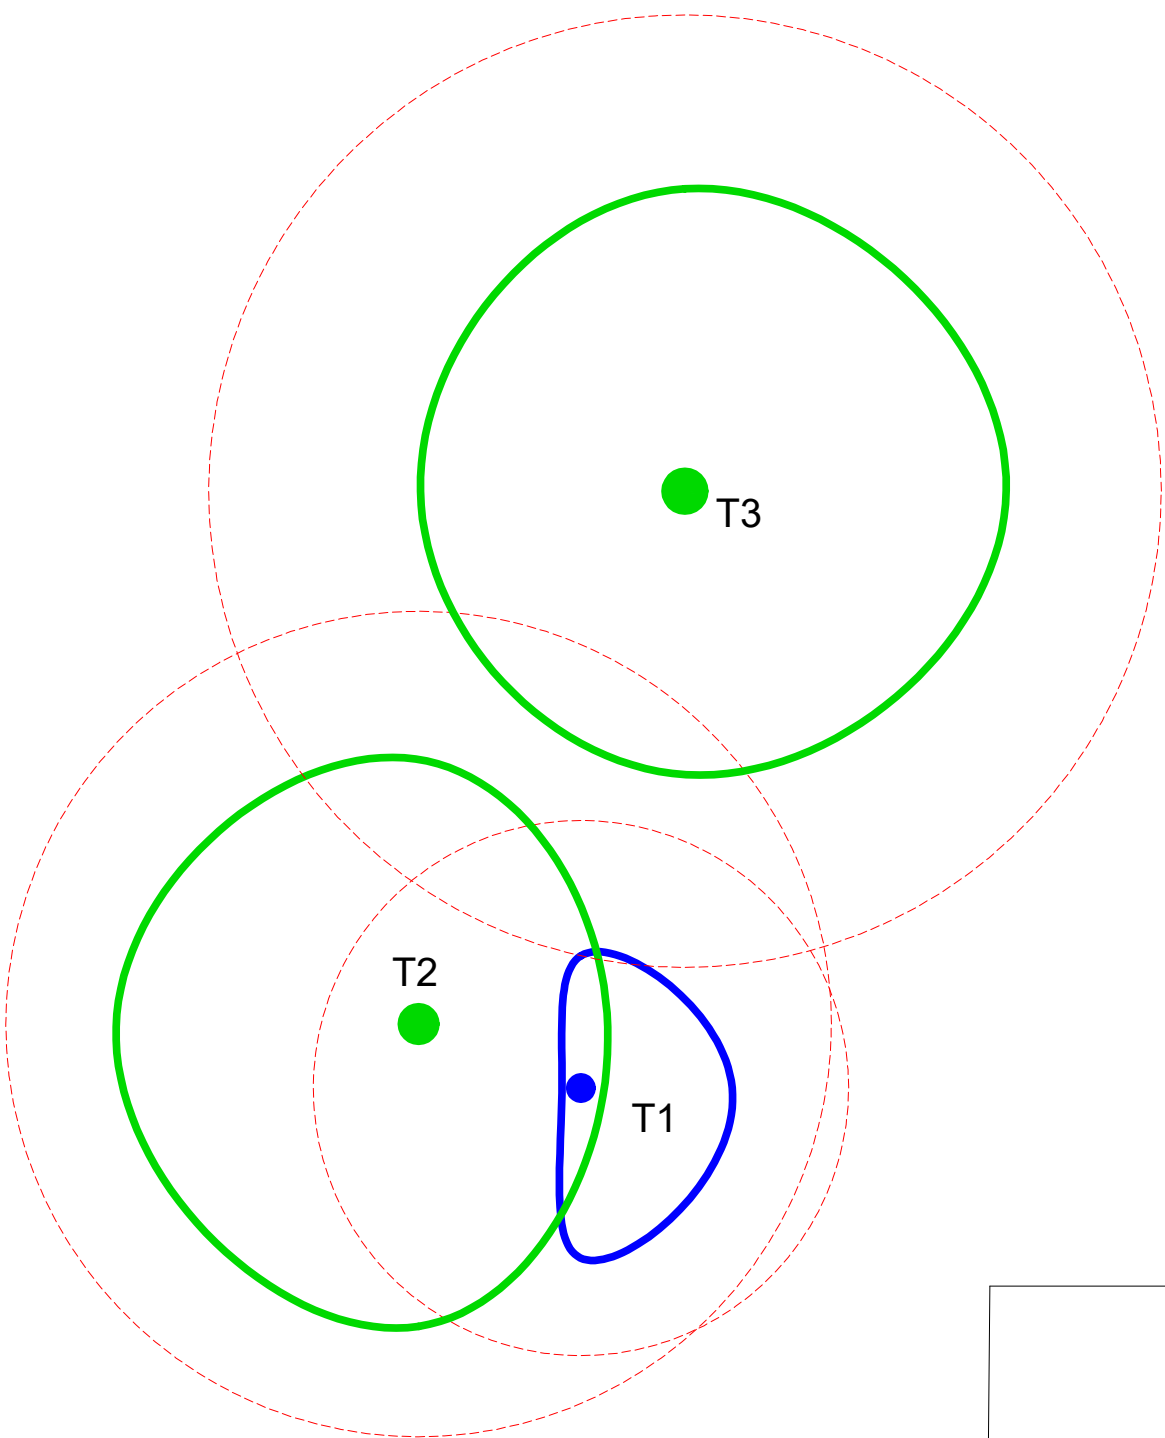
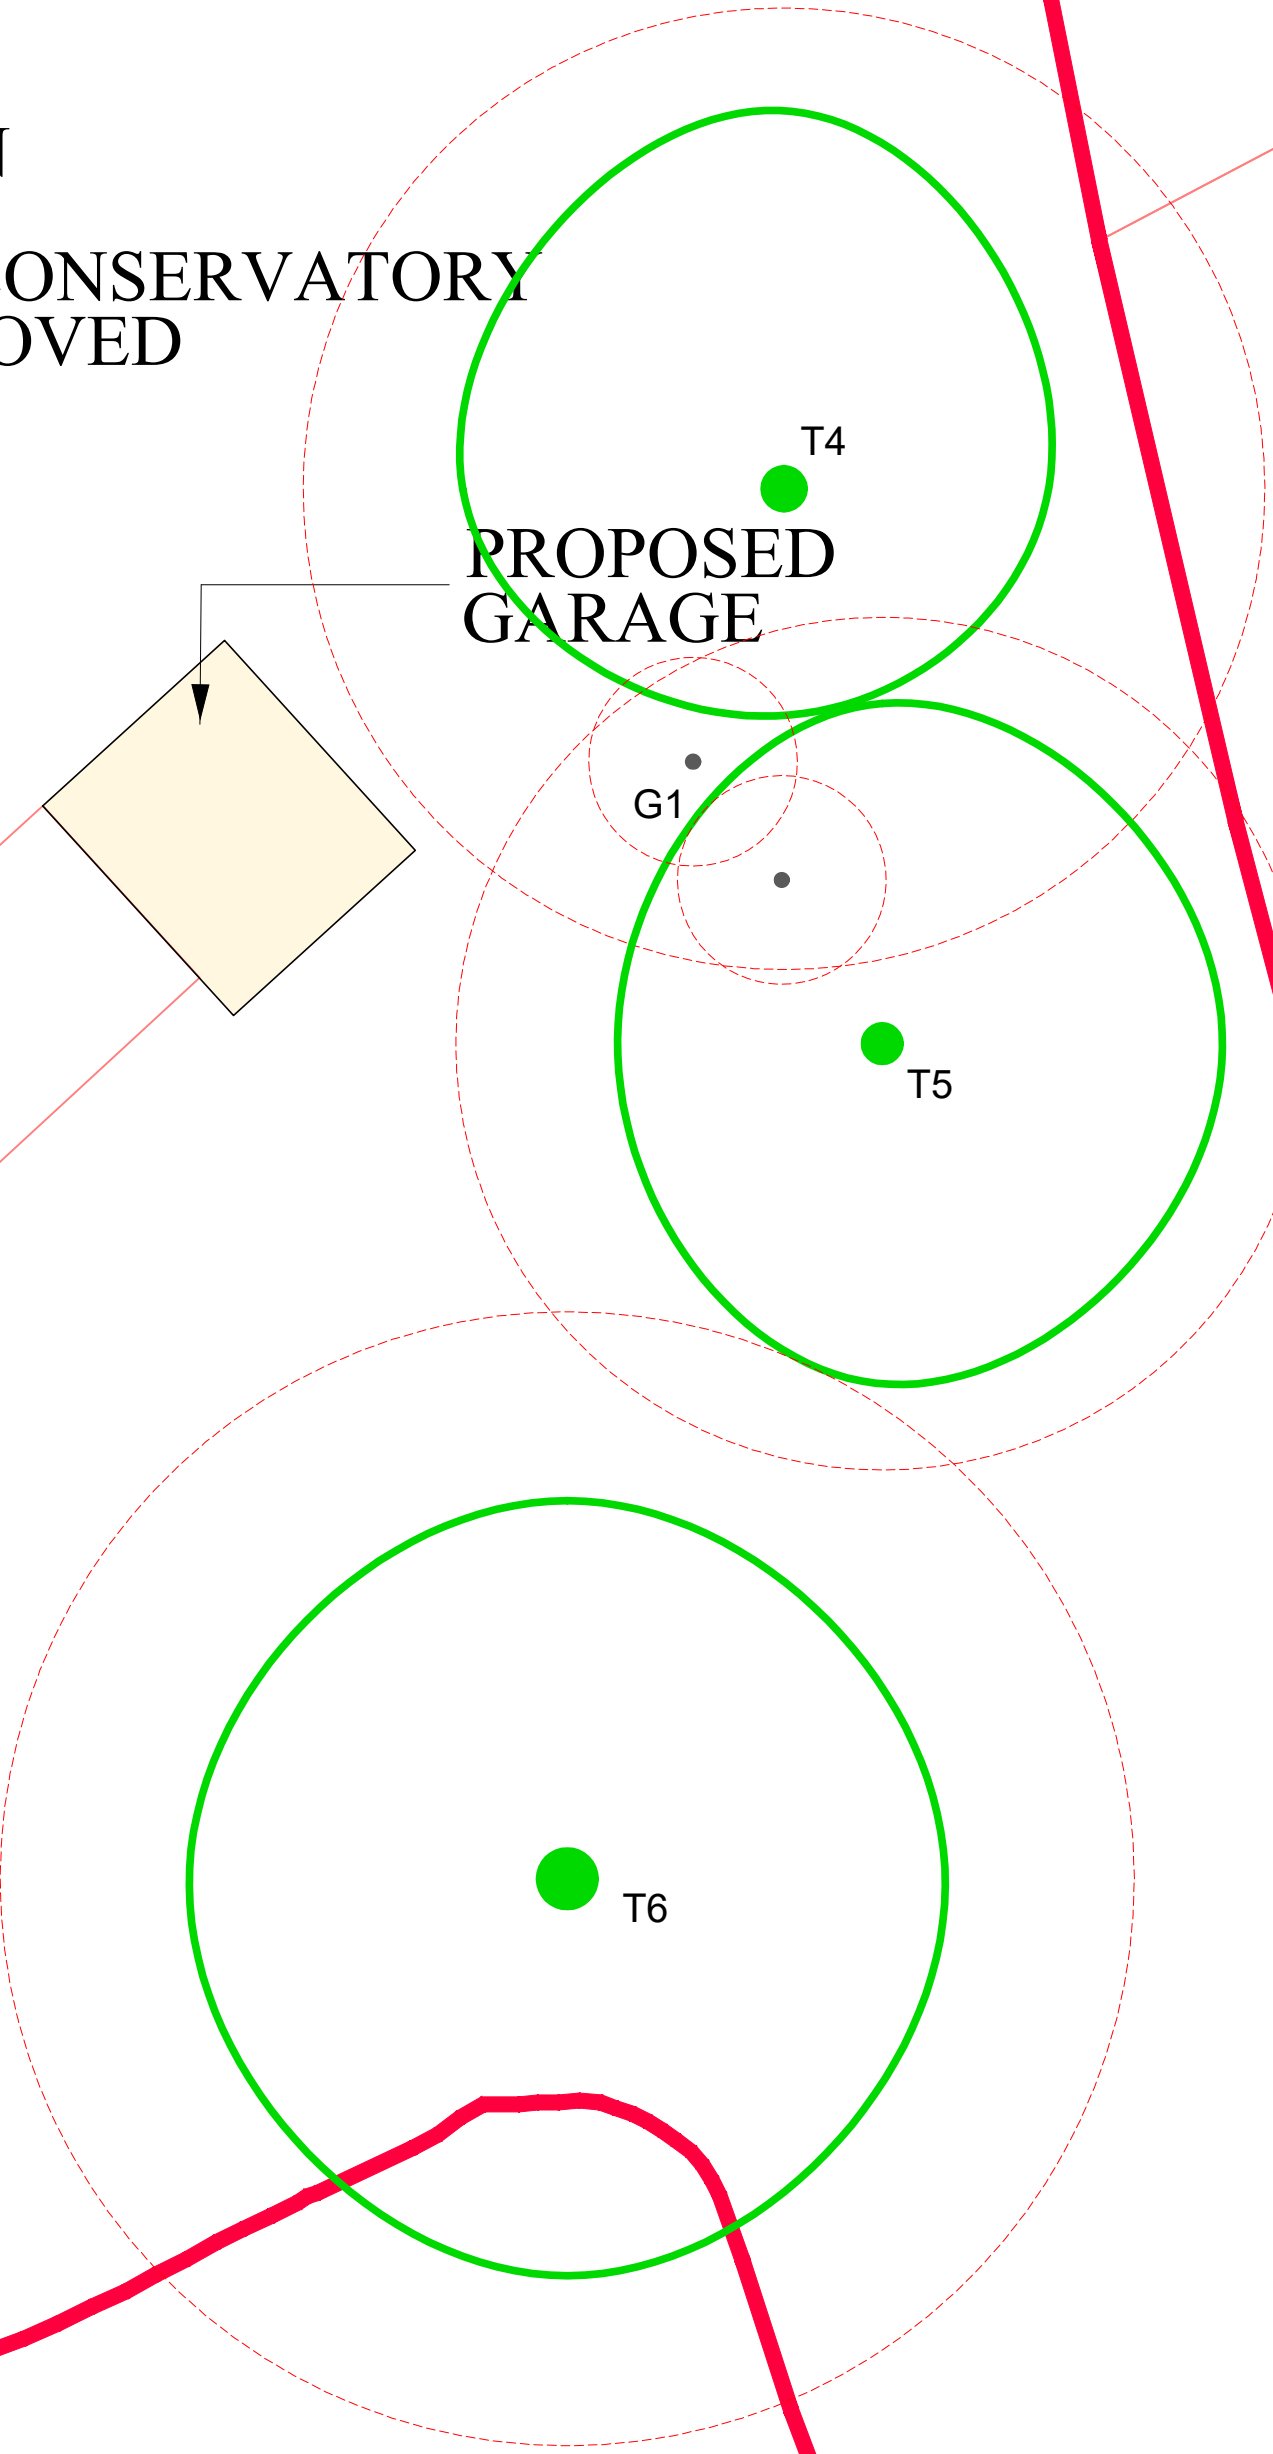
Drawing Title:  
AIS Plan

PROPOSED  
EXTENSION

EXISTING CONSERVATORY  
TO BE REMOVED

PROPOSED  
GARAGE

- 3.1 Due to the proposed development and its associated infrastructure there are a number of locations where the proposals are in close proximity to the trees surveyed. The Site Layout Plan within appendix three identifies the trees in relation to the proposed development.
- 3.2 In order to fully assess the impact of the proposals an Impact Table has been created detailing each tree, which shows the proximity of the associated works to the tree.
- 3.3 This can then be assessed in accordance with BS 5837:2012 to determine whether the development will have a detrimental impact on the health of each tree. Once this has been determined remedial measures can be detailed to reduce the impact the proposals will have on the treescape.
