## Ground Investigation Report

Proposed LED Floodlit 3G PlayZone Pitch

Back O'th Moss, Heywood

Document no.: STW6378-R02-Rev\_A

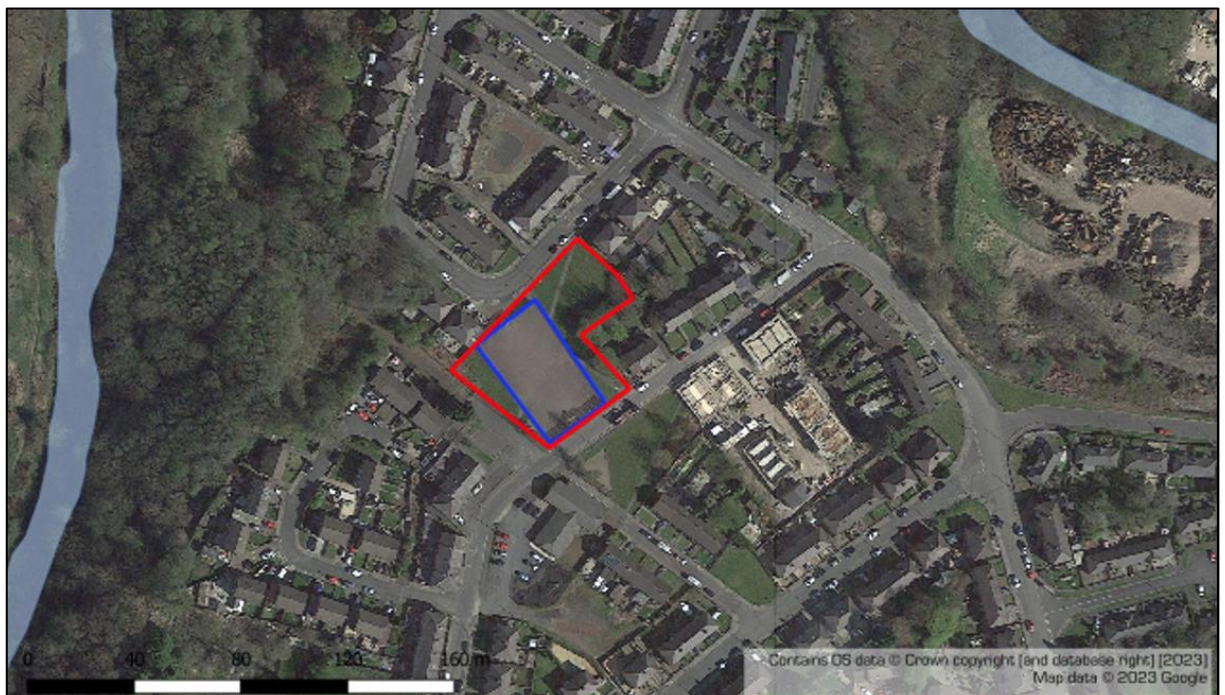
Figure 2-A: Aerial photograph of site boundary (red) and PlayZone Pitch footprint (blue)

2.2.2 An aerial image showing the approximate site boundary and development footprint is presented below, followed by a table summarising the key site features and a series of site photographs. A site plan is provided within Appendix A.

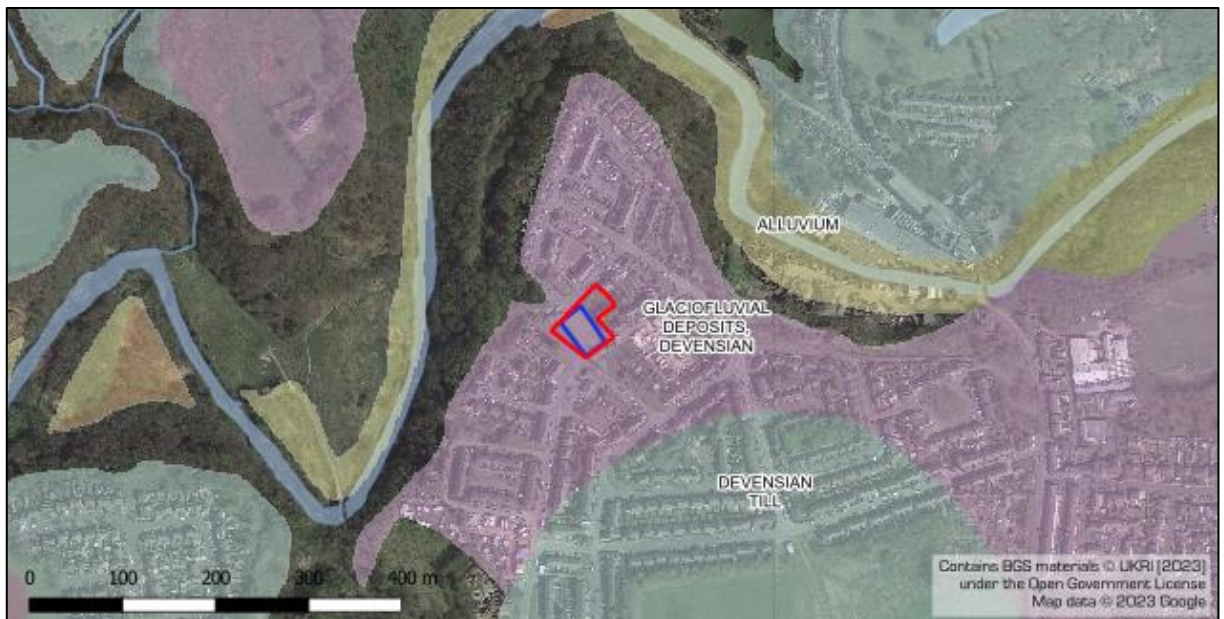
Figure 2-E: Extract from BGS showing superficial geology at the site

- 2.4.1 Based on a review of available records, the site is anticipated to be underlain by superficial Glaciofluvial Deposits (refer to Figure 2-E, below), with Alluvium surrounding the nearby River Roch. Devensian Till is also noted in the area and could also underlie the site.
- 2.4.2 In addition, due to historical terraced housing at the site, it is anticipated that Made Ground is present across the entire site footprint. This could comprise of reworked natural soils and demolition materials, where infilling of basements or cellars could have occurred.
- 2.4.3 The underlying bedrock is recorded as Pennine Lower Coal Measures Formation across the entirety of the site, with coal seams running parallel ~120m northeast and southwest of the site (refer to Figure 2-F, below).

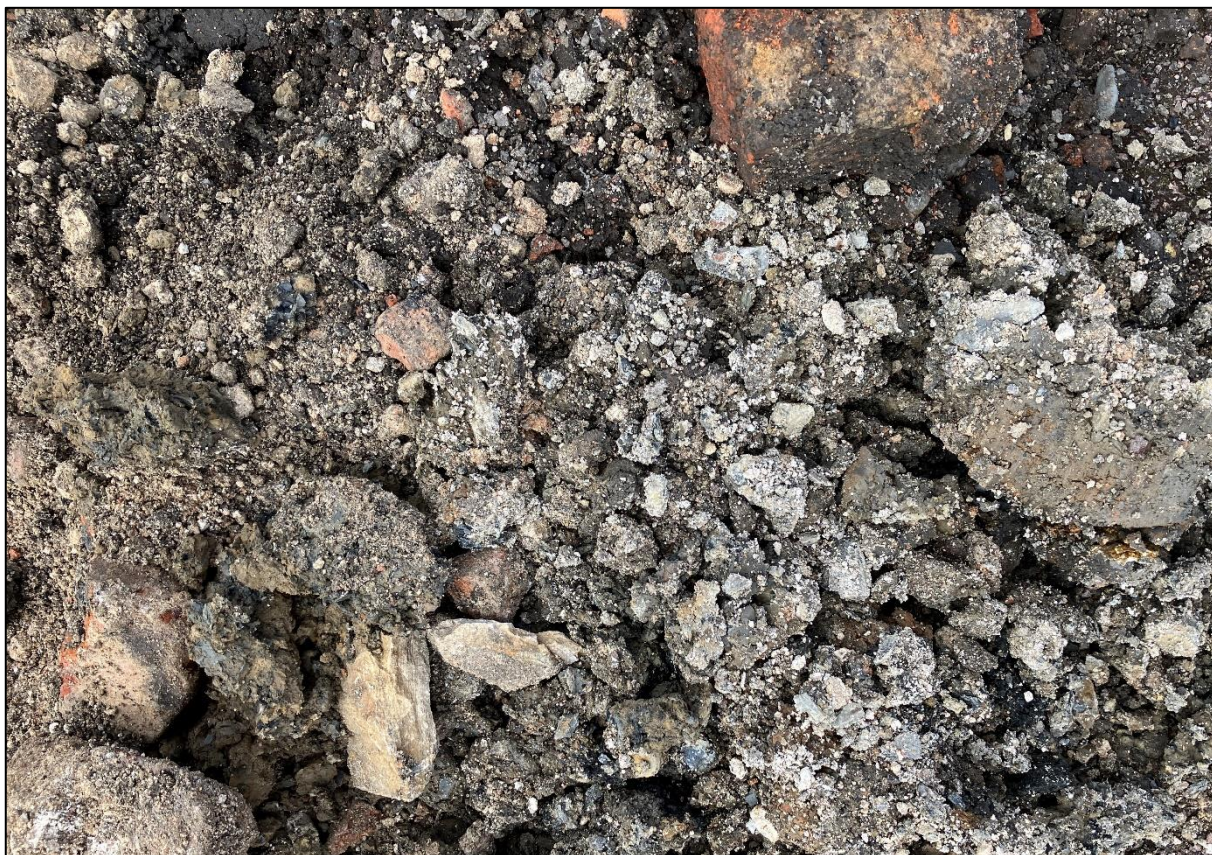
*Figure 5-A: Made Ground encountered within WS01*

5.3.2 The Made Ground was observed as either a brown very gravelly slightly clayey fine to coarse sand, or a dark brown slightly sandy slightly gravelly clay. Gravels comprised of brick, concrete, coal, sandstone, metal fragments, plastic fragments, tiles, slate and ceramics. In WS04 (southeast of proposed development area), the Made Ground comprised predominantly cobbles of brick between a depth of 0.15m and 0.45m bgl.

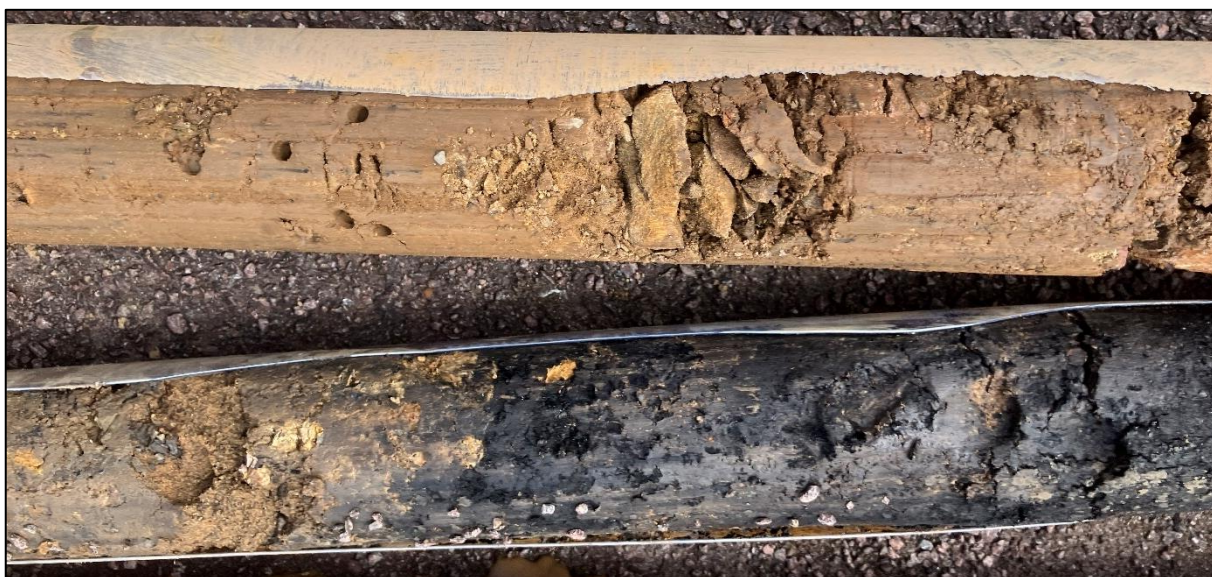
*Figure 5-B: Made Ground – Reworked Till encountered within WS02*

- 5.4.1 Reworked Till was encountered in all exploratory holes (except HP02 where the initial Made Ground was not fully penetrated). The base of the unit ranged from 2.7m to 3.2m bgl and was observed between 1.50m to 2.55m in thickness.
- 5.4.2 It is anticipated that the Reworked Till represents the material used to possibly infill the site following demolition of the former terraced housing.
- 5.4.3 The unit generally consisted of a firm and stiff sandy gravelly clay, with gravels of sandstone and coal. A band of dark brown to black organic rich clay containing coal was noted within WS02 (northwest of proposed development area), between a depth of 2.3m and 3.0m bgl.
- 5.4.4 A photograph of the Made Ground – Reworked Till is presented below.

7.3.3 However, the Reworked deposits of Till, present from depths of 0.65m to 1.2m bgl and overlying the loose Glaciofluvial Deposits, are likely to be considered suitable for supporting floodlight foundations. It is considered deposits were placed following the historic clearance of the dwellings onsite. Such deposits will have generated some self-weight settlement, the majority of which is likely to have occurred.

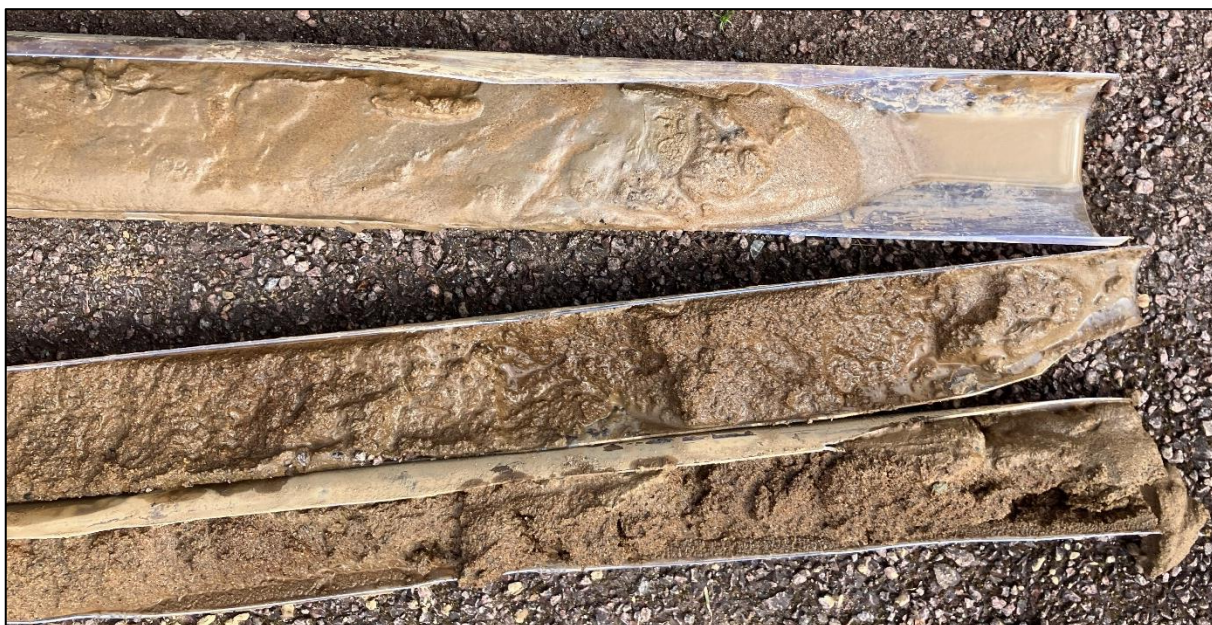
*Figure 5-C: Glaciofluvial Deposits encountered within WS02*

- 5.5.1 Glaciofluvial Deposits were encountered in all exploratory holes except HP01 and HP02. The base of the unit and thickness was not proven as it surpassed termination depth of all exploratory holes.
- 5.5.2 The Glaciofluvial Deposits typically consisted of very loose greyish brown clayey gravelly sand with localised bands of soft greyish brown slightly sandy clay.
- 5.5.3 A photograph of the Glaciofluvial Deposits encountered is presented below.

7.3.2 The naturally derived Glaciofluvial Deposits were observed from depths of 2.7m to 3.2m bgl and typically comprised of very loose deposits of sand. Such soils are considered unsuitable for supporting concentrated foundation loads for floodlighting without promoting excess settlement. Moreover, the depth of the deposits will also likely render the construction of a traditional foundation uneconomical/impractical difficult to achieve at such depths.
