# **Remediation Strategy and Implementation Plan Residential Development Neighbourhood, Rochdale**

**Report Prepared for Willmott Dixon Construction Ltd**

**Report Ref: 14251 - FPE0422NRF**

**September 2022 – FINAL**

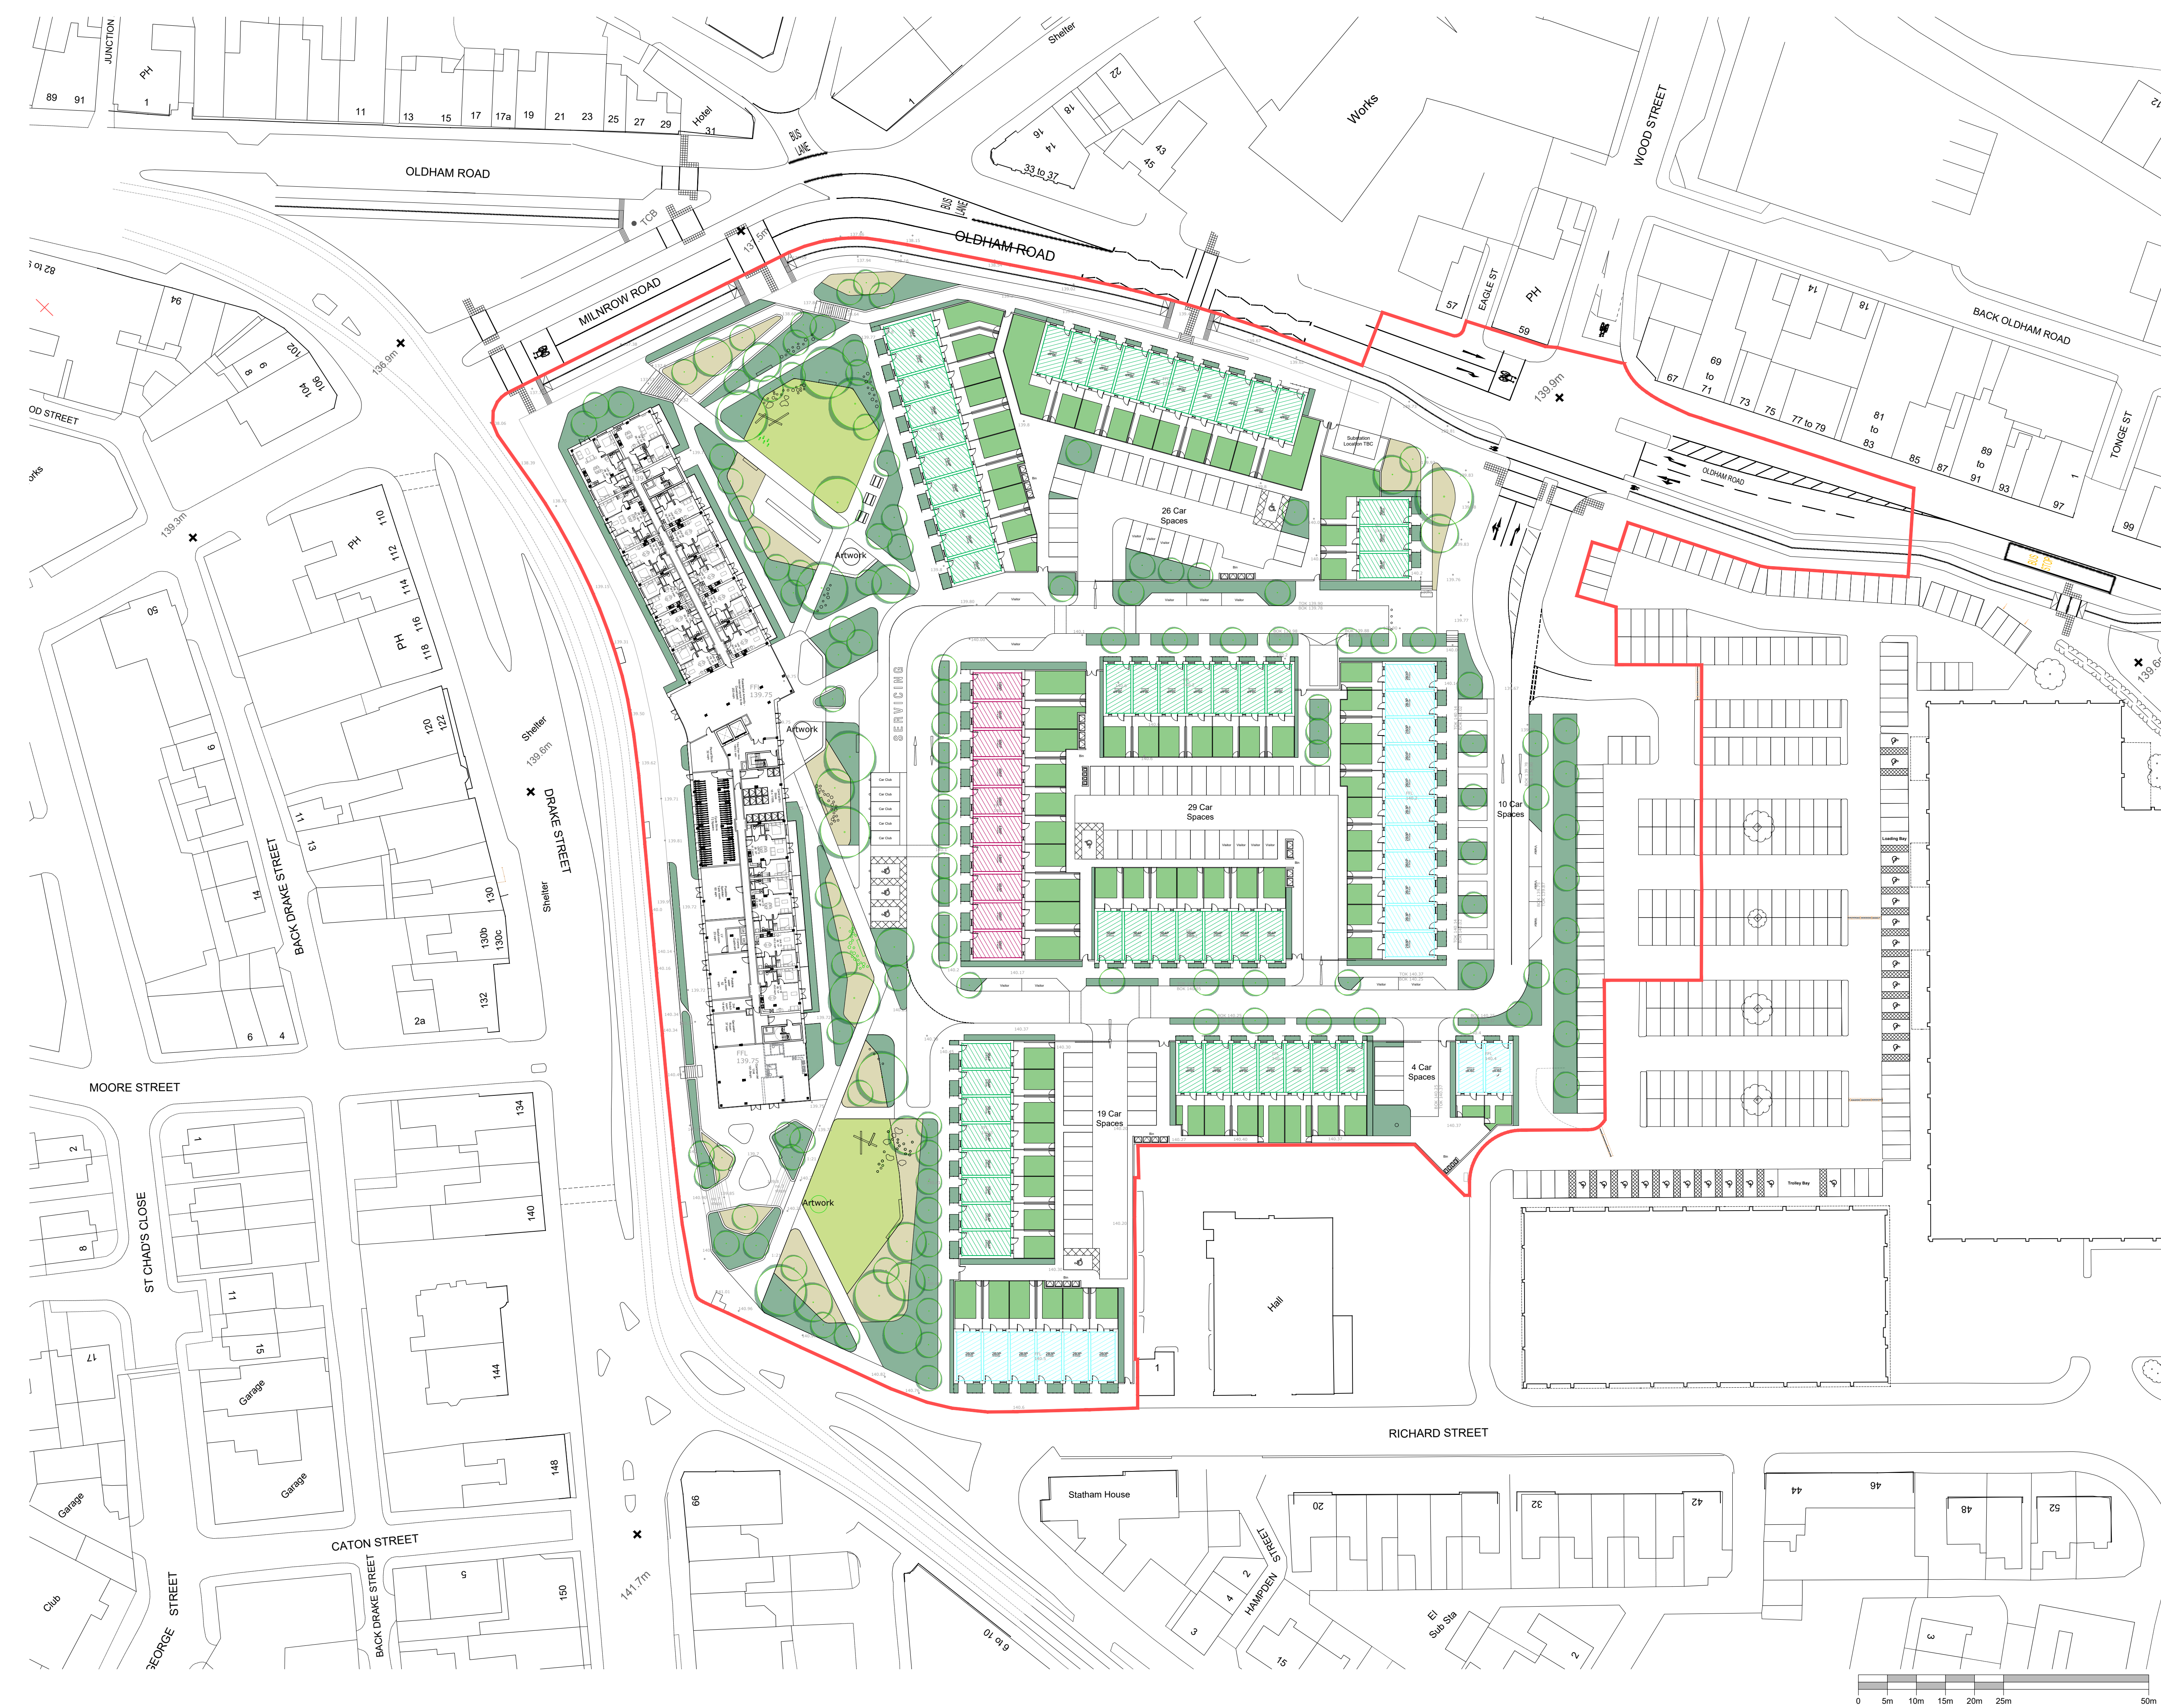
- WS: DEVOTES WINDOW SAMPLE BOREHOLES UP TO 5.0m BGL
- CP: DEVOTES CABLE PERCUSSION BOREHOLES UP TO 30m BGL
- H: DEVOTES HAND EXCAVATED PIT TO 1.2m BGL
- TT1-TT18: DEVOTES TRIAL TRENCHES UP TO 3.0m BGL TO RECORD GROUND FLOOR SLAB THICKNESS AND INSPECT EXISTING FOUNDATIONS
- TT19-TT20: DEVOTES TRIAL TRENCHES UP TO 3.0m BGL TO LOCATE CANAL WALLS. REFER TO LOSS T19M TO T19M FOR EXTENT OF T19M TRIAL TRENCH. T20M TO T20M FOR T20M EXTENT AND T20M TO T20M FOR T20M EXTENT
- B: DEVOTES BOUNDARY
- AREA OF HIGH BOUNDARY INTO THE SITE

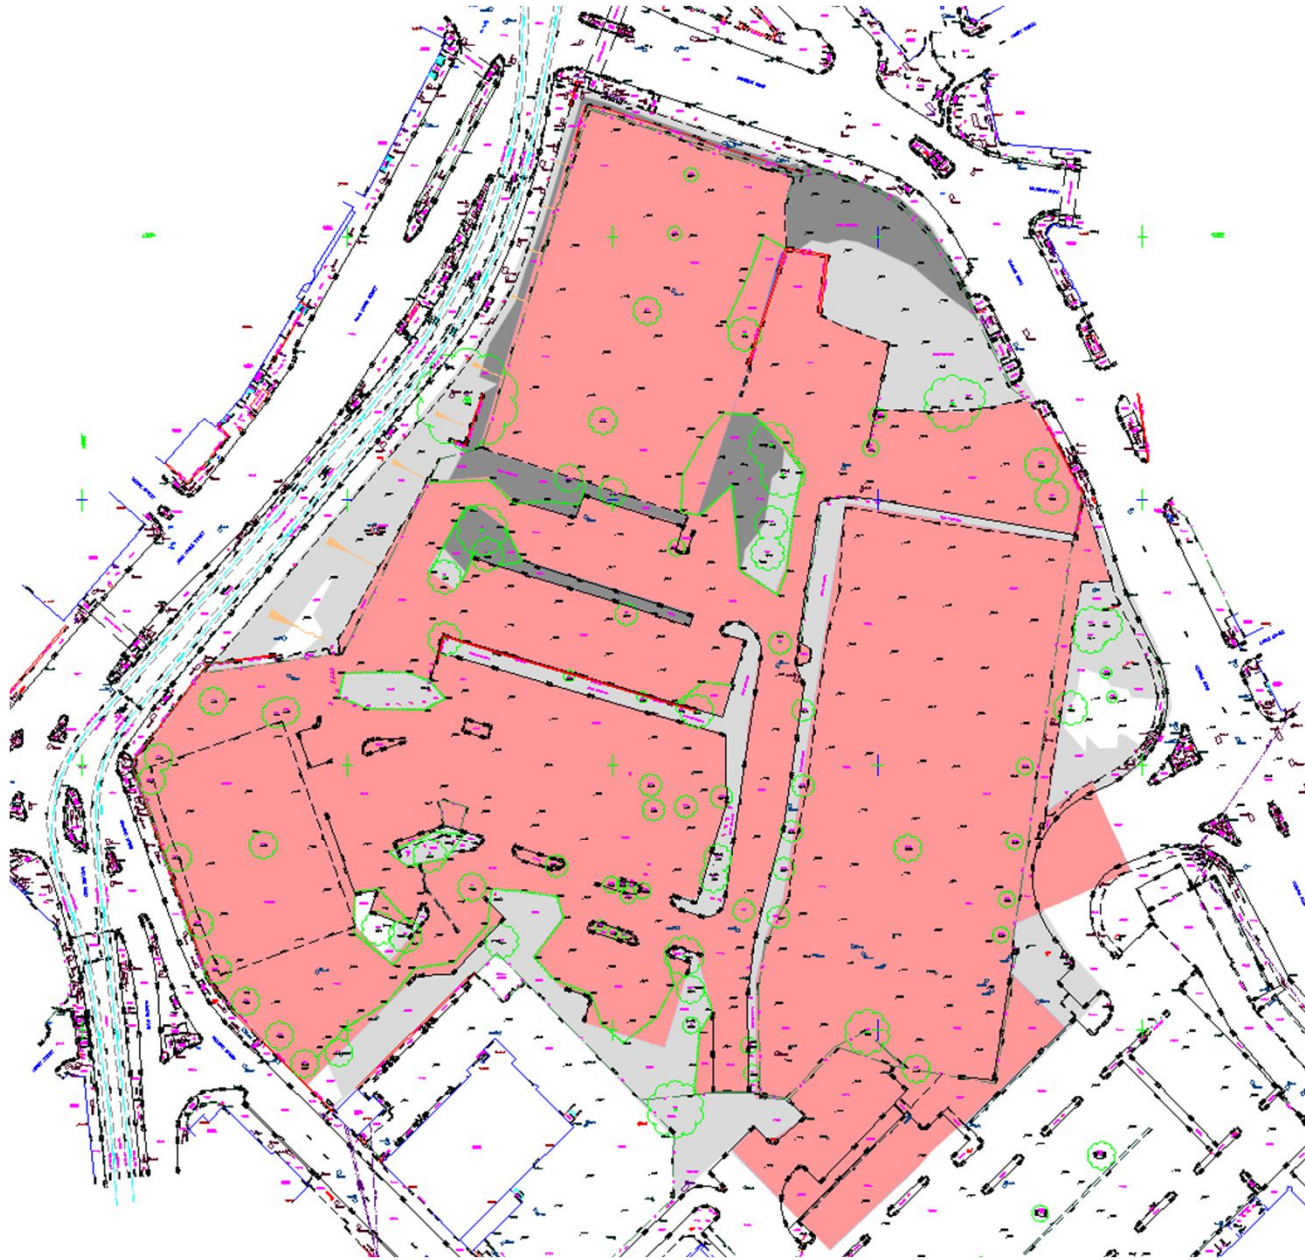
Figure 3: Lift hardstanding and slabs to stockpile, circa 2,900m<sup>3</sup>.

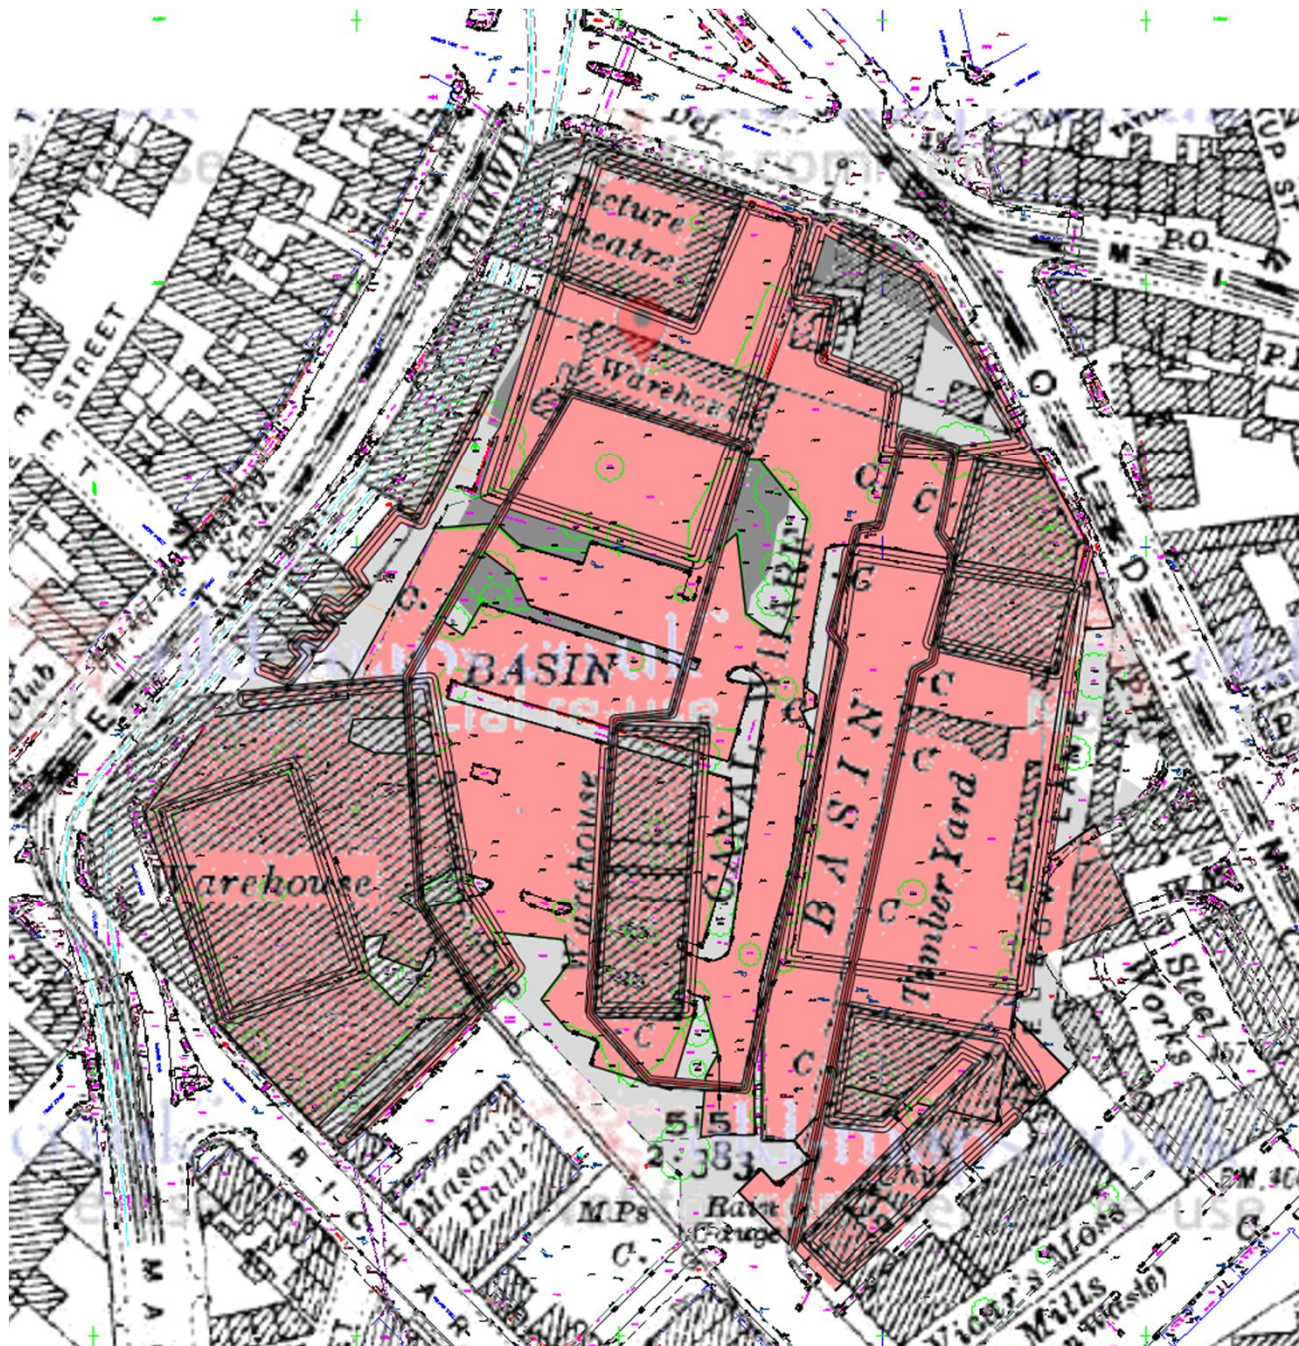
Figure 4: Strip sub-base and break out relic foundations to stockpiles, circa 6,200m<sup>3</sup>.

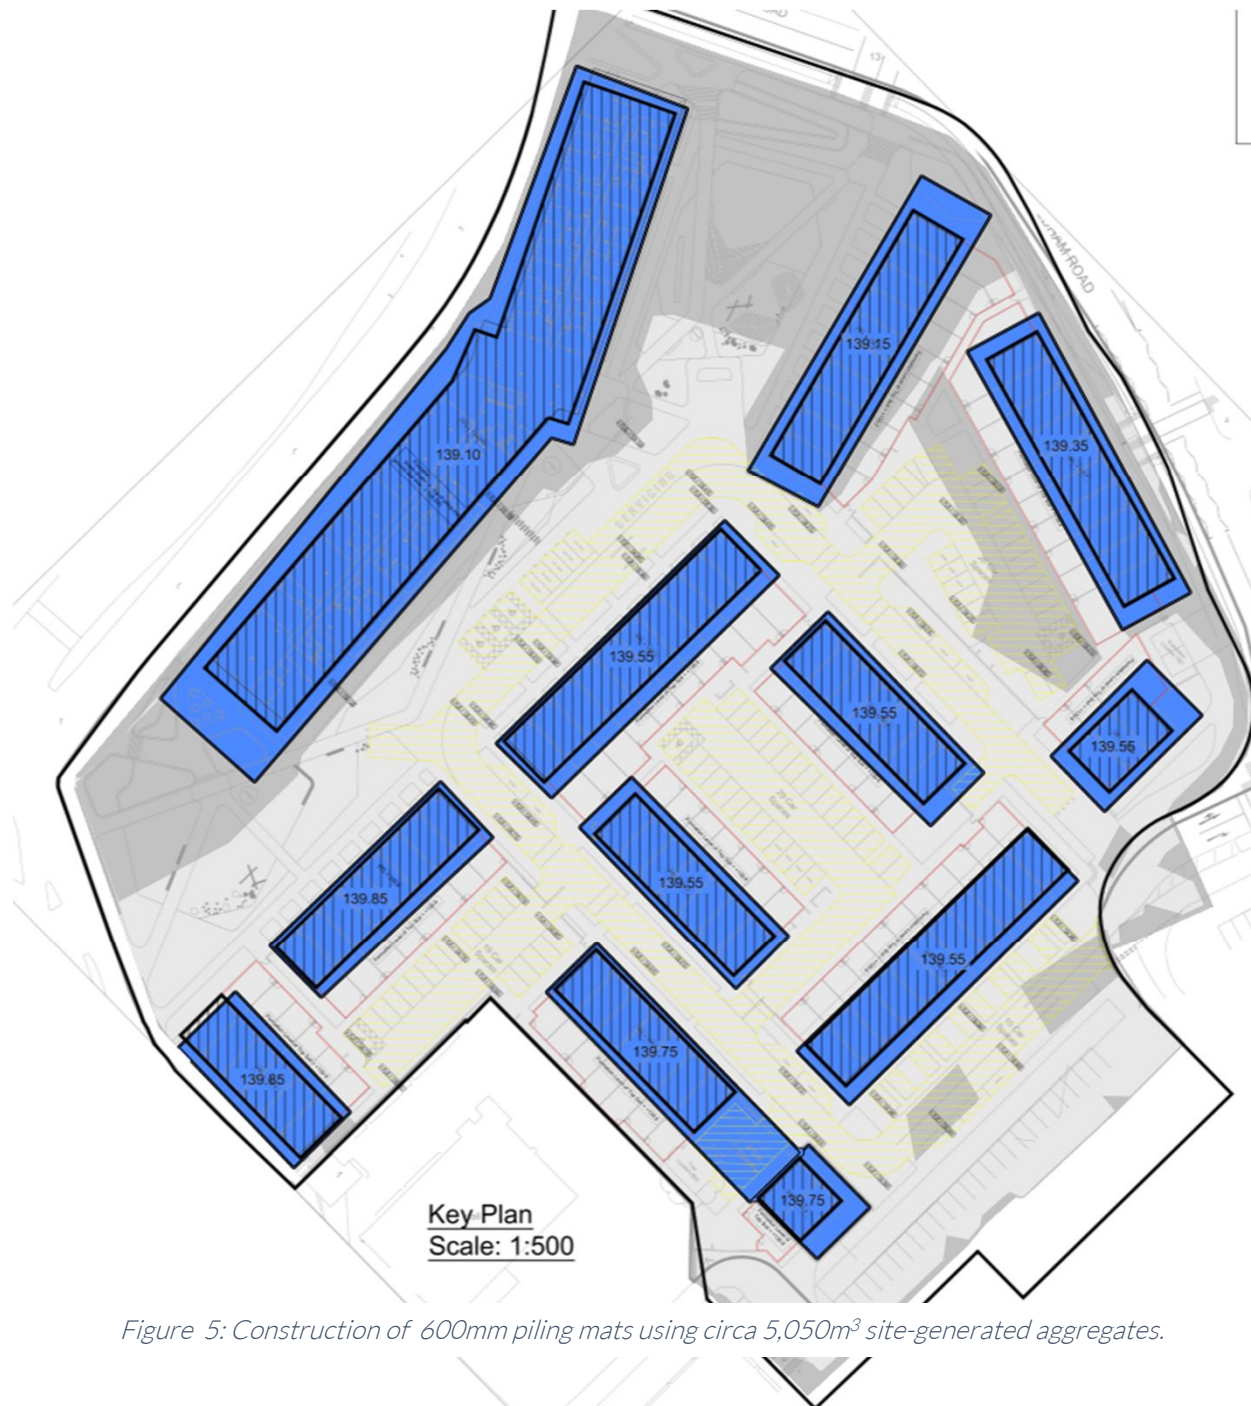
Figure 5: Construction of 600mm piling mats using circa 5,050m³ site-generated aggregates.
