## **Piling Risk Assessment**

**Wildhouse Lane  
Milnrow  
For  
Lancet Homes Limited**

| <b>Report number</b> | 429.11.22.PRA |

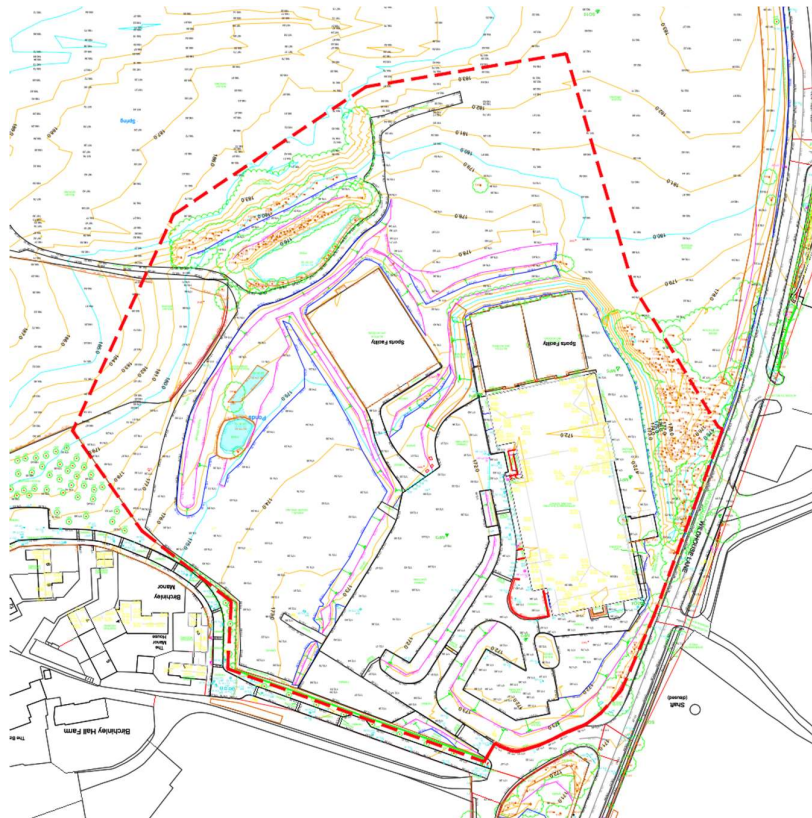
Figure 1- Site Layout

The site is located off Wildhouse Lane, Milnrow OL16 3TP at National Grid Reference 392907 413729. The site lies within a predominantly rural location, surrounded by open fields and houses. The site comprises circa 4.8 ha. The site is bound by Wildhouse Lane to the west, an access road to Birchinley Hall Farm to the north, with open fields to the east and south. The site is accessed from the north via Wildhouse Lane.

All above ground buildings have been demolished and the site has been prepared ready for construction.

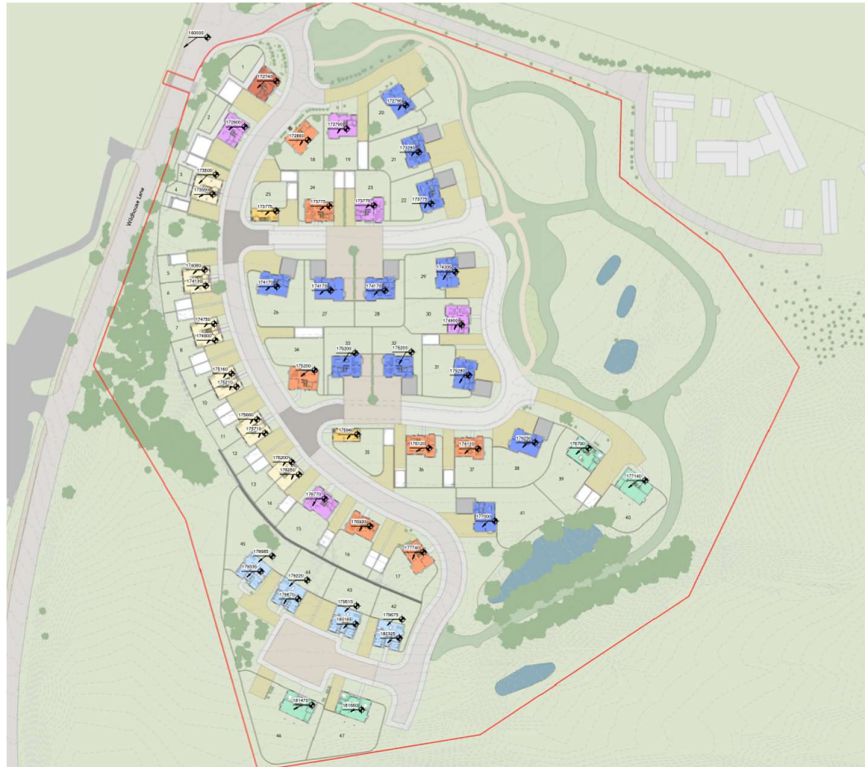
**Figure 2 – Proposed Site Layout.**

The proposed development comprises the construction of 47No. houses with associated gardens, driveways and access roads as shown on the Masterplan Drawing included in Appendix A (see Buttress 8764-BA-ZZ-00-DR-A(04)201-V) and below.

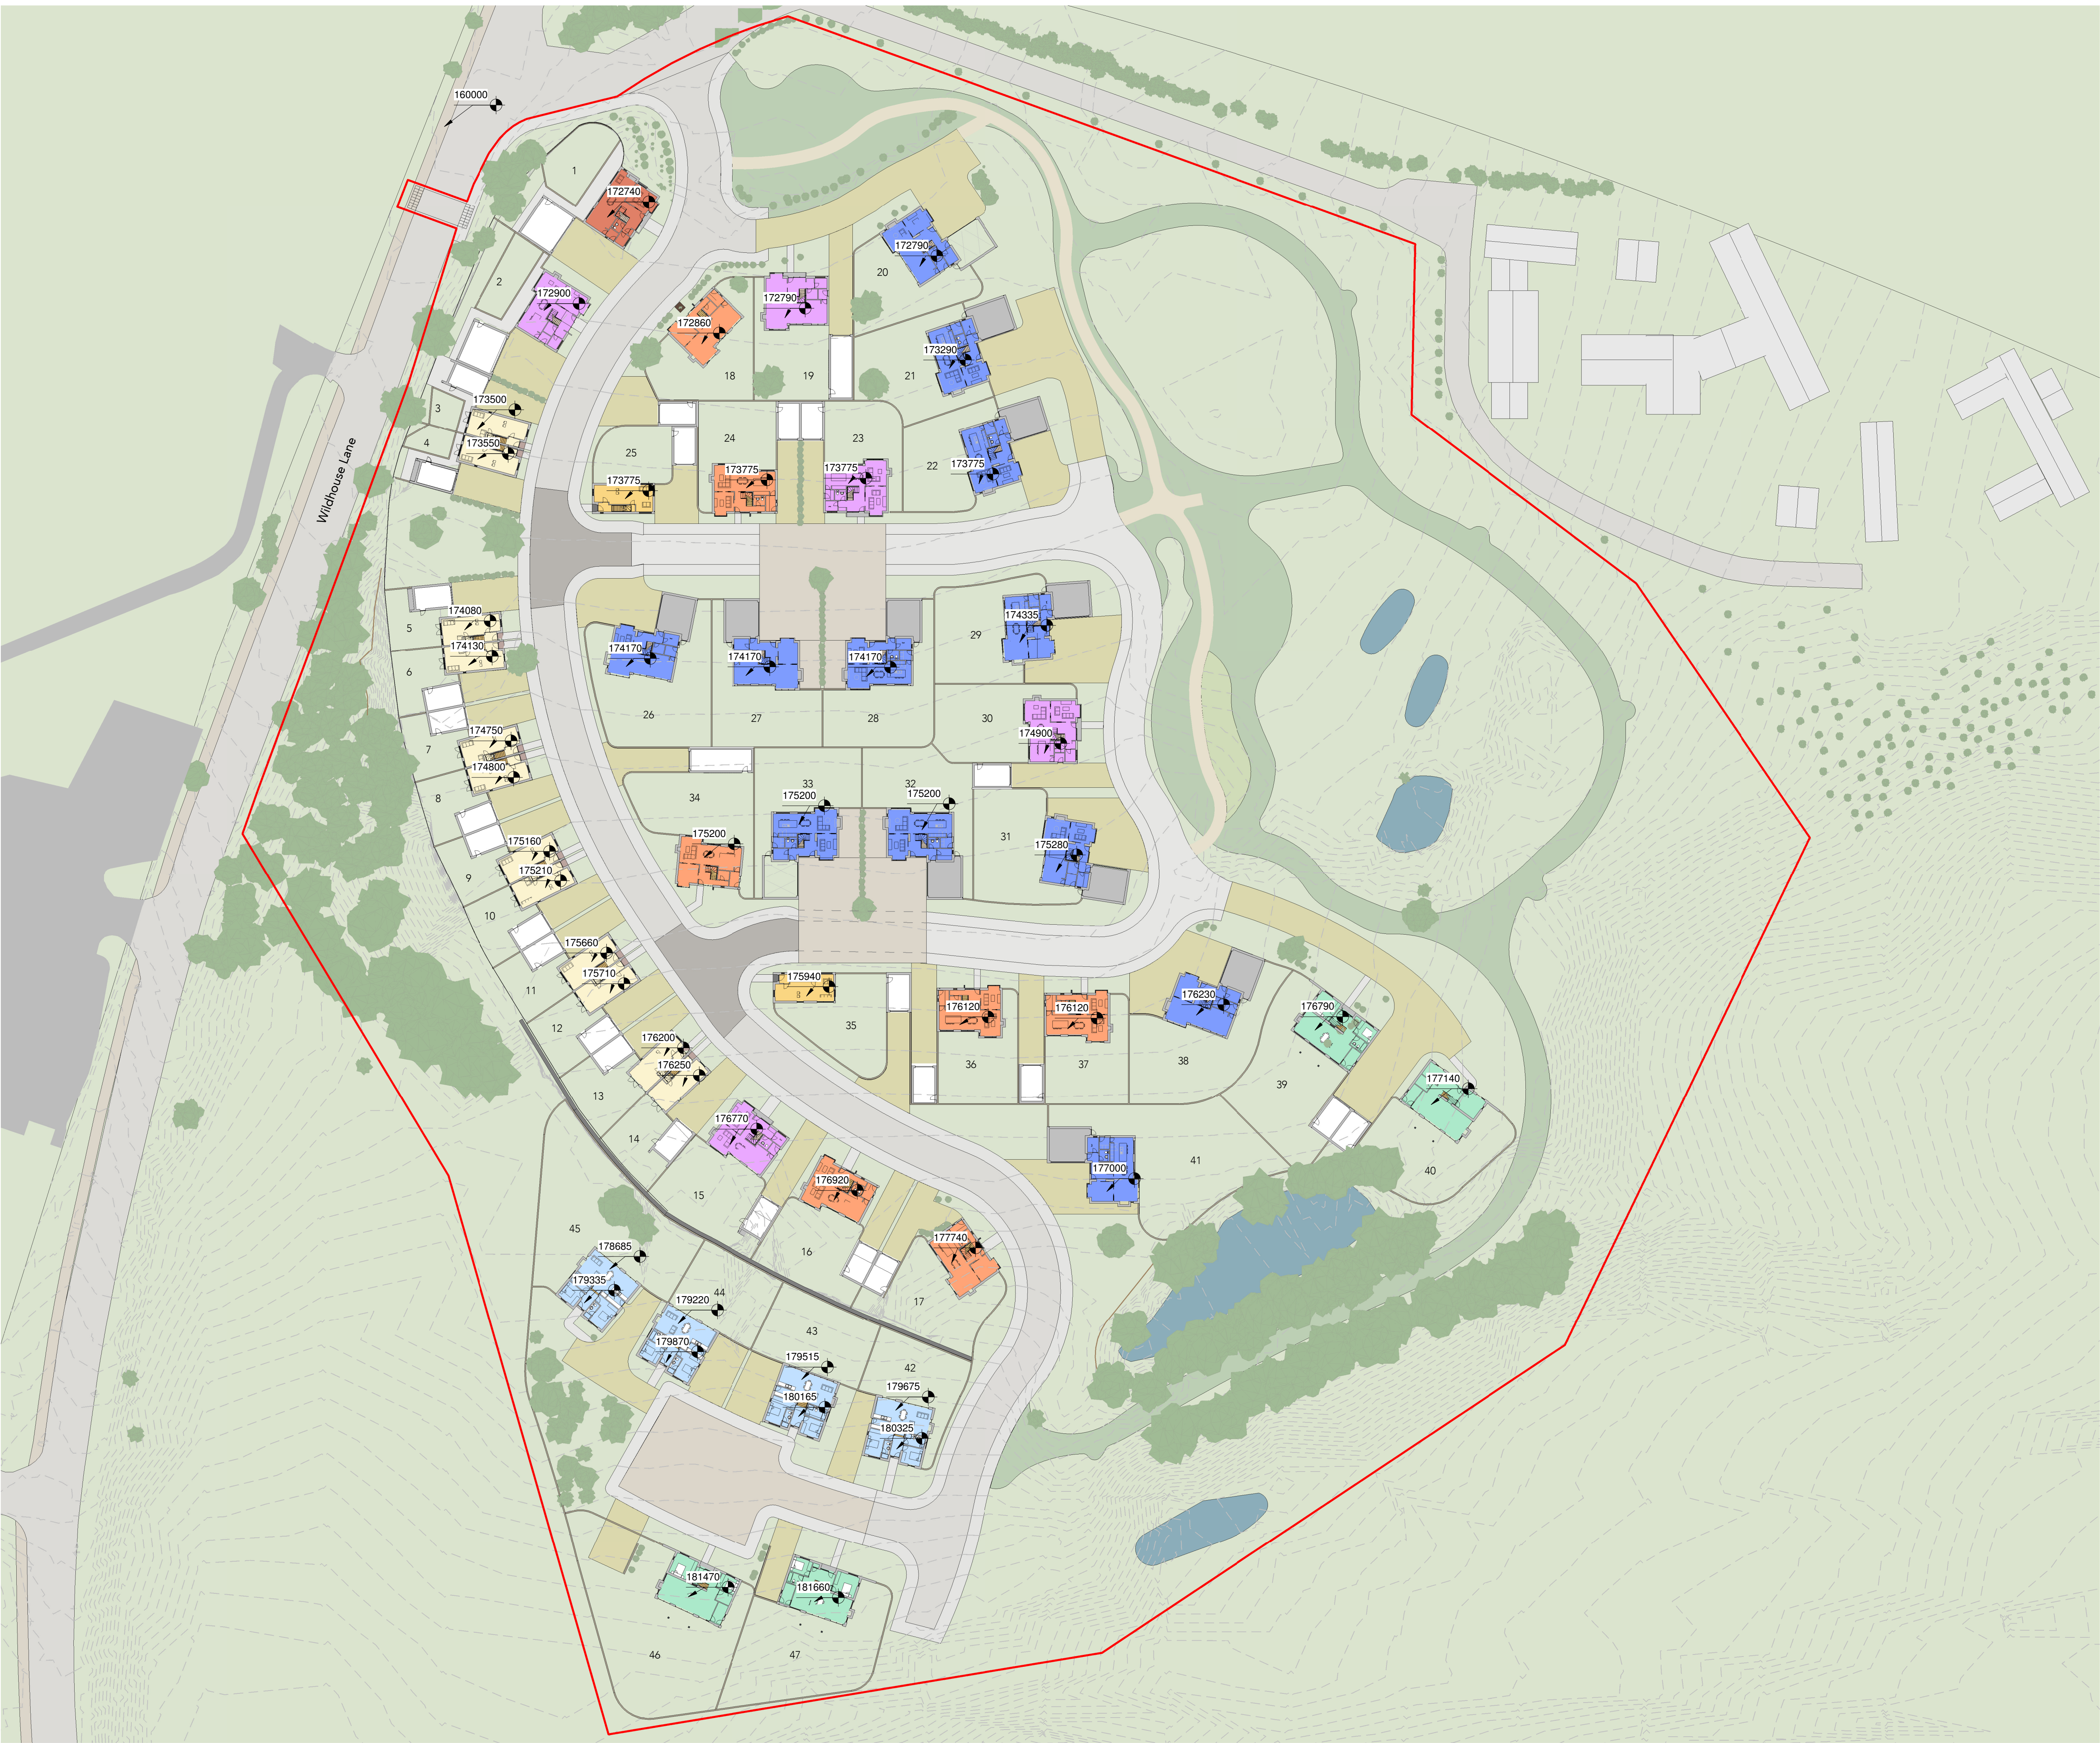
| Drawing ref | Site Plan |

- Key
- HT01 - 5 Bed 191.1m<sup>2</sup> - 12 units
- HT02 - 4 Bed 159.6m<sup>2</sup> - 5 units
- HT03 - 4 Bed 143.8m<sup>2</sup> - 7 units
- HT04 - 4 Bed 159.6m<sup>2</sup> - 1 units
- HT05 - 2 Bed Bungalow 88.9m<sup>2</sup> - 4 units
- HT06 - 3 Bed Bungalow 111.3m<sup>2</sup> - 4 units
- HT07 - 3 Bed Semi - 111.6m<sup>2</sup> - 12 units
- HT08 - 3 Bed Detached 84.4m<sup>2</sup> - 2 units

Total Units: 47
