# Contaminated Land Phase II Intrusive Investigation for proposed residential development at 112 Church Street, Littleborough, OL15 8AS.

Prepared for

James Campbell Associates,  
Campbell House,  
173 Rochdale Road,  
Firgrove,  
Rochdale,  
OL16 3BN.

December 2023

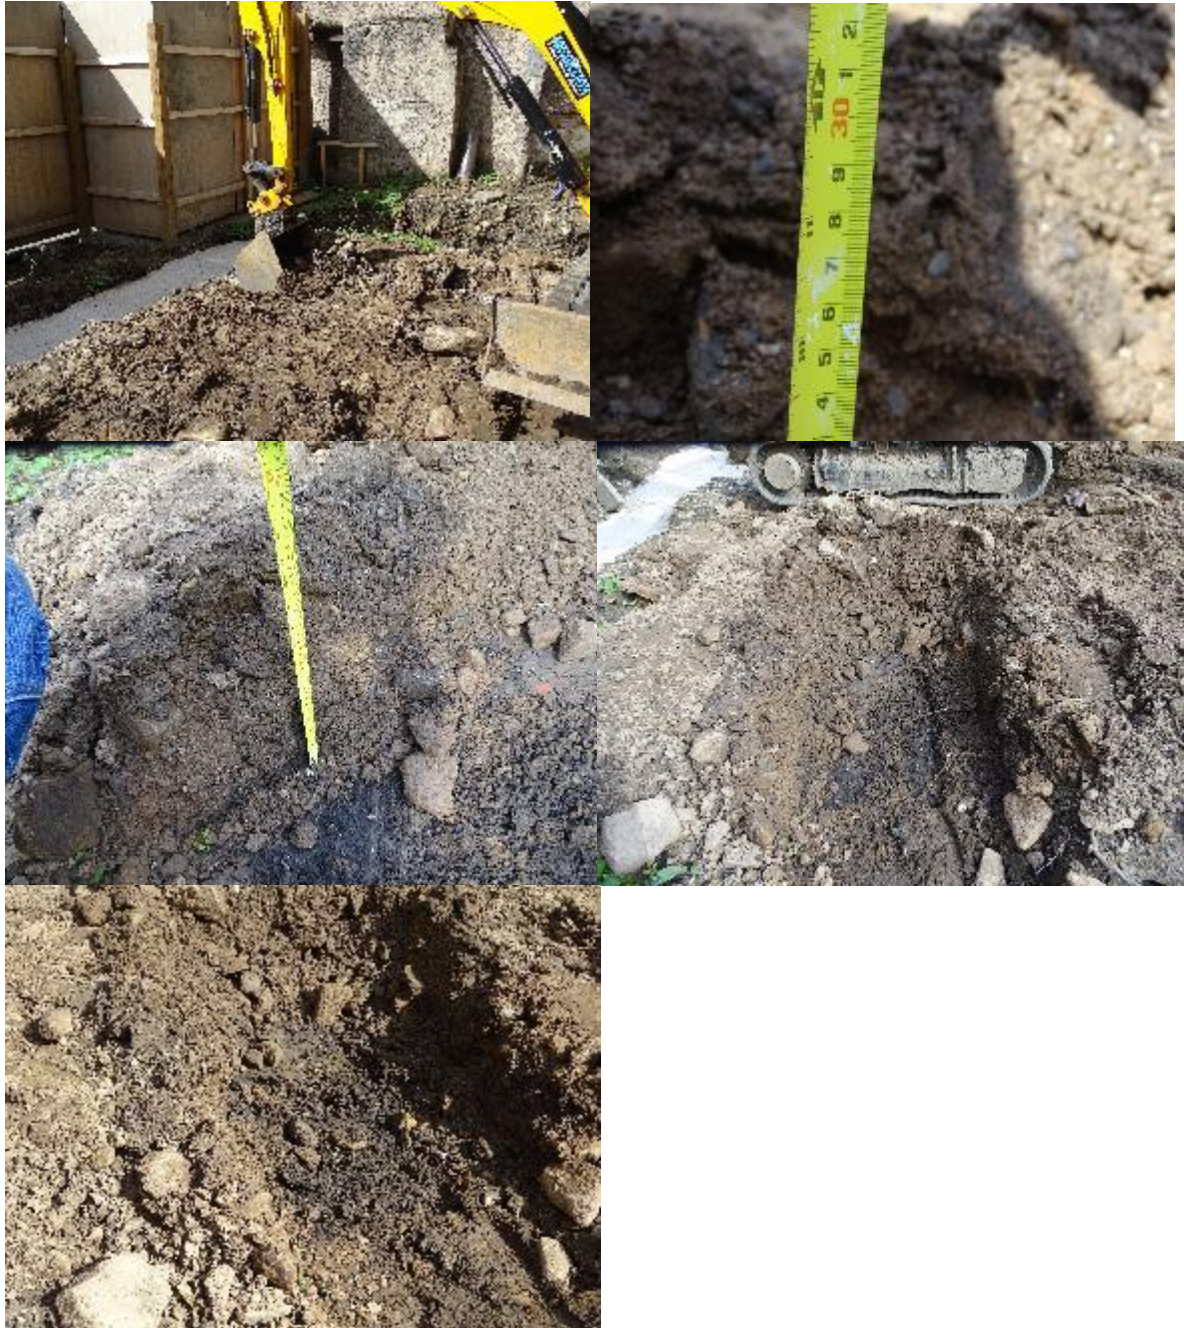
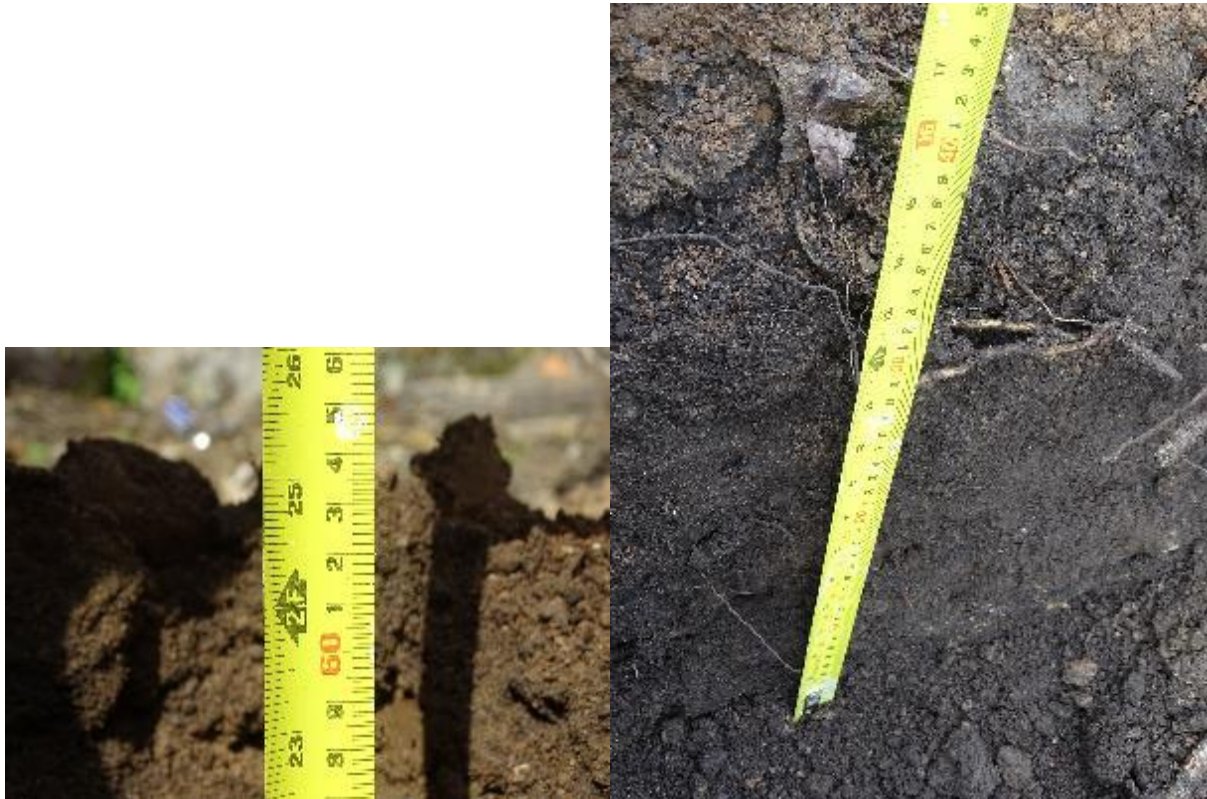
### Trail Pit 1a

Trail pit 1 – South boundary by road, within foundations

0.00-0.30m      loamy sandy soil, clay, stone, gravel and roots,

0.30-0.60m      loamy sandy soil, stone gravel, and roots,

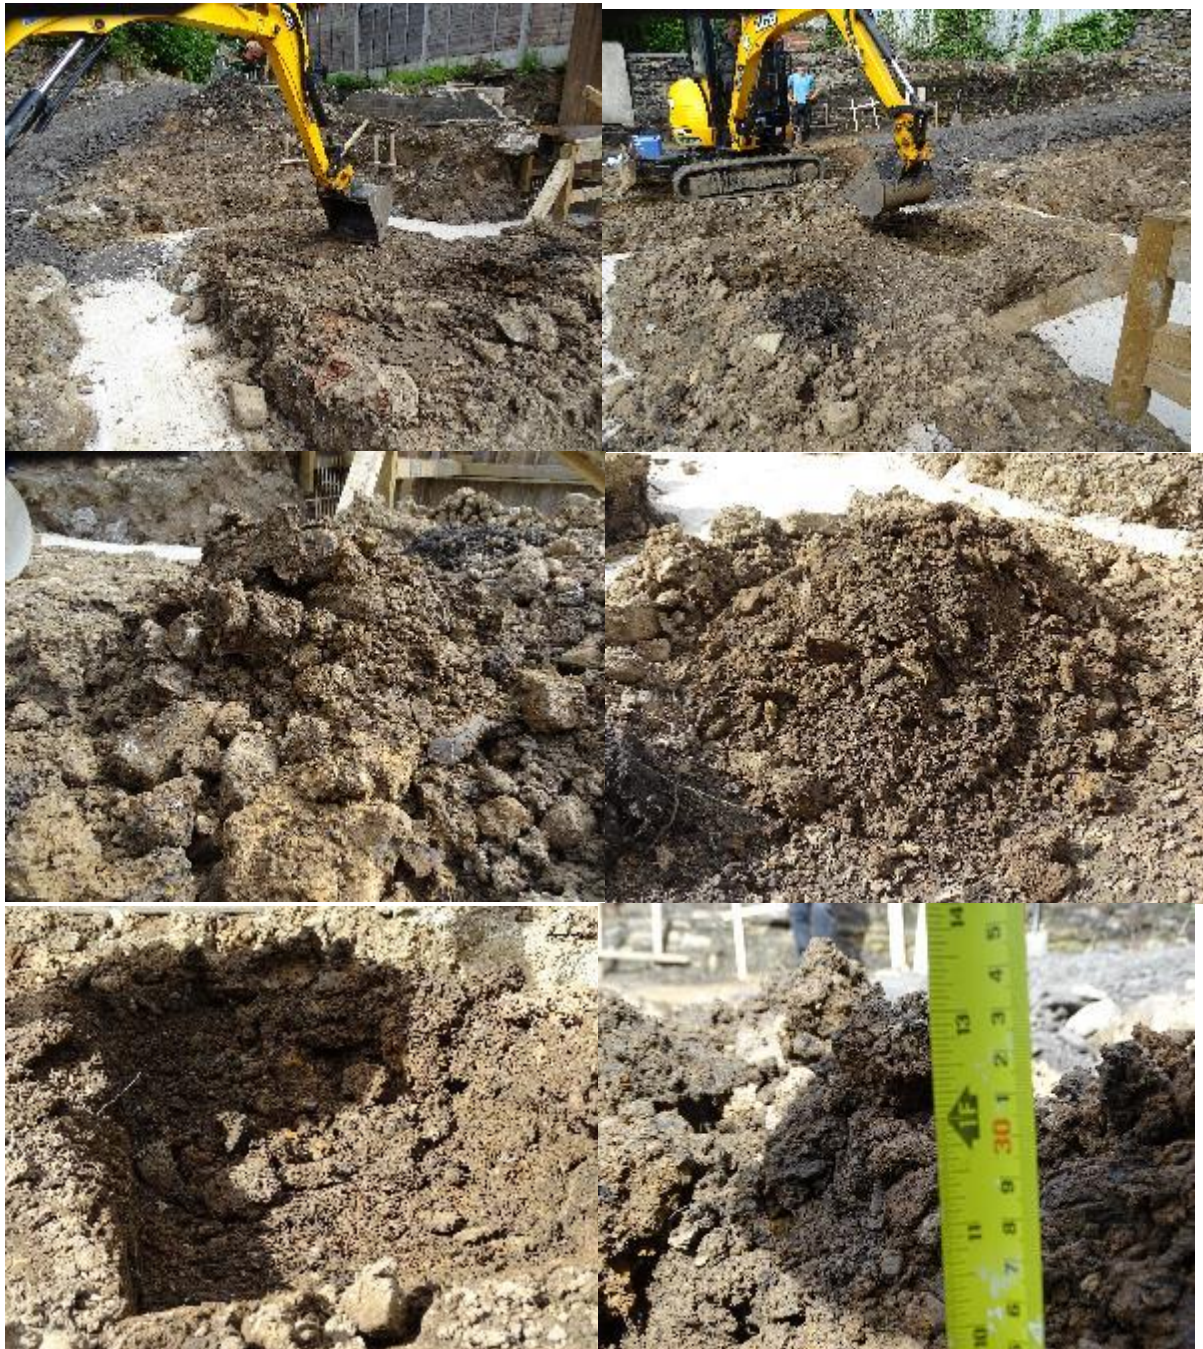
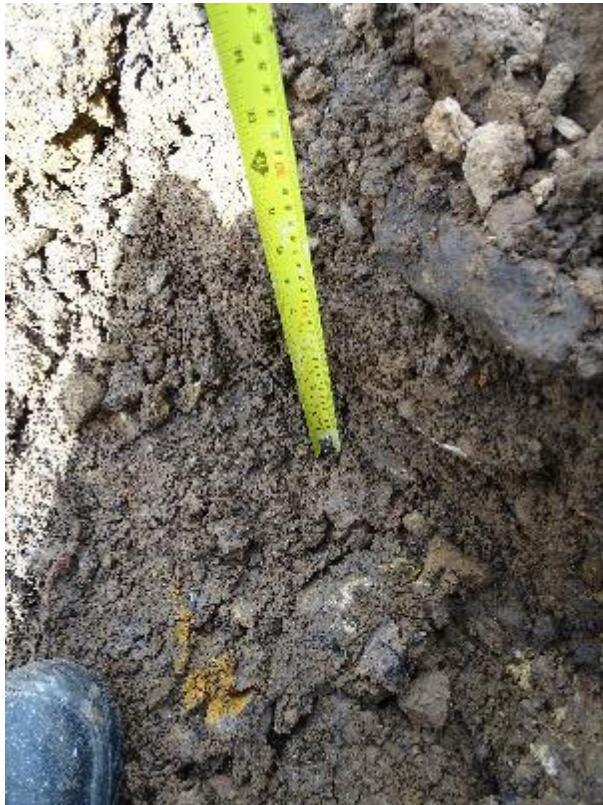
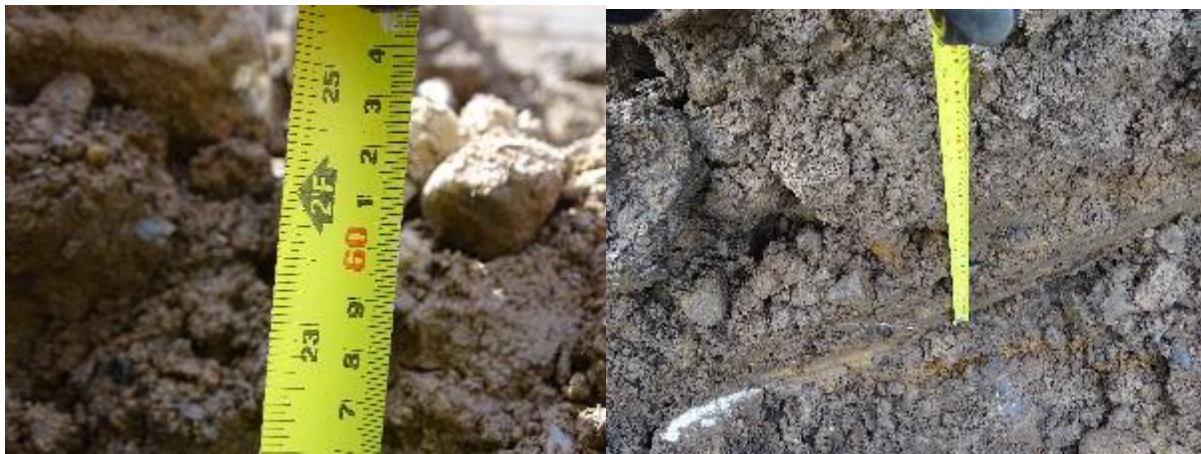
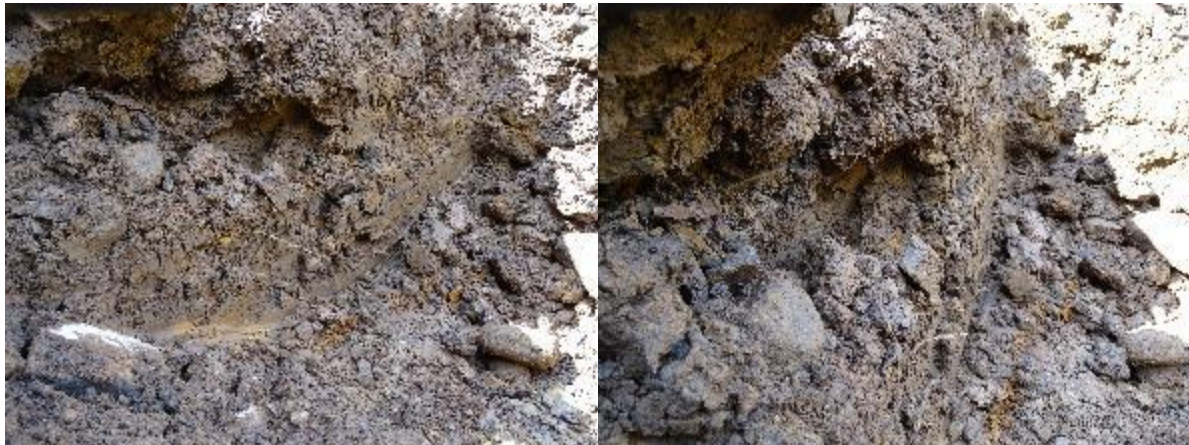
## Trail Pit 2a

Trail pit 2 – Rear of neighbouring house to the west,  
within foundations

0.00-0.30m      Sandy Clay with stones and gravel,

0.30-0.60m      Sandy clay stones and gravel

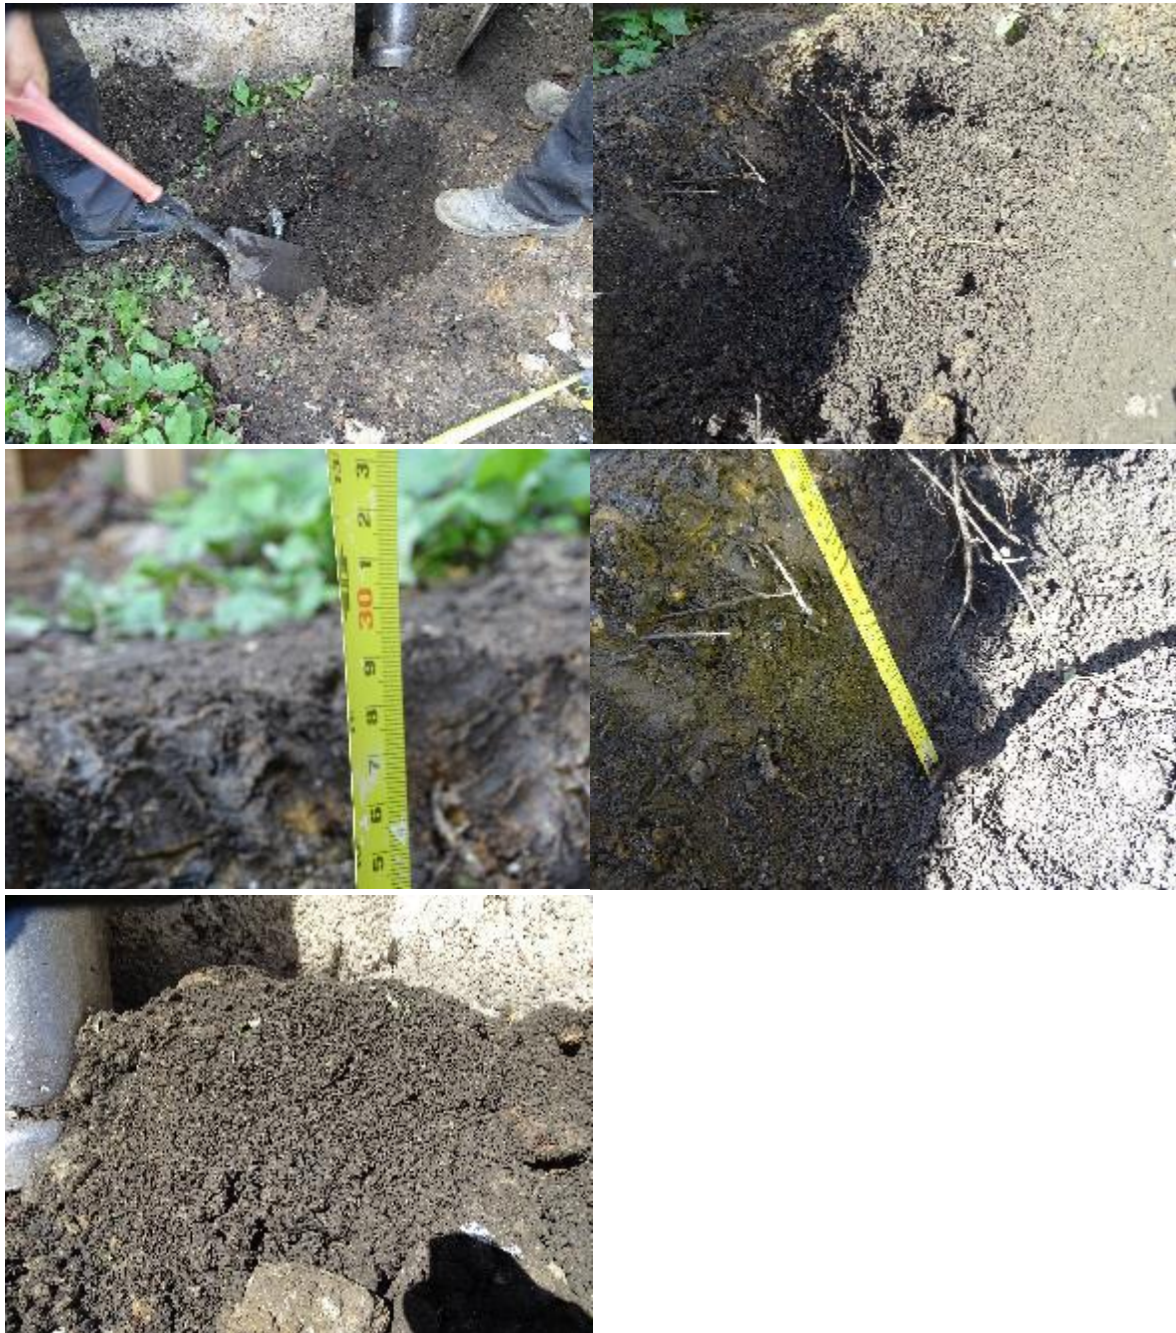
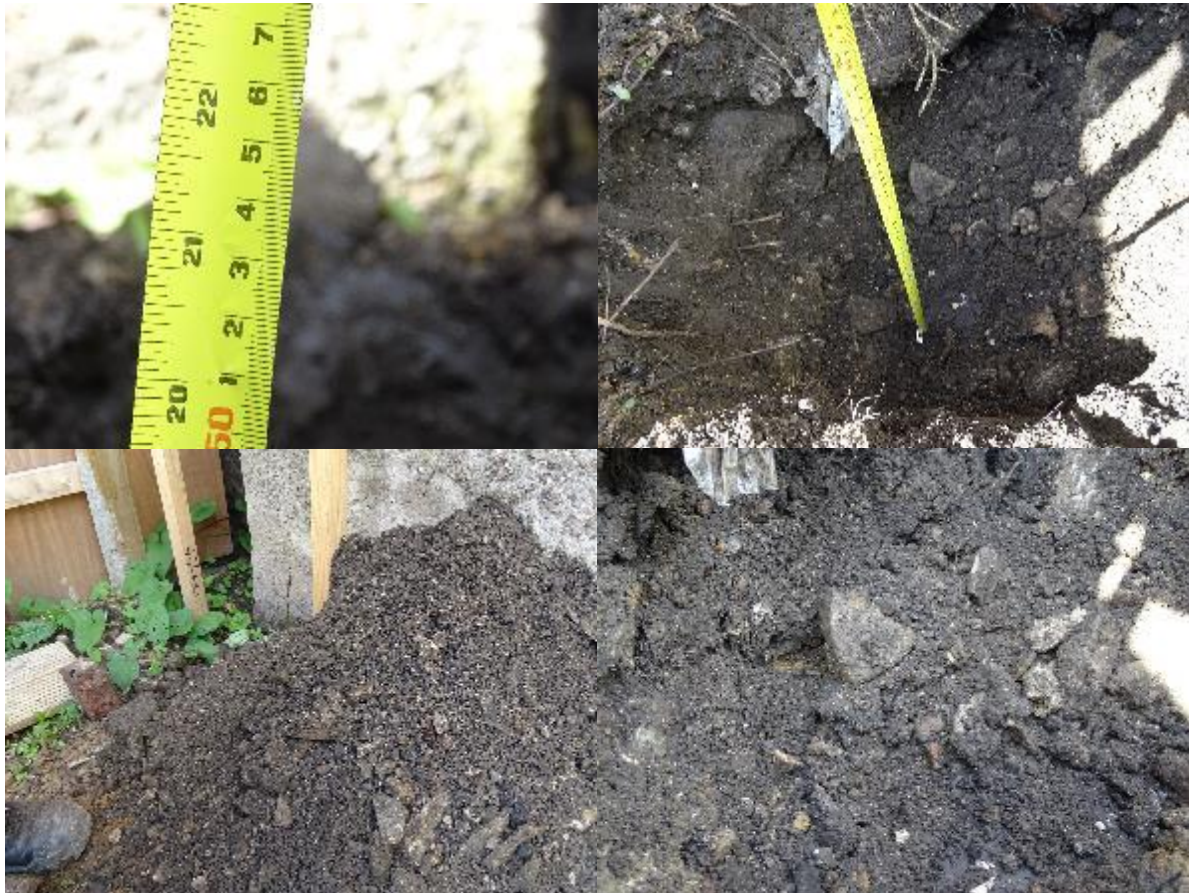
### Trail Pit 3a

Trail pit 3 – southwest boundary adjacent to the neighbouring property

0.00-0.30m loam, gravel and roots,

0.30-0.52m loam, gravel, stones, some brick.

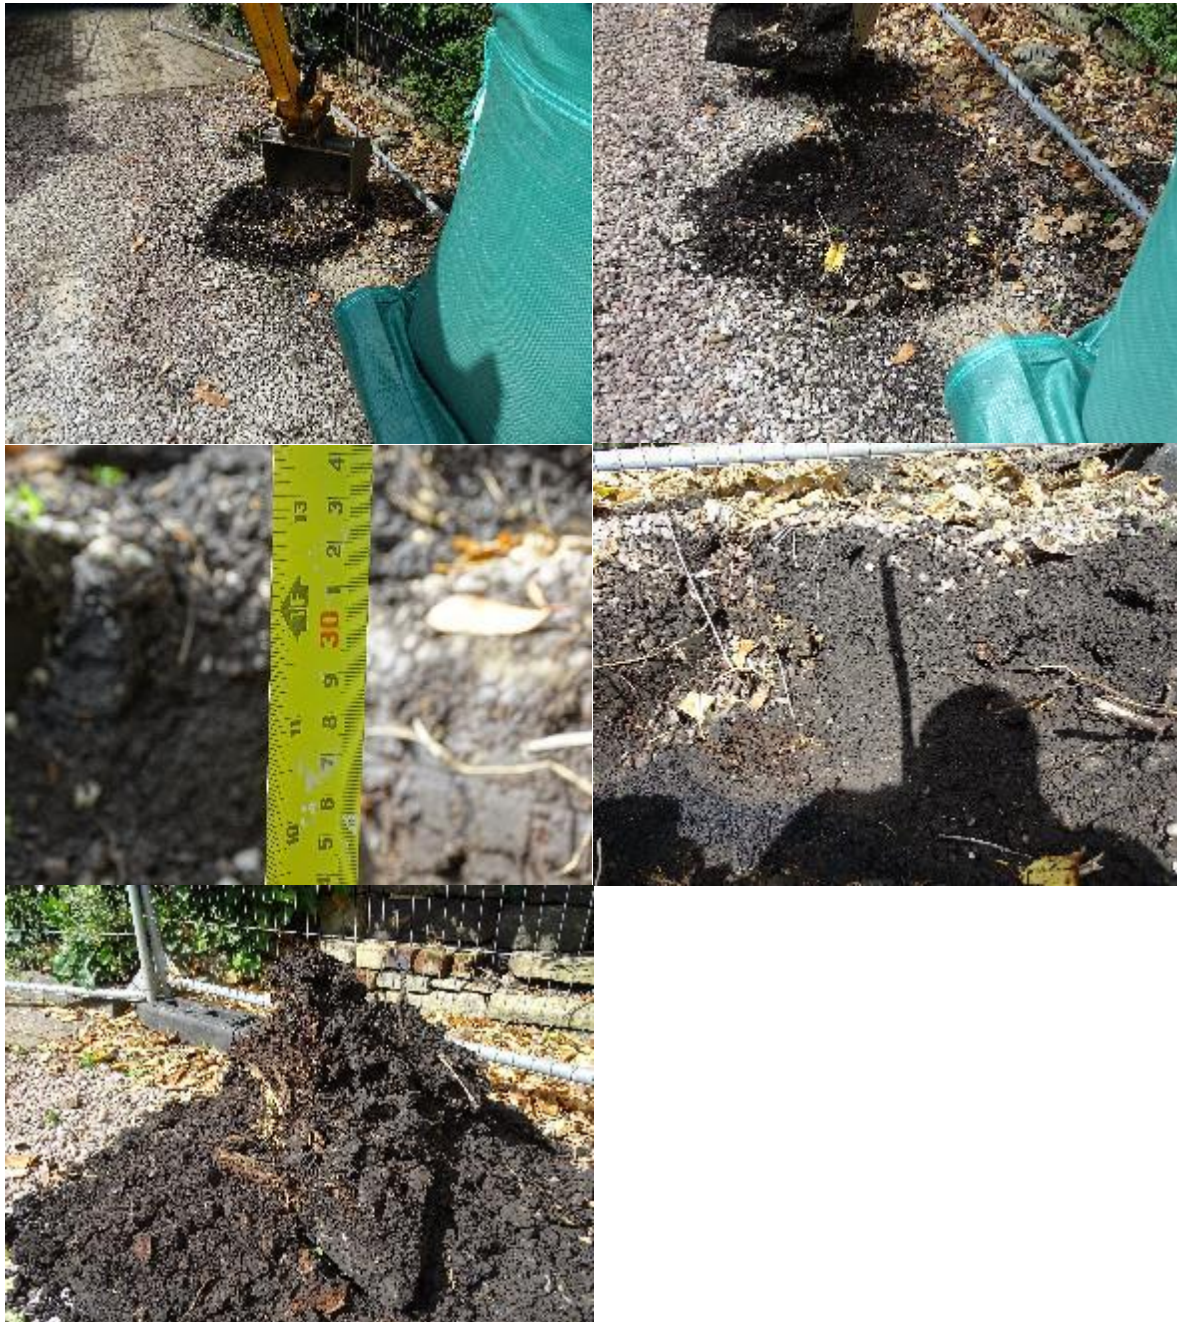
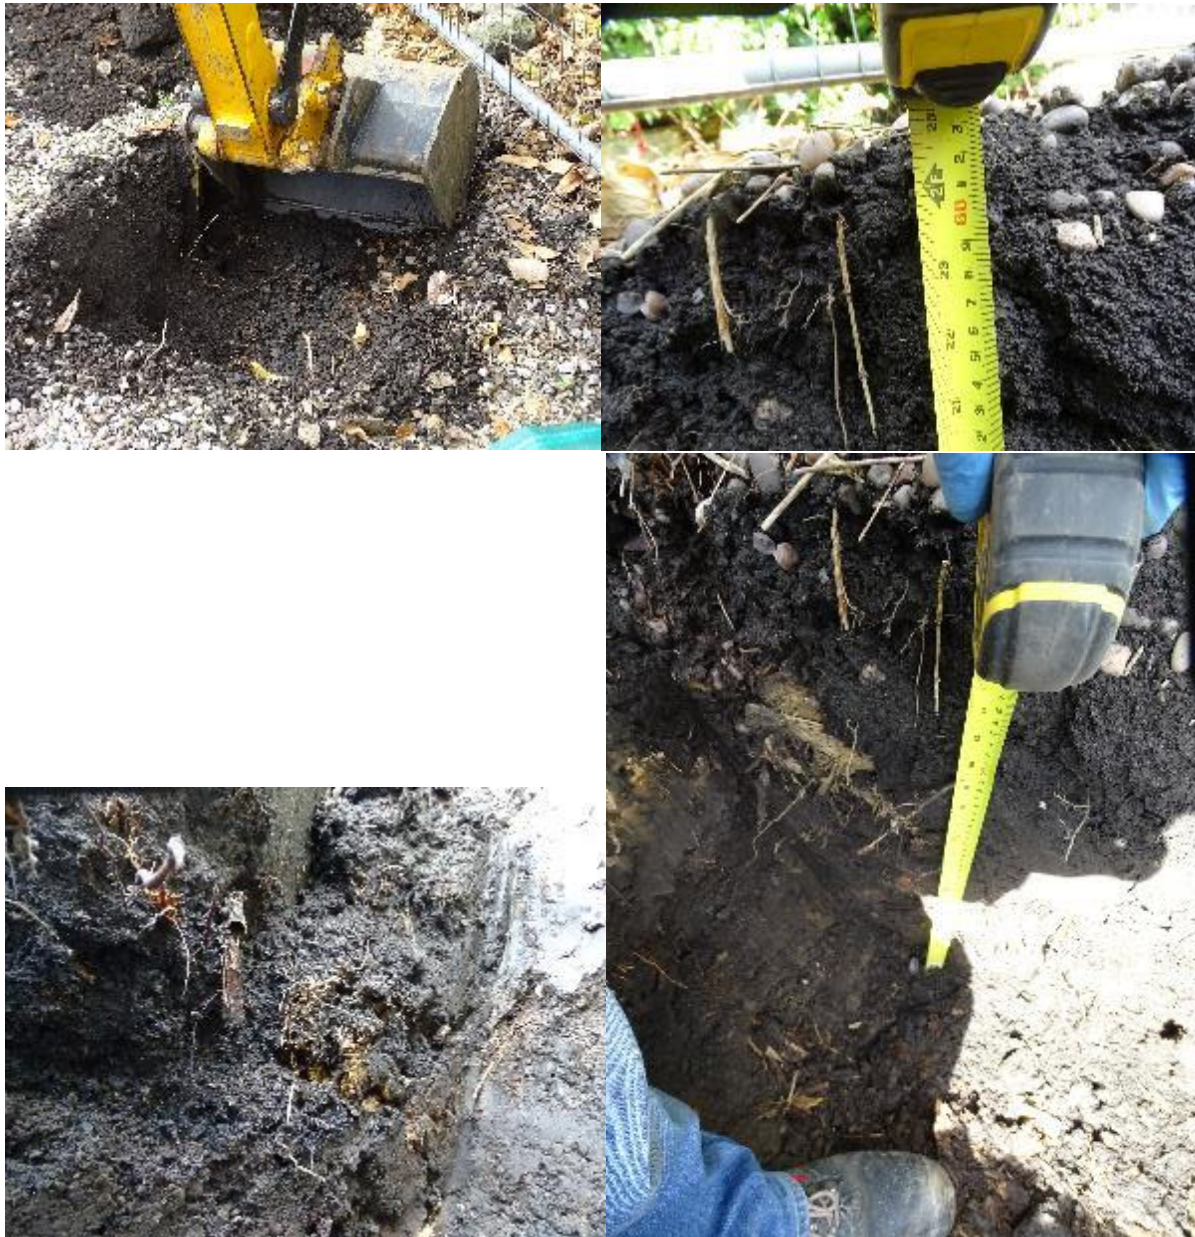
### Trail Pit 4a

Trail pit 4 – northwest boundary opposite driveway entrance

| 0.00-0.05m | Stone surface, |
| 0.30-0.60m | loam, dark organic matter, stones |

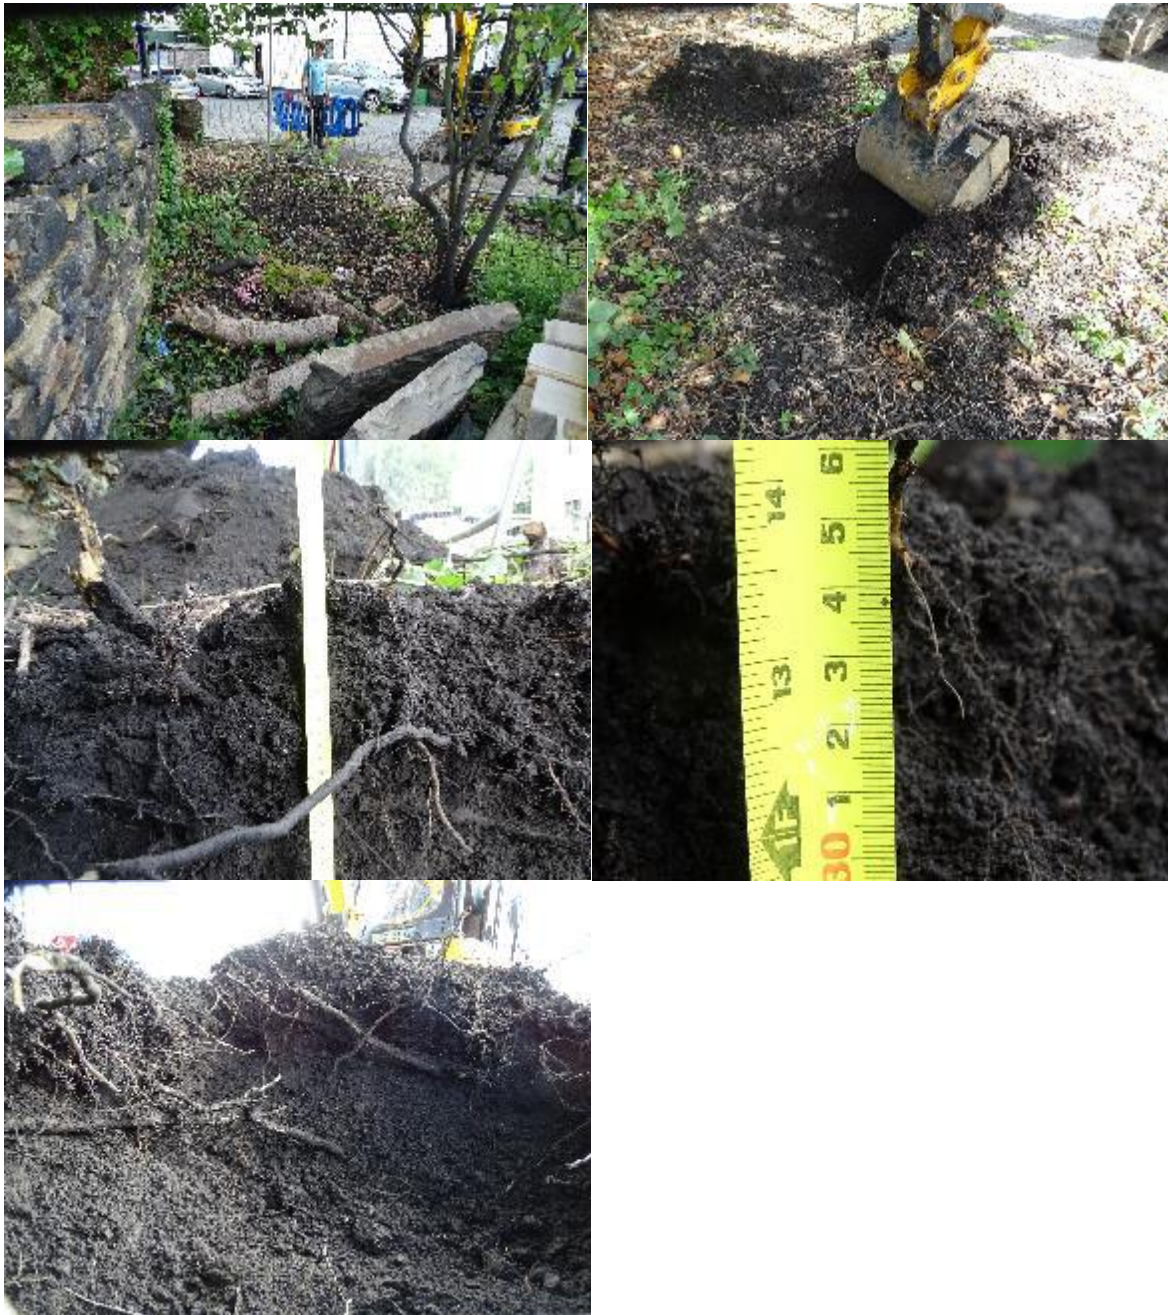
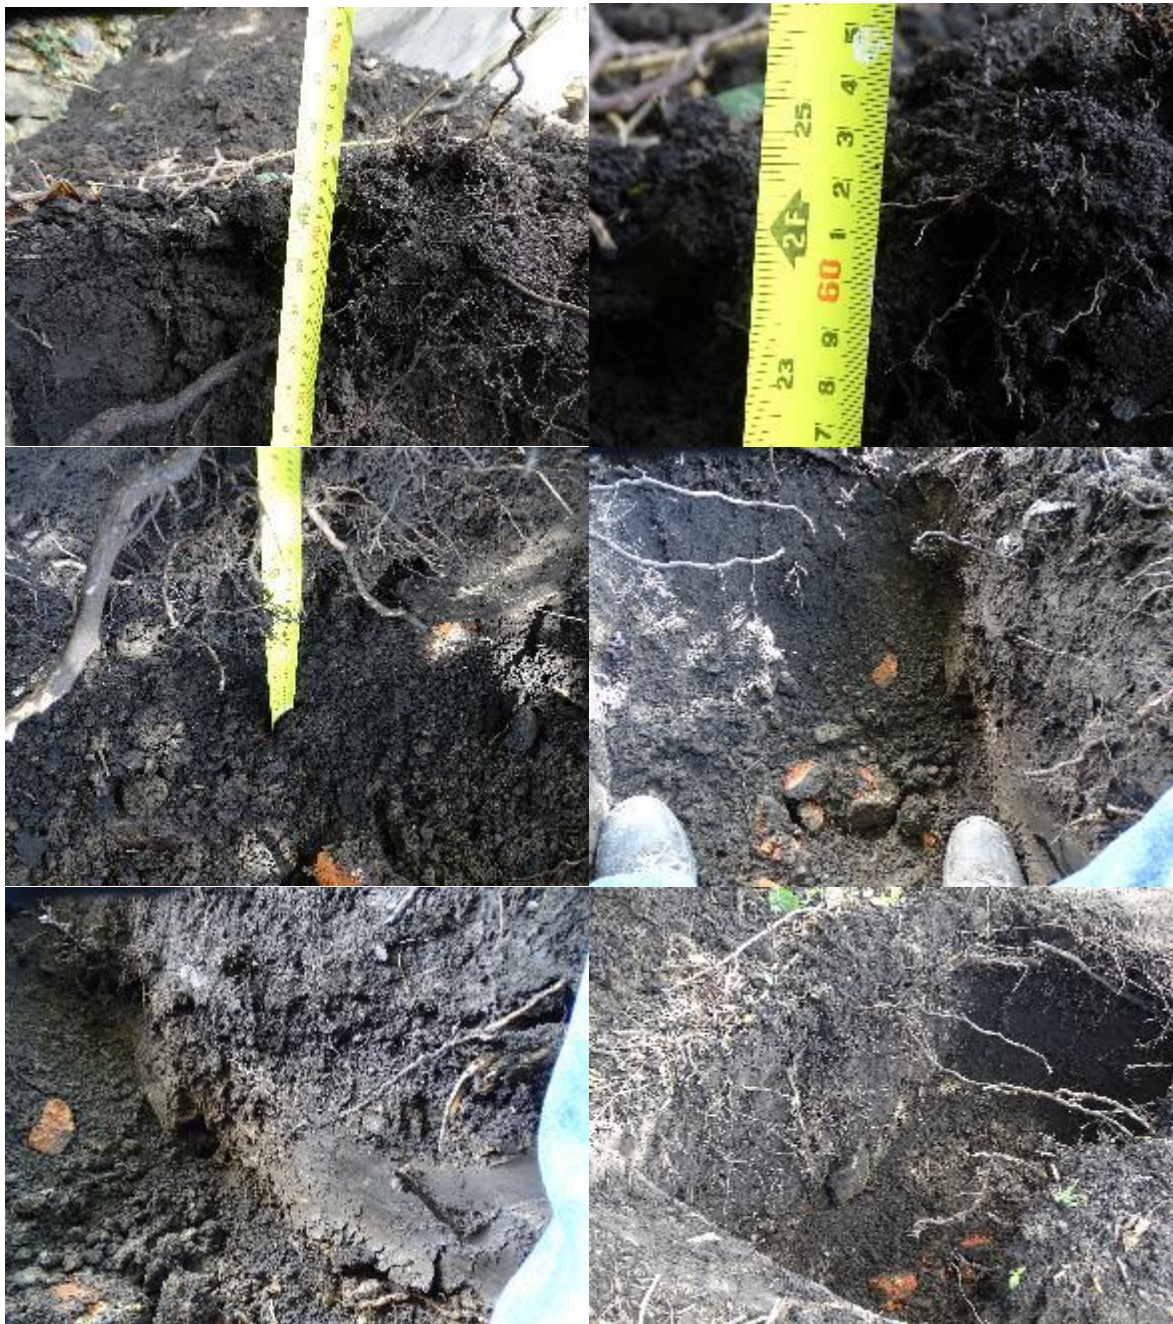
### Trail Pit 5a

Trail pit 5 – north corner of the site

| 0.00-0.30m | Sandy loam, clay, gravel, dark organic matter, some roots. |
