Our Ref: 6646HTWM230713L  
NHBC Ref. ENG235581

**Re: Verification of the Removal of Peat Strata at Hollin Lane, Middleton**

- Coopers' Drawing No. 6646/Fd – Annotated Fd Extract with Approximate Location of Valley Peat Deposits, Revision B. (previously enclosed with 6646HTWM210806L)
- Coopers' Trial Pits TP401 to TP405, dated 20<sup>th</sup> March 2023.
- Coopers' Trial Pits TP406 to TP409, dated 16<sup>th</sup> May 2023.
- Coopers' Drawing No. 6646/400/PH2/HL – Peat Removal and Validation Plan.

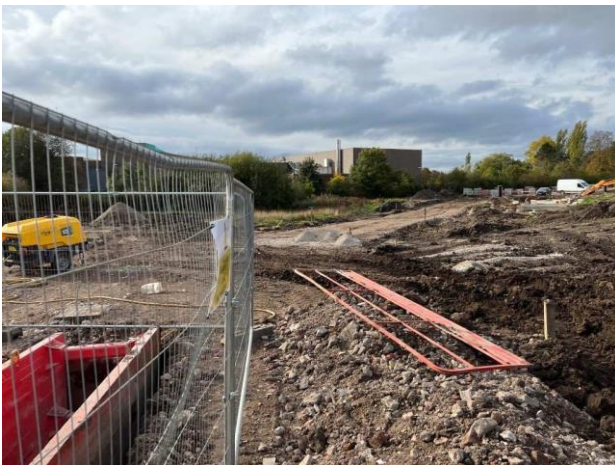
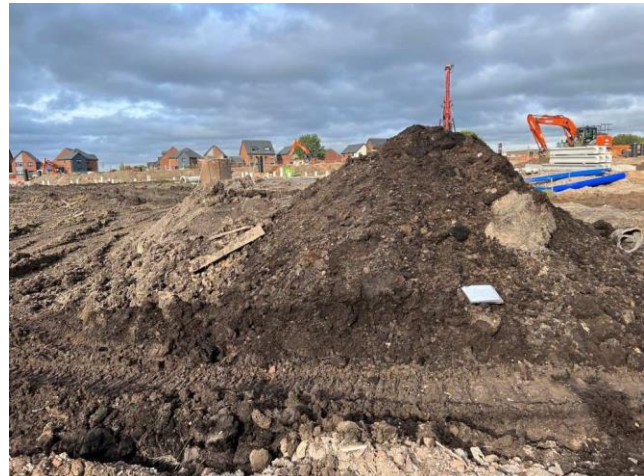
*Photograph 100 (left) & 101 (right): Looking to the south, photograph 100 shows the road and sewer corridor construction in progress adjacent to Plots 136-142. Looking toward the west, photograph 101 shows peat that has been excavated from the adjacent road corridor and stockpiled on top of the proposed location of Plots 139-142, dated 19<sup>th</sup> October 2022.*

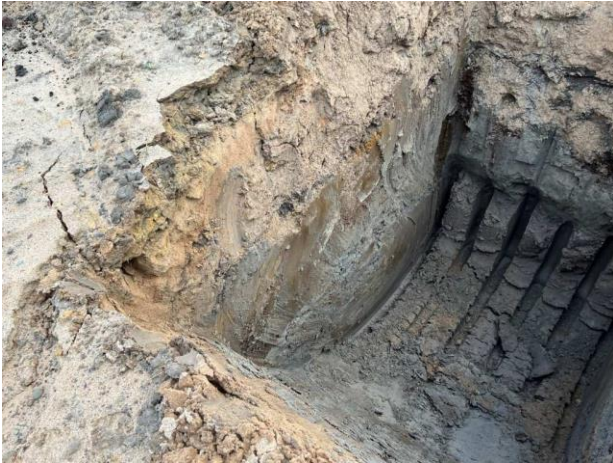
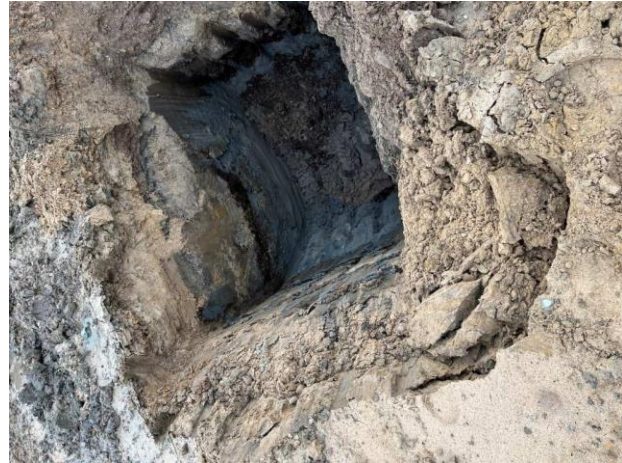
Coopers returned to the site on 27<sup>th</sup> October 2022 and carried out further delineation works in the rear garden areas of Plots 139-142 to determine how far west any peat deposits extended in this area. It was confirmed via small excavations that limited peat deposits were present in the east facing side of an excavation circa ~5m off the proposed rear wall trench of Plot 142 but were absent on the western edge of the excavation. Circa ~2m off the rear wall trench of Plots 139-140, peat was still present extending in to the rear garden of Plots 139-140, but it was intermittent and thinning toward the west (refer to photographs 102 & 103).

*Photograph 102 (left) & 103 (right): A view of photograph 102, showing the eastern face (right field of view) of the small excavation in the rear garden of Plot 142 exposing a thin band of peat, with no peat present toward the western edge of the excavation. In a similar vein, photograph 103 shows intermittent peat deposits present in the southern face of the excavation in the rear garden of Plots 139-140, with the peat thinning toward the western extreme of the excavation, dated 27<sup>th</sup> October 2022.*

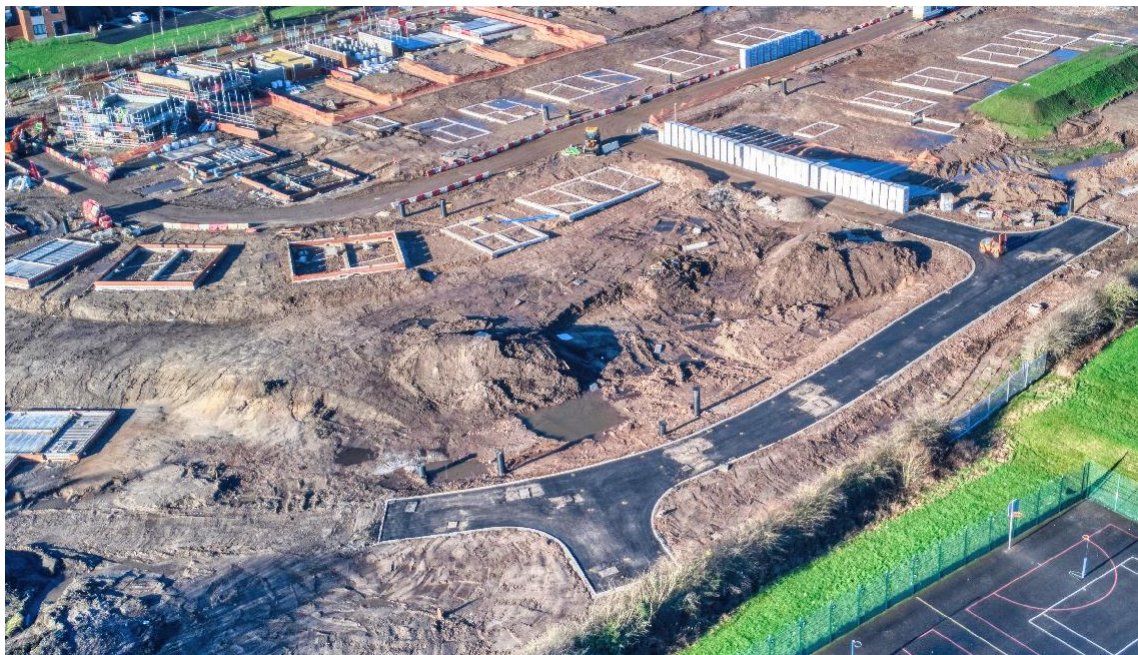
*Photograph 104: Drone photograph showing progress of excavation and removal of peat by PAS, received by Coopers on 26<sup>th</sup> January 2023.*

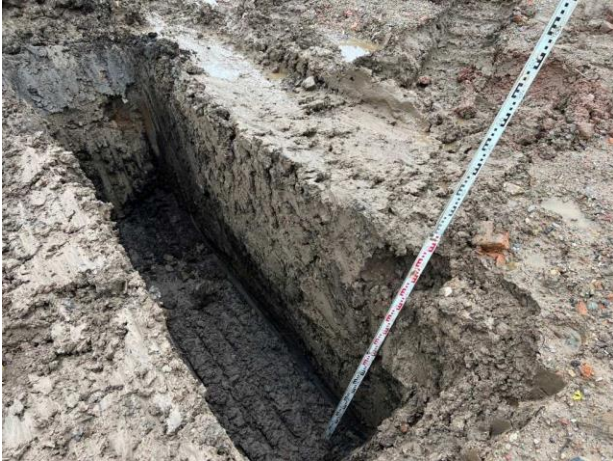
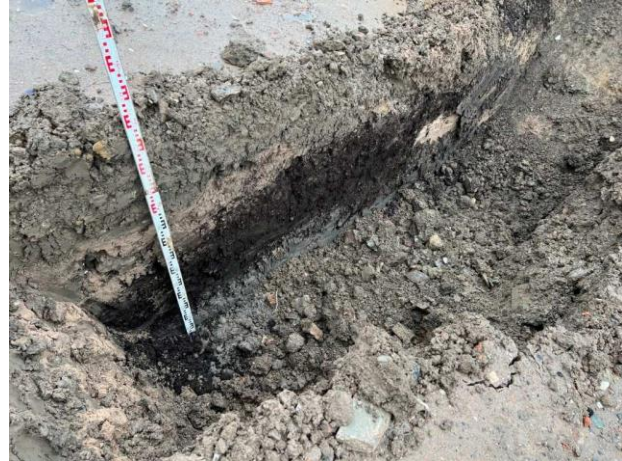
Trial pits TP404 & TP405 had been completed within the southern section of site to confirm the extent of peat in the frontages of Plots 136-142 and determine if the peat still extended into the plot footprints. Within TP404 (refer to photograph 104), completed in the front of Plots 140-141, peat was identified to a maximum depth of 1.00m below current ground and a maximum thickness of 0.60m. Within TP405 (refer to photograph 105), completed to the front of Plots 136-138, peat was encountered to a depth of 0.80m below ground level with a maximum thickness of 500mm.

*Photograph 104 (left) & 105 (right): A view of photograph 104, showing the peat deposits still present on the eastern face of Trial pit TP404 in front of Plot 141. Similarly, photograph 105 shows peat deposits present on the western face of the trial pit in front of Plots 136-138, dated 20<sup>th</sup> March 2023.*

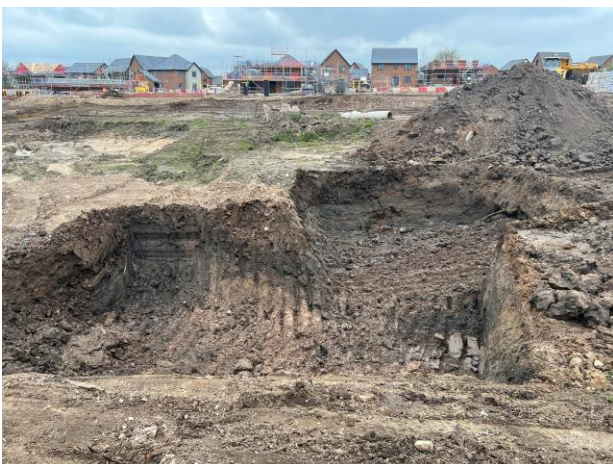
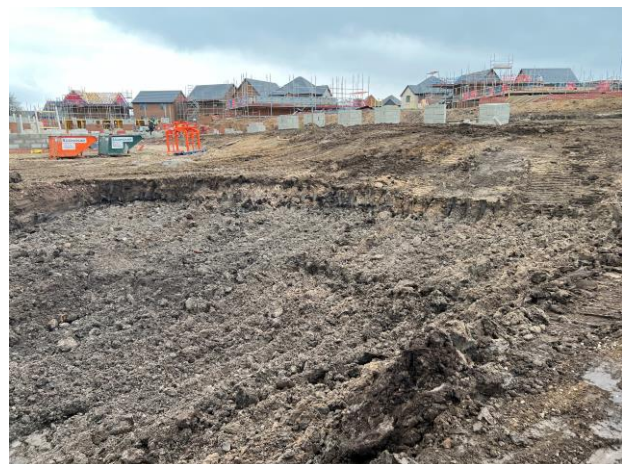
Coopers attended site on 28<sup>th</sup> April to witness 2 No. areas dug out around the former trial pits TP404 & TP405. Firstly, a broadly rectangular area around Plots 140-142 (TP404) was excavated with all peat removed. Underlying the peat was greyish brown silty sand, once the sand had been encountered and peat absent on the faces of excavations, the extent of the pit was terminated.

*Photograph 106 (left) & 107 (right): Looking in a westerly direction, photograph 106 shows the completed extent of the peat removal in Plots 140-142, revealing the sands at the base. Looking in a south westerly direction, photograph 107 shows peat removal during excavation, with a thin band of peat progressively removed along the western face of the excavation, dated 28<sup>th</sup> April 2023.*

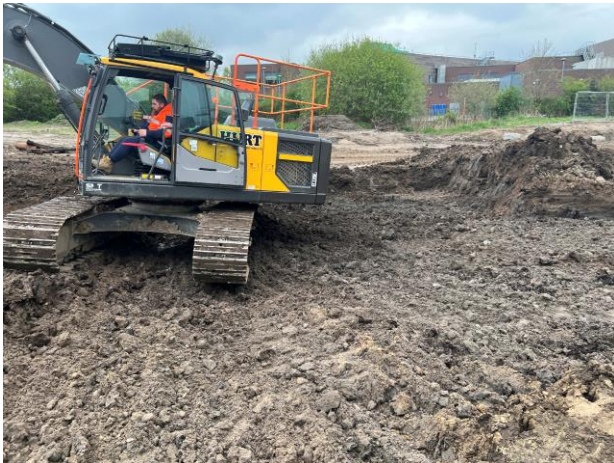
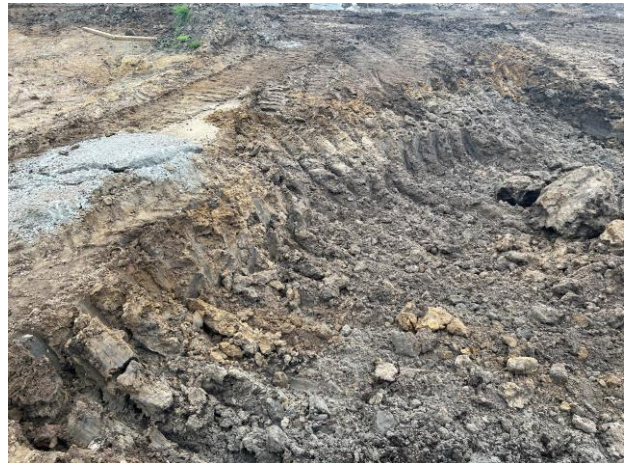
The second area witnessed during the visit was located around Plots 136-138 (TP405). The extent of removal was generally completed in an oval shape. The peat had been removed to a maximum depth of 1.00m below ground level, revealing the greyish brown silty sand at the base. The excavation was terminated once all witnessed peat had been removed. Below is a photographic summary of each section during the visit demonstrating the progressive removal and verification.

*Photograph 108 (left) & 109 (right): Firstly, 108 shows the completed extent of the peat removal in the area of Plots 140-142 along the eastern face of the excavation. Looking in a northerly direction, photograph 109 shows the western most face of the excavation following the completed removal of remaining peat, dated 28<sup>th</sup> April 2023.*

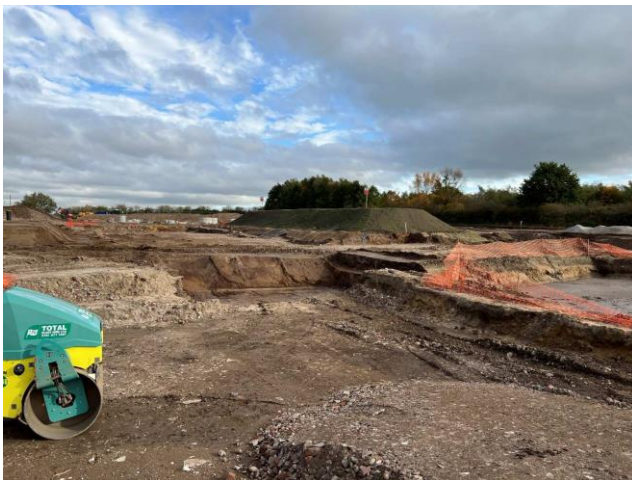
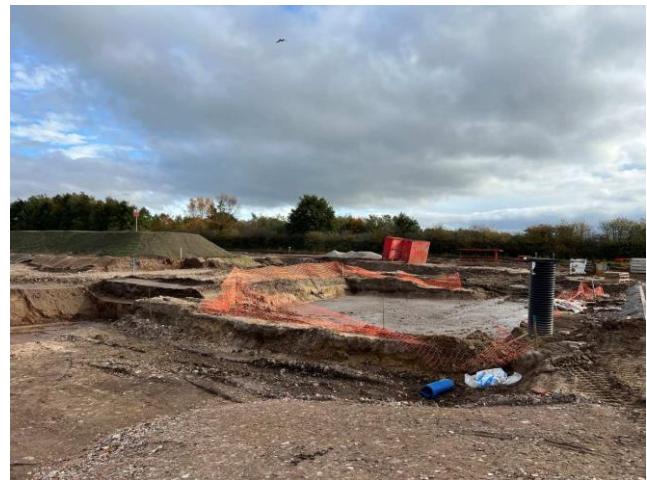
During an earlier visit on 19<sup>th</sup> October 2022, Coopers observed a reduced level excavation to accommodate a pile mat for the construction of Plots 144-148, where it could be determined in the face and base of the excavations that no peat was present in this area as shown in photographs 201 and 202 below. This observation concurred with the exploratory holes of trial pits TP55, TP221-223, and boreholes WS19 and BH08 undertaken during previous phases of site investigation.

*Photographs 201 and 202: Looking at a reduced level dig to accommodate pile mats for Plots 144-148 on 19<sup>th</sup> October 2022, where peat was proven not to be present.*

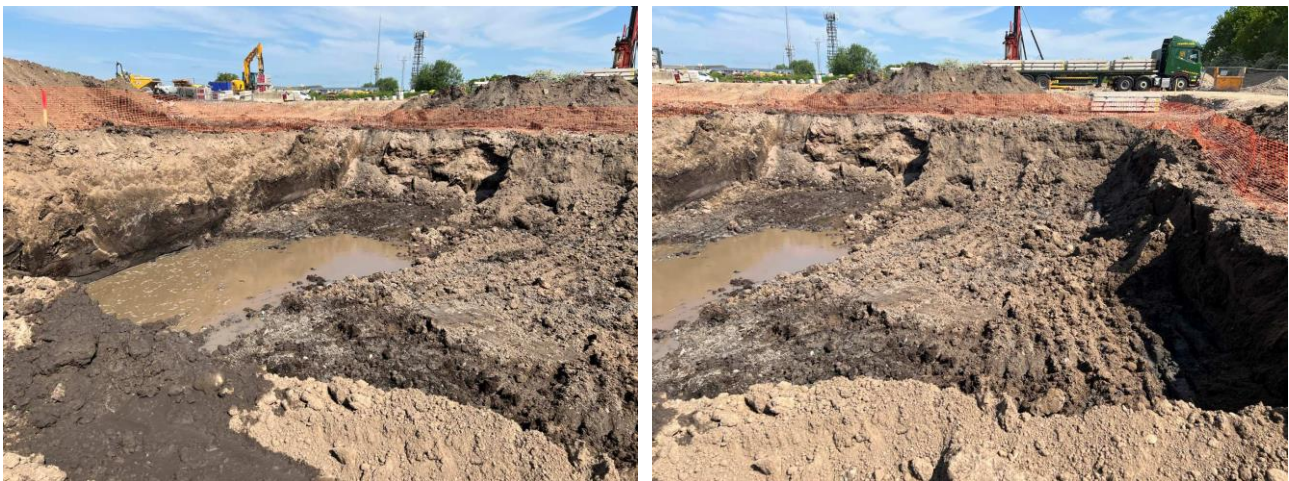
*Photographs 203 and 204: Looking north west and northwards, verifying the excavation and removal of peat from the footprint of Plots 152 and garage, and the rear garden and garage of Plot 153. Note a thick layer of peat still present on the face of the excavation which at the time is noted to be the rear garden of Plot 154 and the eastern end of the garden of Plot 152, dated 24<sup>th</sup> May 2023.*

The excavation shown in photographs 203 to 206 spanning the area of Plots 152, its garage and the garden of Plot 153 was witnessed on arrival at site. The orientation and extent of the excavation in relation to proposed plot numbers could be determined using surveyed wooded stakes which were placed at 2m offsets of each plot, previously installed to mark the extent of the proposed pile mats. The depth of excavation was approximately 2.5-3.0m deep and any peat which was 2.5m at its deepest was verified to have been removed with the typical underlying grey sand or clay exposed at the base. Remnant layers of peat however were still observed in the face of the excavation to the south, west and north where further excavation was advised to PAS. No peat appeared to be present on the east face to the front of Plot 152. To avoid leaving a large excavation open for long periods, Coopers were requested to stay the remainder of the day and witness the extension of the excavation so that PAS could progressively back fill the following day.

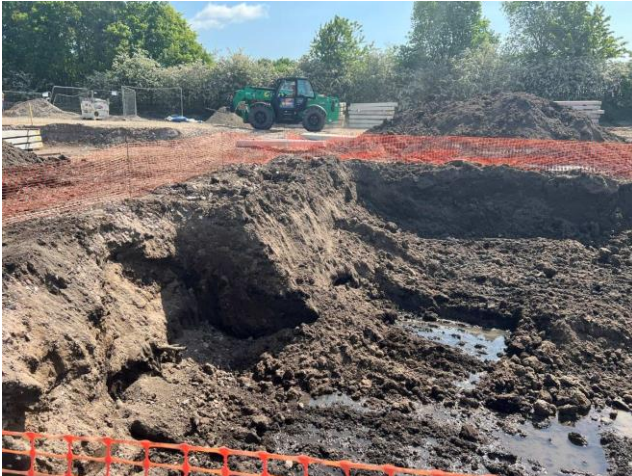
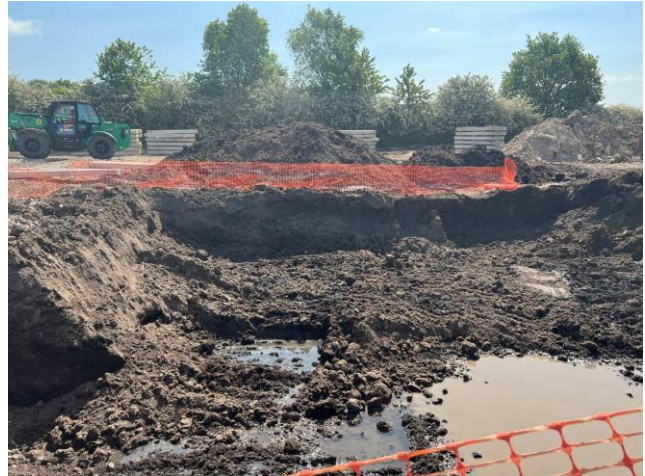
*Photographs 205 and 206: Same excavation as photographs 203 and 204 looking westwards. The opposite face of the excavation is along the line of the proposed shared drive to the front of Plot 152. A layer of peat approximately 200-300mm thick was observed on the north face to the left, however the layer of peat appears to have disappeared to the east under the shared drive, dated 24<sup>th</sup> May 2023.*

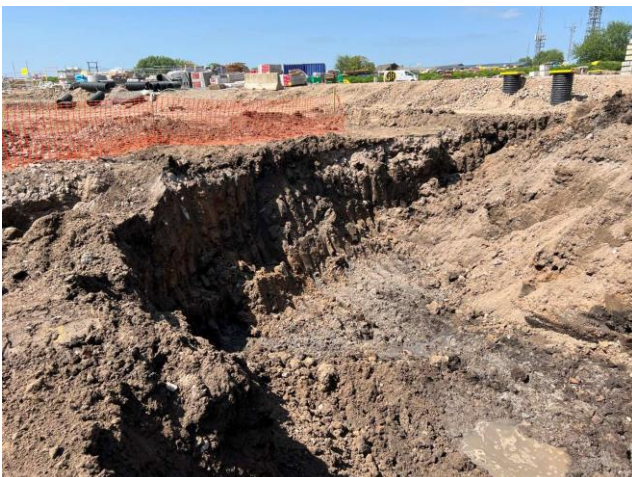
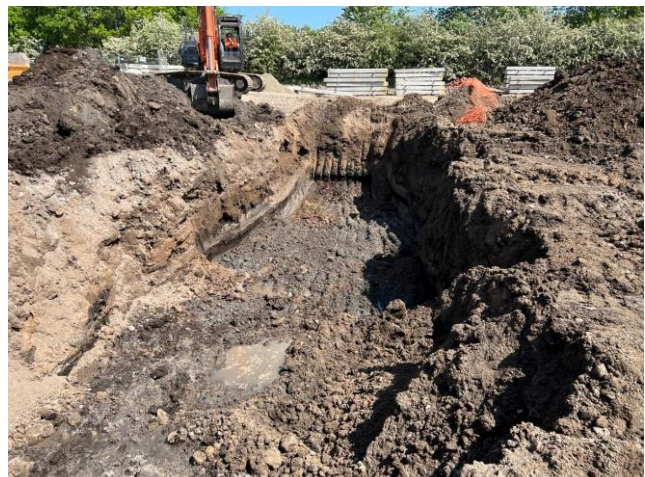
*Photographs 207 and 208: Additional excavation spanning the southern half of Plot 153 and front left of Plot 154, dated 24<sup>th</sup> May 2023.*

During the course of the afternoon a secondary excavation (leaving just a 1-2 metre strip between this and the excavation in photos 203-206) was excavated to a depth of 3.0m, continuing to expose, chase and remove peat until the presence of stockpiles limited the excavation northwards. At the end of the day 300mm of fibrous peat was still observable as a dark layer shown on photograph 210

which is beneath Plot 153. The opposite face of the excavation in photograph 208 shows a 200mm layer of peat to continue beneath the proposed shared driveway to the east.

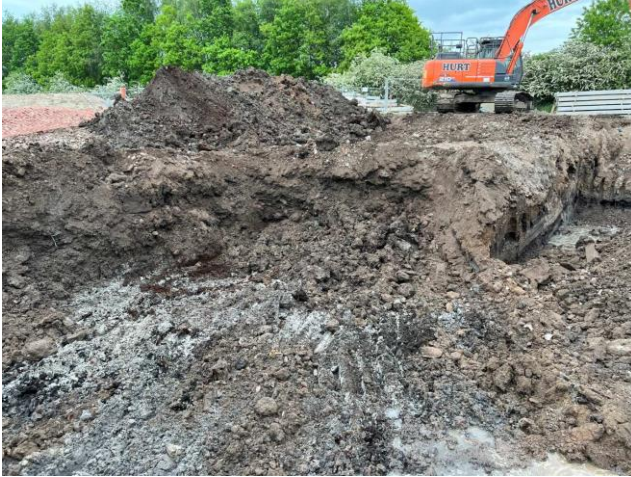
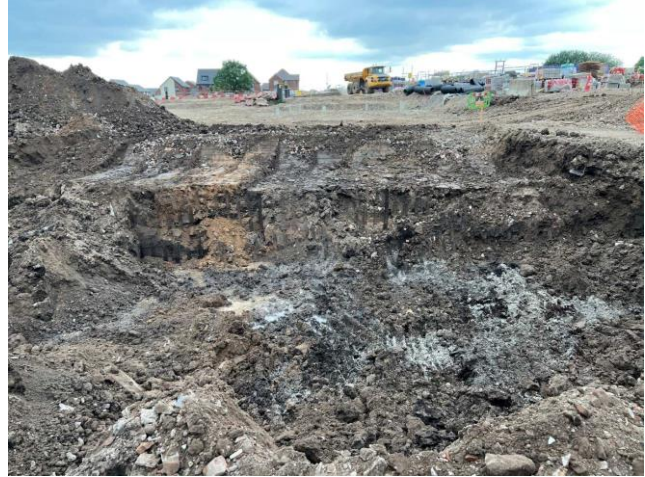
*Photographs 209 and 210: Looking west and eastwards respectively. Photo 209 shows limited further excavation and continued presence of peat beneath Plot 153. Photograph 210 shows the face of the excavation to be largely absent of peat, which is only present in the left corner where peat was previously witnessed in photograph 207, dated 25<sup>th</sup> May 2023.*

Excavation on 25<sup>th</sup> May was limited with works largely concentrating on backfilling and moving stockpiles prior to Coopers' attendance. The works undertaken however was noted to have merged both excavations from the 24<sup>th</sup> May 2023, however peat remained present along the north of the excavation halfway through Plot 153. In order to complete the removal of peat up to the road along the north of Plots 153 and 154, it was decided PAS would complete muckshifting of stockpiles and backfill the excavation to date in order to provide a platform to access and remove the last remaining peat prior to Coopers' next visit.

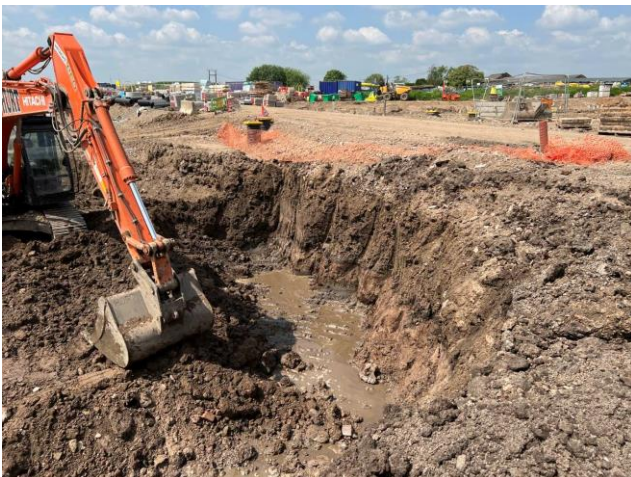
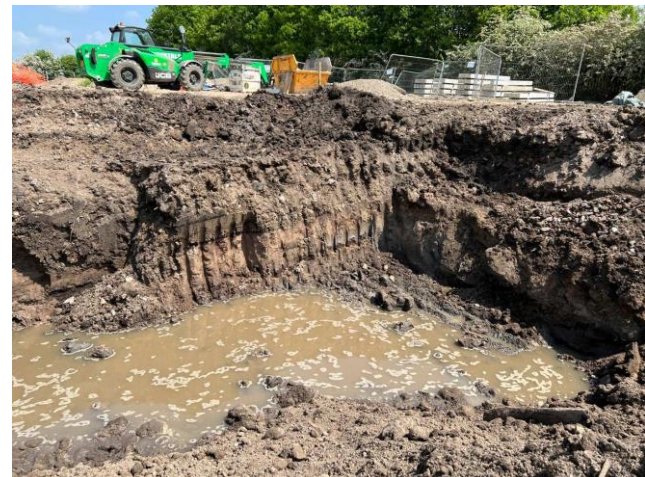
*Photographs 211 and 212: Looking north west and north eastwards respectively, verifying the excavation and removal of peat from beneath the footprint of Plot 153 and front left of Plot 154, dated 26<sup>th</sup> May 2023.*

The excavation was taken as far as possible up to the road, completing the removal of peat from the footprint of Plot 153 and the front left of Plot 154. Here the peat was noted to begin to shallow and thin to approximately 100mm thick. No remnant peat was witnessed on the east face of the excavation into the remainder of Plot 154 shown to the left of photograph 211. Peat was also absent in the corner of the road turning head off the front left of Plot 153. A thinner 100mm layer remained present adjacent the road to the north where excavations were restricted due to the presence of services. Excavation had also continued through the right side of Plot 151 and a part of its rear garden. No peat was present on the east face which concurred with the previous trial pit TP225. Some amorphous peat remained present on the face of the excavation to the south, and thick fibrous peat remained present in the west face into the rear gardens of the plots which would be the focus of further excavation.

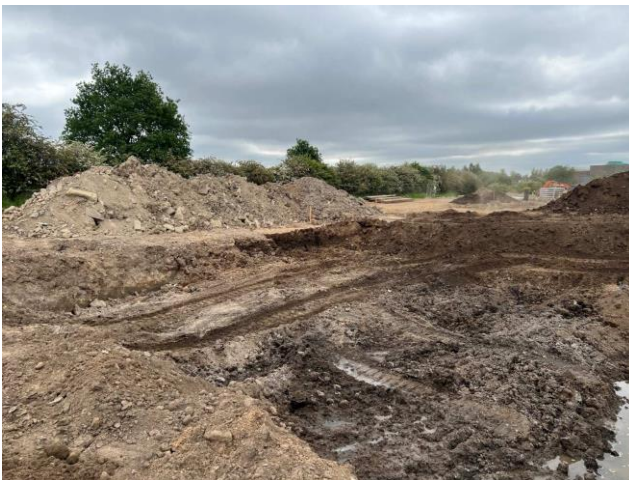
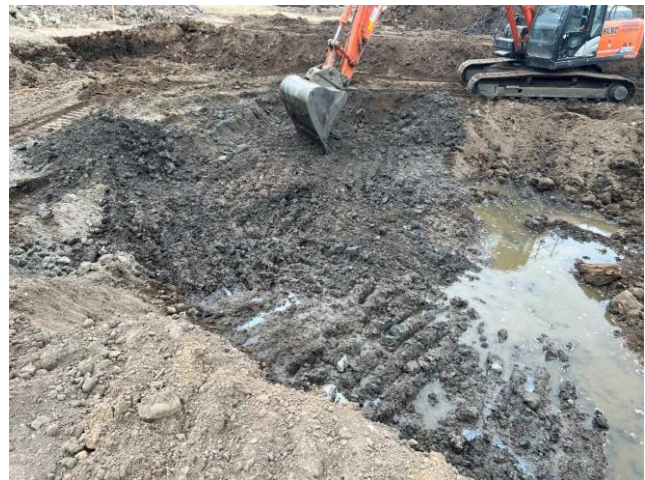
*Photographs 213 and 214: Looking south east into the extent of excavation spanning Plot 151 and the right side of Plot 150. A band or pocket of re-worked peat between 200-300mm thick was present at 0.5m depth to the front of the right side of Plot 150 only, shown in the corner of the excavation in photograph 213, dated 31<sup>st</sup> May 2023.*

On arrival the excavation had extended to span the footprint of Plot 151 and the right side of Plot 150 and a section of their rear gardens. Coopers instructed that some loose disturbed peat left at the base of the excavation was removed which is demonstrated in photograph 214. With the topography

falling southwards, the peat and the excavation was beginning to shallow to 1.0m to 1.5m depth by this point. A shallow 300mm amorphous peat layer approximately 1.0m deep remained present in the south face of the excavation into the remainder of Plot 150 garden. No peat was noted in the face of the excavation to the east below the proposed shared drive or into the front left portion of the footprint of Plot 150 which concurred with trial pit TP224.

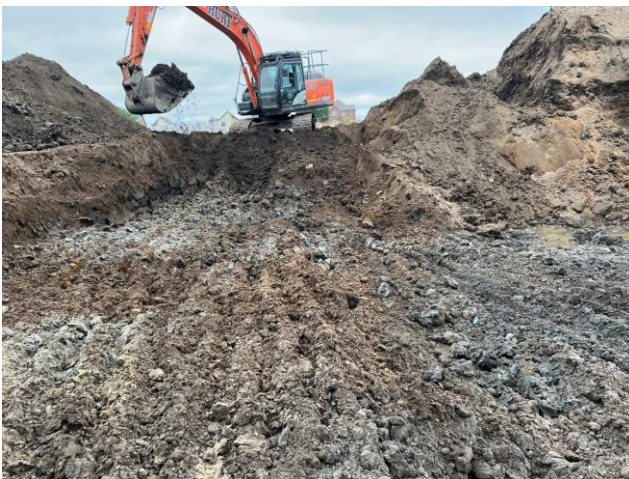
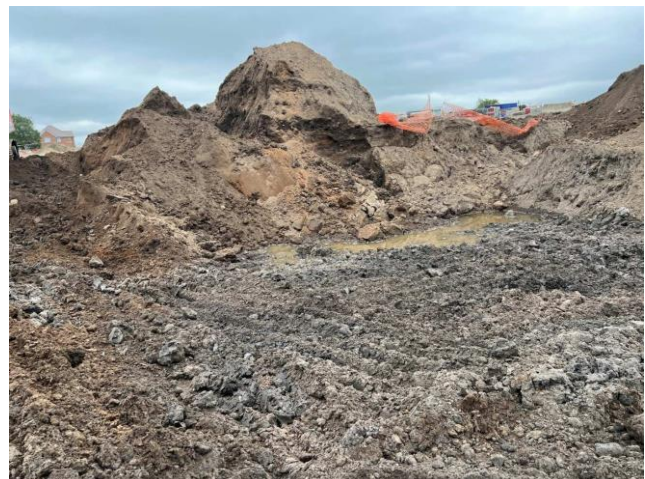
*Photographs 215 and 216: Looking westwards at the progressive removal into the gardens of Plots 150 and 151. Remnant fibrous peat was still present beneath the loose spoil, dated 31<sup>st</sup> May 2023.*

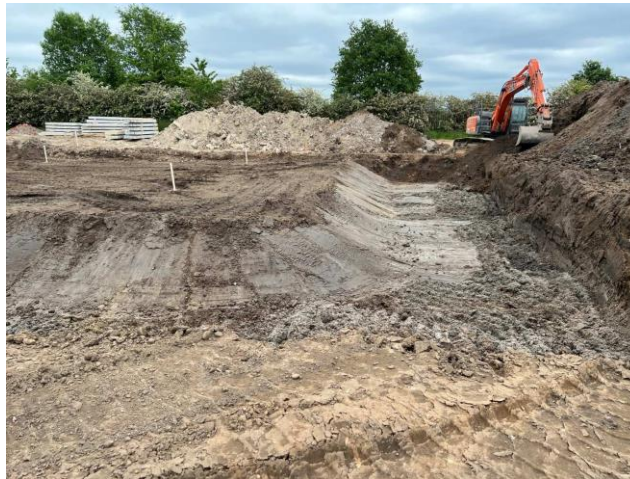
*Photograph 217: Looking eastwards at the excavation spanning the remainder of Plot 150 and progressive backfill, dated 1<sup>st</sup> June 2023.*

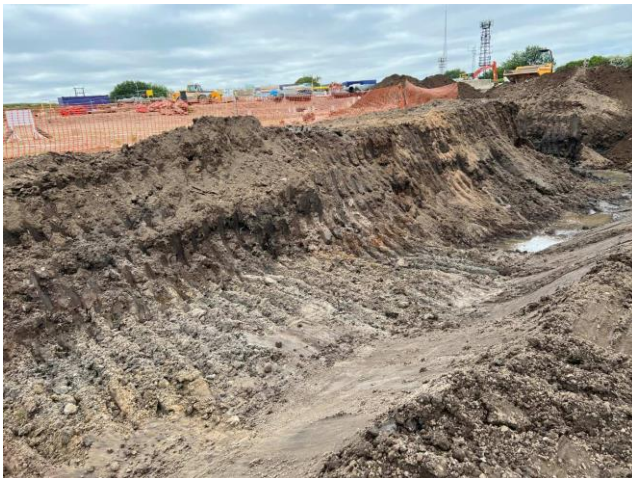
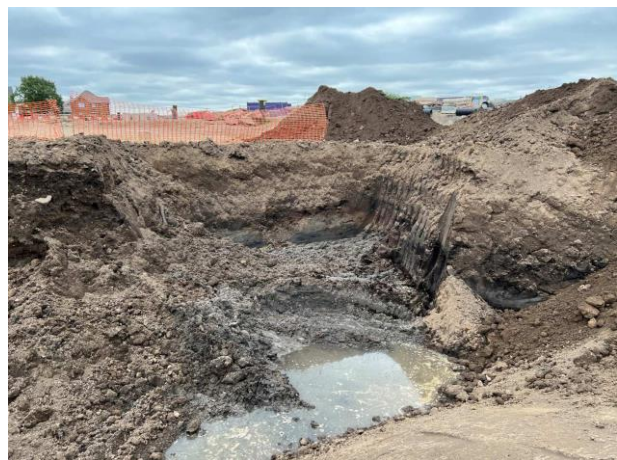
*Photographs 218 and 219: Looking north westwards and westwards respectively at the excavation spanning the rear garden areas of Plots 150-152 and part of the gardens of Plots 154 and 155 respectively, dated 1<sup>st</sup> June 2023.*

The excavation witnessed on this day had confirmed the southern most extent of the peat in this northern area with no remnant peat observed in the south face of the excavation beyond Plot 150 as shown to the right in photograph 217. The excavation on this day also extended into the rear gardens of Plots 150-152 and a part of the gardens of Plots 154 and 155, removing the thicker fibrous layer of peat exposed in progressive excavations to date. A thin layer of dark brown clayey silt of relic topsoil was observable at approximately 1.0m depth on the west face of the excavation to Plots 159-162 as seen in the above photographs, which concurred with the findings in trial pits TP406 to TP408. Whilst the peat had been largely removed from the plot and garden areas, a small area of thick fibrous peat remained in the rear gardens of Plots 154 and 155 as shown on the right side of photograph 221.

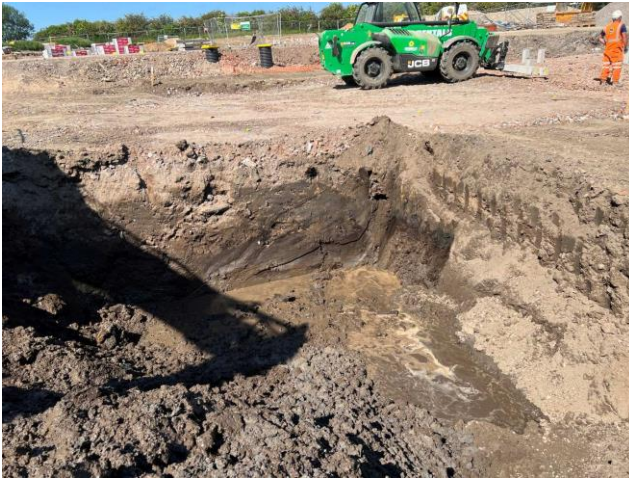
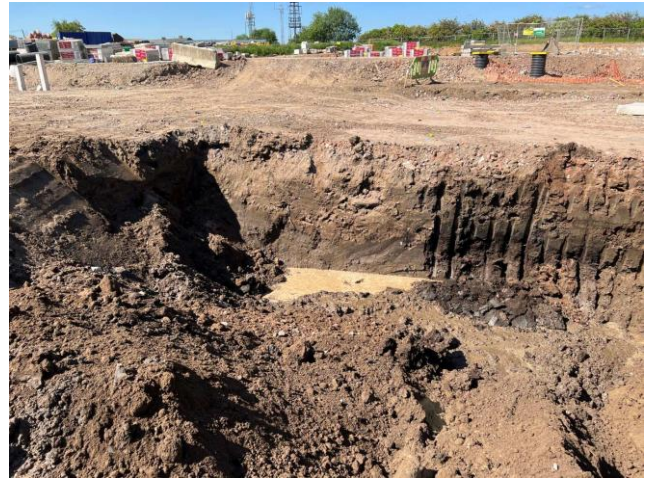
*Photographs 220 and 221: Looking north-north eastwards showing progressive excavation of Plots 154 and 155's rear gardens and continued exposure of fibrous peat in the rear garden and rear wall of proposed Plot 154, dated 5<sup>th</sup> June 2023.*

On this day Coopers verified the further extent of peat to the west had been removed from the east of the rear garden of Plot 155 and the whole of the garden of Plot 154. The remaining excavation however still showed fibrous peat was present on the proposed rear wall of Plot 154 as shown by the darker band particularly on the right of photograph 221. The excavations by this point had almost gone full circle and it was anticipated the remaining peat would only comprise a small pocket before encountering the backfill of the previous excavation. This verification occurred at the very end of the day and due to the anticipated small extent and familiarity of the peat strata, it was agreed on site with PAS that they would explore this last remaining pocket and photograph it and send to Coopers for verification the following day.

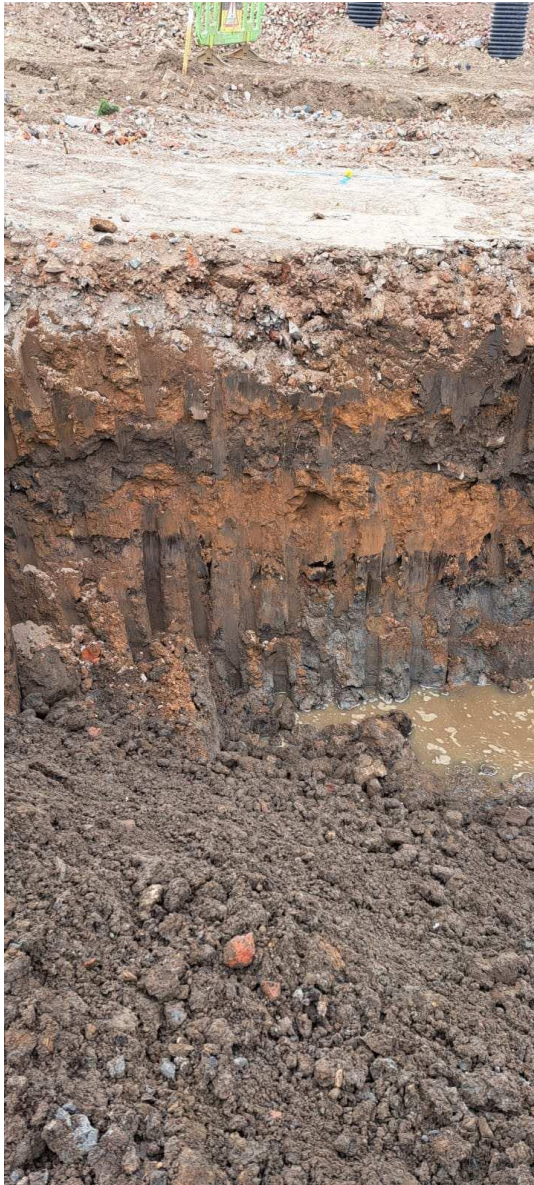
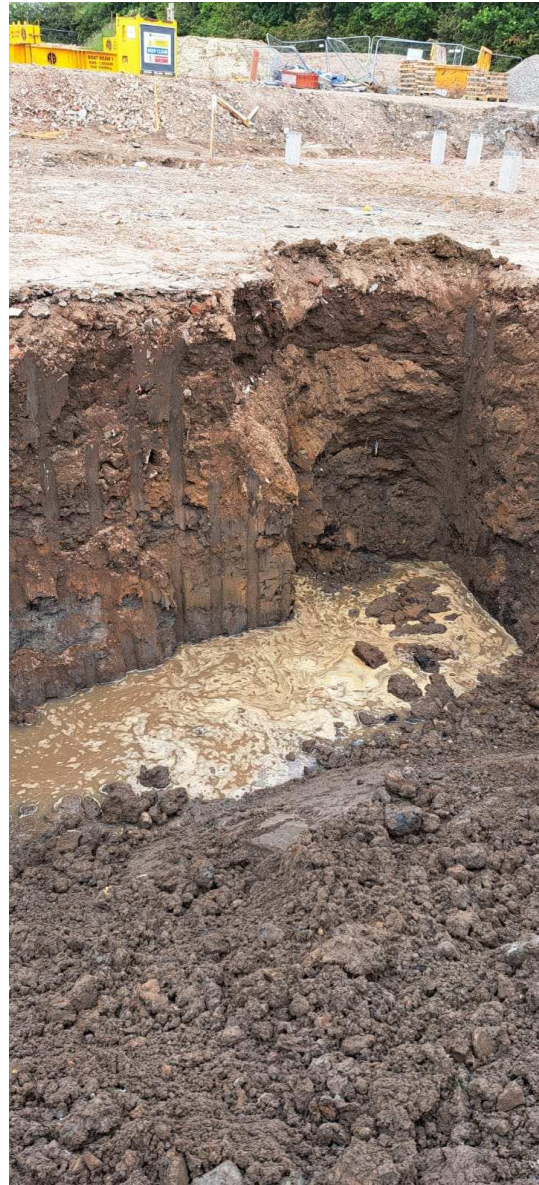
*Photographs 222 and 223: Looking north-north eastwards showing the removal of the last remaining dark area of fibrous peat from the rear of Plot 154, dated 5<sup>th</sup> June 2023.*

Coopers received the above photographs from the PAS foreman the following morning, and could confidently verify the removal of the last remnants of peat from this northern area.

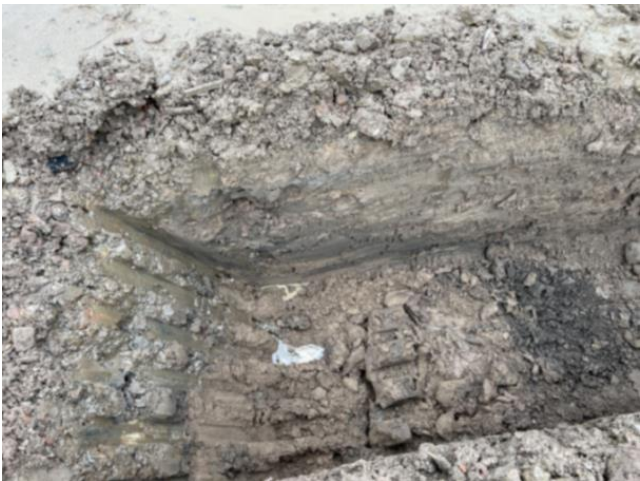
| <div> <div>Coopers (Chester) Ltd</div> <div>tel: 01244 684 910</div> <div>web: www.coopers.co.uk</div> <div>email: admin@coopers.co.uk</div> </div> | | | | <b>Site</b><br>HOLLIN LANE EAST, PHASE 2, MIDDLETON | | <b>Trial Pit Number</b><br><b>TP401</b> | | | |
|---|---|---|---|---|---|---|---|---|---|
| | | | | | 0.80 | MADEGROUND. Light brown, slightly silty, slightly gravelly, fine to coarse SAND. Gravel is angular to sub-angular, fine to coarse of brick fragments. *Assumed as loose to medium dense. | | | |
| | | | | | 1.10 | Firm, brown, slightly sandy, slightly gravelly, silty CLAY with thin lenses of light reddish brown, fine to medium sand. Sand is fine to medium. Gravel is sub-angular to sub-rounded, fine to coarse of various lithologies. | | | |
| | | | | | 1.40 | Complete at 1.40m | | | |
| | | | | | | <b>Remarks</b><br><br>Location CAT scanned prior to excavation.<br>Sides stable during excavation.<br>Surface water ingress only.<br>*Based upon trenchside stability characteristics.<br>Please note that discolouration of photographs may occur when viewed on screen as a PDF, or when printed as a hard copy.<br>Trial pits excavated to determine presence of peat deposits.<br>To be read in conjunction with Drawing No. 6646/HL/Fd/PH2/01 Revision D<br>Trial pit excavated adjacent to rear right corner of Plot 184.<br>Backfilled upon completion. | | | |

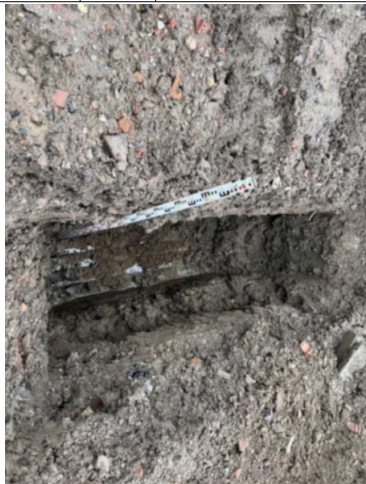
| | | | | | 2.10<br>(0.30) | Yellowish brown, slightly silty, fine to medium SAND. *Assumed as loose to medium dense. | | | |
| 2.20 | B | | | | 2.40 | Complete at 2.40m | | | |
| | | | | | | Location CAT scanned prior to excavation.<br>Spalling from 0.00 - 1.70m during excavation. Stable below 1.70m.<br>Seepage at 1.30m during excavation.<br>*Based upon trenchside stability characteristics.<br>Please note that discolouration of photographs may occur when viewed on screen as a PDF, or when printed as a hard copy.<br>Trial pits excavated to determine presence of peat deposits.<br>To be read in conjunction with Drawing No. 6646/HL/Fd/PH2/01 Revision D<br>Trial pit excavated adjacent to front left corner of Plot 154.<br>Backfilled upon completion. | | | |

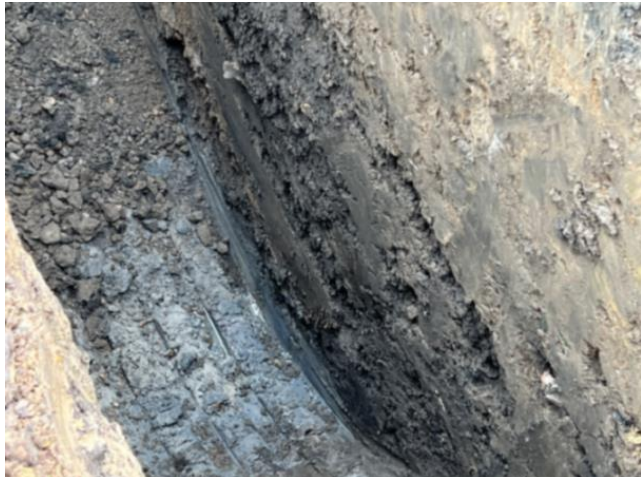
| 2.80 | B | | | | (0.40) | | | | | | |
| | | | | | 2.90 | Complete at 2.90m | | | | | |
| | | | | | | Location CAT scanned prior to excavation.<br>Sides stable during excavation.<br>Surface water ingress only.<br>*Based upon trenchside stability characteristics.<br>Please note that discolouration of photographs may occur when viewed on screen as a PDF, or when printed as a hard copy.<br>Trial pits excavated to determine presence of peat deposits.<br>To be read in conjunction with Drawing No. 6646/HL/Fd/PH2/01 Revision D<br>Trial pit excavated to the rear of Plot 159's detached garage.<br>Backfilled upon completion. | | | | | |

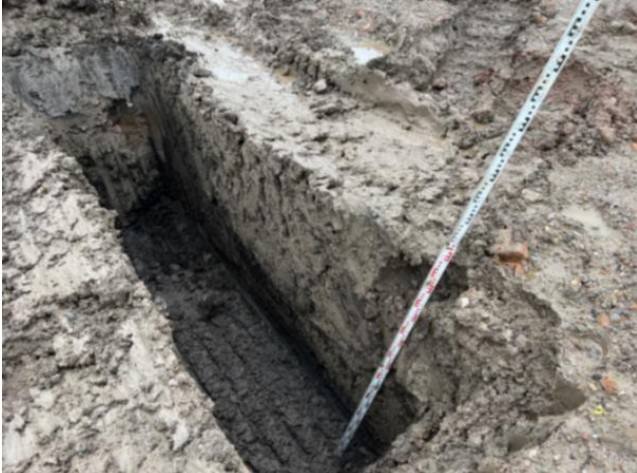
| <b>coop</b> ers<br><small>chartered consulting engineers</small> | | | | Coopers (Chester) Ltd<br>tel: 01244 684 910<br>web: www.coopers.co.uk<br>email: admin@coopers.co.uk | | <b>Site</b><br>HOLLIN LANE EAST, PHASE 2, MIDDLETON | | <b>Trial Pit Number</b><br><b>TP404</b> |
|---|---|---|---|---|---|---|---|---|
| 1.70 | B | | | | 1.60<br>(0.40) | Grey, slightly silty, slightly gravelly, fine to coarse SAND. Gravel is sub-angular to sub-rounded, fine to coarse of various lithologies. *Assumed as loose to medium dense. | | |
| | | | | | 2.00 | Complete at 2.00m | | |
| | | | | | | <b>Remarks</b><br><br>Location CAT scanned prior to excavation.<br>Sides stable, minor spalling only.<br>No groundwater encountered during excavation.<br>*Based upon trenchside stability characteristics.<br>**Only on east face of trial pit.<br>Please note that discolouration of photographs may occur when viewed on screen as a PDF, or when printed as a hard copy.<br>Trial pits excavated to determine presence of peat deposits.<br>To be read in conjunction with Drawing No. 6646/HL/Fd/PH2/01 Revision D<br>Trial pit excavated adjacent to the front left corner of Plot 141.<br>Backfilled upon completion. | | |

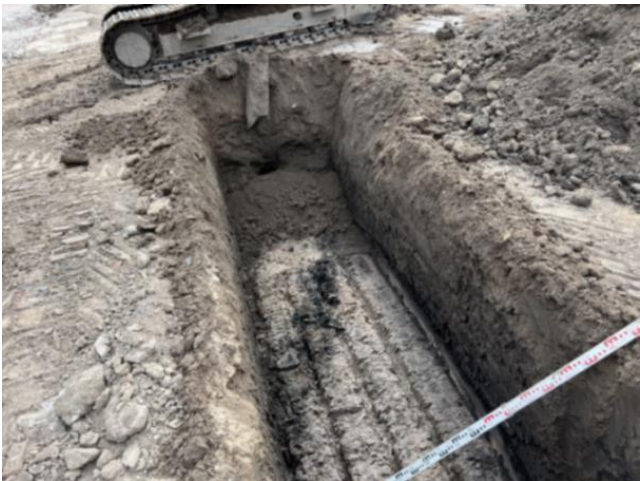
| | | | | | Light grey and light brown, slightly silty, slightly gravelly, fine to medium SAND. Gravel is sub-angular to sub-rounded, fine to coarse of various lithologies. *Assumed as loose to medium dense. | | | | | | |
| | | | | | | Complete at 1.20m | | | | | |
| | | | | | | <b>Remarks</b><br><br>Location CAT scanned prior to excavation.<br>Sides stable during excavation.<br>No groundwater encountered during excavation.<br>*Based upon trenchside stability characteristics.<br>Please note that discolouration of photographs may occur when viewed on screen as a PDF, or when printed as a hard copy.<br>Trial pits excavated to determine presence of peat deposits.<br>To be read in conjunction with Drawing No. 6646/HL/Fd/PH2/01 Revision E.<br>Trial pit excavated in the rear gardens of Plots 155 - 156.<br>Backfilled with arisings upon completion. | | | | | |

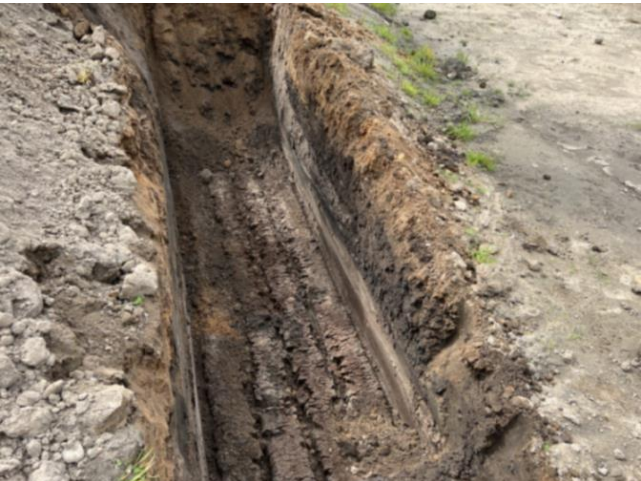
| | | | | | 0.50<br>0.50<br>(0.20)<br>0.70<br>(0.30)<br>1.00 | MADEGROUND. Light brown and orangish brown, slightly clayey, gravelly, fine to coarse SAND. Gravel is angular to sub-rounded, fine to coarse of various lithologies including brick fragments, plastic and natural stone. *Assumed as loose to medium dense.<br><br>MADEGROUND. Dark brown, slightly sandy, slightly gravelly, clayey SILT. Sand is fine to coarse. Gravel is sub-angular to sub-rounded, fine to coarse of various lithologies including coal. Contains rootlets. (Relic topsoil).<br><br>Light brown and brown, slightly silty, slightly gravelly, fine to medium SAND. Gravel is sub-angular to sub-rounded, fine to coarse of various lithologies. *Assumed as loose to medium dense.<br><br>Complete at 1.00m | | <br><br> | |
| | | | | | | <b>Remarks</b><br><br>Location CAT scanned prior to excavation.<br>Sides stable during excavation.<br>No groundwater encountered during excavation.<br>*Based upon trenchside stability characteristics.<br>Please note that discolouration of photographs may occur when viewed on screen as a PDF, or when printed as a hard copy.<br>Trial pits excavated to determine presence of peat deposits.<br>To be read in conjunction with Drawing No. 6646/HL/Fd/PH2/01 Revision E.<br>Trial pit excavated in the rear garden of Plot 159.<br>Backfilled with arisings upon completion. | | | |

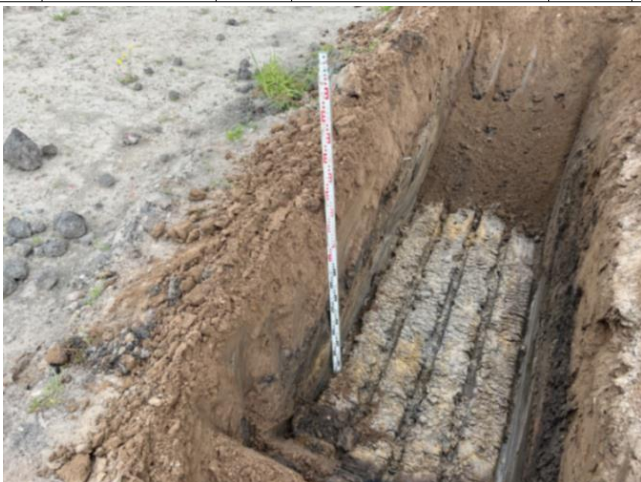
| | | | | | <div><div></div><div>(0.95)</div></div> <div><div></div><div>0.95</div></div> <div><div></div><div>1.00</div></div> <div><div></div><div>(0.50)</div></div> <div><div></div><div>1.50</div></div> | <div>MADEGROUND. Light brown and brown, slightly clayey, slightly gravelly, fine to coarse SAND with inclusions of topsoil. Gravel is angular to sub-rounded, fine to coarse of various lithologies including brick fragments and natural stone. *Assumed as loose to medium dense.</div> <div>MADEGROUND. Dark brown, slightly sandy, slightly gravelly, clayey SILT. Sand is fine to coarse. Gravel is sub-angular to sub-rounded, fine to coarse of various lithologies including coal. Contains rootlets and organic matter (grass). (Relic topsoil).</div> <div>Light grey and light orangish brown, slightly silty, slightly gravelly, fine to medium SAND with a low cobble content. Gravel is sub-angular to sub-rounded, fine to coarse of various lithologies. *Assumed as loose to medium dense.</div> <div>Complete at 1.50m</div> | <div></div> <div></div> | | |
| | | | | | | <div>Remarks</div> <div>Location CAT scanned prior to excavation.<br/>Sides stable during excavation.<br/>No groundwater encountered during excavation.<br/>*Based upon trenchside stability characteristics.<br/>Please note that discolouration of photographs may occur when viewed on screen as a PDF, or when printed as a hard copy.<br/>Trial pits excavated to determine presence of peat deposits.<br/>To be read in conjunction with Drawing No. 6646/HL/Fd/PH2/01 Revision E.<br/>Trial pit excavated in the rear garden of Plot 161.<br/>Backfilled with arisings upon completion.</div> | | | |

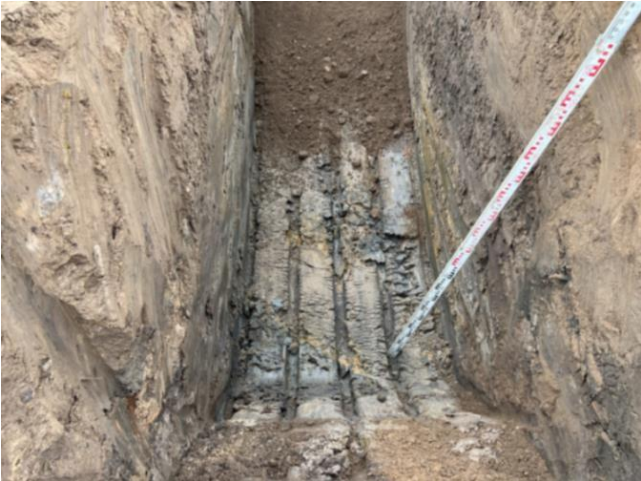
| Depth (m) | Sample / Tests | Water Depth (m) | Field Records | Level (mOD) | Depth (m) (Thickness) | Description | Legend | Water |
|---|---|---|---|---|---|---|---|---|
| | | | | | | MADEGROUND. Light brown and brown, slightly clayey, slightly gravelly, fine to coarse SAND. Gravel is angular to sub-rounded, fine to coarse of various lithologies including brick fragments, timber and natural stone. *Assumed as loose to medium dense. | | |
| | | | | | 1.30 | Light brown and grey, slightly silty, slightly gravelly, fine to medium SAND with lenses of firm, grey clay. Gravel is sub-angular to sub-rounded, fine to coarse of various lithologies. *Assumed as loose to medium dense. | | |
| | | | | | 2.30 | Complete at 2.30m | | |

Location CAT scanned prior to excavation.  
 Sides stable during excavation.  
 No groundwater encountered during excavation.  
 \*Based upon trenchside stability characteristics.  
 Please note that discolouration of photographs may occur when viewed on screen as a PDF, or when printed as a hard copy.  
 Trial pits excavated to determine presence of peat deposits.  
 To be read in conjunction with Drawing No. 6646/HL/Fd/PH2/01 Revision E.  
 Trial pit excavated in the rear gardens of Plots 163 - 164.  
 Backfilled with arisings upon completion.
