# **Bat Survey Report and Method Statement European Protected Species (Bats)**

## **Reasonable Avoidance and Mitigation Measures**

**Rakewood Higher Mill,  
Rakewood Road,  
Hollingworth,  
OL15 0AP**

**24.11.2022**

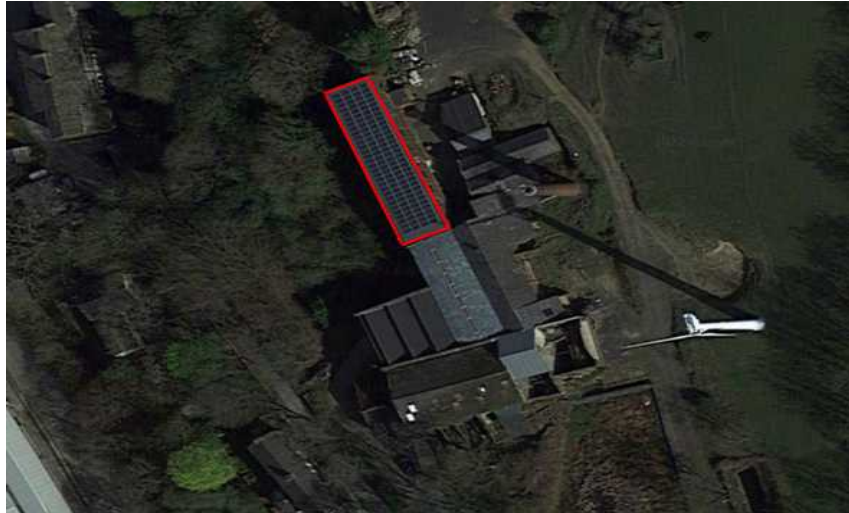
The property consists of a two storey wing of Rakewood Mill located to the north of the mill complex. External walls are generally well pointed with no obvious cracks, gaps or crevices located in areas affected by proposed works. Some crumbling brickwork was observed however the resulting gaps are shallow, exposed and remain sealed from any cavity.

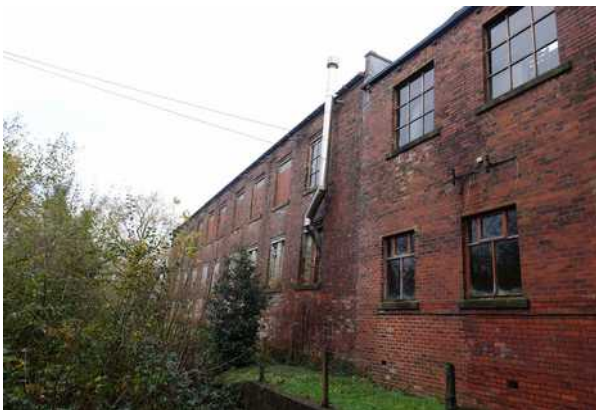
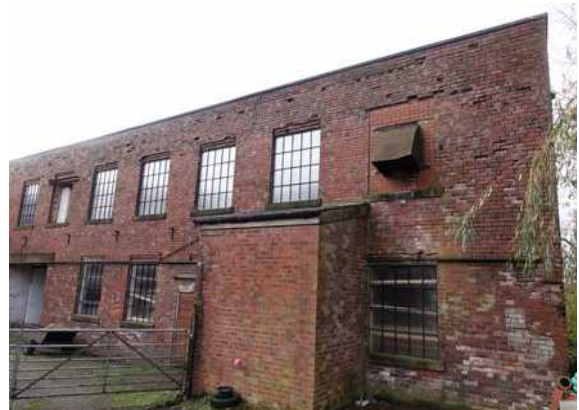
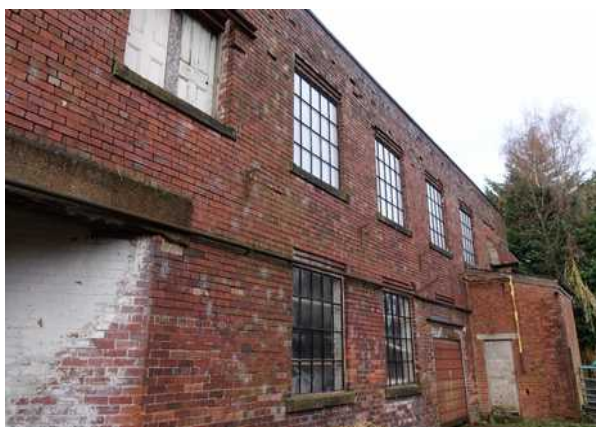
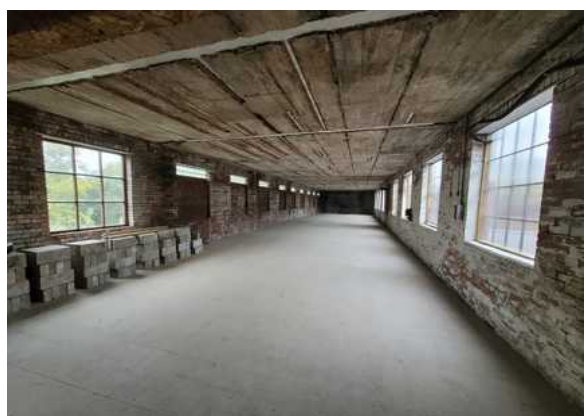
The flat roof has a solar array present. The concrete roof panels are unlined to the interior and exposed with no loft space present. Guttering is close fitting.

The building can be considered to offer negligible potential for roosting bats when the condition of the building, and location is considered.

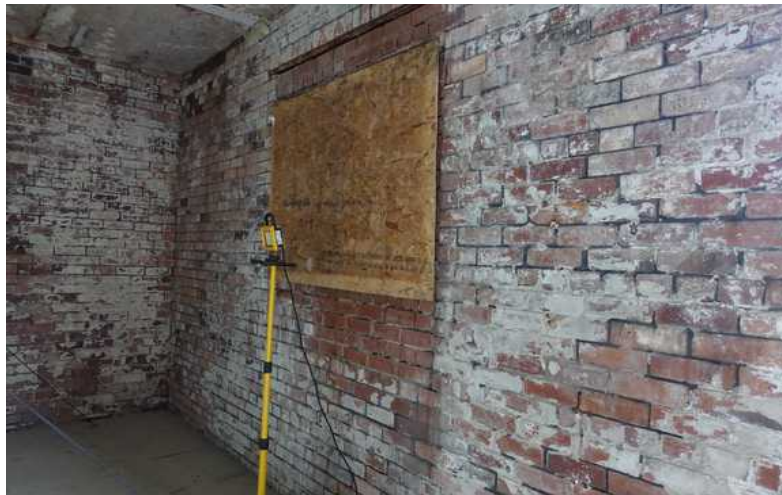
Some gaps are present around a duct installed within an upper floor bricked up window on the north eastern aspect, and the duct is timber boarded to the interior, however inspection via endoscope revealed no evidence to suggest use by bats or nesting birds.

*Timber boarding to interior of duct present within bricked up window.*
