Phase II Geoenvironmental Site Assessment

George Street, Heywood

Reference: 13-224-R2-1  
Date: February 2022

Land off George St  
Heywood  
OL10 4PW

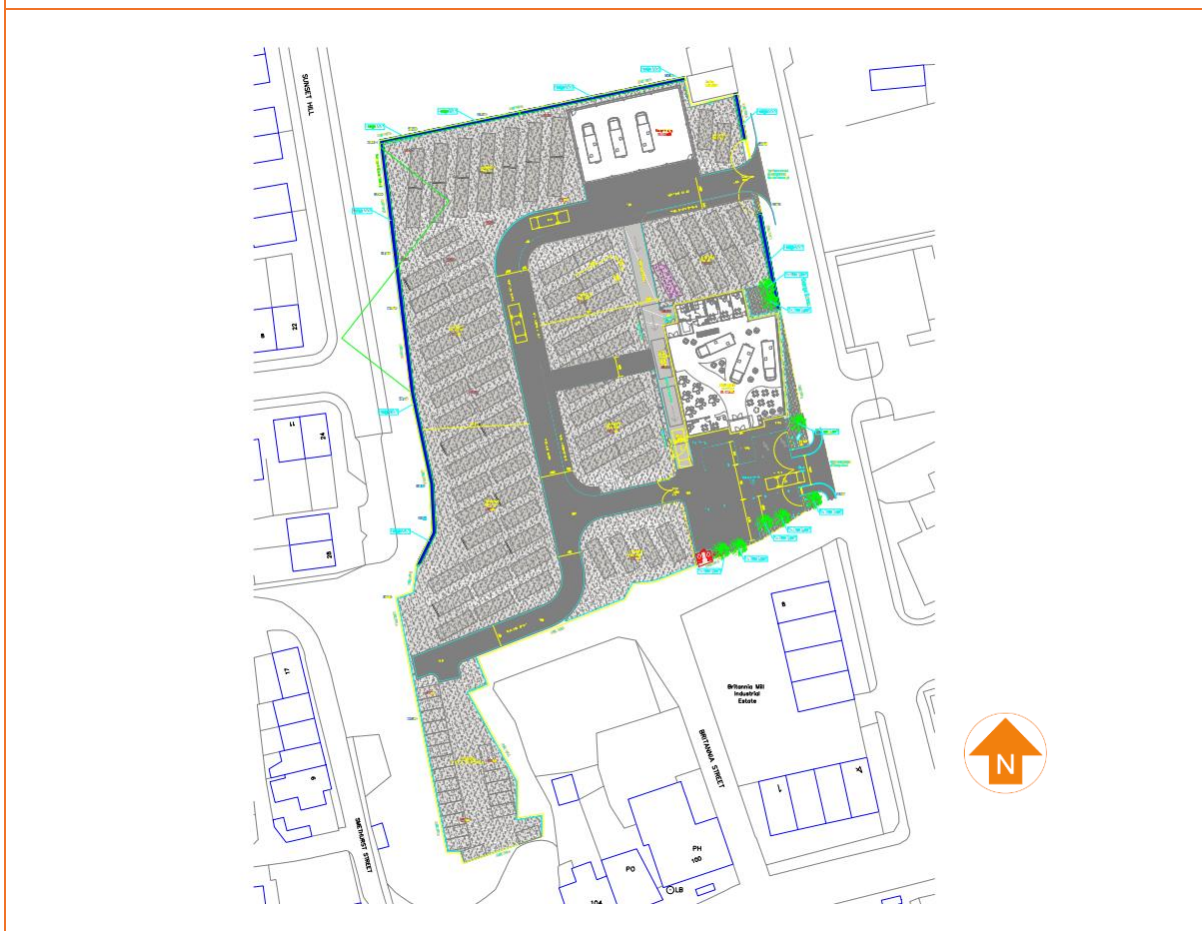
FIGURE 1.1      SNAPSHOT OF PROPOSED DEVELOPMENT

A snapshot of the proposed development layout is indicated in Figure 1.1.

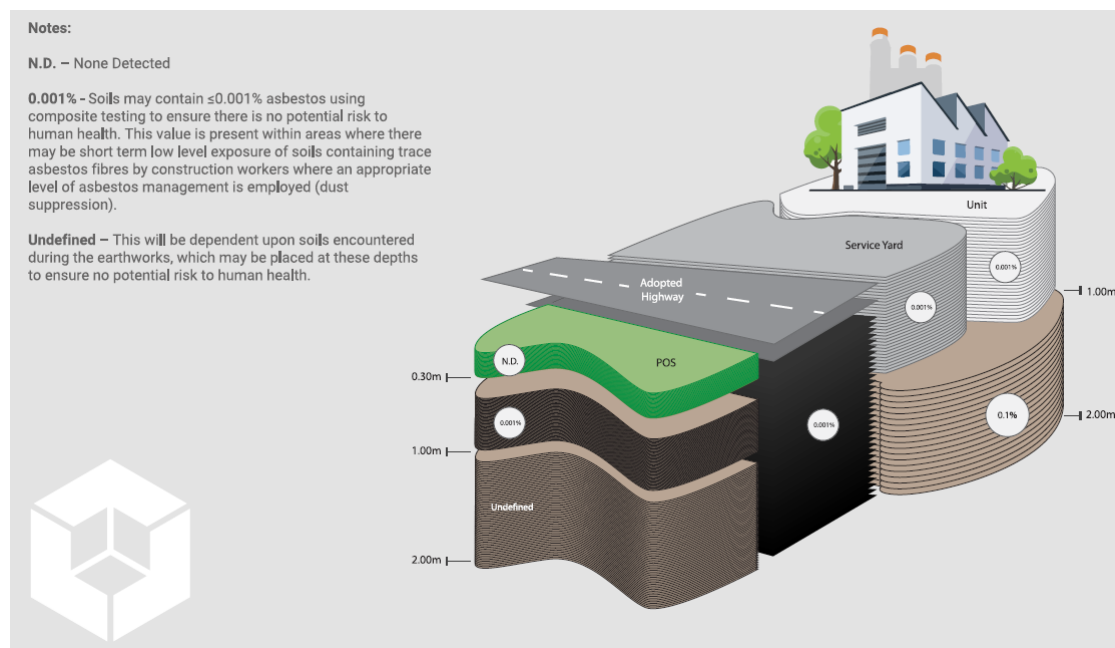
FIGURE 4.1 ASBESTOS RISK MITIGATION CONCEPTUAL SITE MODEL

Bulk fragments of asbestos will need to be removed from the Made Ground with any residual trace fibres managed according to the asbestos risk mitigation conceptual site model shown in Figure 4.1.

| <b>Human Health</b> | <p>The results of the tier 1 comparison indicates that there are no exceedances when compared with the screening criteria for a commercial end-use.</p> <p>Previous site investigations (both the LK Consult and E3P investigations) encountered soils with between &lt;0.001% to 0.097% asbestos and have also noted localised areas of ACM within the Made Ground.</p> <p>Asbestos impacted soils should be managed according to the asbestos risk mitigation conceptual site model.</p> |

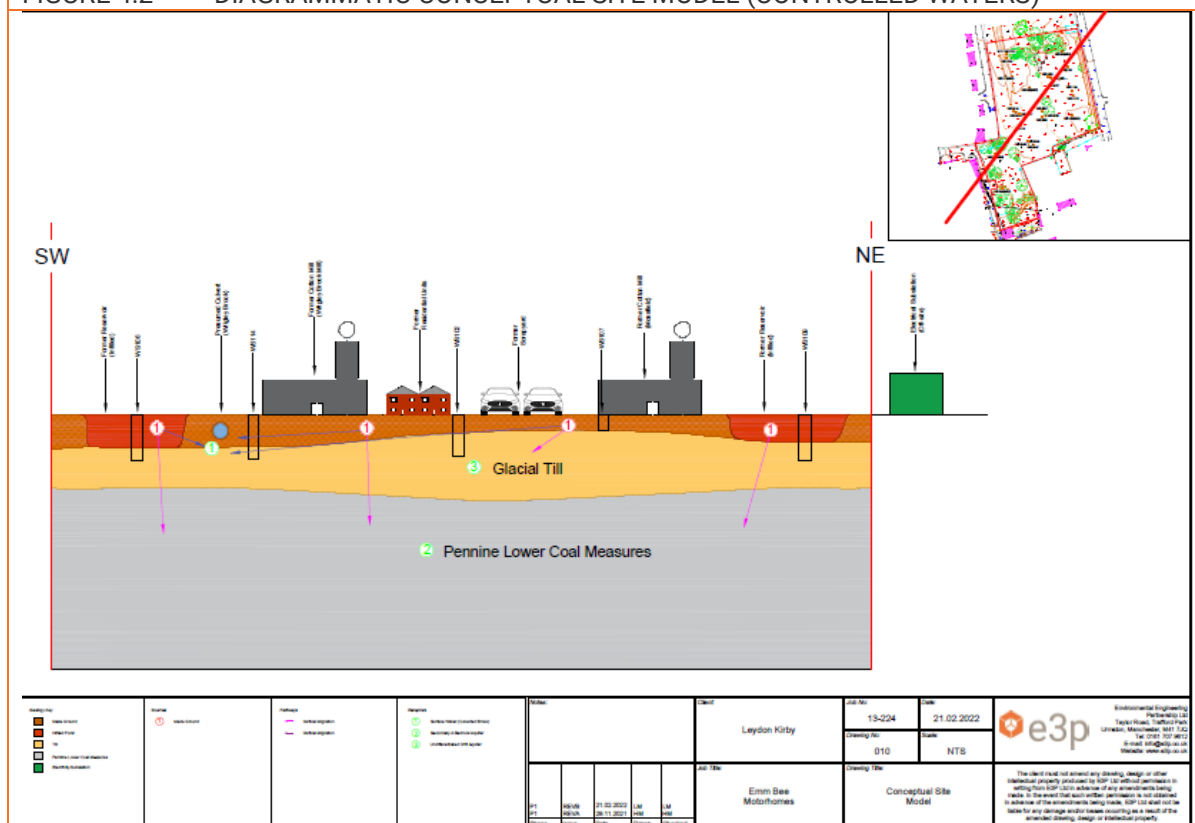
FIGURE 4.2      DIAGRAMMATIC CONCEPTUAL SITE MODEL (CONTROLLED WATERS)

In addition to above, E3P has developed a diagrammatic conceptual model which considers the factors in Table 4.2. This is available as Drawing 13-224-010 and a snapshot is included in Figure 4.2.

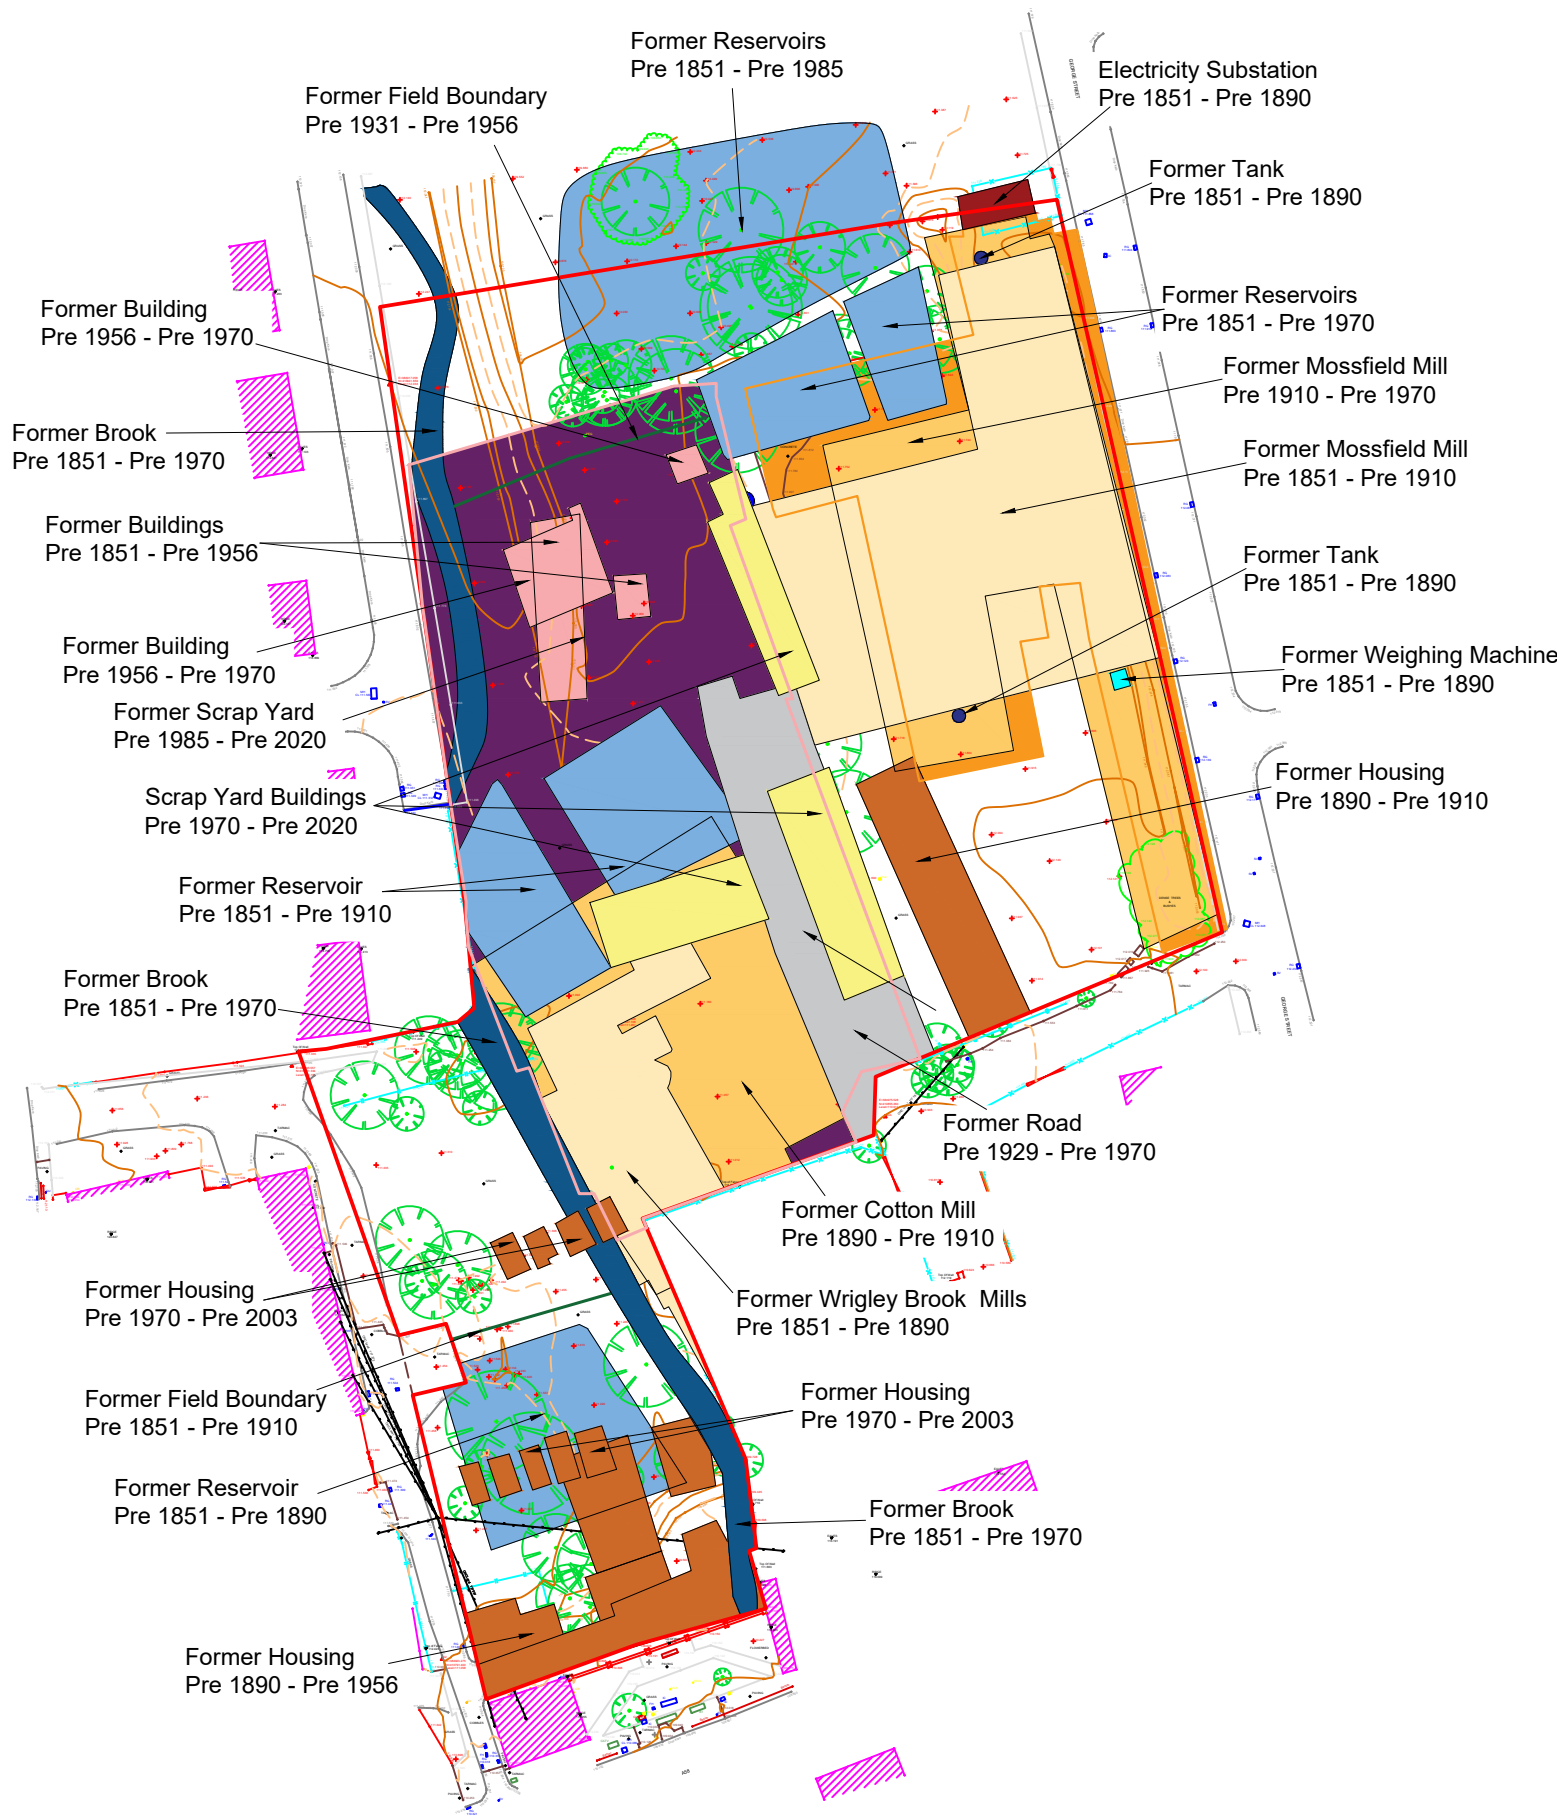
| <div>Historical Features</div> <div><div><div>Former Reservoir</div><div>Former Brook</div><div>Former Housing</div><div>Former Mill</div><div>Former Mill</div><div>Former Mill</div><div>Former Scrap Yard Buildings</div><div>Former Building</div><div>Former Weighing Machine</div></div><div><div>Former Tank</div><div>Electricity Substation</div><div>Former Road</div><div>Former Field Boundary</div><div>Former Scrapyard</div></div></div> | | <div>Notes:</div> | | | | | <div>Client:</div> <div>Fleet Grace</div> | | <div>Job No:</div> <div>13-224</div> <div>Drawing No:</div> <div>003</div> | | <div>Date:</div> <div>28.02.2022</div> <div>Scale:</div> <div>NTS@ A3</div> | | <div><div><div></div><div>e3p</div></div><div>Environmental Engineering Partnership Ltd<br/>Taylor Road, Trafford Park<br/>Urmston, Manchester, M41 7JQ<br/>Tel: 0161 707 9612<br/>E-mail: info@e3p.co.uk<br/>Website: www.e3p.co.uk</div></div> | |

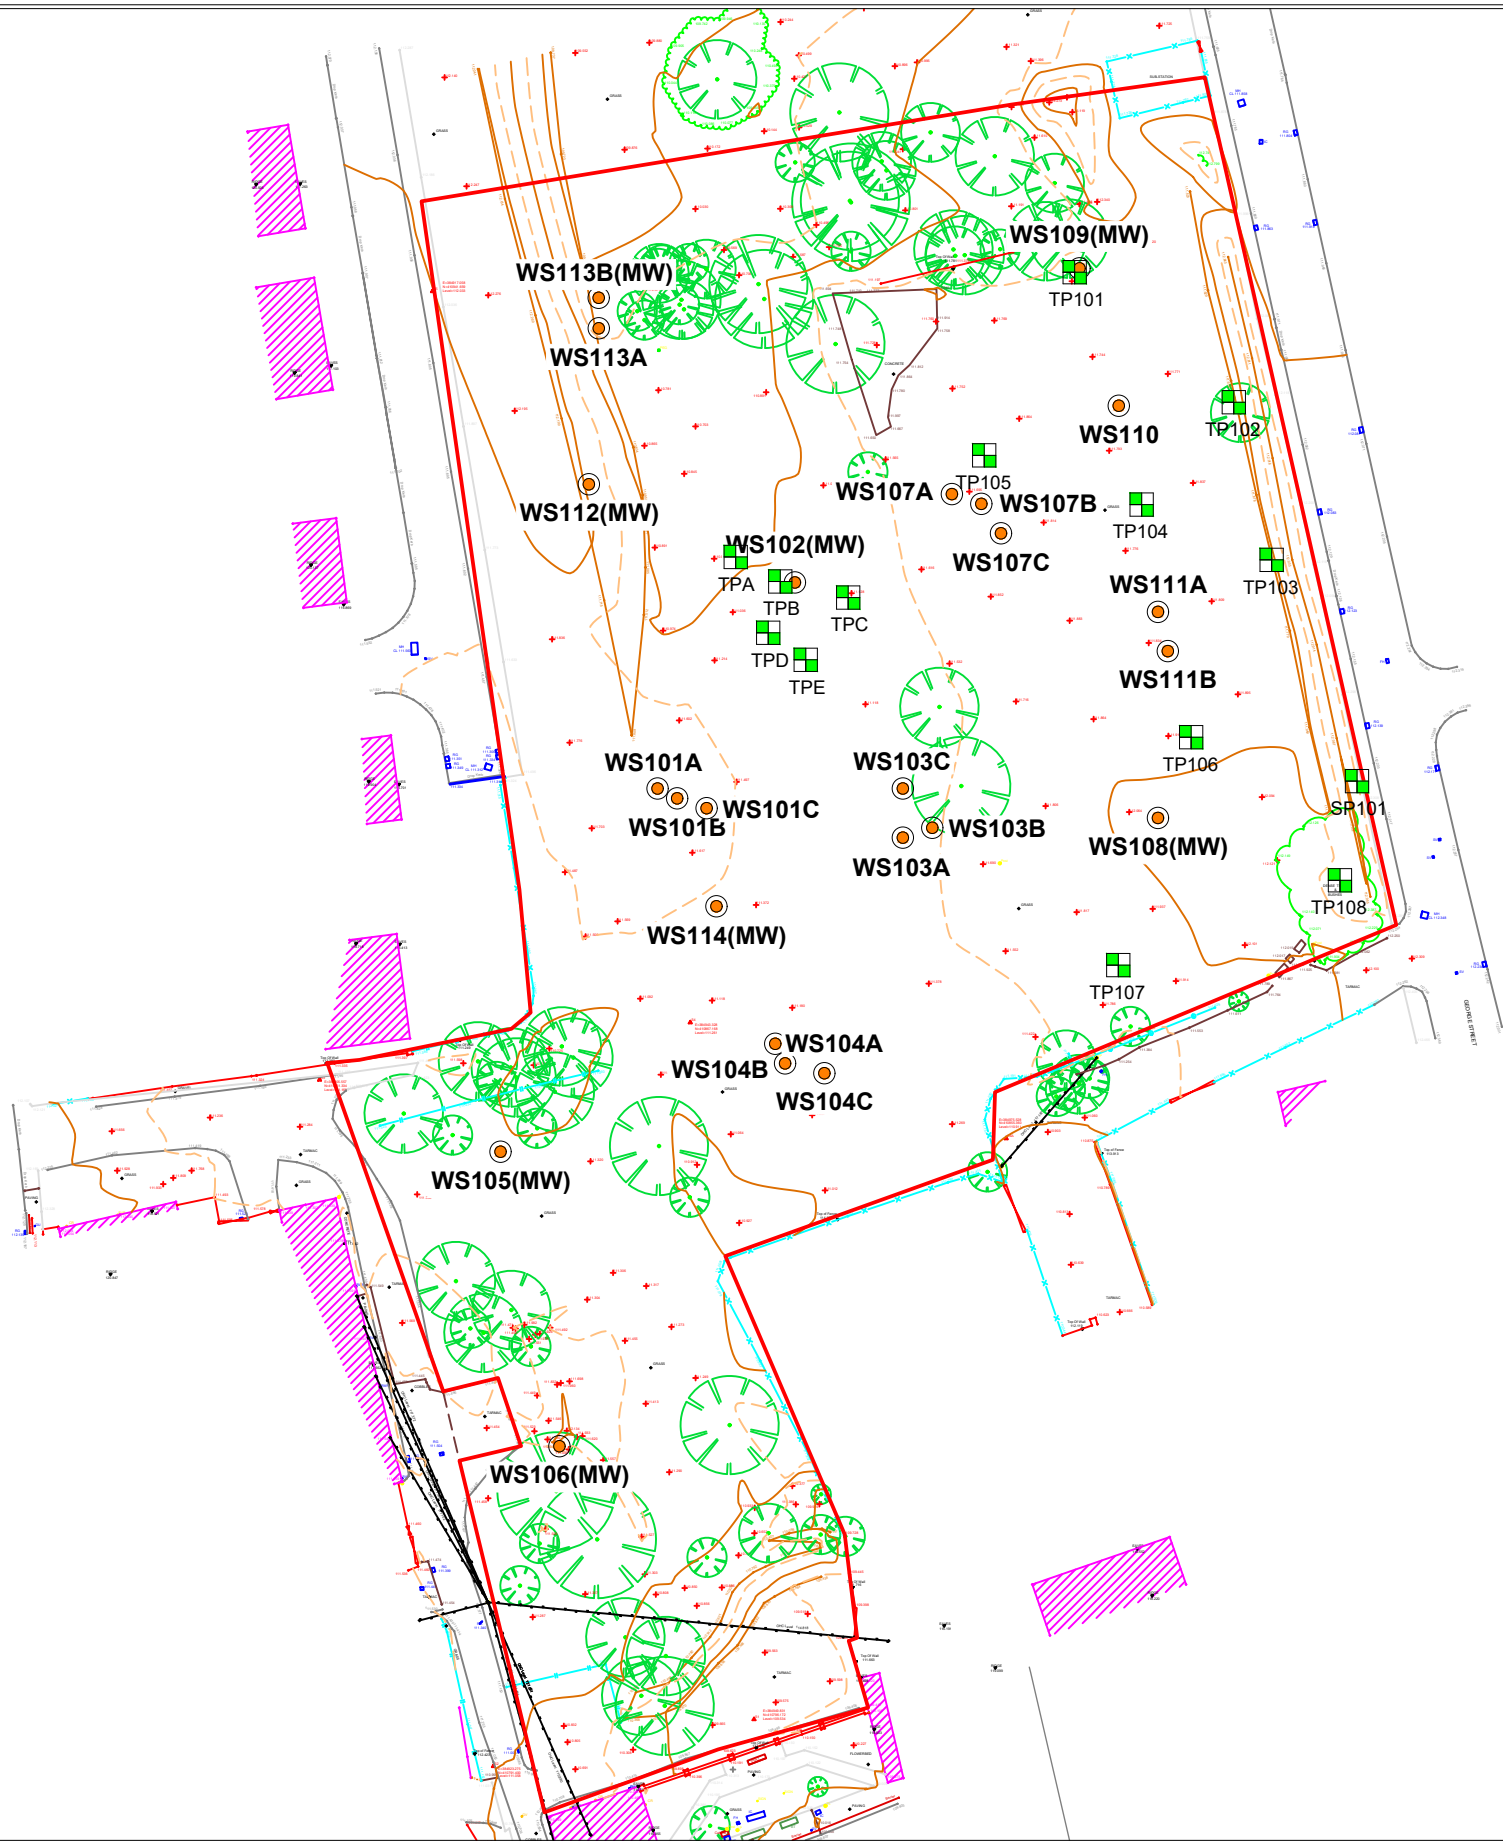
Exploratory Hole  
Location Plan

Location Symbols

The sampling locations are illustrated in Drawing 13-224-005 (Appendix III). The ground conditions encountered are indicated on the logs, which are provided in Appendix IV.

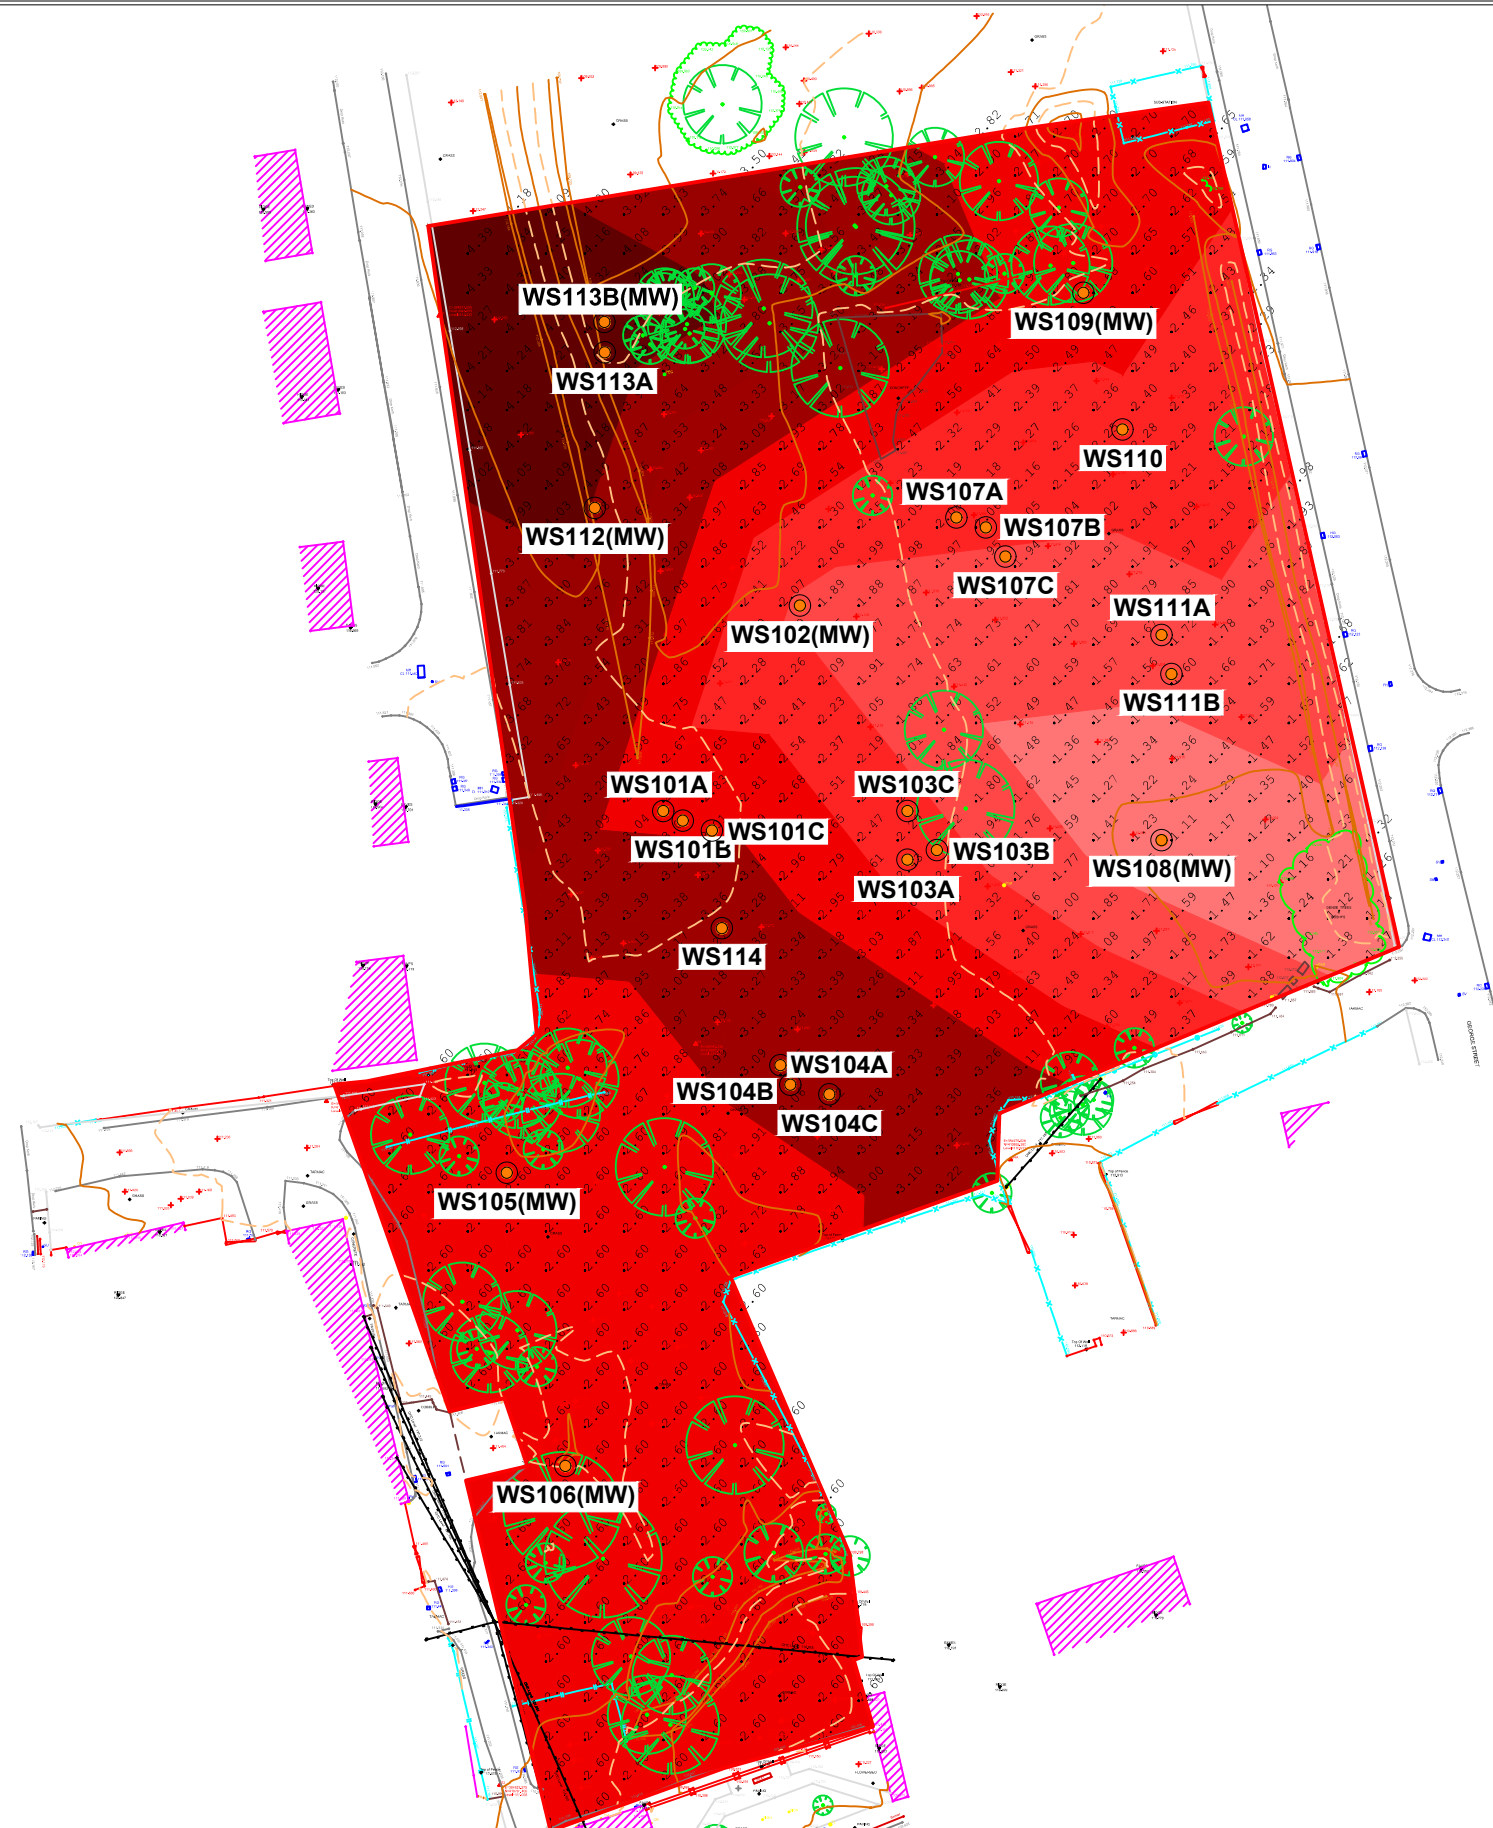
| <div> Approximate Window Sample Probehole Location</div> <div> Approximate Window Sample Probehole Location with Install</div> | | <div> Depth of Made Ground 0.00 - 0.49m</div> <div> Depth of Made Ground 0.50 - 0.99m</div> <div> Depth of Made Ground 1.00 - 1.49m</div> <div> Depth of Made Ground 1.50 - 1.99m</div> <div> Depth of Made Ground 2.00 - 2.49m</div> <div> Depth of Made Ground 2.50 - 2.99m</div> <div> Depth of Made Ground 3.00 - 3.49m</div> <div> Depth of Made Ground 3.50 - 3.99m</div> <div> Depth of Made Ground &gt;4.00m</div> | | | | | | <div>P1<br/>P1</div> <div>REV B<br/>REV A</div> <div>25.02.2022<br/>22.02.2022</div> <div>EB<br/>LM</div> <div>EF<br/>ND</div> <div>Phase<br/>Issue</div> <div>Date</div> <div>Drawn</div> <div>Checked</div> | | <b>Job Title:</b><br><br>George Street,<br>Heywood | | | | <b>Drawing No:</b><br><br>006 | |

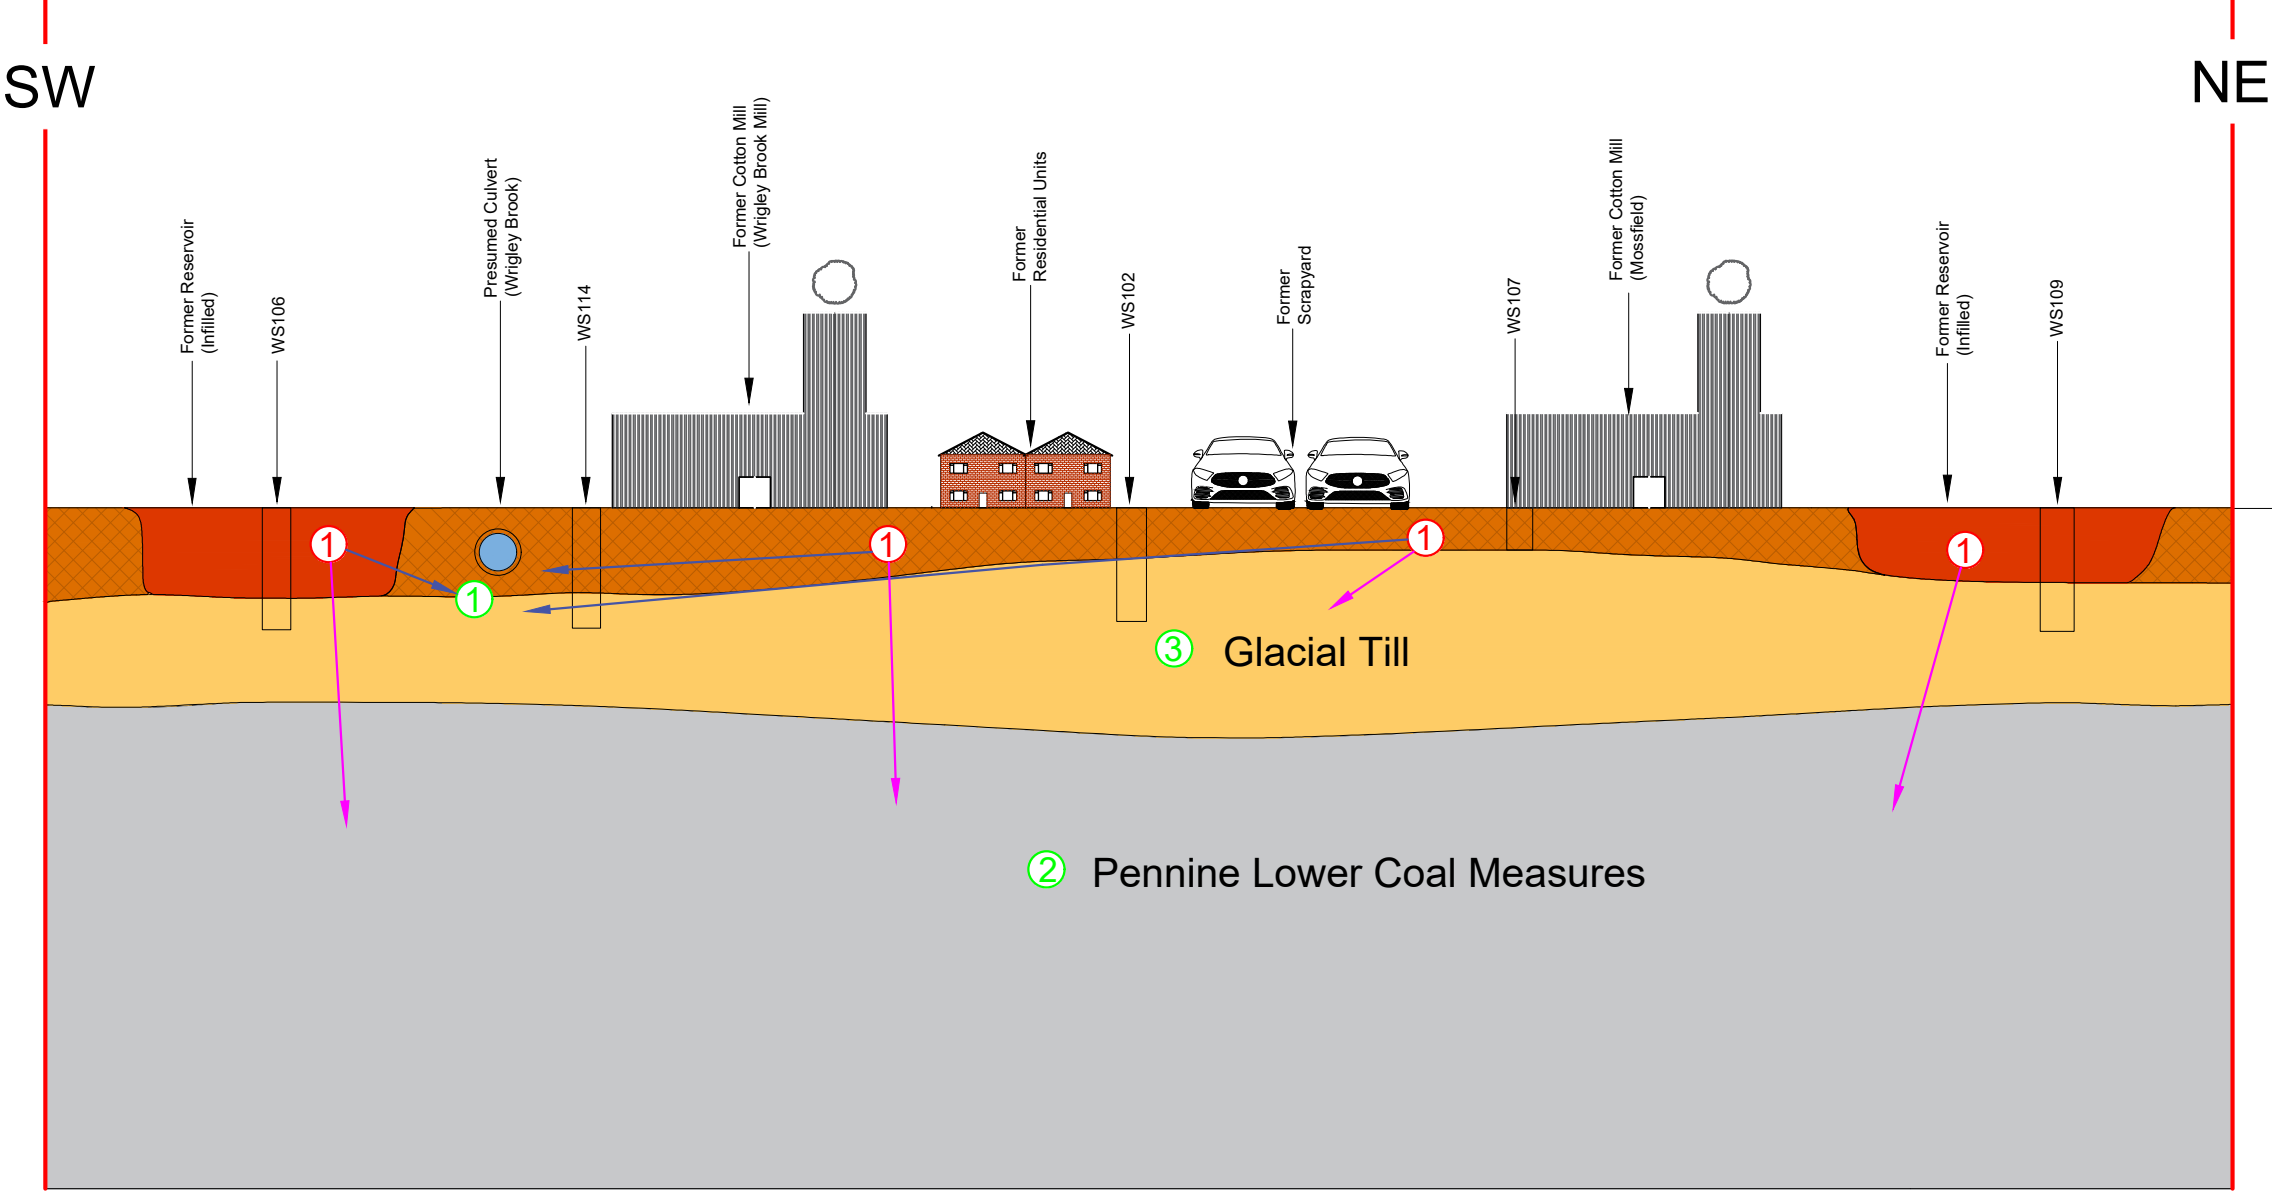
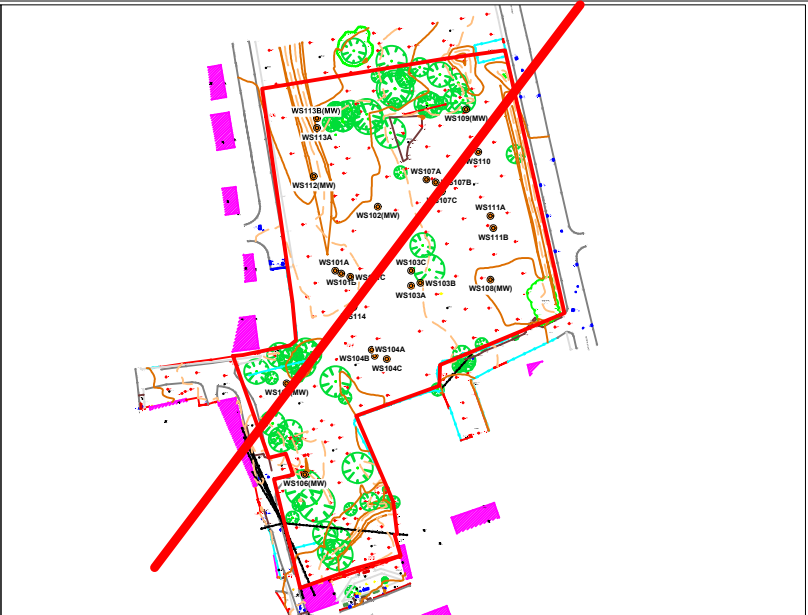
| <div>Geology Key</div> <div><div>Made Ground</div><div>Infilled Pond</div><div>Till</div><div>Pennine Lower Coal Measures</div><div>Electricity Substation</div></div> | <div>Sources</div> <div><div>①</div> Made Ground</div> | <div>Pathways</div> <div><div>Vertical Migration</div><div>Vertical Migration</div></div> | <div>Receptors</div> <div><div>①</div> Surface Water (Culverted Brook)</div> <div><div>②</div> Secondary A Bedrock Aquifer</div> <div><div>③</div> Undifferentiated Drift Aquifer</div> | <div>Notes:</div> | | | | | <div>Client:</div> <div>Leydon Kirby</div> | | <div>Job No:</div> <div>13-224</div> | <div>Date:</div> <div>21.02.2022</div> | <div><div><div></div></div><div>e3p</div><div>Environmental Engineering Partnership Ltd<br/>Taylor Road, Trafford Park<br/>Urmston, Manchester, M41 7JQ<br/>Tel: 0161 707 9612<br/>E-mail: info@e3p.co.uk<br/>Website: www.e3p.co.uk</div></div> | | | | |
