RE: 2023 Method Statement for reinstatement of marshy grassland  
SITE: Edgar Wood Temporary School, Hopwood Hall College, Rochdale Road, Middleton,  
Manchester, M24 6XH

Please find details of a Method Statement for the reinstatement of the area of marshy grassland at the site of the temporary school accommodation on land south of Hopwood Hall College, Middleton campus.

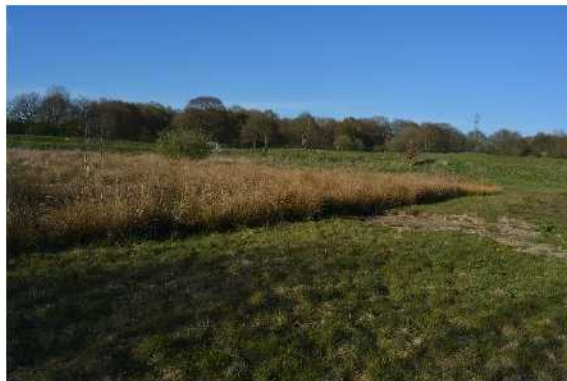
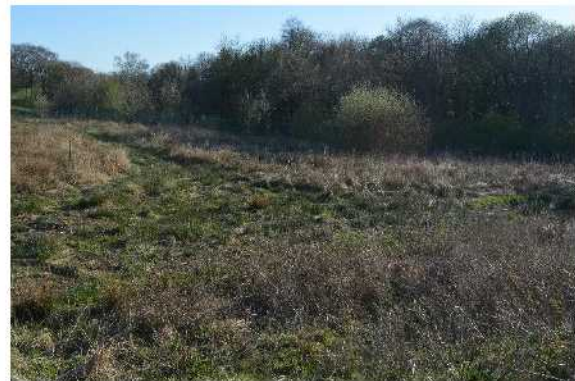
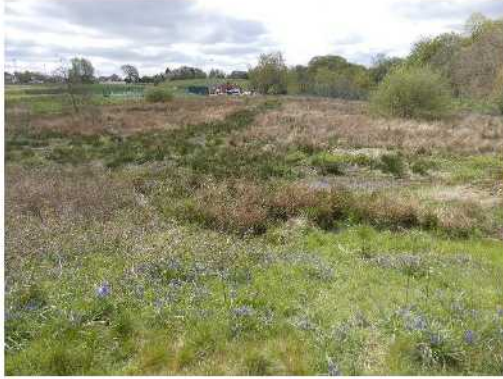
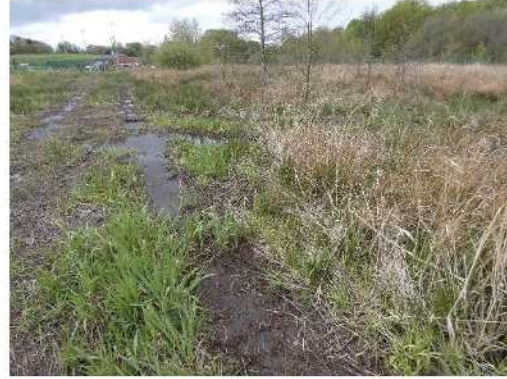
However, the marshy grassland (Figs. 2-5 overleaf) contains a more diverse floral community, including dominant Soft Rush *Juncus effusus* and Hard Rush *J. inflexus*, along with Common Reed *Phragmites australis* (F), Greater Bird's-foot Trefoil *Lotus pedunculatus* (O), Rosebay Willowherb *Chamerion angustifolium* (F), Greater Willowherb *Epilobium hirsutum* (O), Field Vetch *Vicia sativa* (O), Cow Parsley *Anthriscus sylvestris* (O), Spear Thistle *Cirsium vulgare* (O), Creeping Thistle *C. arvense* (O), Common Ragwort *Jacobaea vulgaris* (O), Tufted Hair grass *Deschampsia cespitosa* (F), and Meadow Foxtail *Alopecurus pratensis* (R). Mosses *Bryophyta spp* carpet the ground layer.

**Figs. 2 & 3 Marshy grassland – April 2021**

**Figs. 4 & 5 Marshy grassland – May 2021**

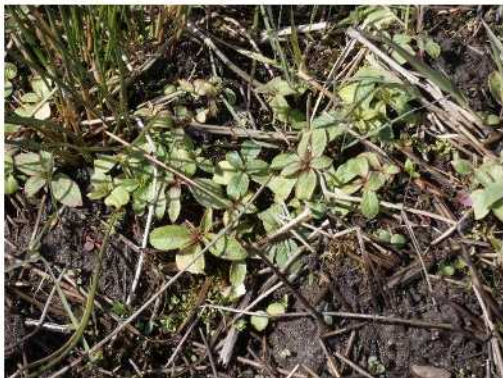
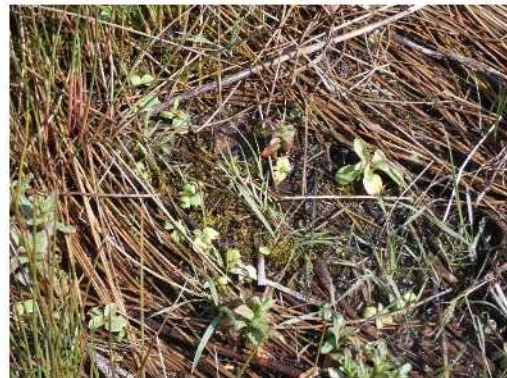
Around 30% of the marshy grassland contains Himalayan Balsam *Impatiens glandulifera*, this scattered across the grassland, in particular the wetter areas (Figs. 6 and 7).

**Figs. 6 & 7 Himalayan Balsam seedlings – 11<sup>th</sup> May 2021**

If the Himalayan Balsam starts to grow in the re-surfaced area, this will be hand pulled and spread out to dry on another terram mat next to the site. Once dried out, the balsam is no longer viable.

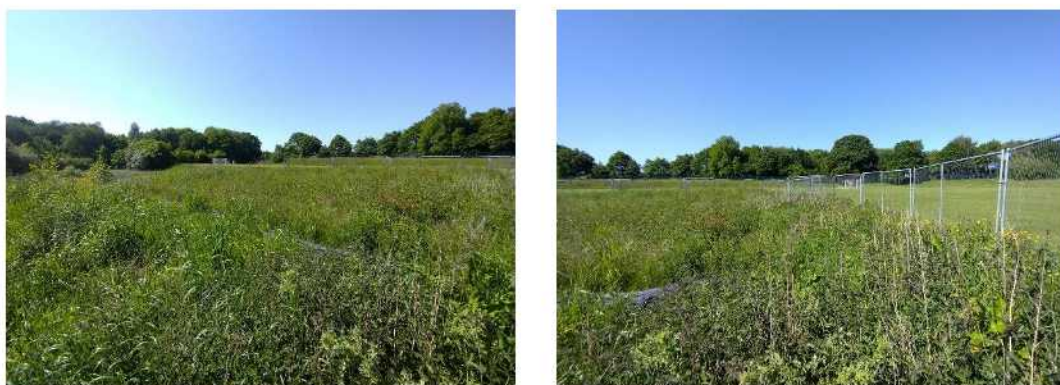
Some roots from the marshy grassland species were present in this layer, and un-germinated seeds from the sward. These re-generated without the presence of Himalayan Balsam, and a sward of marshy grassland species was noted during a site inspection on 2<sup>nd</sup> June 2023 (Fig. 10 and 11 overleaf).

**Fig. 10 & 11 Regenerated marshy grassland topsoil storage area 2<sup>nd</sup> June 2023**
