# **GEO-ENVIRONMENTAL AUDIT**

## **PHASE 1 PRELIMINARY RISK ASSESSMENT**

## **PHASE 2 SITE INVESTIGATIONS**

**PROPOSED RESIDENTIAL DEVELOPMENT**  
**LAND AT 26 FALCON CLOSE**  
**NORDEN**  
**ROCHDALE**  
**OL12 7RY**

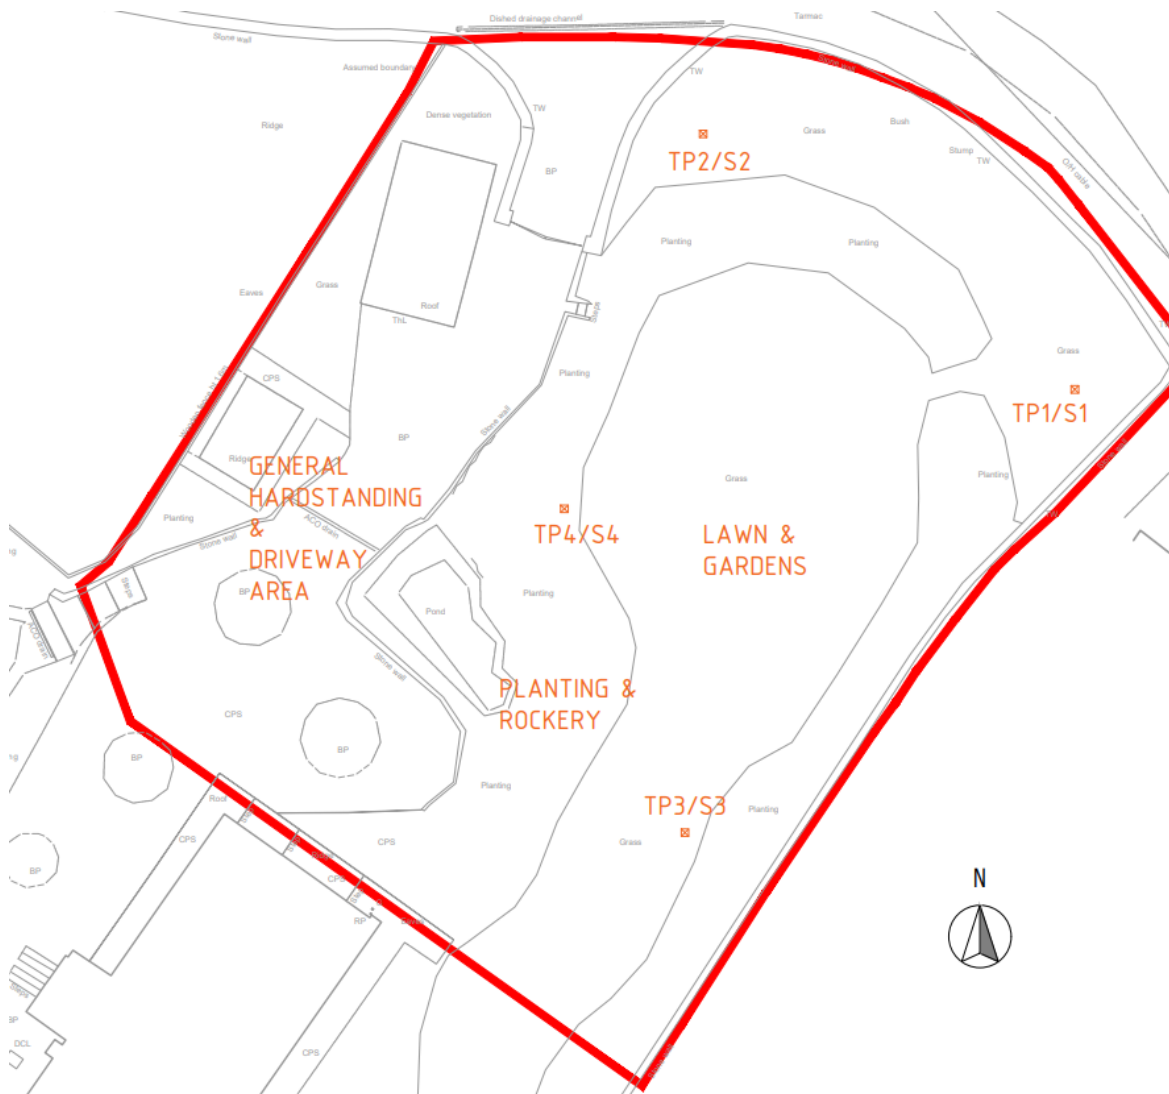
#### 2.1.2. Site Investigation Plan.

Site Investigations were undertaken by T J Booth Associates and comprised 4No. hand excavated trial holes (THs 1-4). 4No. soil samples were also taken for chemical analysis of the upper site soils (S1-4).

Trial holes & soil samples were located in nominally equidistant positions where possible across the Site, to gain an understanding of the general background contamination levels.

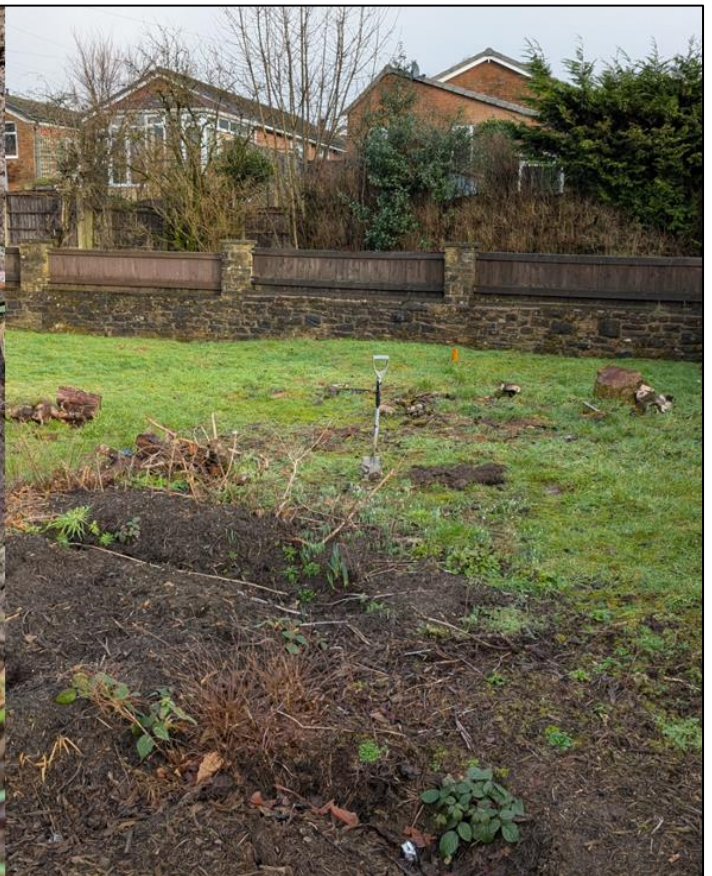
0-390mm Dark brown, slightly gravelly clayey topsoil MADE GROUND. Gravel is brick, stone, slate & glass.

| Trial Hole/Soil Sample | Made ground horizon | Mitigation/Action |
|---|---|---|
| TP1/S1 | Dibenz[ah]anthracene. | FURTHER ACTION |

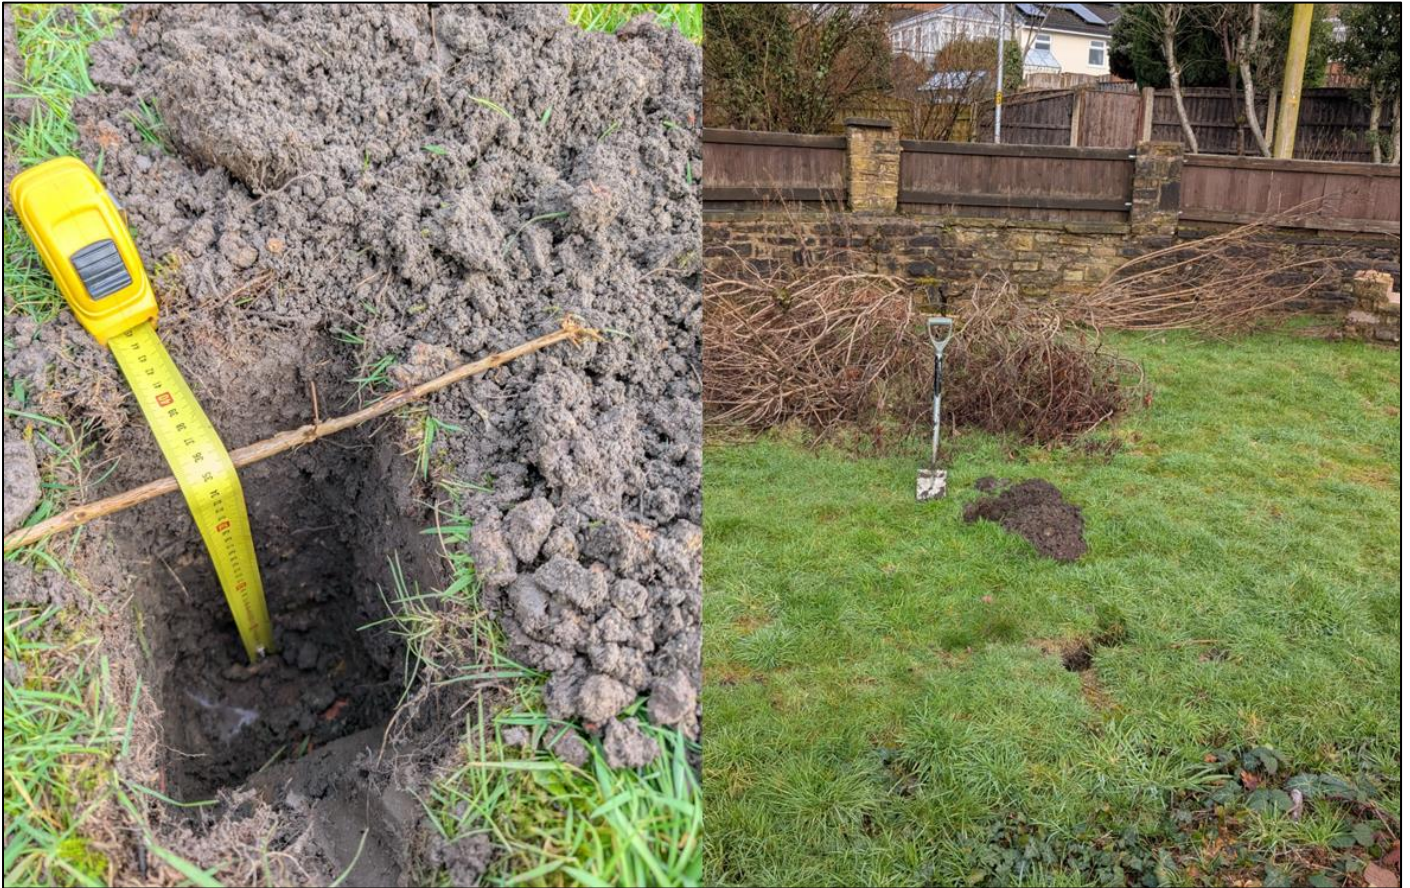
0-350mm Dark brown, slightly gravelly clayey topsoil MADE GROUND. Gravel is brick, stone, slate, coal & ash.

| Trial Hole/Soil Sample | Made ground horizon | Mitigation/Action |
|---|---|---|
| TP2/S2 | Benzo[a]anthracene, benzo[a]pyrene, benzo[b]fluoranthene, chrysene, dibenz[ah]anthracene. | FURTHER ACTION |

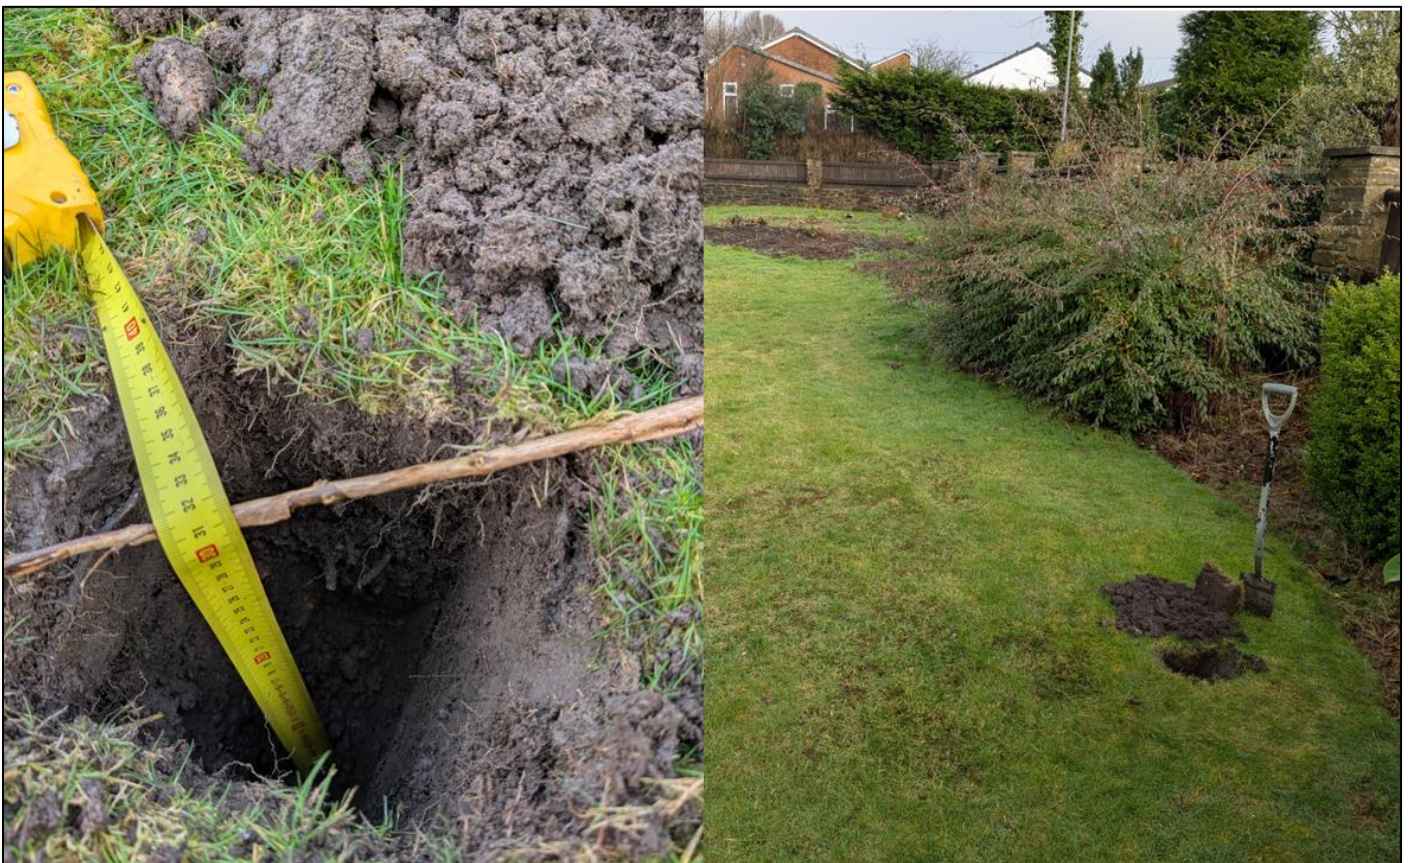
0-310mm Dark brown, slightly sandy, slightly gravelly silt topsoil MADE GROUND. Gravel is brick & stone.

| Trial Hole/Soil Sample | Made ground horizon | Mitigation/Action |
|---|---|---|
| TP3/S3 | Chromium III, lead. | FURTHER ACTION |

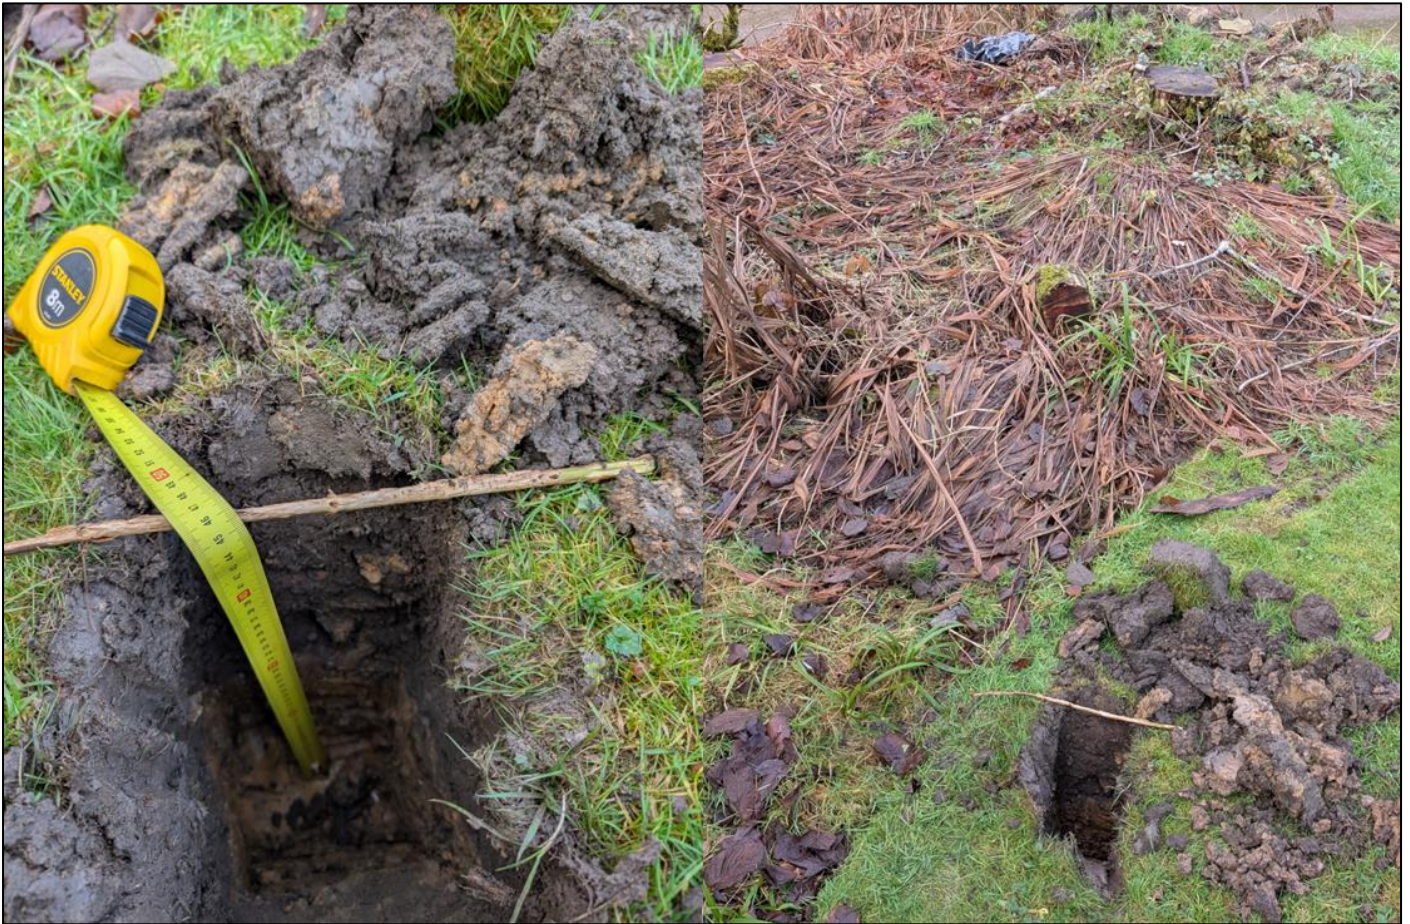
0-250mm Dark brown, slightly sandy, slightly gravelly silt topsoil MADE GROUND. Gravel is brick & stone.

250-450mm Soft to firm light brown/grey mottled, slightly gravelly CLAY

| Trial Hole/Soil Sample | Made ground horizon | Mitigation/Action |
|---|---|---|
| TP4/S4 | Lead | FURTHER ACTION |
