# PROPOSED REDEVELOPMENT AT BROWN STREET

## HERITAGE ASSESSMENT

LITTLEBOROUGH, METROPOLITAN BOROUGH OF  
ROCHDALE

JUNE 2020

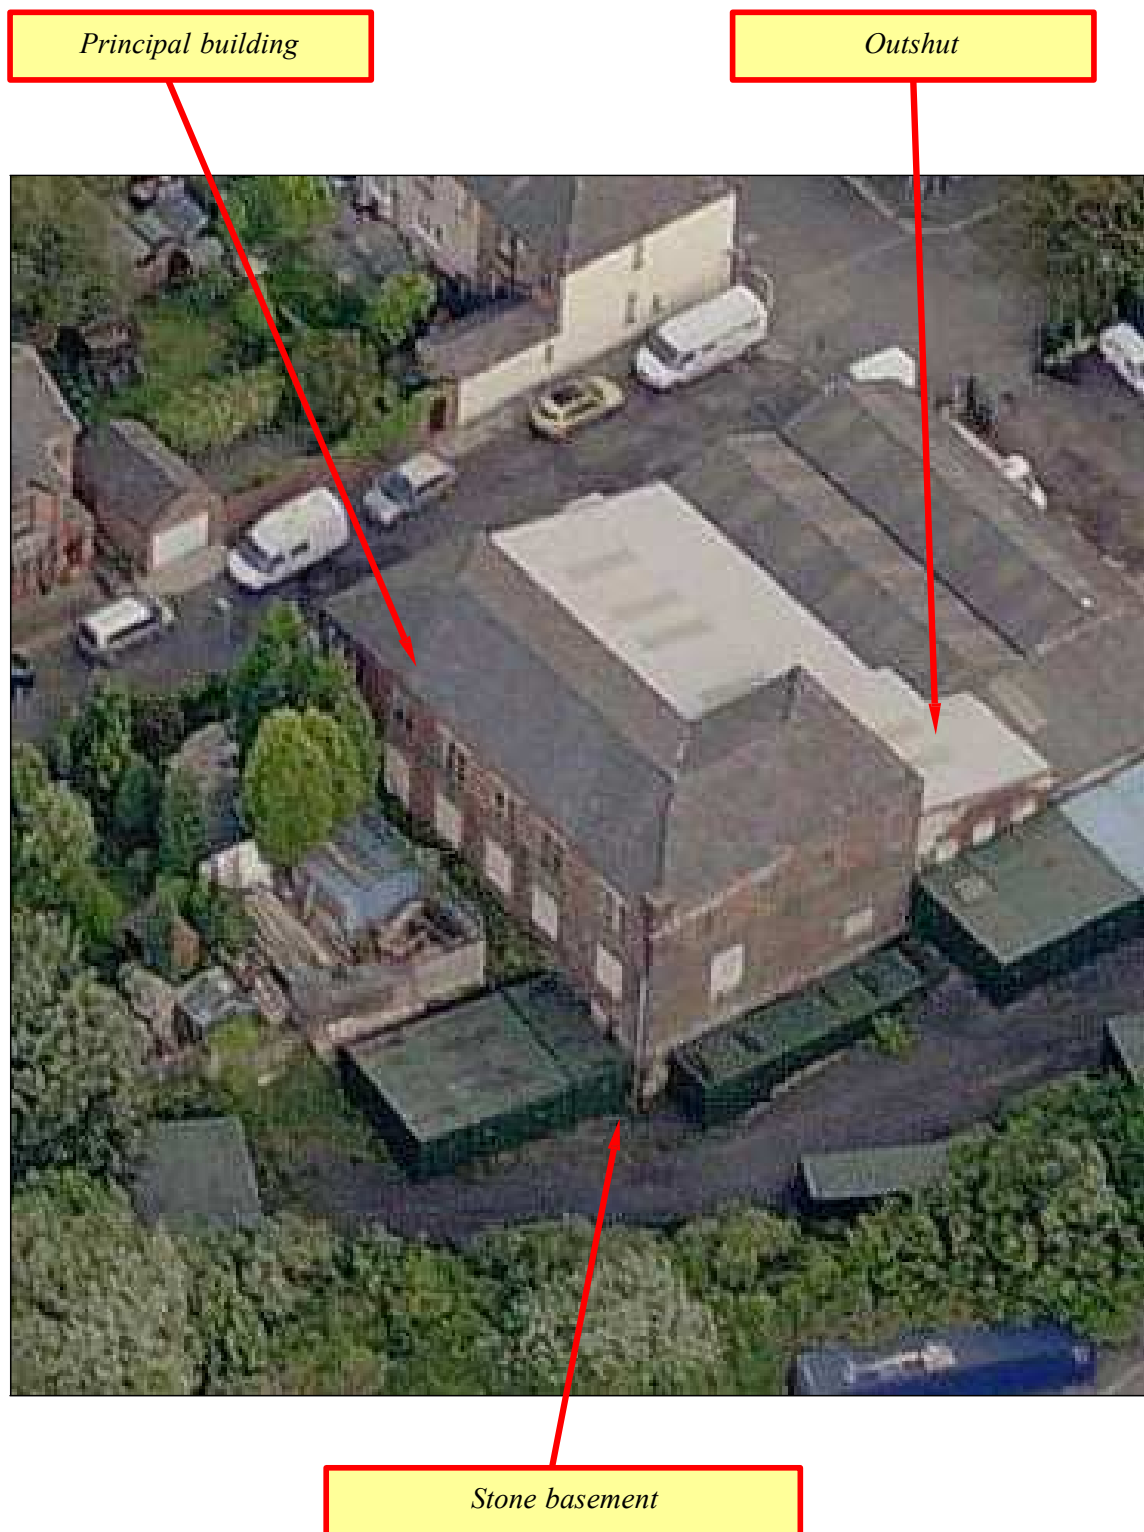
The building involves three distinct elements:

- a. An L-shaped **principal building**, built of brick and of two storeys. This comprises a main range aligned on a southwest-northeast axis with the main elevation to the northwest, and a short rear wing at its southwest end
- b. An **outshut** added as a continuation of the rear wing and built between 1890 and 1908 on map evidence
- c. A stone **basement** beneath the northwest corner of the principal building, accommodated within falling ground at this end and probably of earlier date; it is currently inaccessible.

7. Elements of the building (based on GMAU photograph)

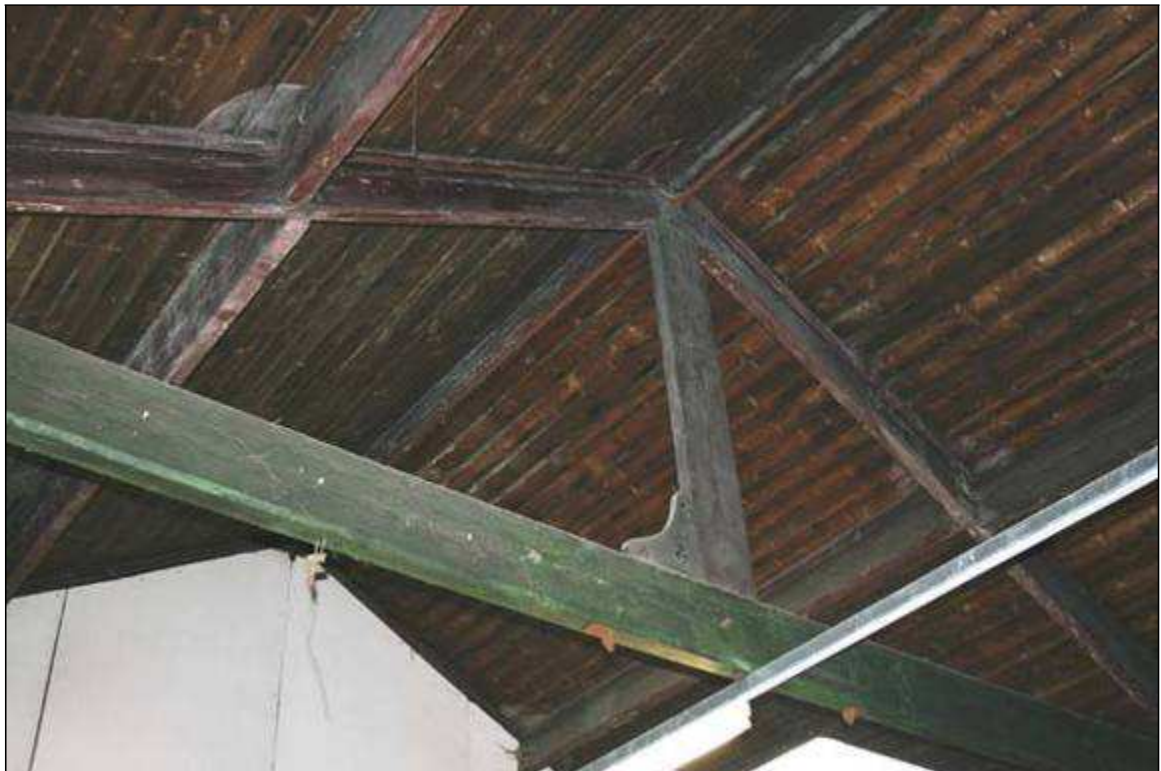
- b. **Roof construction.** The slate-covered roof of the principal building is hipped at each end and carried on five machine-cut kingpost trusses, supporting a ridge and one deeply-trenched purlin on each side. Some of the trusses have wooden braces from wall to tiebeam with simple pierced decoration; the truss from the northeast retains one survivor from a pair of small braces to its kingpost (Plate 8).

8. Roof truss with small surviving brace to kingpost

**3. The sequence of roof trusses in the principal building**

*Reason:* as a detail of the building's construction; also for the use of decorative braces (most of which have been lost)

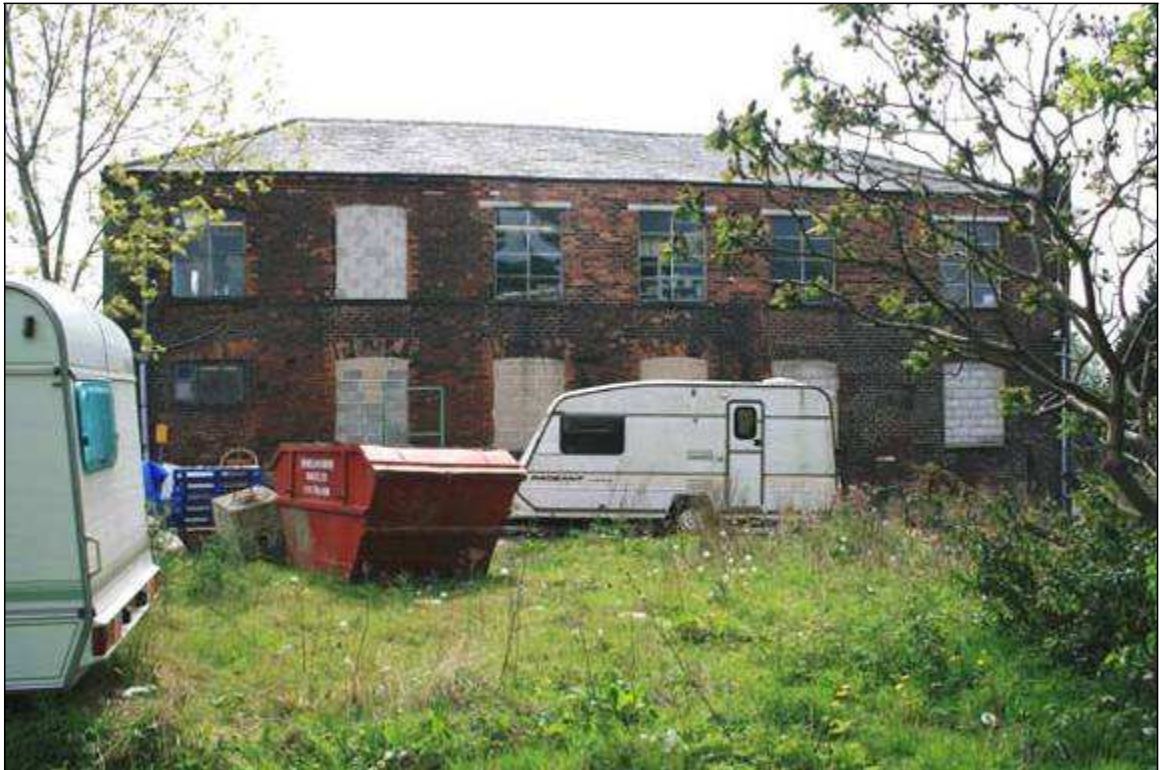
- a. **Northwest (principal) elevation.** This is of six bays, with regularly-spaced windows on both floors, most with shallow segment-arched heads. Those on the ground floor are blocked with the exception of the first window, (enumerating from northeast) which has been reduced in depth. The second has been enlarged to form a doorway and is also blocked. The first window on the first floor retains fixed four-pane glazing which appears original; the second window is blocked and the rest are eight-pane probably mid-20<sup>th</sup> century replacements, with straight concrete lintels; the brickwork around these windows shows signs of rebuilding. Between the fifth and sixth bays, which are more widely spaced, is a narrow ground floor opening, blocked at an early date, which may have been a loading doorway from the lower level outside the basement. At the far southwest end, between the ground and first floor windows of the sixth bay, is a circular aperture blocked in 20<sup>th</sup> century brick. A small chimney rises from the eaves at the northwest corner of this end. A rather surprising touch of decoration in this otherwise plain and functional building is found in the remains of a cornice in dogtooth brickwork.

*11. Main elevation of principal building, from northwest*

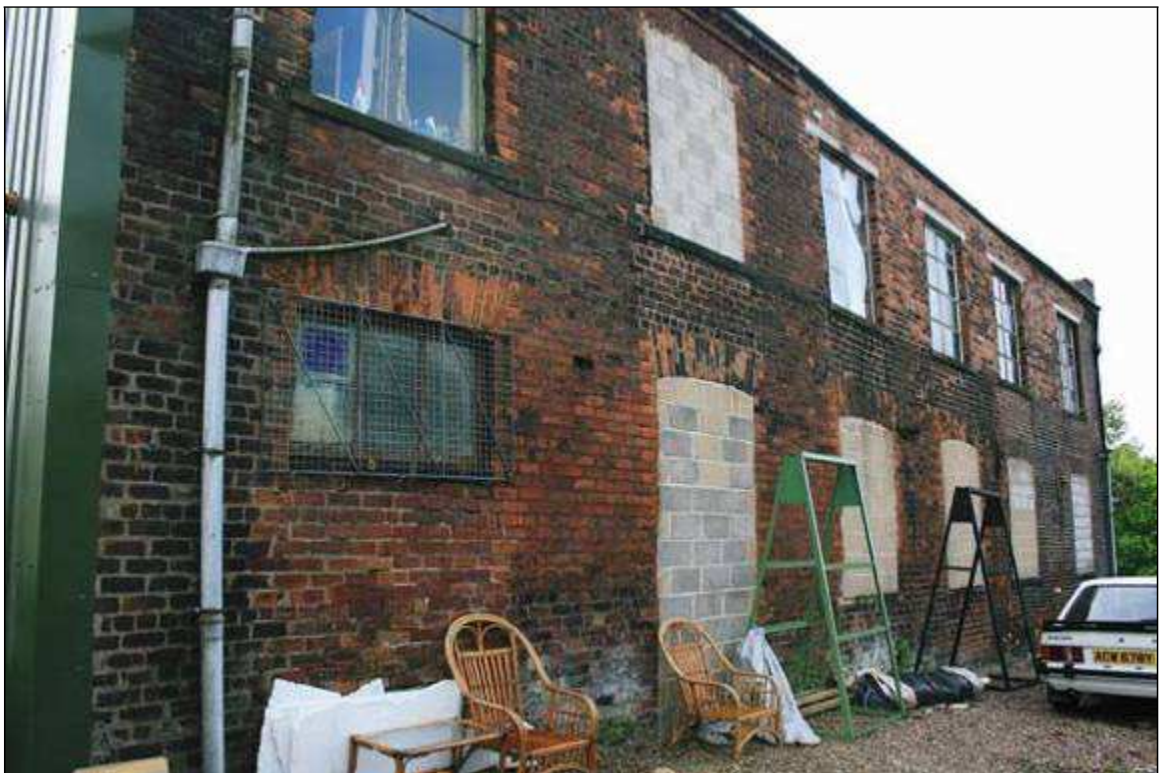
*12. Closer view showing blocked windows*

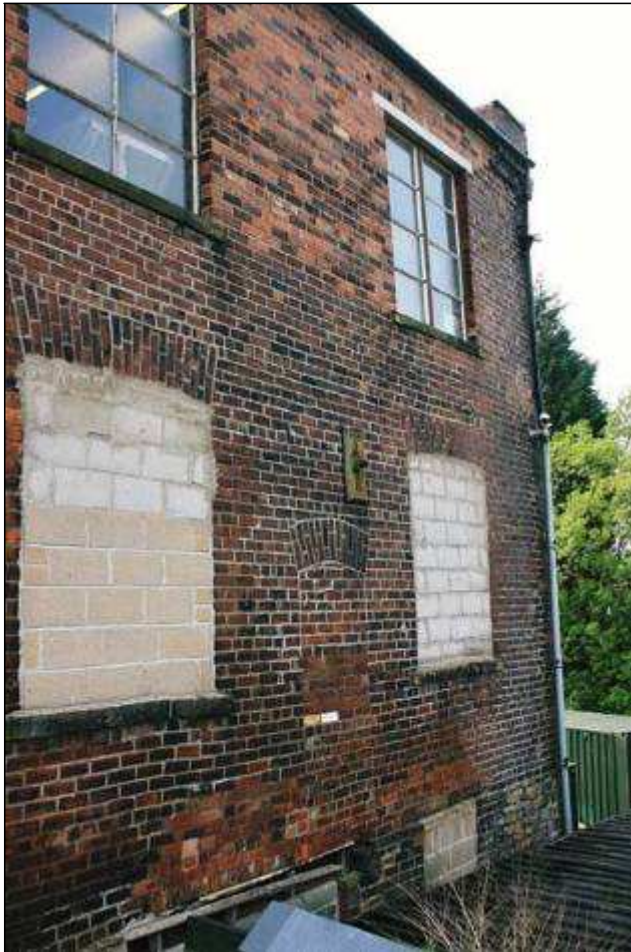
*13. Blocked possible loading door between fifth and sixth bays, above stone basement*

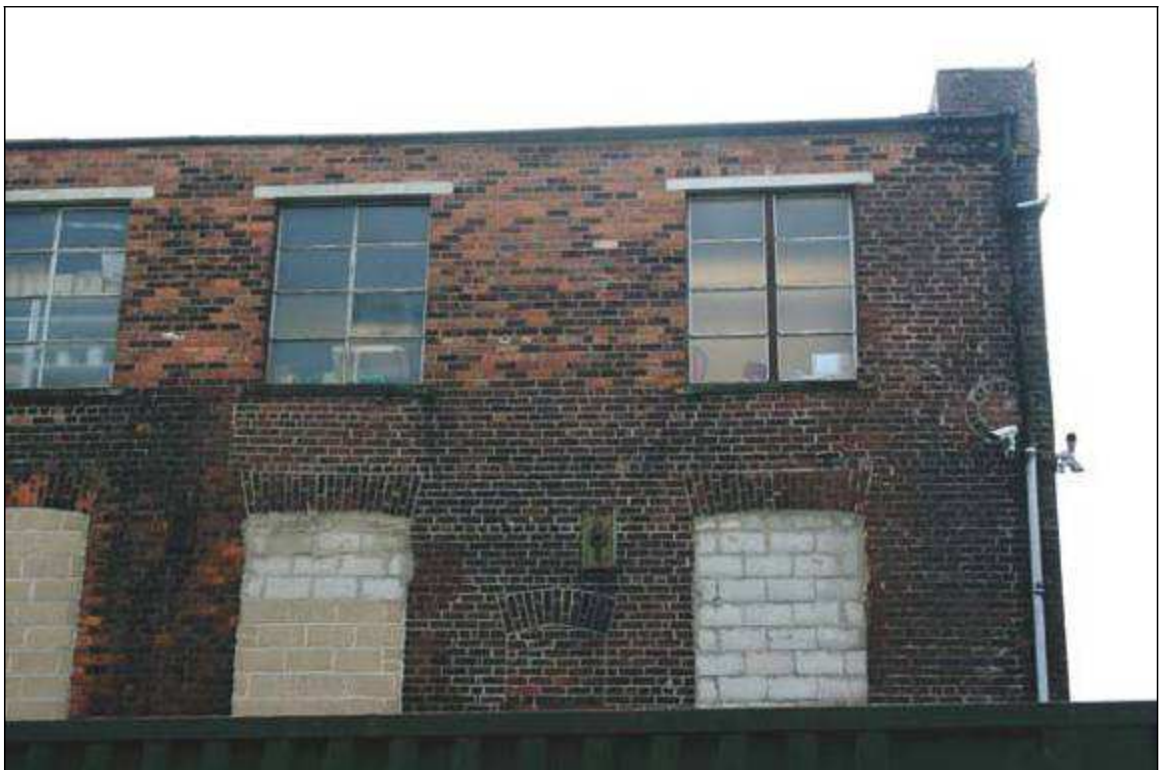
*14. 20<sup>th</sup> century replacement first floor windows, and blocked circular aperture at southwest end of principal building*

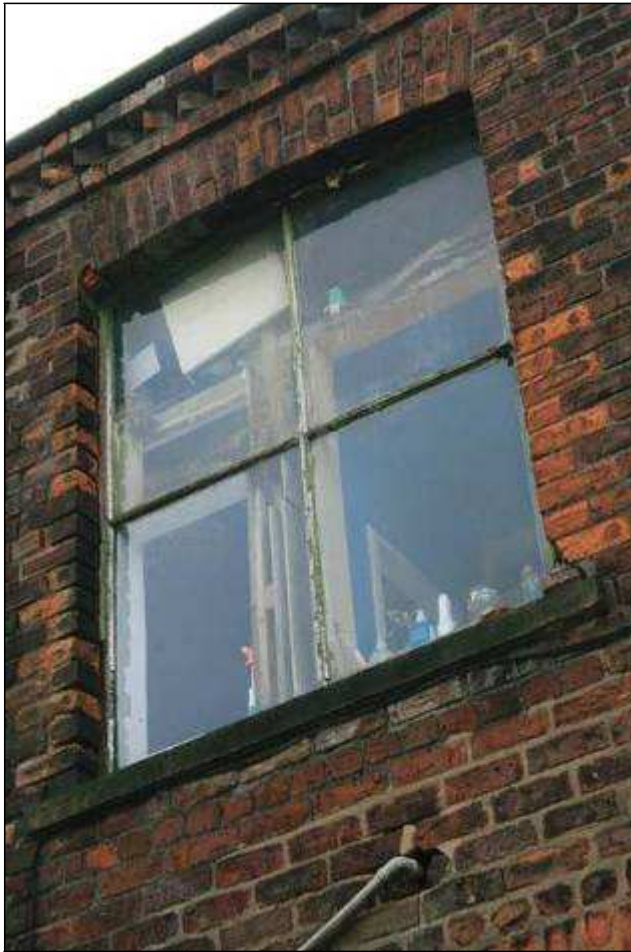
*15. Four-pane, probably original, glazing of first floor window in first bay; also dogtooth eaves cornice*

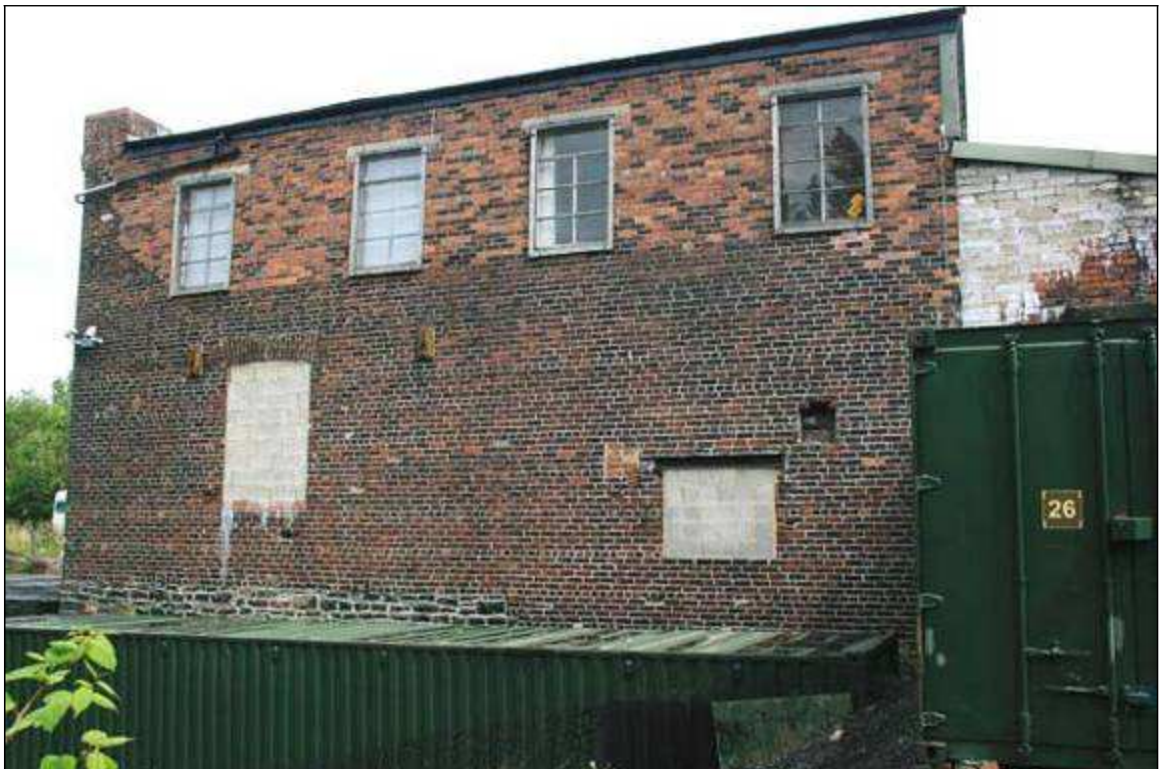
- b. **Southwest elevation.** This end of the main range has two widely-spaced blocked ground floor windows, the left vertical and the right horizontal. The first floor has four evenly-spaced vertical mostly eight-pane windows, again probably mid-20<sup>th</sup> century and with concrete lintels. The brickwork at this level also shows signs of rebuilding.

*16. Southwest elevation, showing first floor rebuilding*

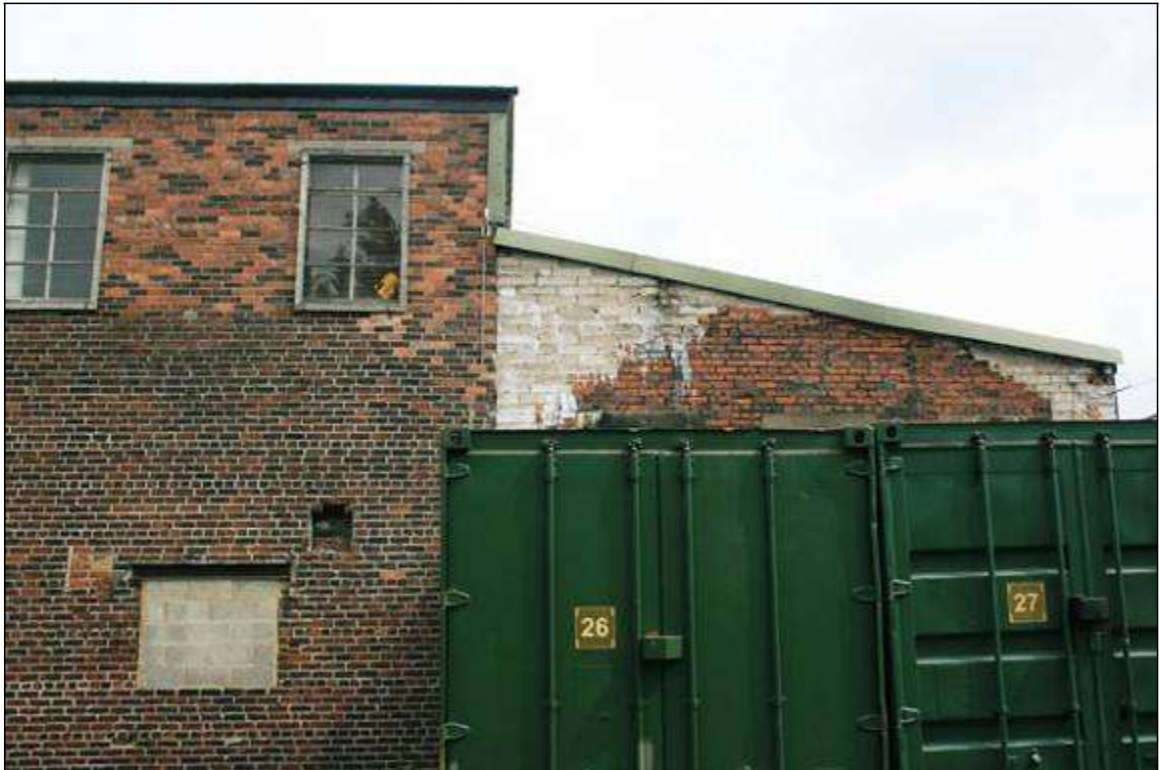
*17. Detail of junction of rear wing and outshut*

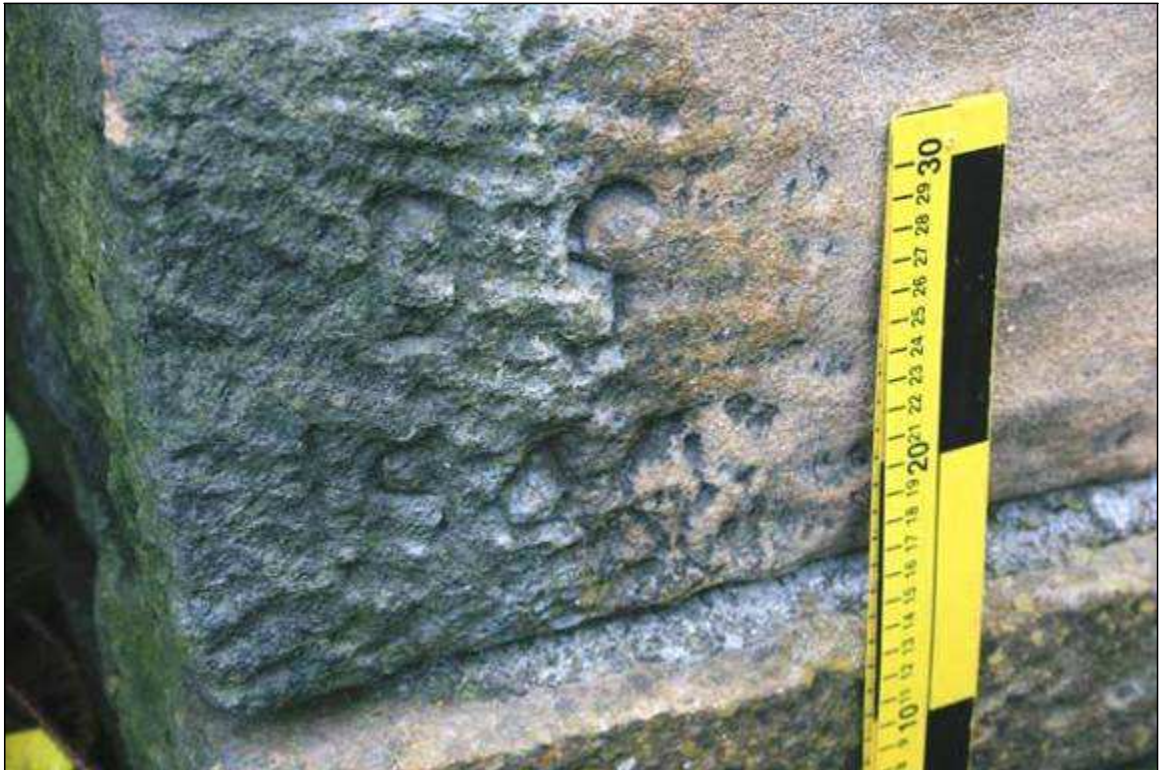
Mostly concealed by storage containers parked alongside. It appears to extend beneath the fifth and sixth bays of the principal building, where the ground level is lower; the stonework stops approximately halfway along the southwest elevation (see Plate 16) so whether the basement extends beneath the rear wing is not known.. The northwest wall has a blocked doorway; a quoin near ground level carries the graffiti date of 1900 or 1909 and the initials BS (Plate 19).

19. Quoin at northwest corner of basement with graffiti initials BS and date of 1900 or 1909

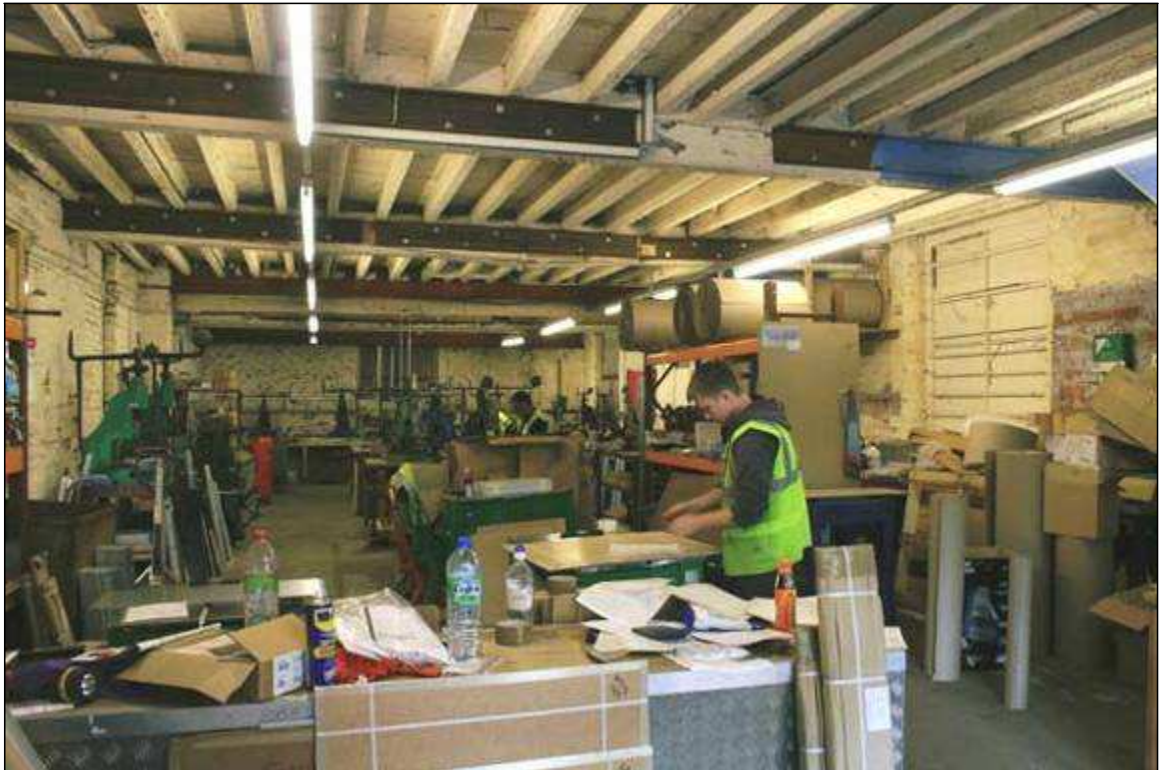
- a. **Ground floor.** The principal building consists almost entirely of a single space running the full length of the main range, separated by a crosswall, with door, from the rear wing. The principal feature is the ceiling, of heavy chamfered wooden beams, most strengthened with steel beams, and closely-spaced joists supporting the floorboards. One beam at the southwest end has a section of simply-moulded cornice, unusual in an industrial building and perhaps suggesting an office space at this end; at the northwest corner is a small blocked cross-corner fireplace. In the northeast corner of the main range is a small room, now a kitchen; adjacent to this is a wooden quarter-turn staircase to the first floor. A further stair, of straight-flight form, is sited against the rear wall of the rear wing. This is unlikely to be in its original position as the rear wall of the wing has a wide blocked opening spanned by an I-section steel beam acting as a lintel; the opening was probably cut through to reach the outshut when the latter was added. The northeast outer walls of the outshut and rear wing have been removed. There is no visible evidence of power systems on this floor.

*20. General view of ground floor of main range, looking southwest*

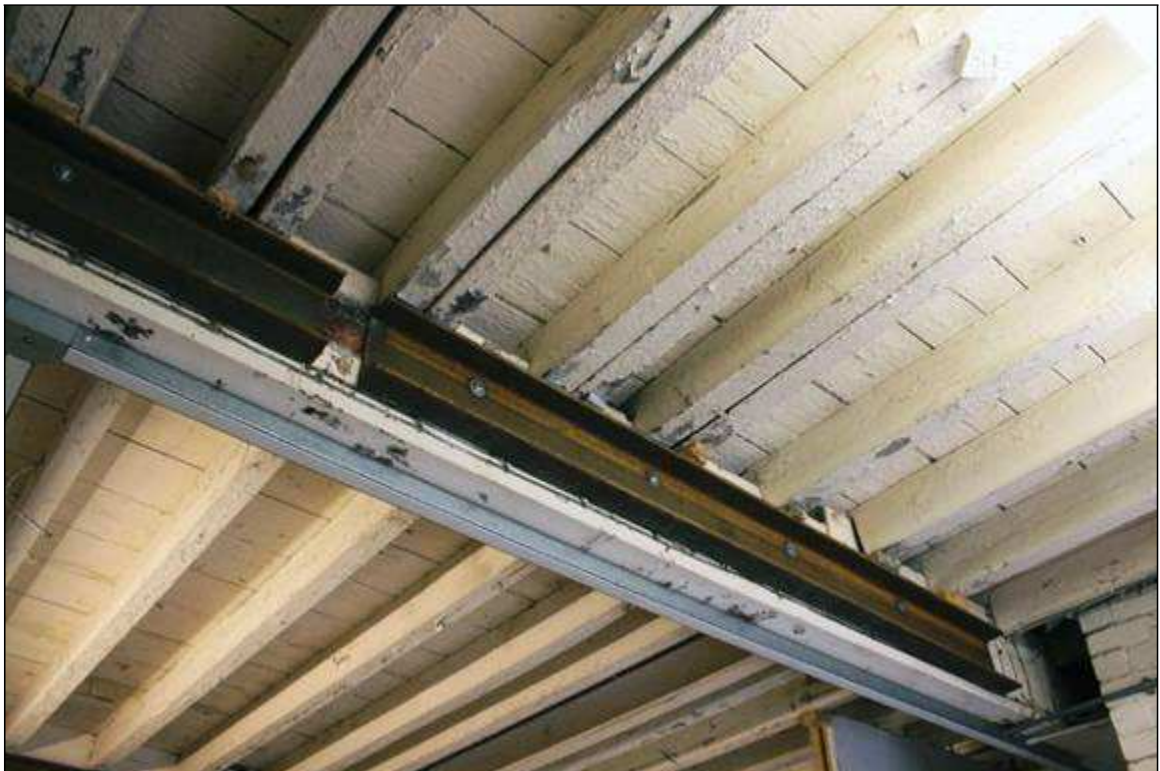
- c. **Fireproofing.** The building is of 'slow-burning' construction, using brick outer walls combined with floors carried on heavy timber beams supporting closely-spaced joists. The technique is found in late 19th century Lancashire textile buildings such as Livingstone Mill, Daneshouse, Burnley of 1887 (1) and Peel Mill, Rose Grove, Burnley, of 1896 (2).

*21. Detail of ceiling construction, with heavy beams and closely-spaced joists*

**4. Ceiling beams and joists in the principal building**

*Reason:* for demonstrating late 19<sup>th</sup> century slow-burning construction techniques

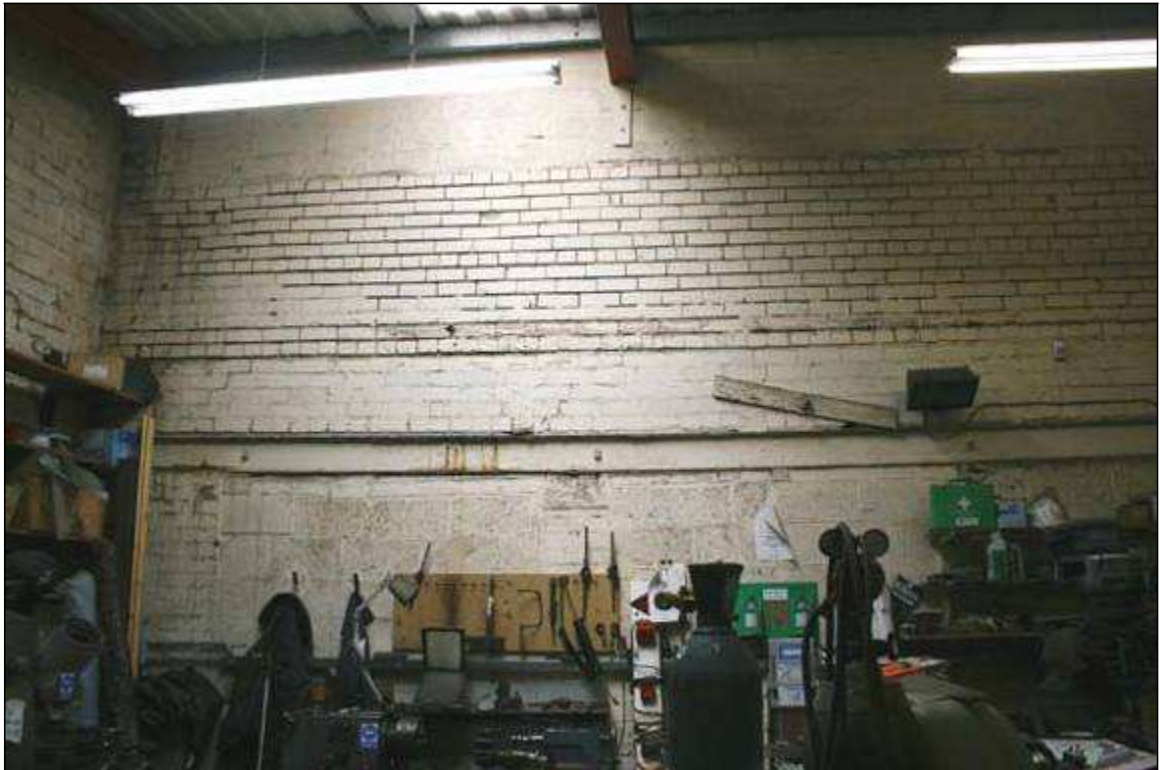
*22. Rear wall of rear wing of principal building showing blocked opening to outshut*

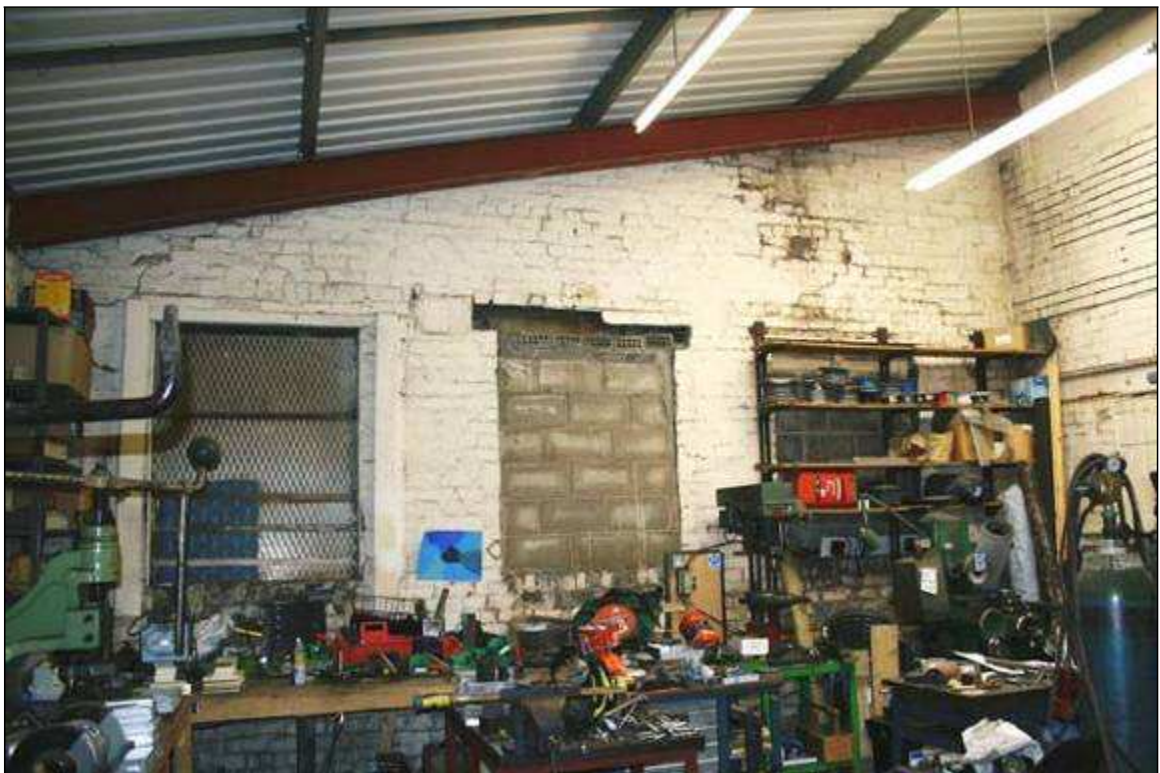
The southwest wall has three blocked windows; the roof is modern; there are no other visible features of interest.

*23. Blocked openings in southwest outer wall of outshut*

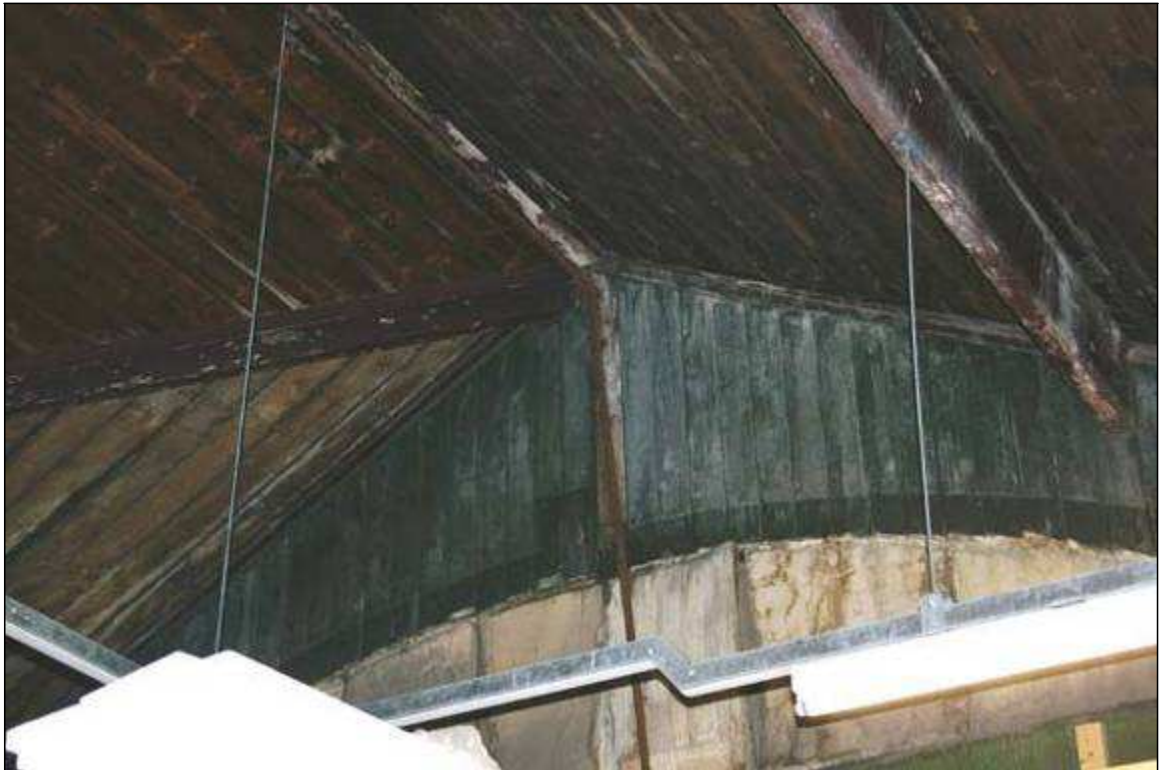
- b. **First floor.** The principal visible feature is the roof truss forming the hip at the southwest end of the main range, which has applied and painted boards in the shape of a segmental arch (Plate 24); this may be the remains of a dais canopy or proscenium dating from the building's early role as a cinema and

*24. Boarded arch applied to roof truss forming hip at southwest end of main range, suggesting a dais or proscenium*

**1. The remains of the first floor arch in the principal building**

*Reason:* possible association with the building's presumed function as a public hall and cinema

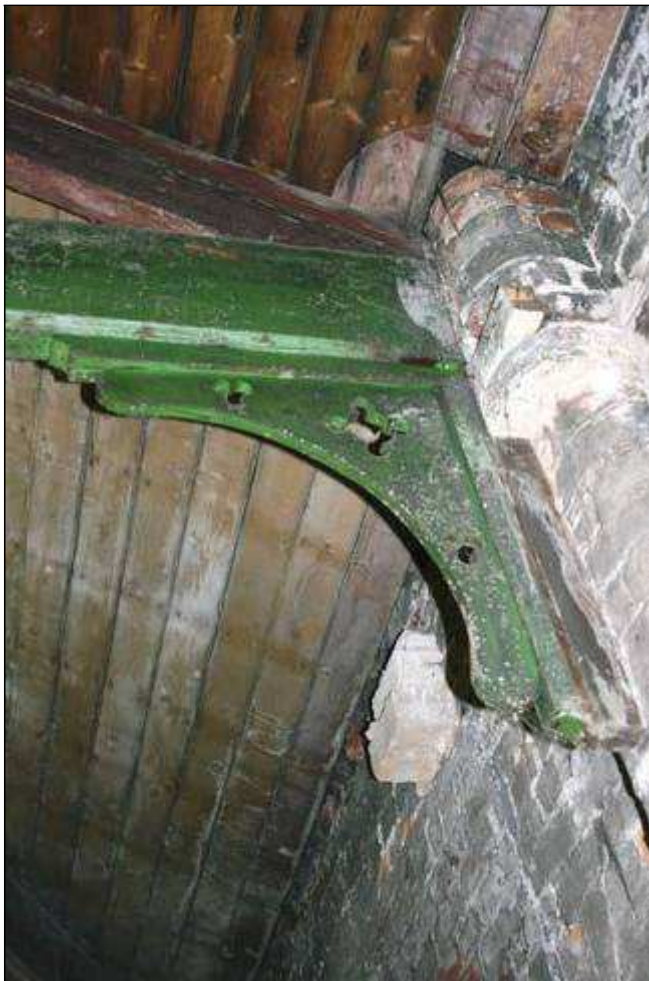
*25. One of the decorative roof truss braces*
