## Internal survey & schedule of works: 132 Drake Street, Rochdale

This document has been prepared to record the fixtures and fittings within the above heritage asset. The building is in a very poor condition and the survey was carried out visually with no intrusive investigations.

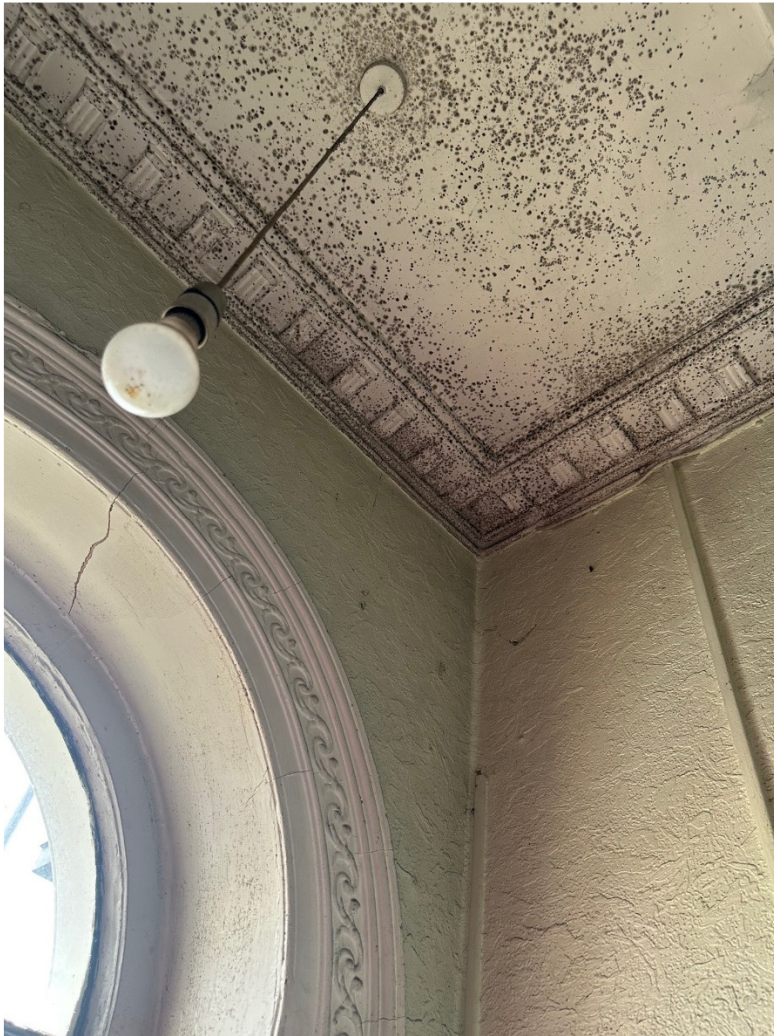
1. Entrance door arch & ceiling

| Room | Room | Comments | Condition | Condition |
|---|---|---|---|---|
| Porch | • Solid hardwood front door | Original | Poor | Beyond repair. Replace with similar hardwood door. |
| | • Decorative Arch | Original | Good | Retain and repair as necessary. |
| | • Coving | Original | Good | Retain and repair as necessary. |

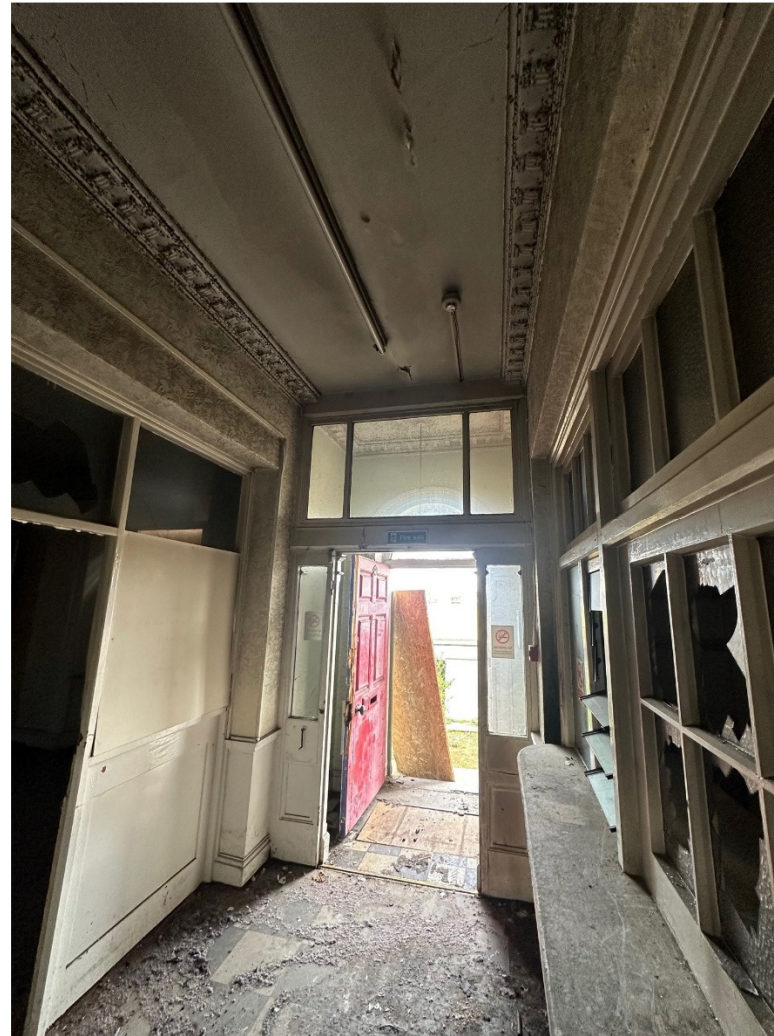
2. Porch & reception

| Room | Room | Comments | Condition | Condition |
|---|---|---|---|---|
| Reception | • Reception counter with timber screen | Not original | Poor. Fire damage | Remove and close off as part of proposed new layout for Flat 1. |

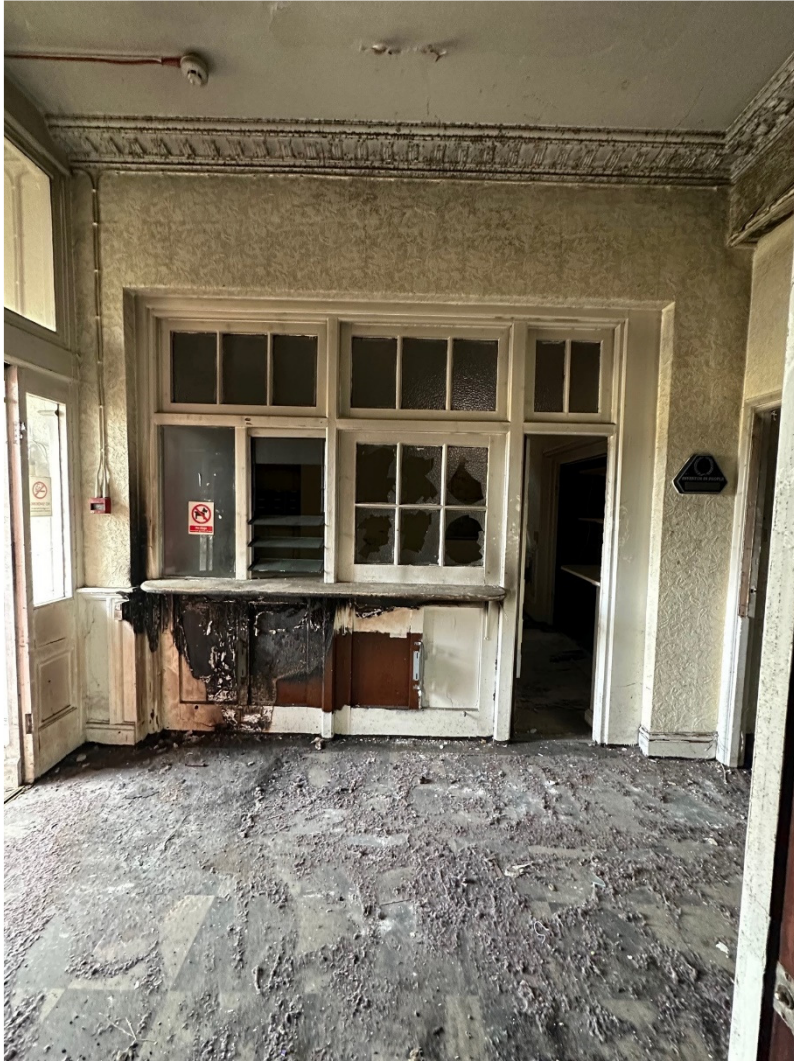
3. Reception screen with admin room

| Room | Features | Comments | Condition | Proposal |
|---|---|---|---|---|
| | • Reception counter & screen with cupboards | Not original | Poor | Remove and close off as part of proposed new layout for Flat 2. |

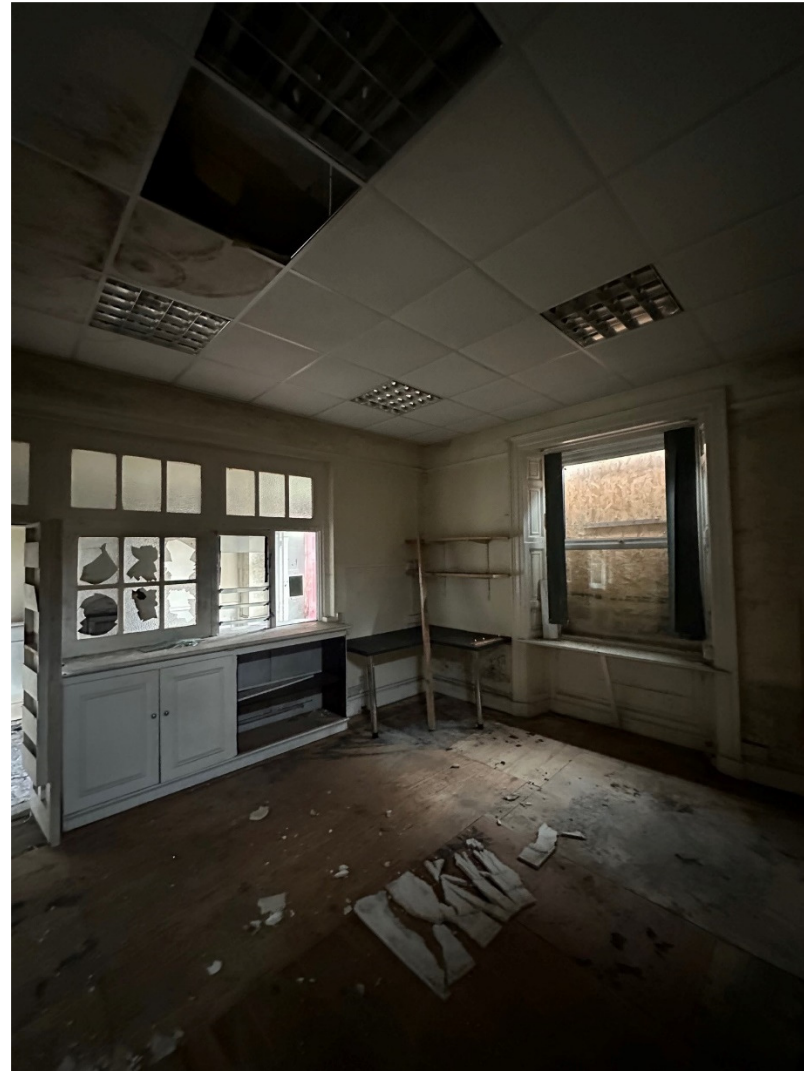
4. Admin office

| Room | Features | Comments | Condition | Proposal |
|---|---|---|---|---|
| Admin | • Timber panelling around front window. | Original | Good | Retain and repair as necessary. |
| | • Coving | Original | Good | Retain and repair as necessary. |
| | • Chimney breast, no fire. | Original | Good | Retained as part of Flat 2. |

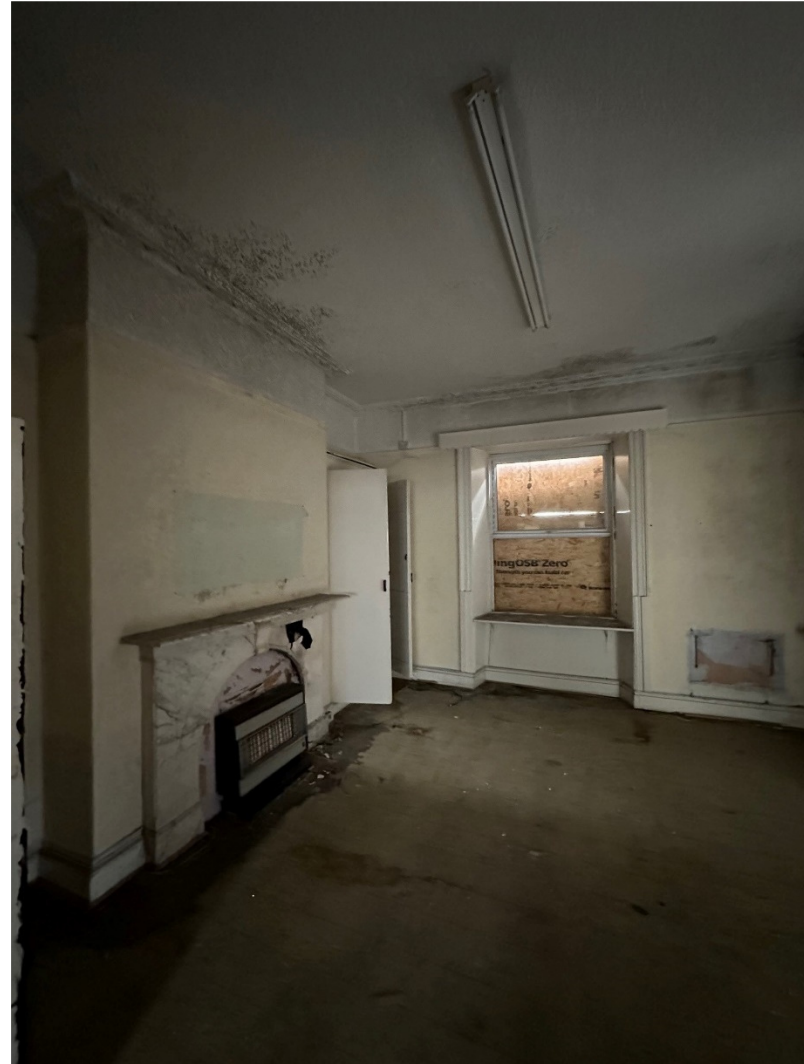
8. Office 1 general view

| Room | Features | Comments | Condition | Proposal |
|---|---|---|---|---|
| | • Coving | Unknown | Poor | Style and pattern differ and has suffered damage. Remove and replace with similar. |

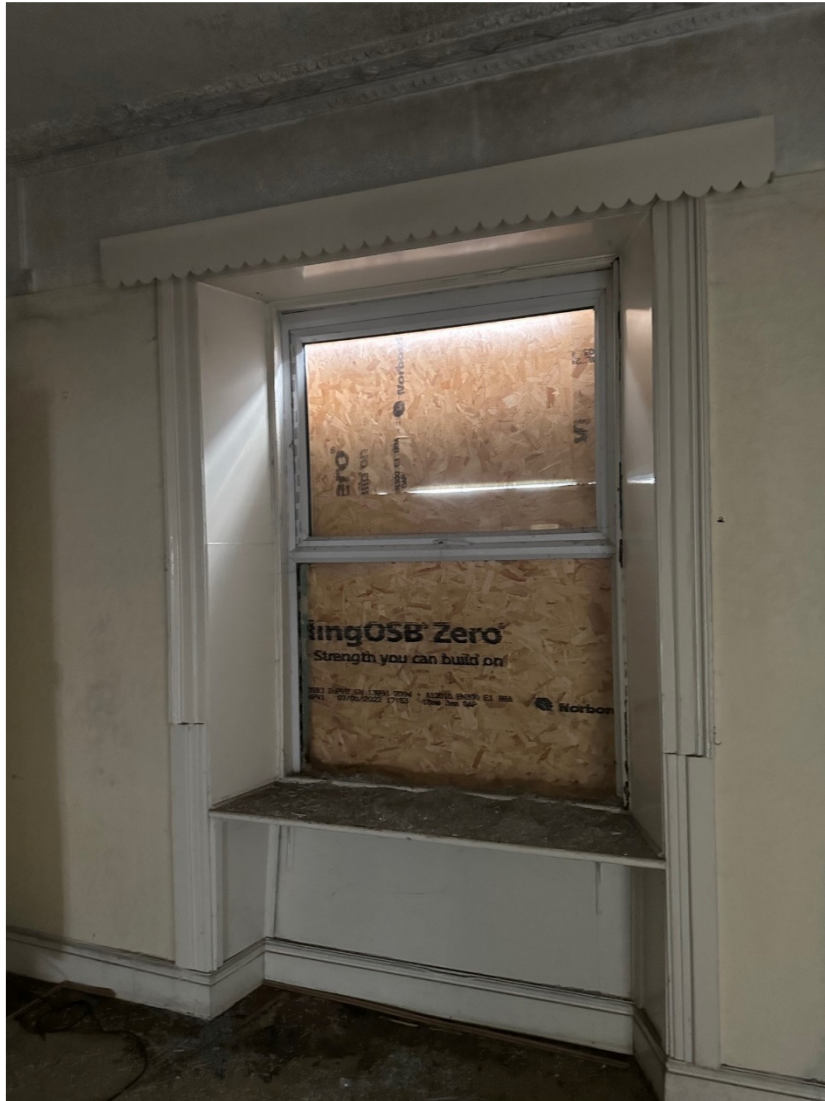
9. Office 1 front window panelling detail

| Room | Features | Comments | Condition | Proposal |
|---|---|---|---|---|
| Office 1 | • Timber panelling around front window. | Original | Poor | Has been poorly altered. Remove unsympathetic additions and reinstate to match original. |

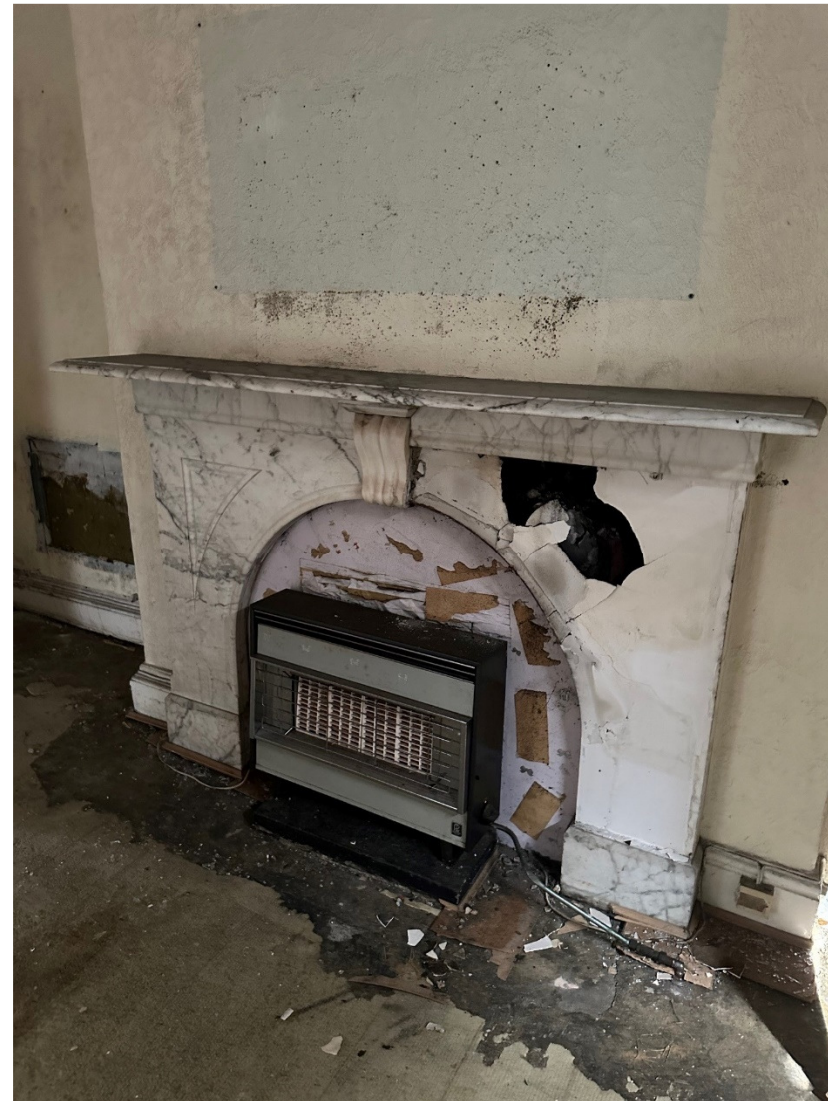
10. Office 1 Fireplace detail

| Room | Features | Comments | Condition | Proposal |
|---|---|---|---|---|
| | • Chimney breast with no fire. | Original chimney breast. Unknown fire surround | Poor | Breast will be retained for Flat 1. Fire surround unknown origin and damaged. Remove and close off opening. |

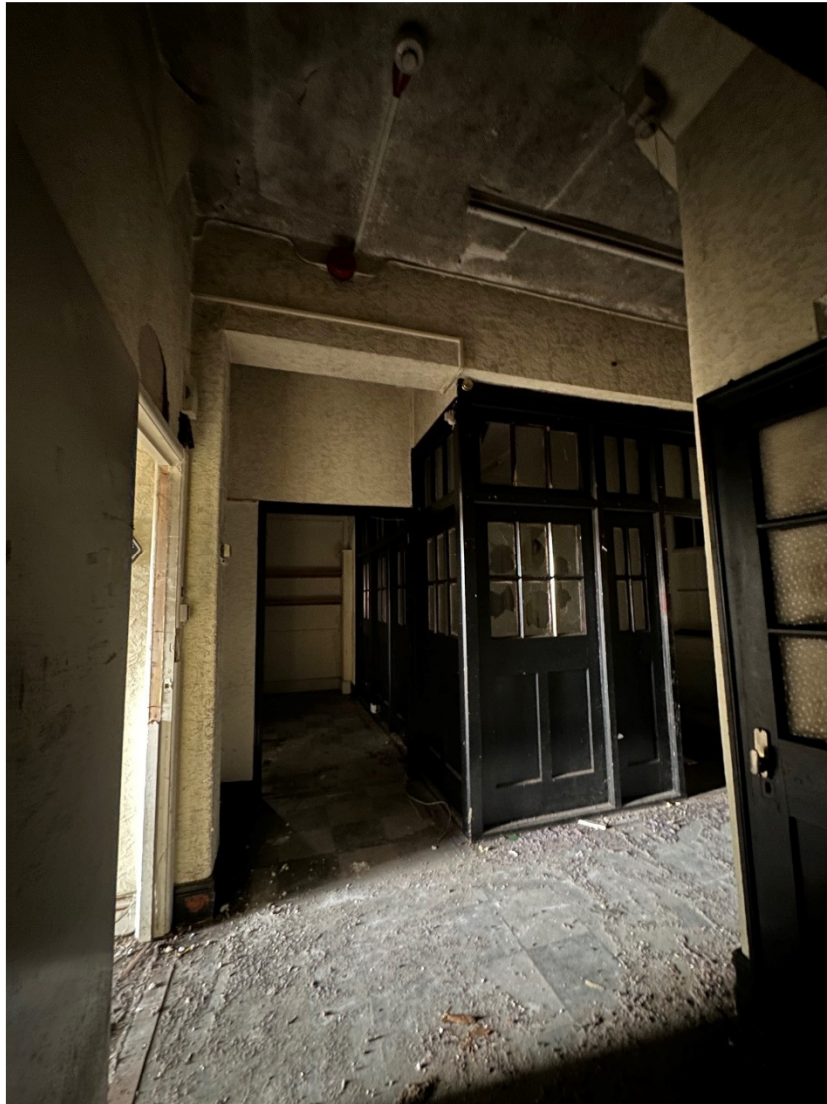
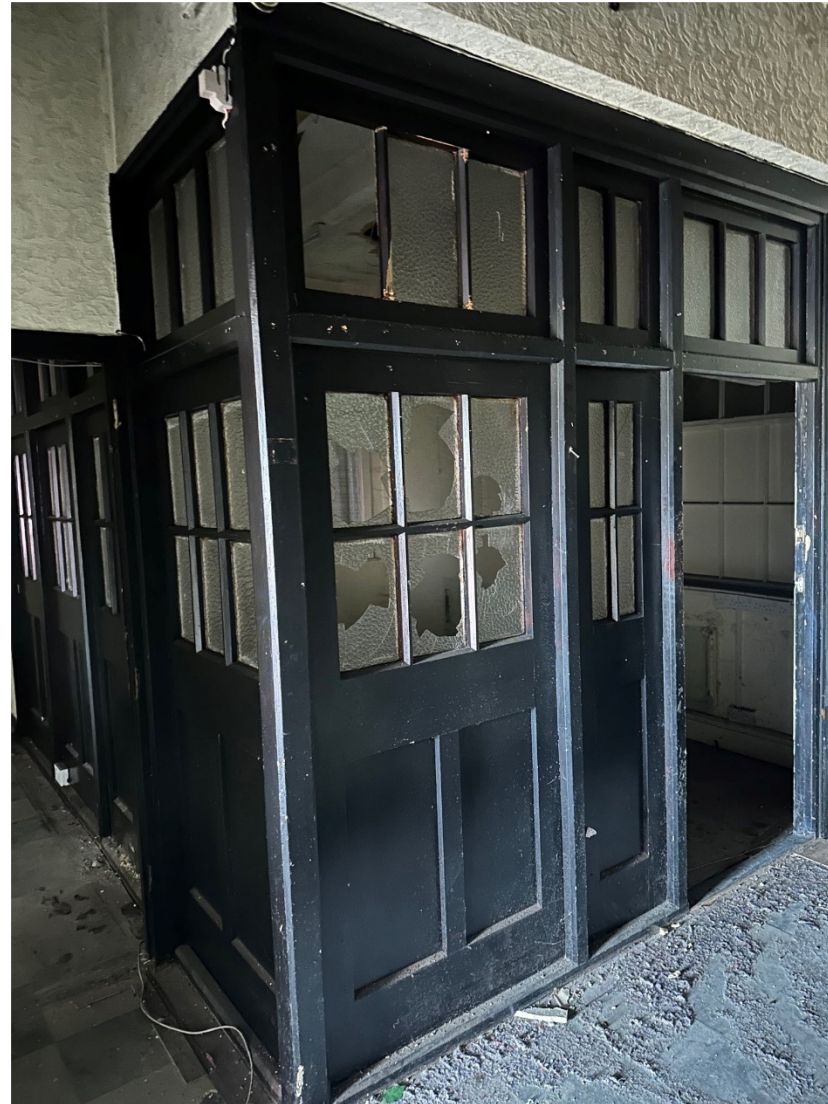
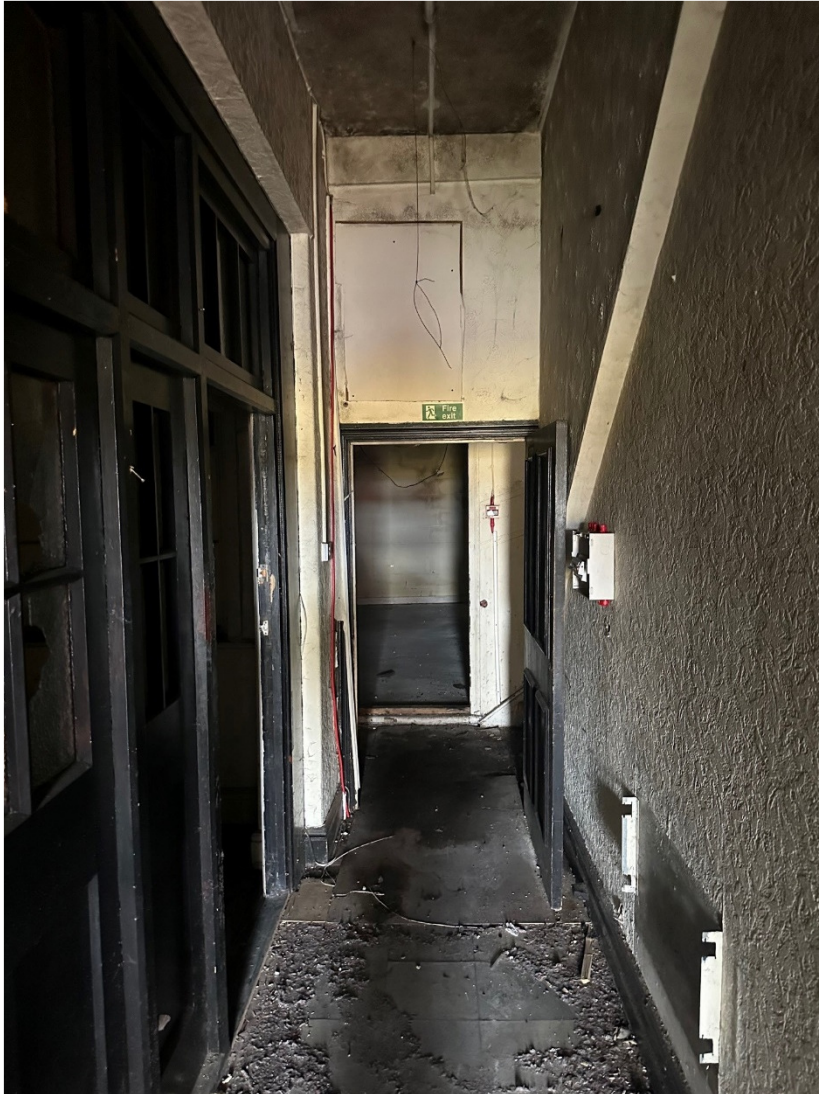
12. Hallway and office 3 screen

| Room | Features | Comments | Condition | Proposal |
|---|---|---|---|---|
| Hall | • Timber screen shared with office 3. | Not original. | Poor | Remove and close off as part of proposed new layout for Flat 2. |

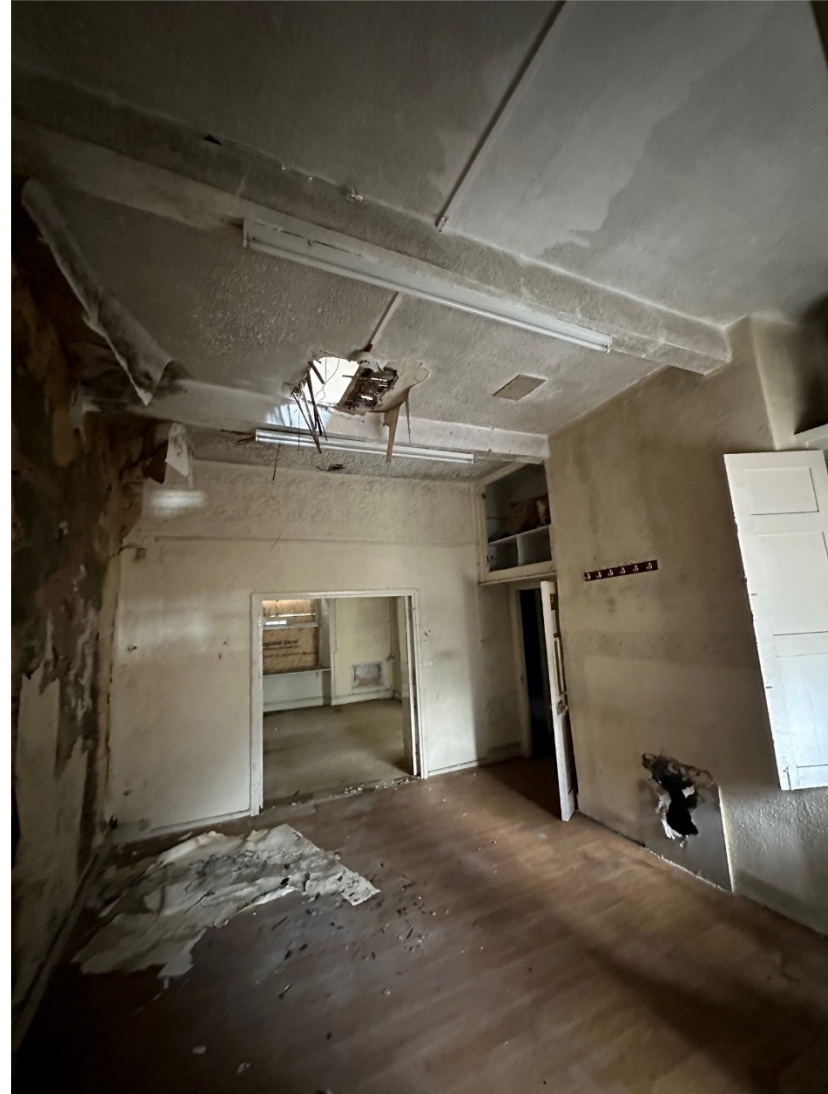
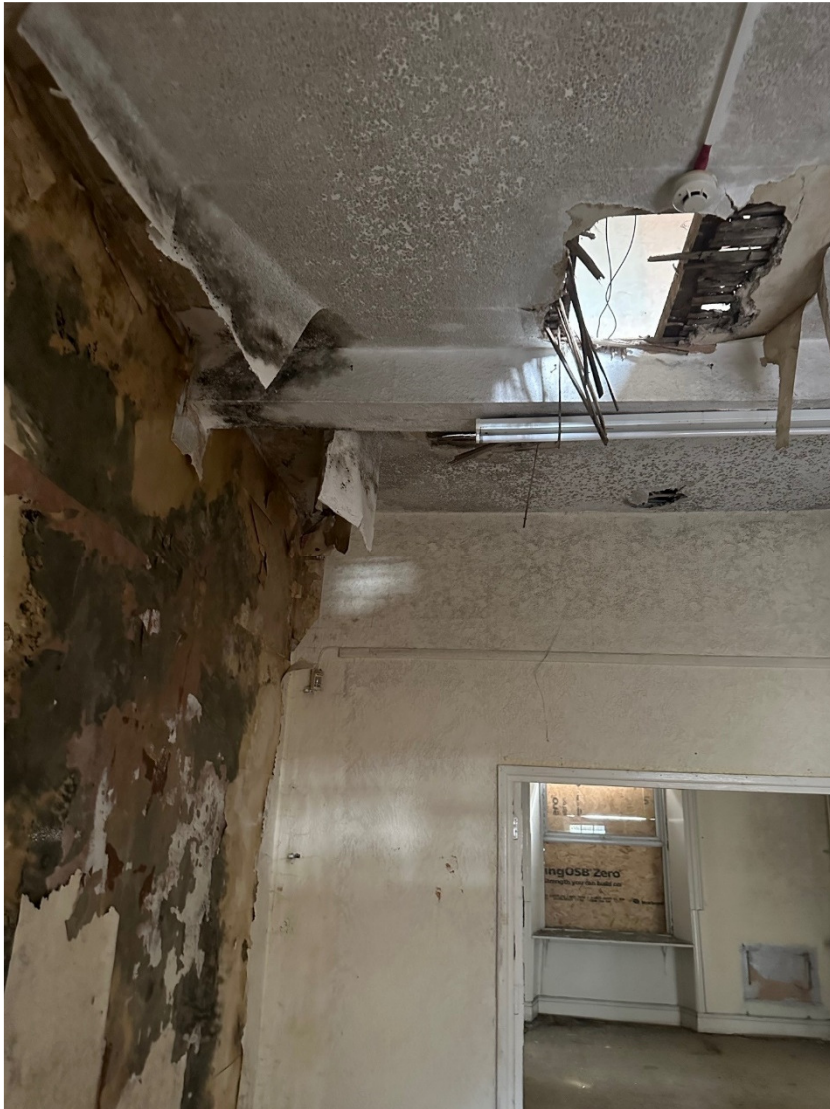
15. Office 2 general view with office 1 in background

| Room | Features | Comments | Condition | Proposal |
|---|---|---|---|---|
| Office 2 | <ul style="list-style-type: none"> <li>Architrave around rear window</li> <li>Chimney breast with no fire &amp; built in cupboards to either side</li> </ul> | Unknown origin | Good | Retain, repair & redecorate. |

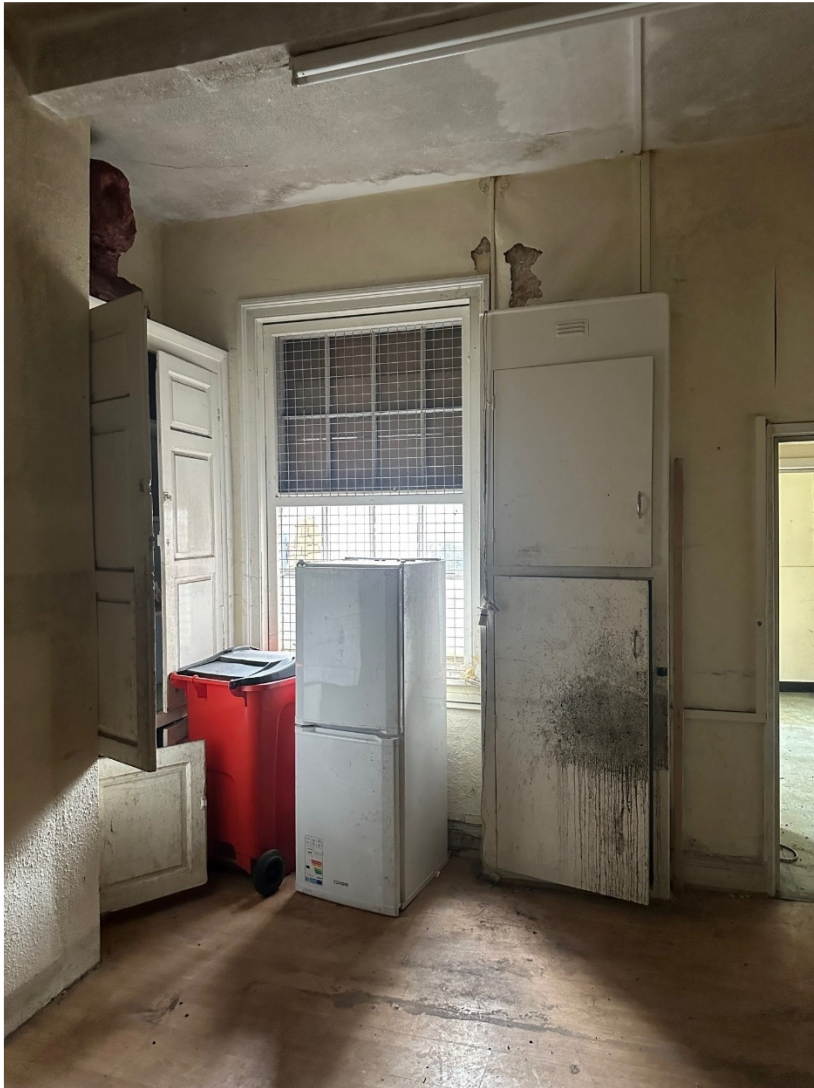
18. Office 2 window & cupboard detail

| Room | Features | Comments | Condition | Proposal |
|---|---|---|---|---|
| | | Original breast unknown origin for cupboards | Poor | Breast will be retained for Flat 1. Cupboards to be removed, do not reinstate. |

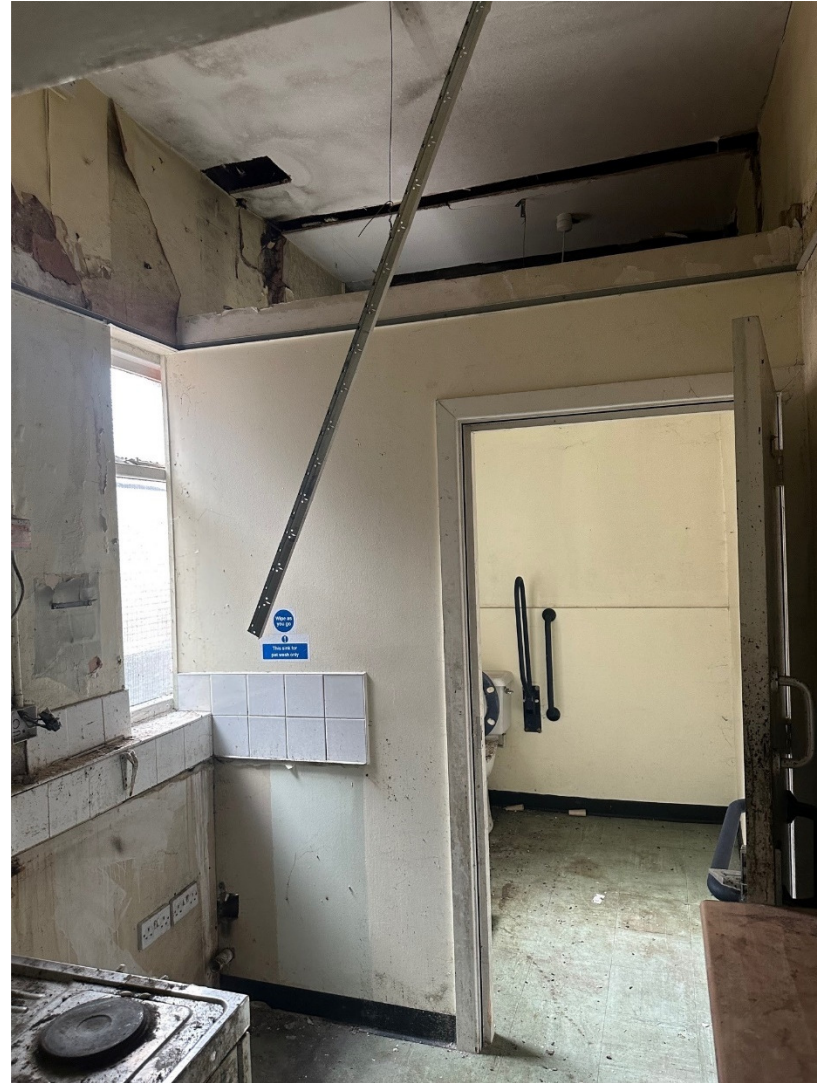
19. Kitchen & WC off office 2

| Room | Features | Comments | Condition | Proposal |
|---|---|---|---|---|
| WC & Kitchen off office 2 | <ul style="list-style-type: none"> <li>None</li> </ul> | No original features | Poor | No original features. Strip out and remove all fixtures and fittings. |

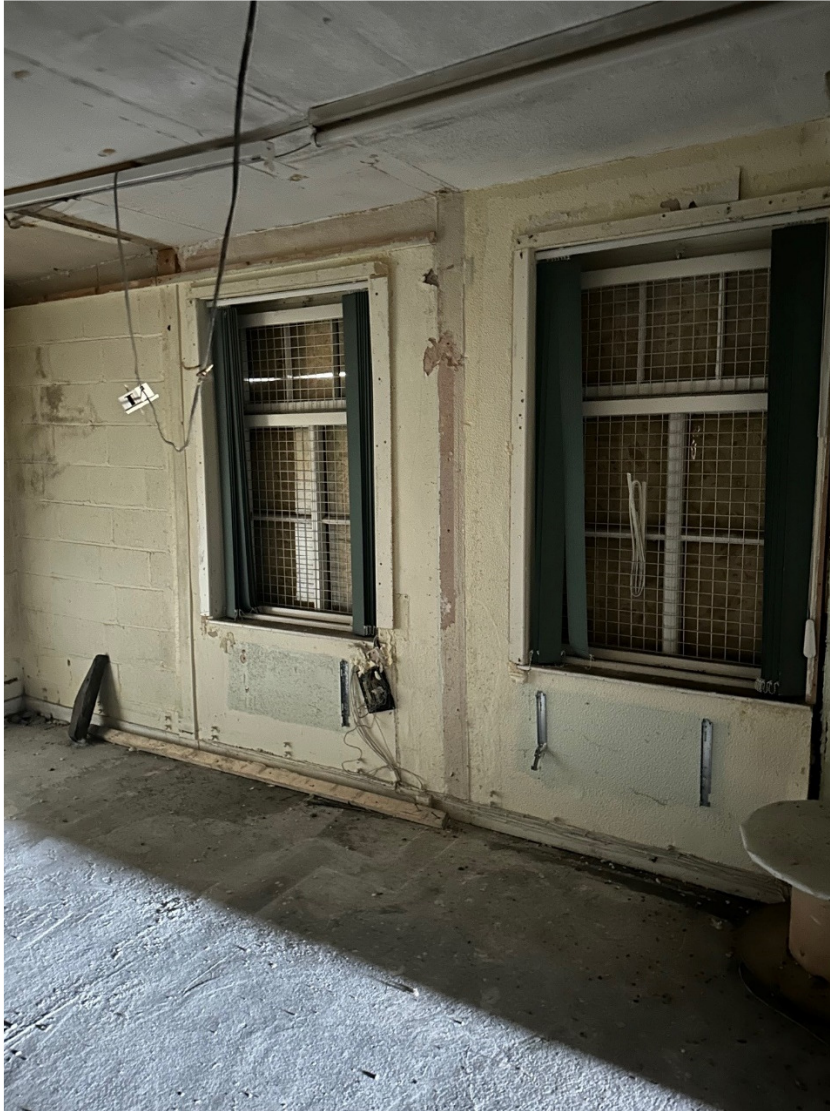
21. Office 4 single storey extension

| Room | Features | Comments | Condition | Proposal |
|---|---|---|---|---|
| Office 4 | <ul style="list-style-type: none"> <li>None</li> </ul> | Not original Extension | Poor | No original features. Strip out and remove all fixtures and fittings. |

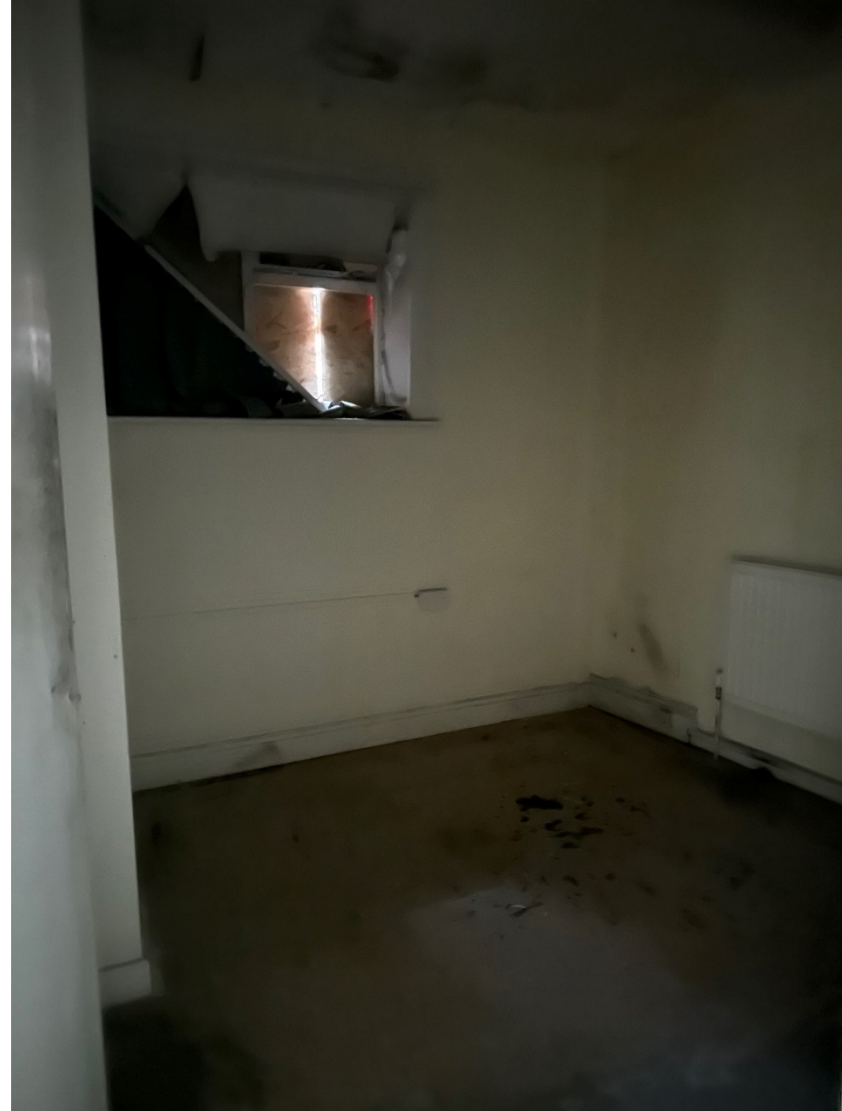
22. Office 5

| Room | Features | Comments | Condition | Proposal |
|---|---|---|---|---|
| Office 5 | <ul style="list-style-type: none"> <li>None</li> </ul> | No original features | Poor | No original features. Strip out and remove all fixtures and fittings. |

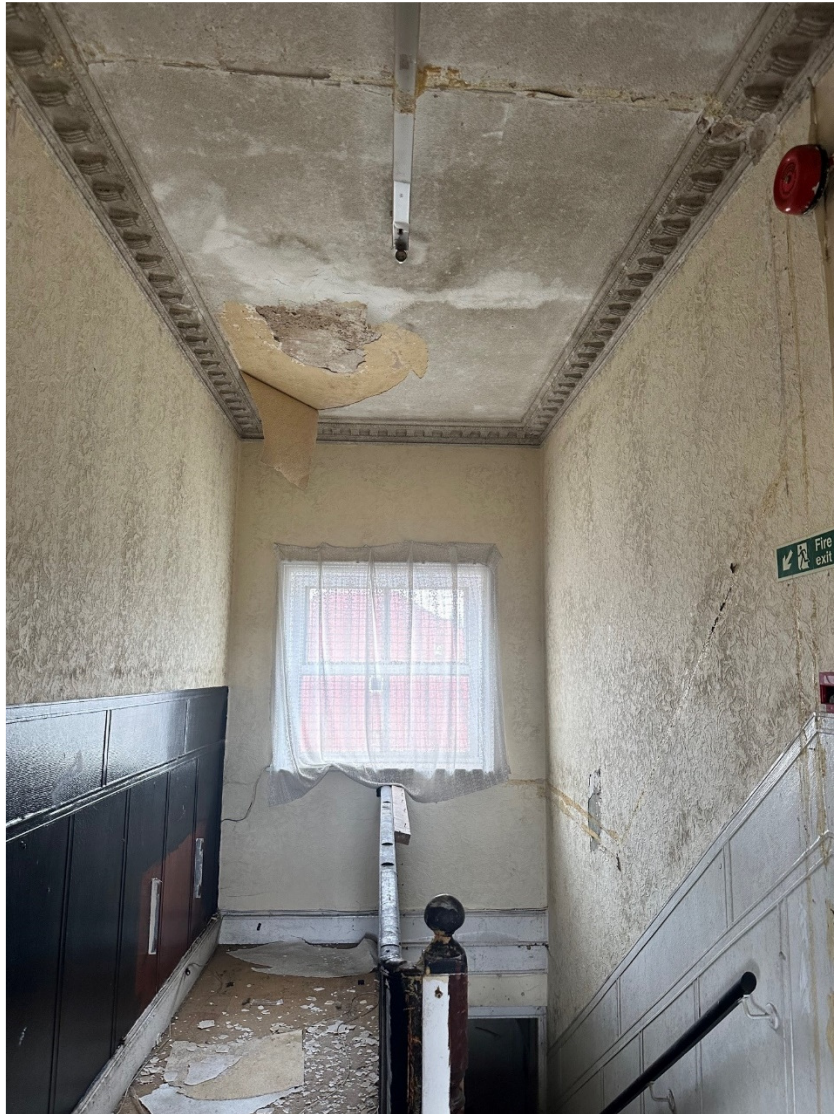
23. First floor landing

| Room | Room | Status | Condition | Proposals |
|---|---|---|---|---|
| | • Wall linings | Not original | Poor | Remove and replaster walls. |
| | • Architraves | Original | Good | Retain and redecorate. |

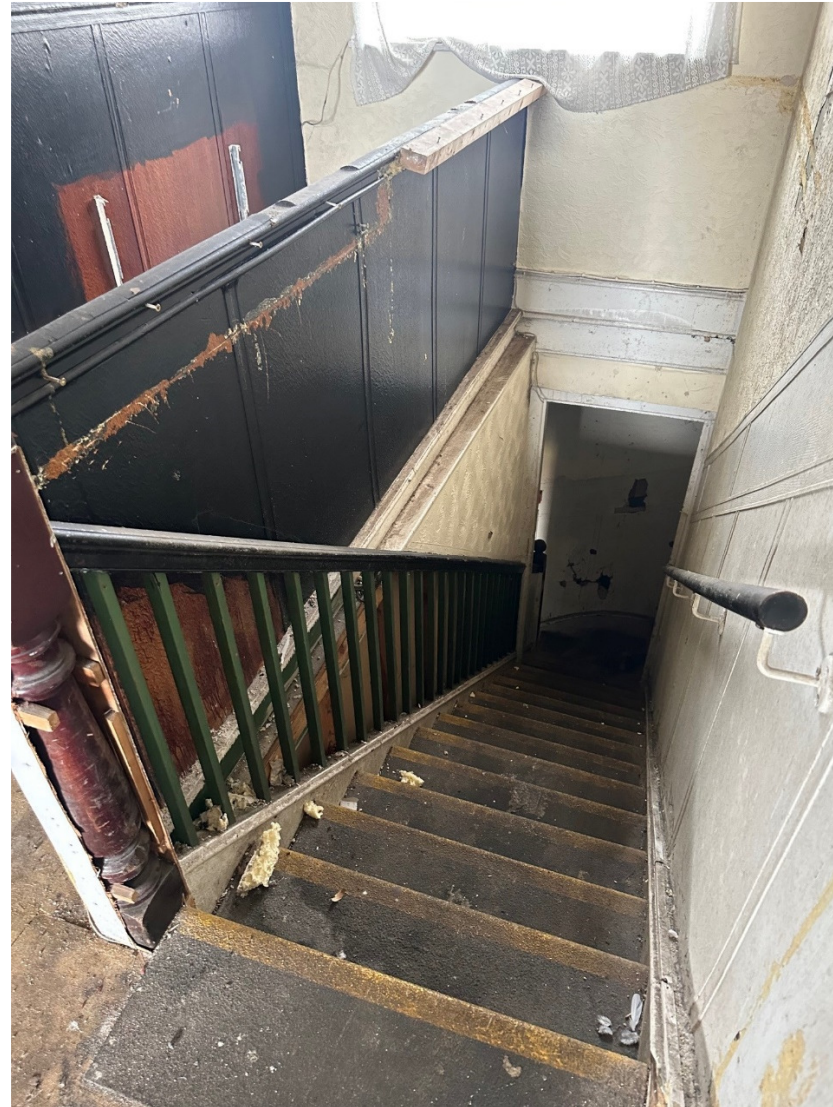
24. Staircase detail

| Room | Room | Status | Condition | Proposals |
|---|---|---|---|---|
| | • Stairs | Original | Good | Retain newel posts and handrail & redecorate. Remove handrail from wall. Remove spindles and replace with period style new spindles. |

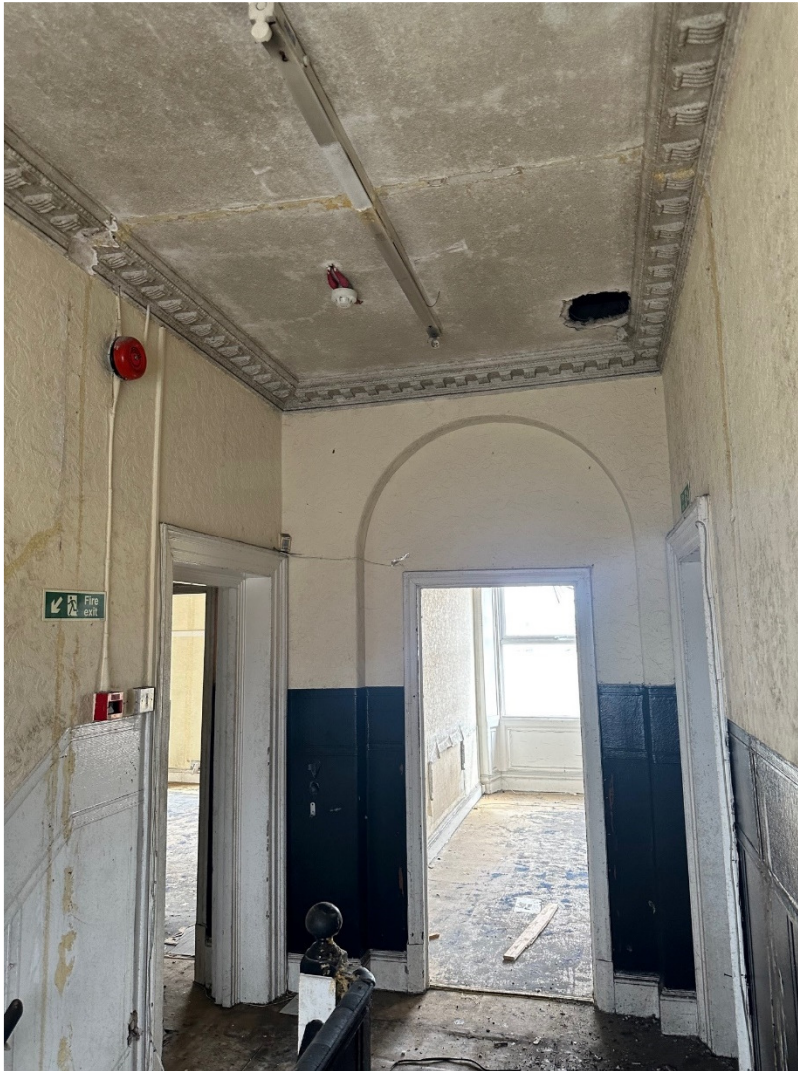
25. First floor landing arch & ceiling detail

| Room | Room | Status | Condition | Proposals |
|---|---|---|---|---|
| Landing | • Arched recess to entrance of office 7 | Original | Good | Retain arch. Door to be closed off, architrave removed. |
| | • Coving | Original | Good | Retain not affected by proposals. |

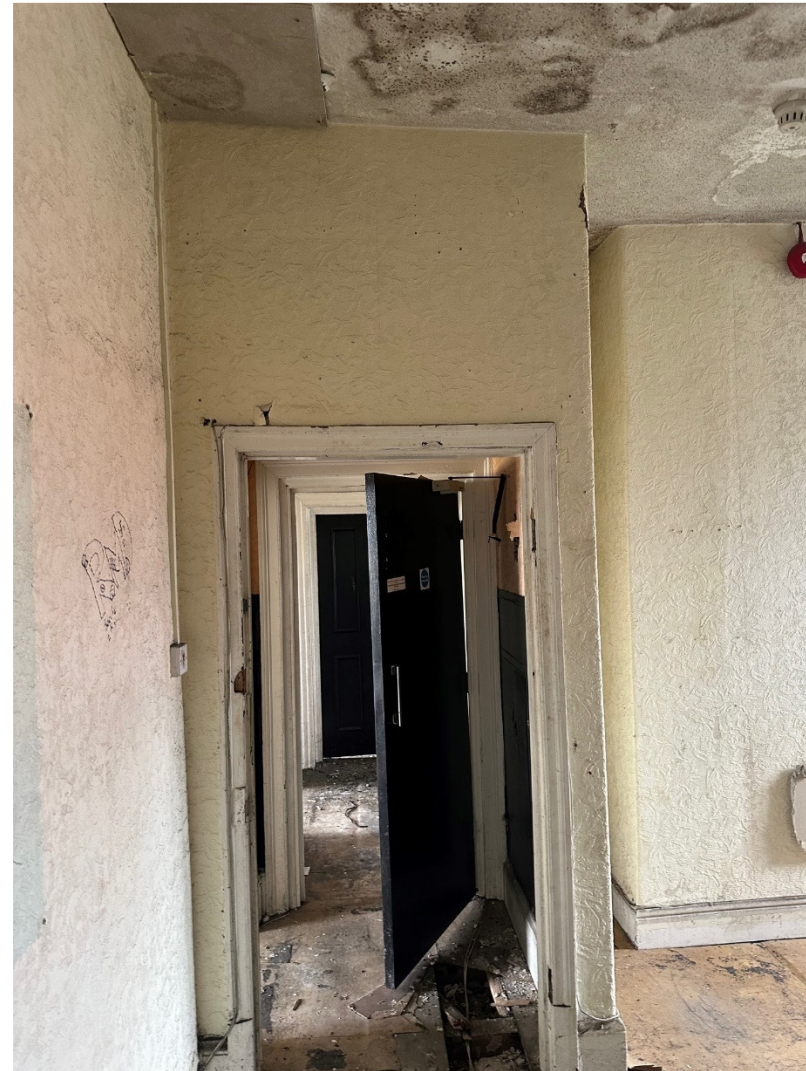
26. Office 6/7 lobby

| Room | Room | Status | Condition | Proposals |
|---|---|---|---|---|
| Office 6 | • Small lobby | Not original | Poor. | Remove all. |

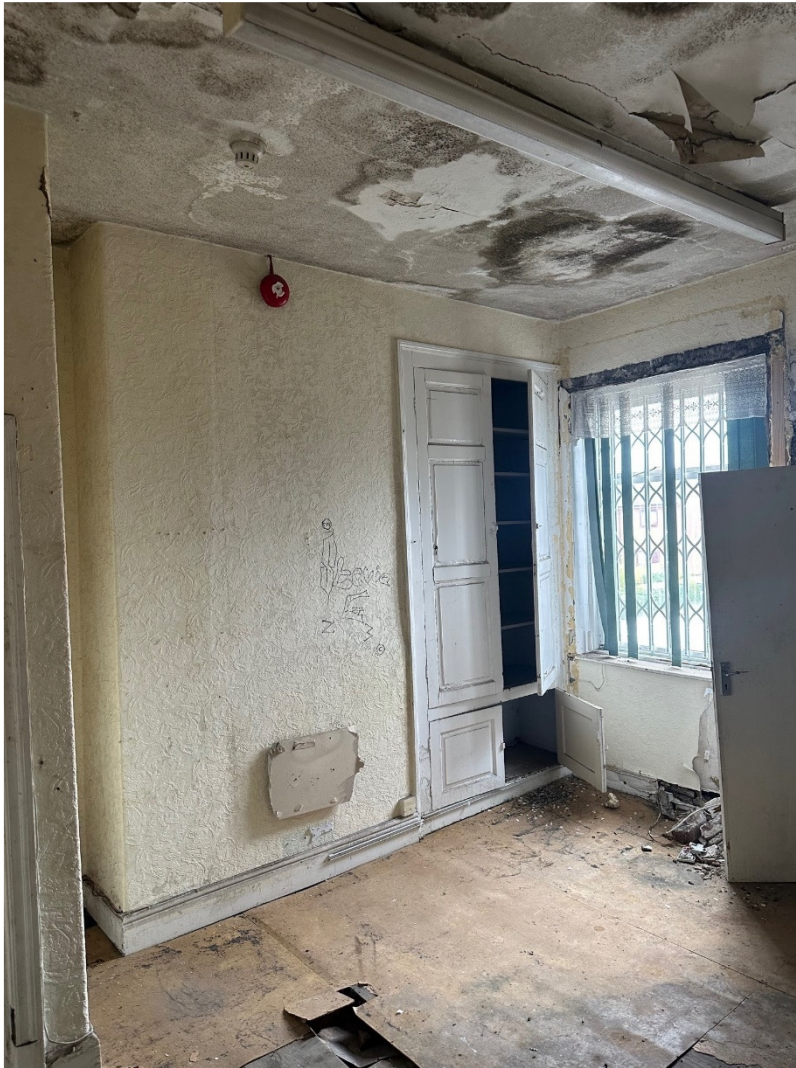
27. Office 6 general view

| Room | Room | Status | Condition | Proposals |
|---|---|---|---|---|
| | • Chimney breast with no fire & built in cupboards to either side | Original breast unknown origin for cupboards | Good | Breast to be retained for Flat 4 bedroom. Cupboards to be removed, do not reinstate. |

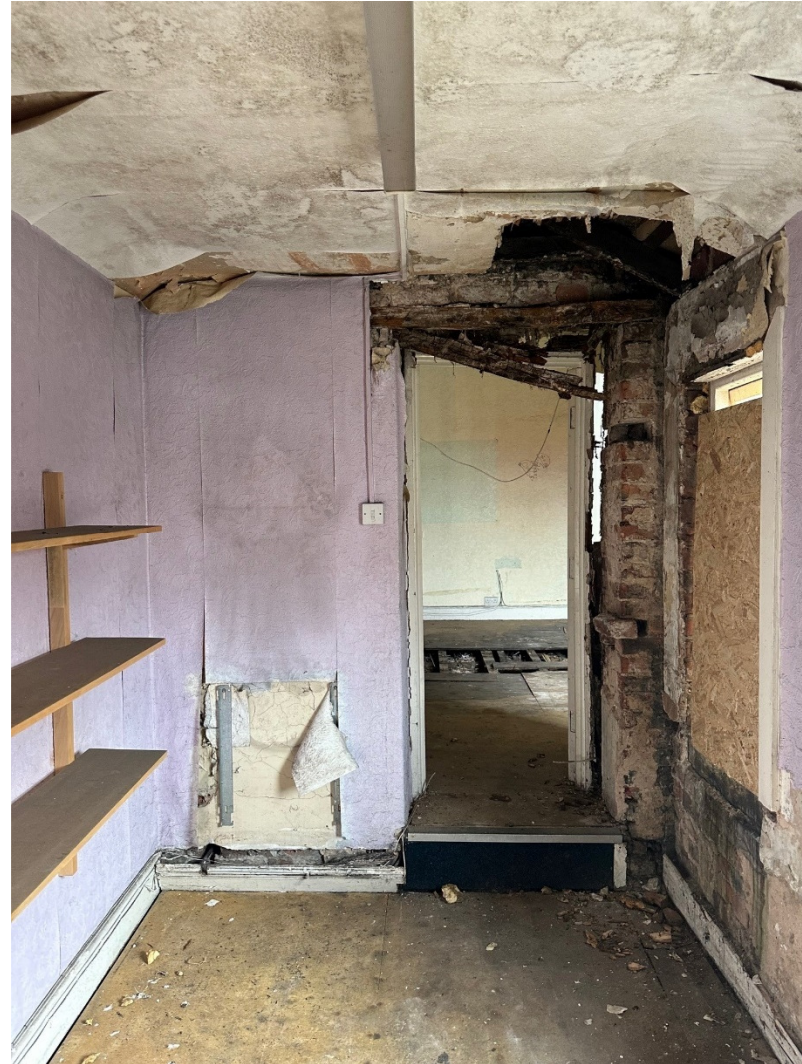
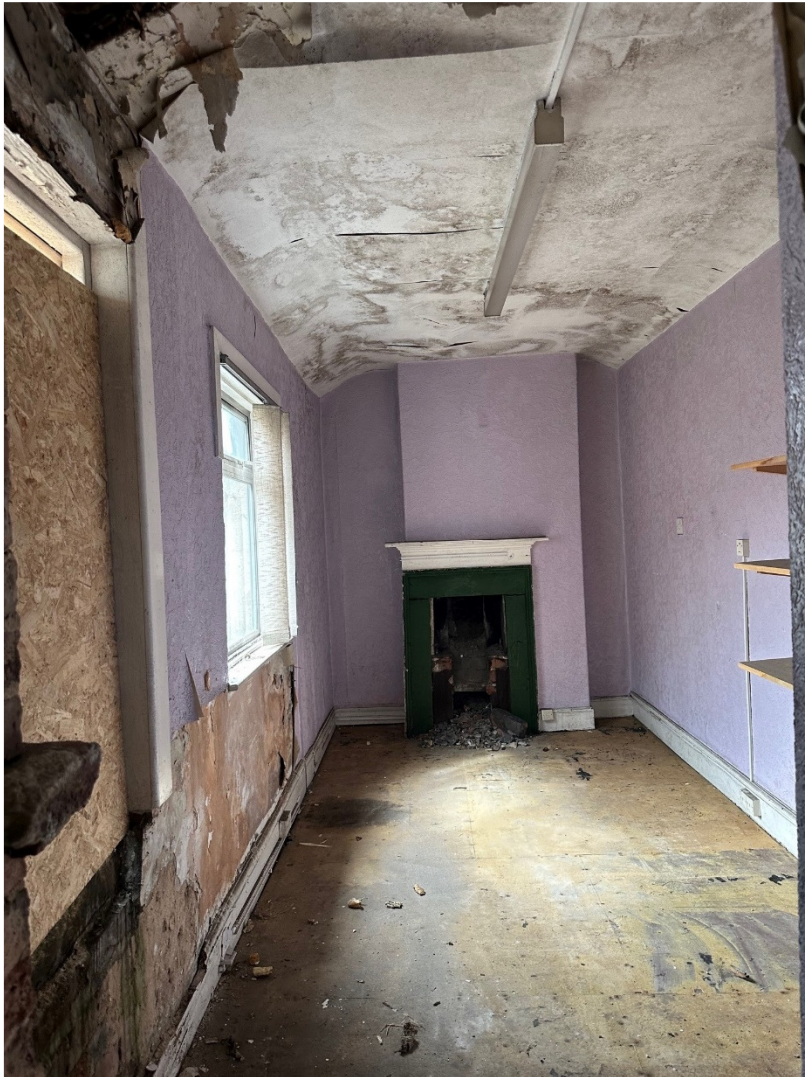
28. Kitchen off office 6

| Room | Room | Status | Condition | Proposals |
|---|---|---|---|---|
| Kitchen off office 6 | • None | Not original | Poor | No original features. Strip out and remove all fixtures and fittings. |

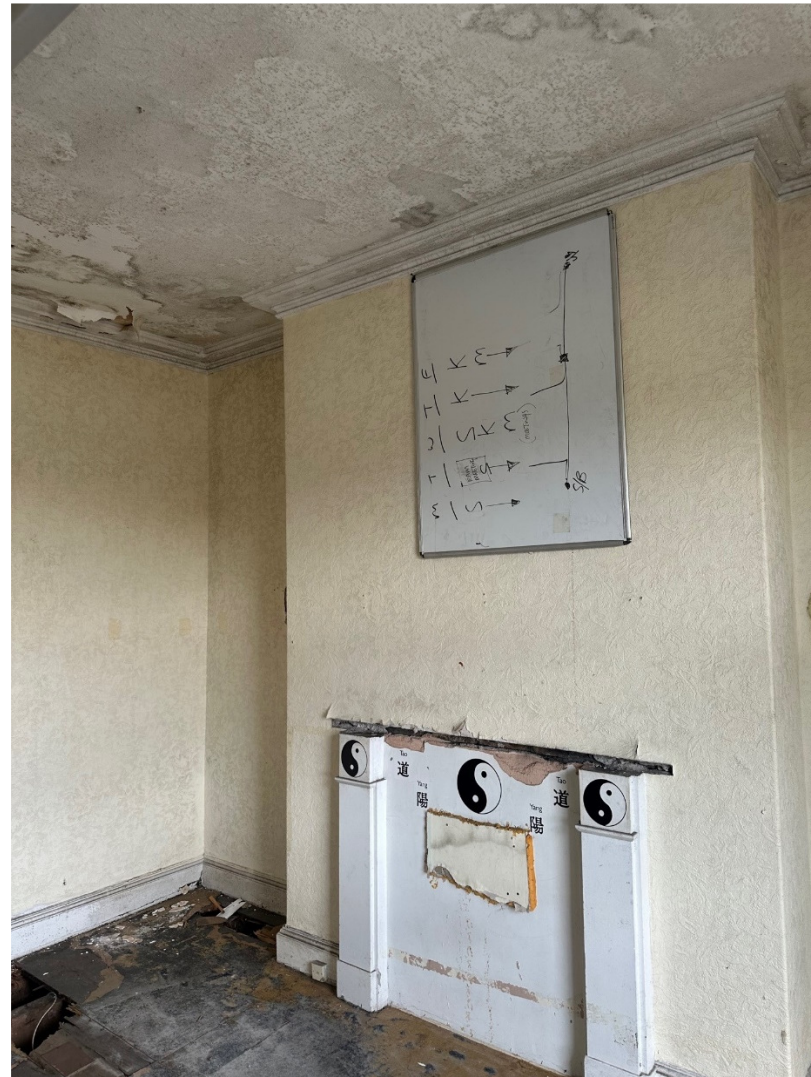
30. Office 7 chimney and ceiling detail

| Room | Room | Status | Condition | Proposals |
|---|---|---|---|---|
| | • Coving | Original | Good | Retain and repair as necessary. |

| | <ul style="list-style-type: none"> <li>Chimney breast, no fire, part surround.</li> </ul> | Original breast, latter surround added | Poor | Chimney breast retained as part of Flat 4 Living room. Fire surround removed. |
