## Internal survey & schedule of works: 132 Drake Street, Rochdale

This document has been prepared to record the fixtures and fittings within the above heritage asset. The building is in a very poor condition and the survey was carried out visually with no intrusive investigations.

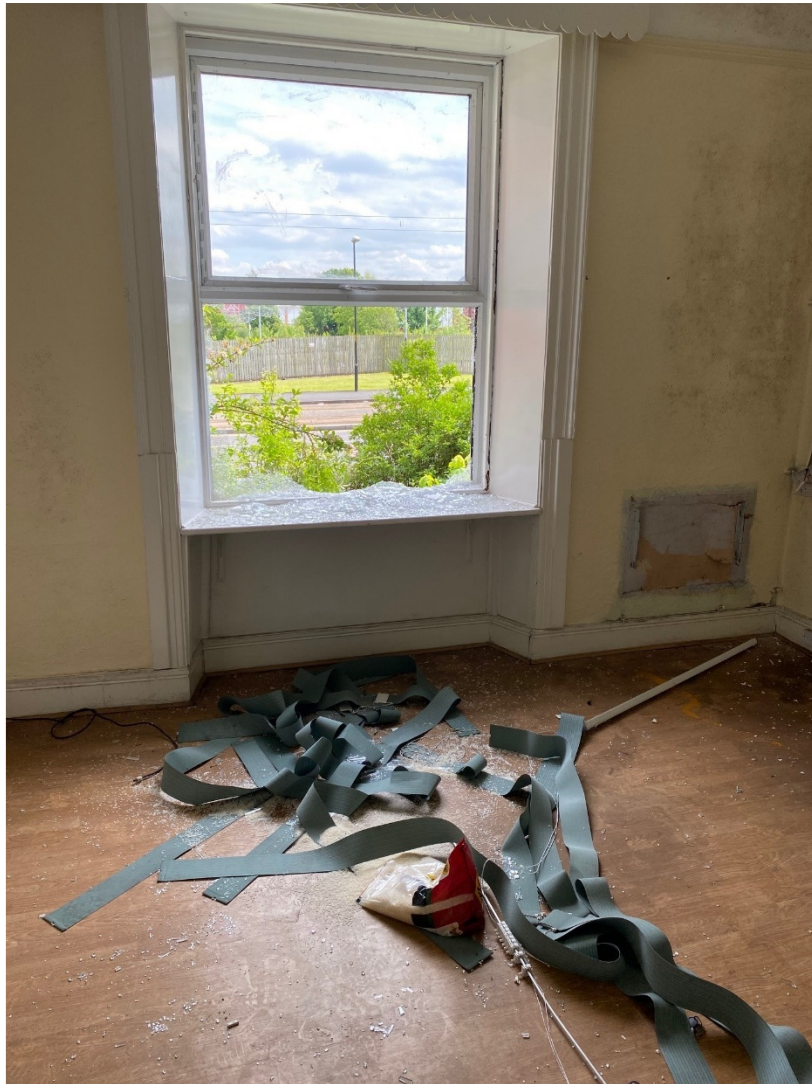
31. Office 7 front Window detail

| Room | Room | Status | Condition | Proposals |
|---|---|---|---|---|
| Office 7 | • Timber panelling around front window | Original | Good | Retain and repair as necessary. |

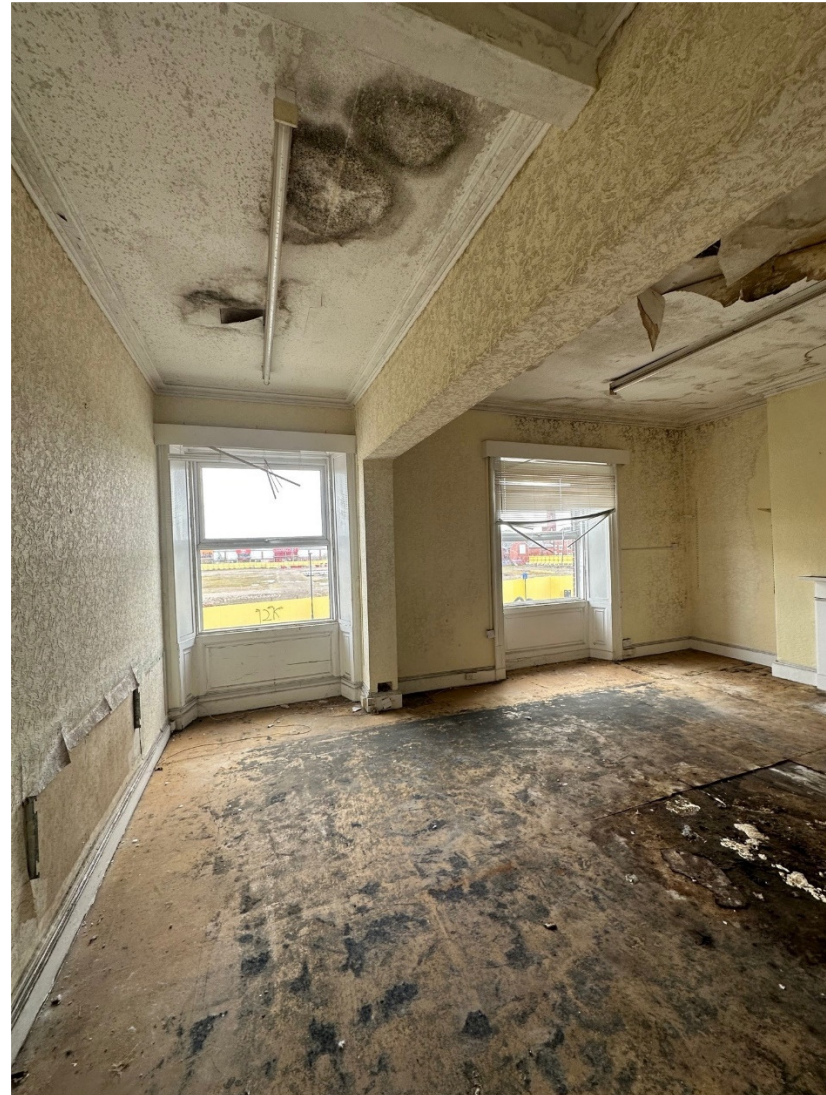
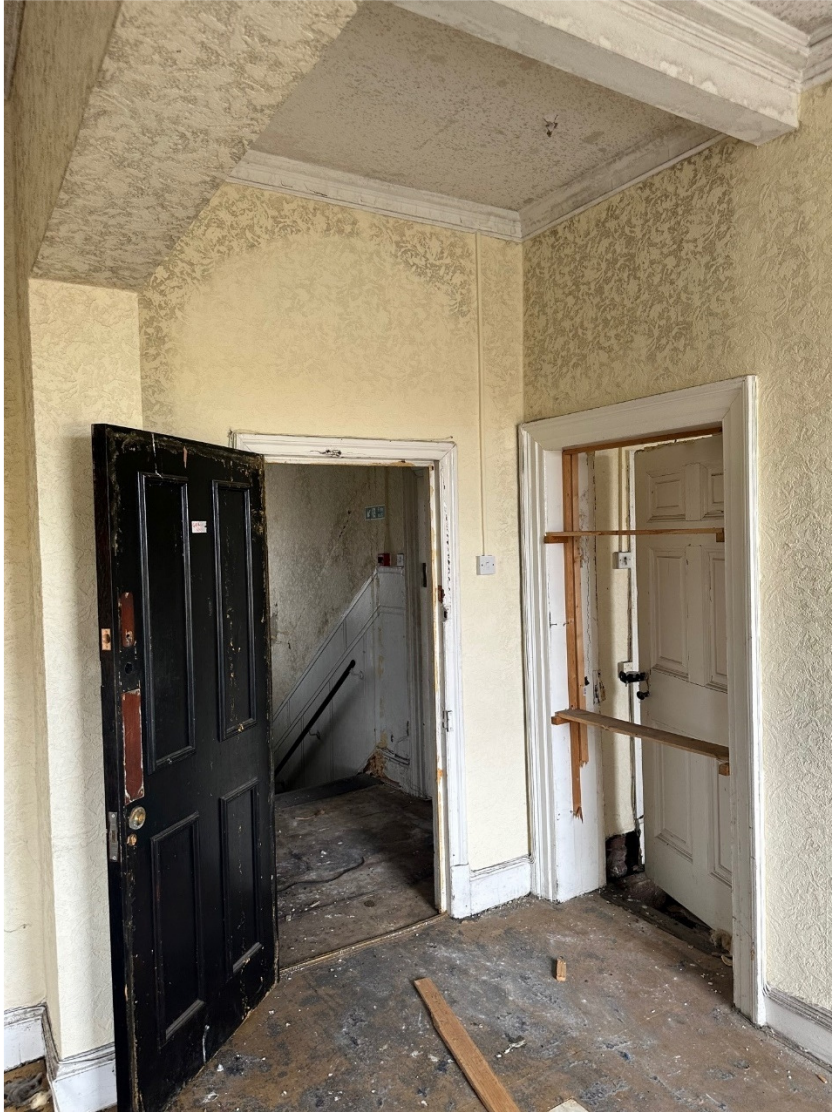
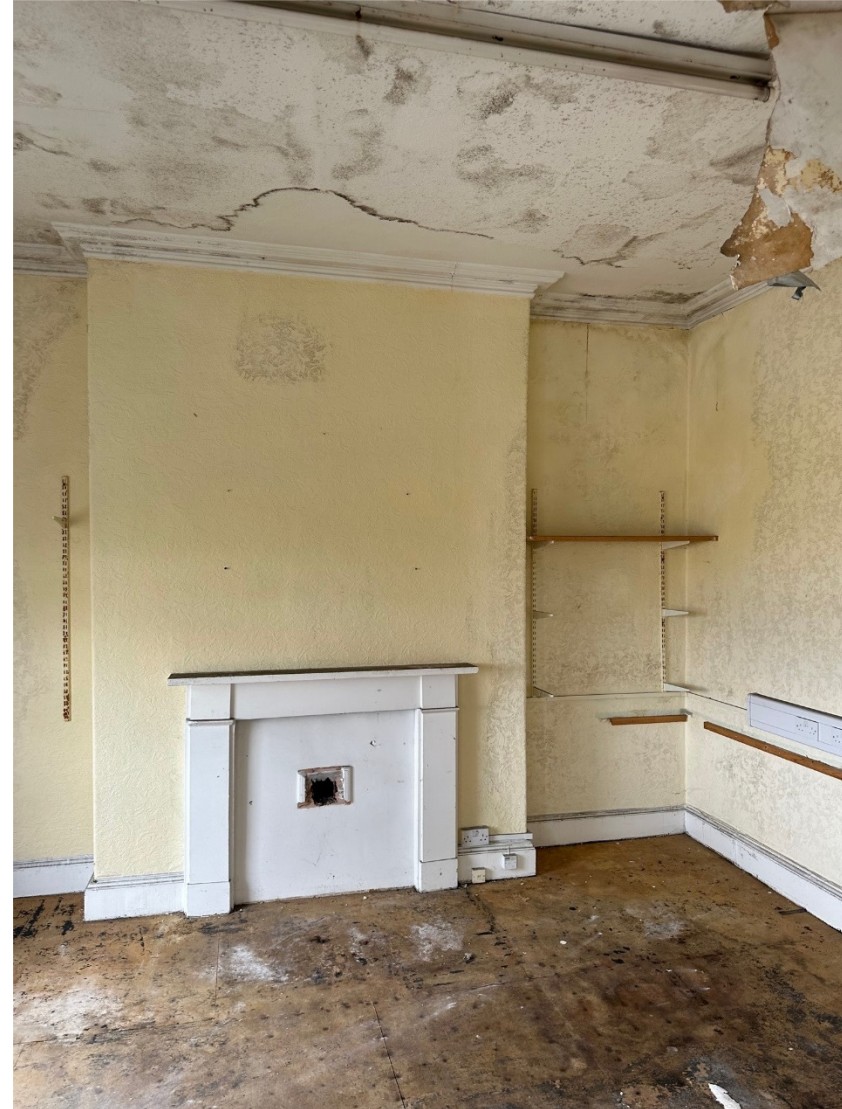
32. Office 8

| Office 8 | <ul style="list-style-type: none"> <li>Timber panelling around front window</li> <li>Coving</li> <li>Chimney breast, no fire, with surround</li> <li>Door frame and architrave Between office 6 &amp; 7</li> </ul> | <p>Original</p> <p>Original</p> <p>Original breast, latter surround added</p> <p>Original</p> | <p>Good</p> <p>Good</p> <p>Good</p> | <p>Retain and repair as necessary.</p> <p>Retain and repair as necessary.</p> <p>Chimney breast retained as part of Flat 5 Living room. Fire surround removed.</p> <p>Opening to be closed off, architrave removed.</p> |

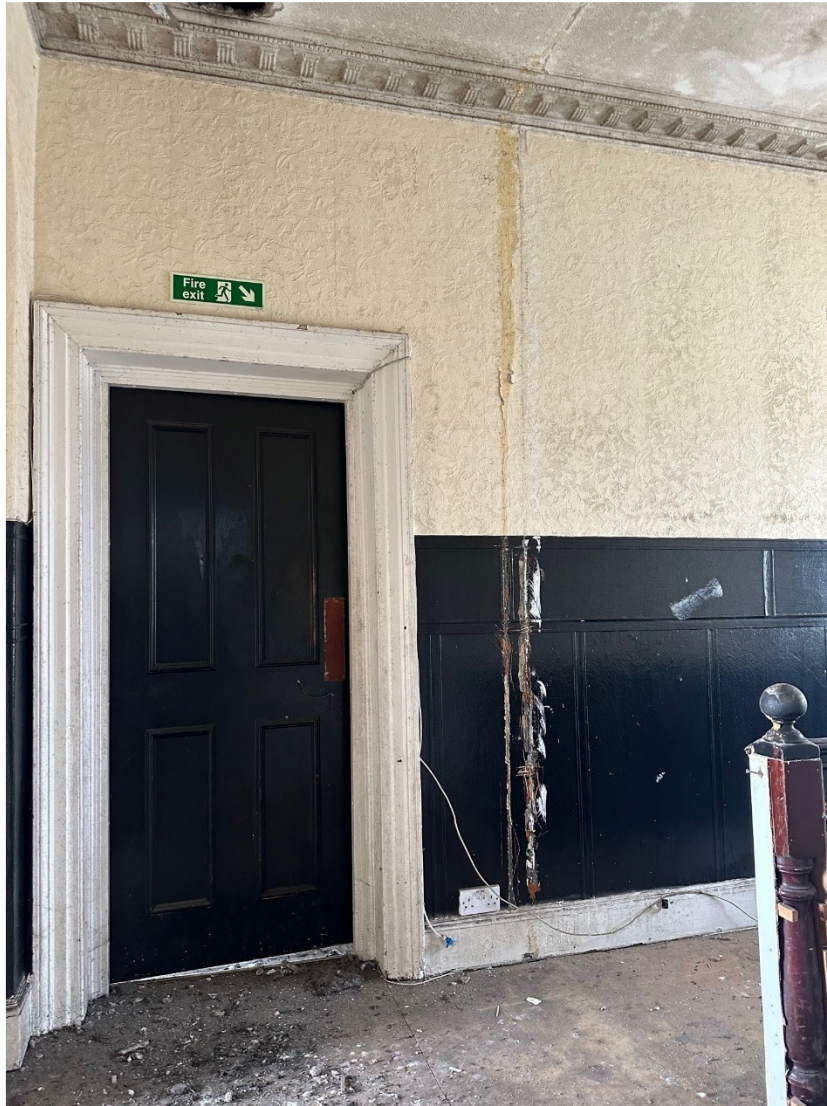
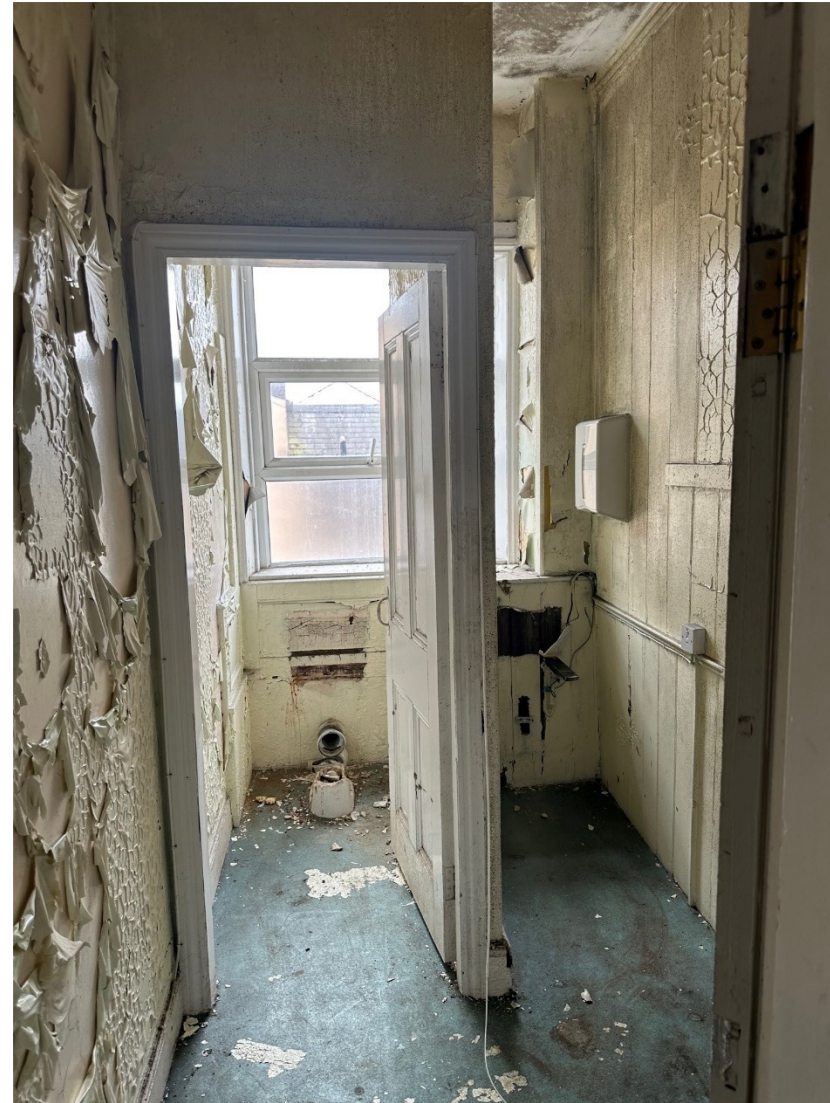
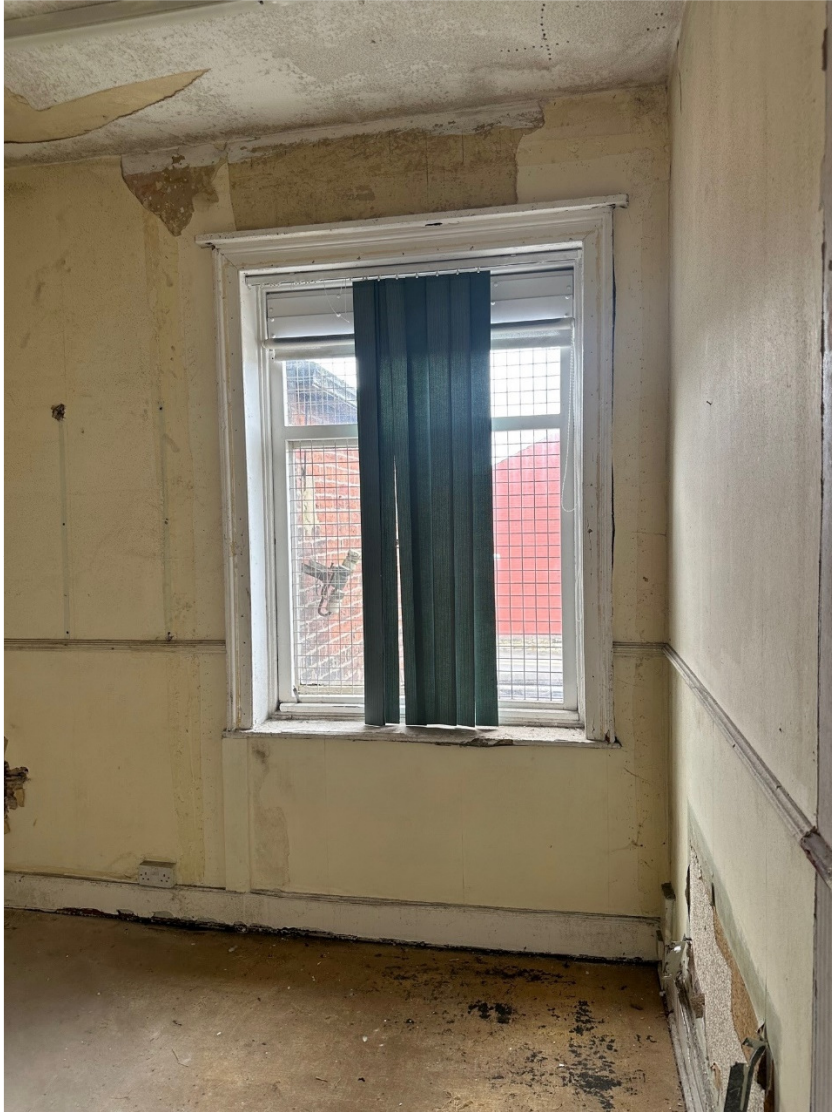
35. Door to office 9 & beyond

| Office 9 & WCs | <ul style="list-style-type: none"> <li>None</li> </ul> | No original feature | Poor | No original features. Strip out and remove all fixtures and fittings. |

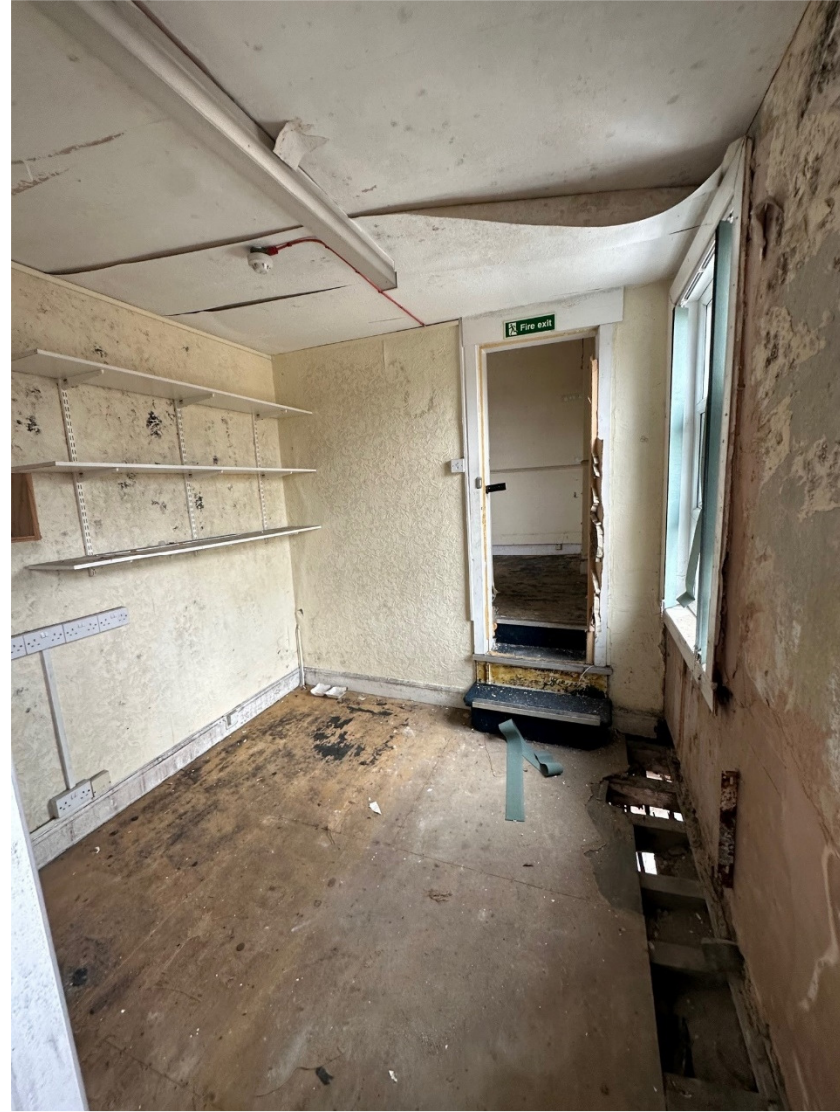
38. Office 10

| Office 10 | <ul style="list-style-type: none"> <li>None</li> </ul> | No original feature | Poor | No original features. Strip out and remove all fixtures and fittings. |

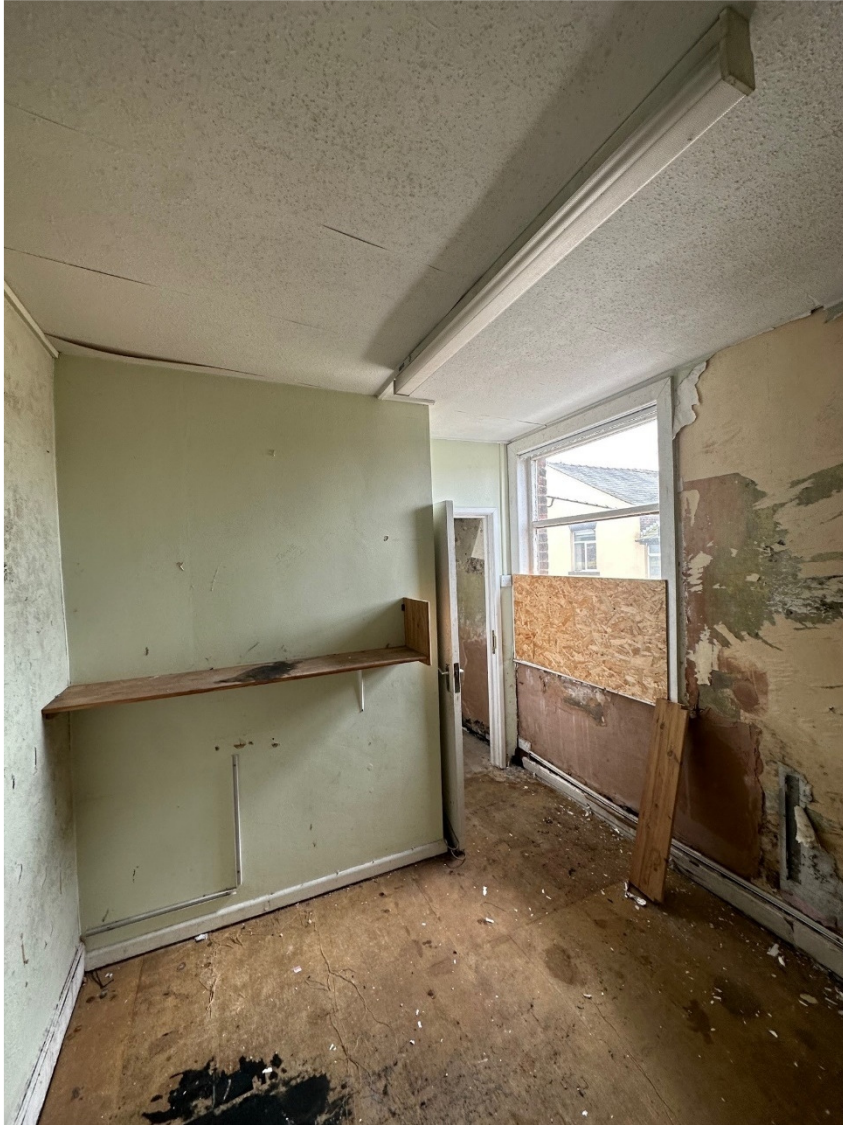
### 39. Office 11

| Office 11 | <ul style="list-style-type: none"> <li>None</li> </ul> | No original feature | Poor | No original features. Strip out and remove all fixtures and fittings. |
