## Phase 1 GeoEnvironmental Desk Study

34-42 Durham Street

Rochdale

**Report No. A5655/23/FDS**

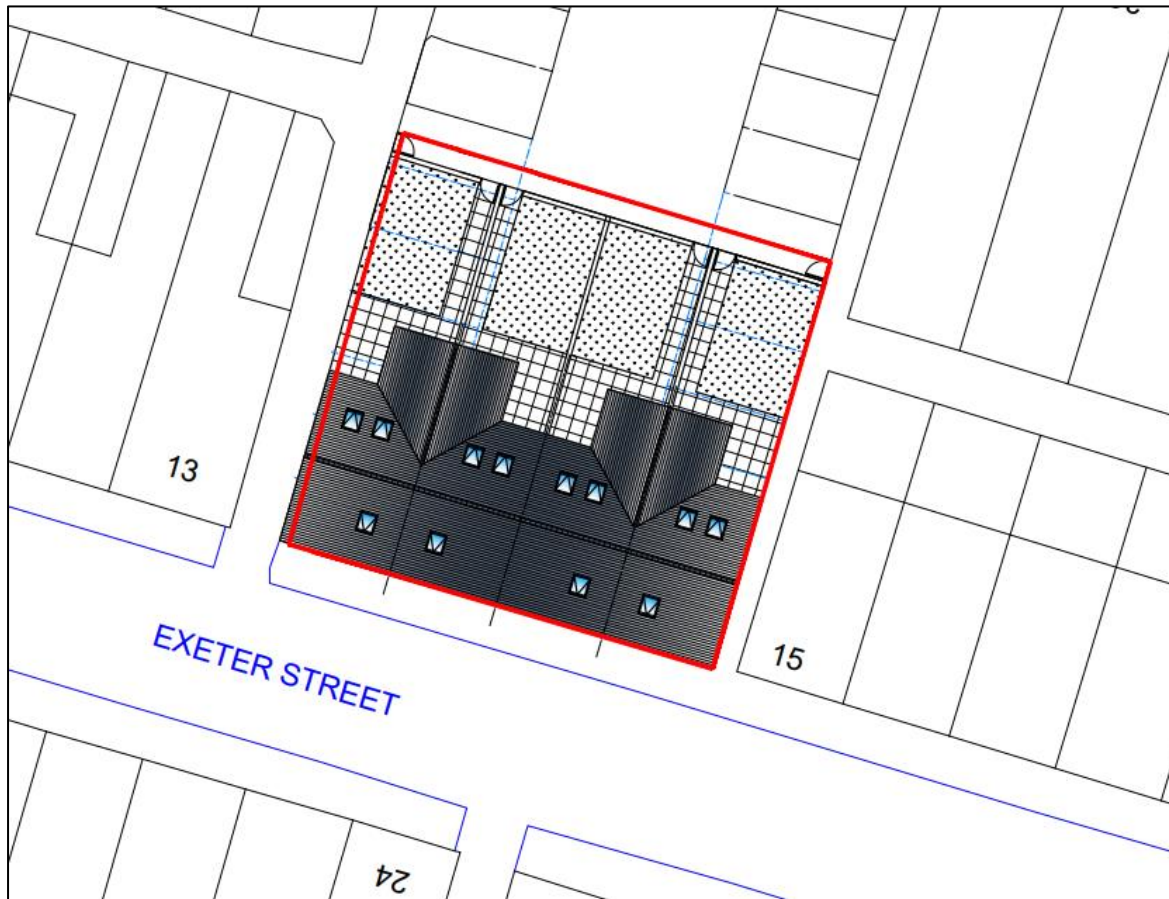
**Figure 2 Proposed Development Layout Plan**

- 2.6 The proposed development is to construct four residential properties on site with associated landscaping.
- 2.7 A location plan is shown below as Figure 1, along with a proposed development layout plan as Figure 2.

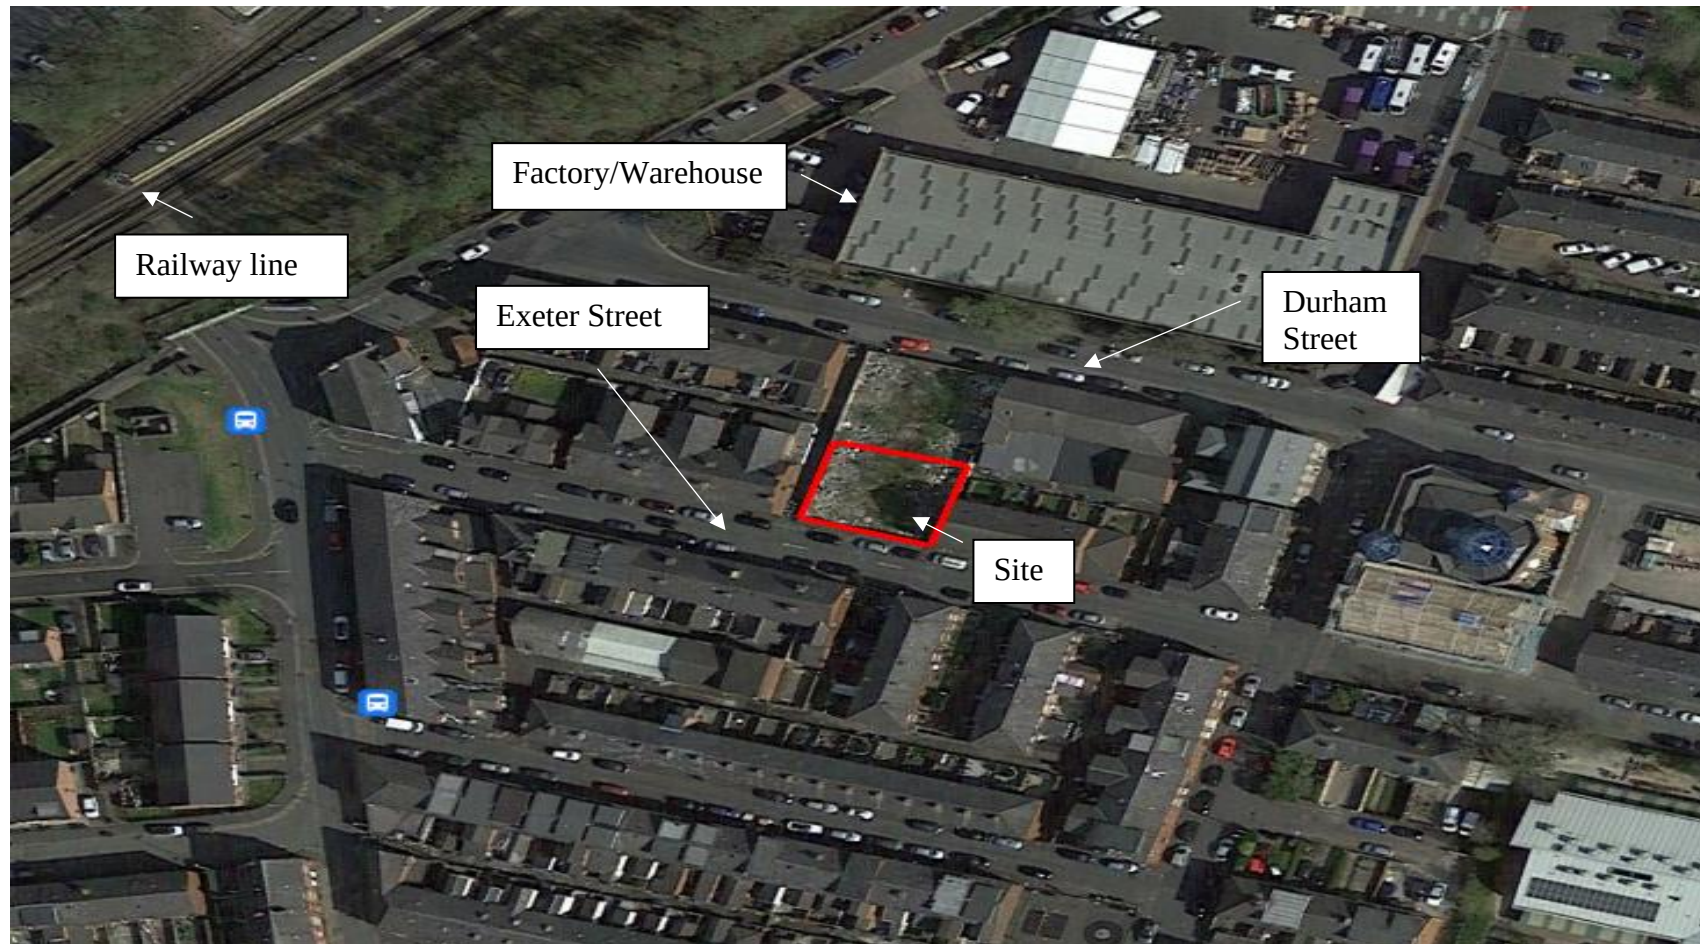
**Figure 7 Site Features plan**

- 5.6 There is a manhole cover adjacent to the site.
- 5.7 A site features plan is presented as Figure 7 overleaf.

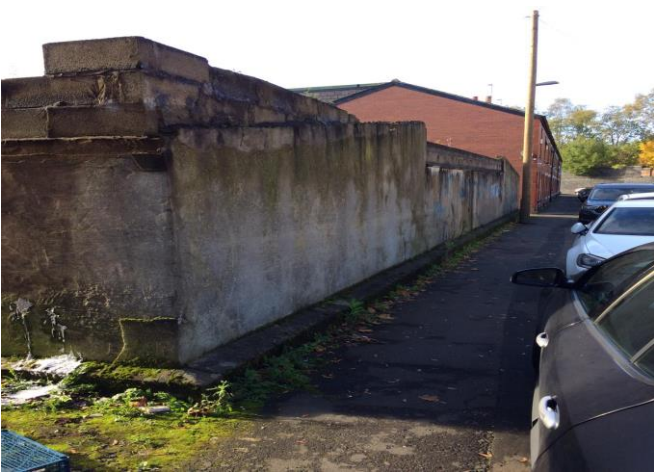
| <p>Plate 1 Viewing west on Durham Street showing site boundary wall.</p> | <p>Plate 2 Viewing south, entry between adjacent residential properties and east of site leading to Exeter Street.</p> |

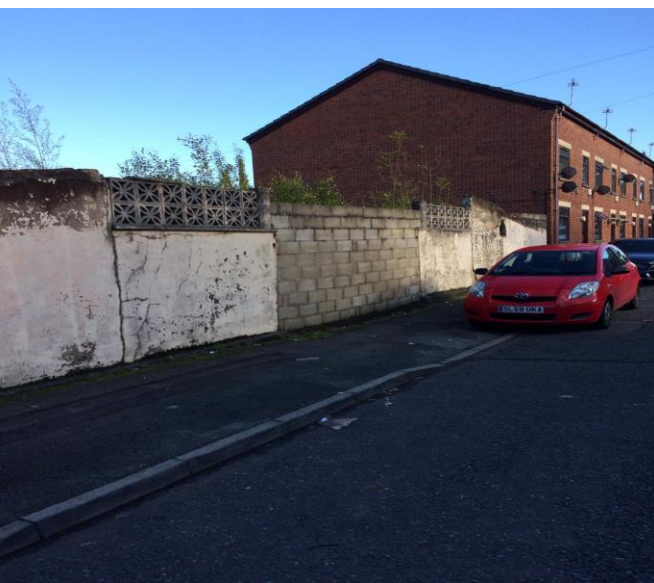
| <p>Plate 3 Viewing north from Exeter Street showing site boundary wall.</p> | <p>Plate 4 Viewing south entry between adjacent residential properties and west of site leading to Exeter Street.</p> |

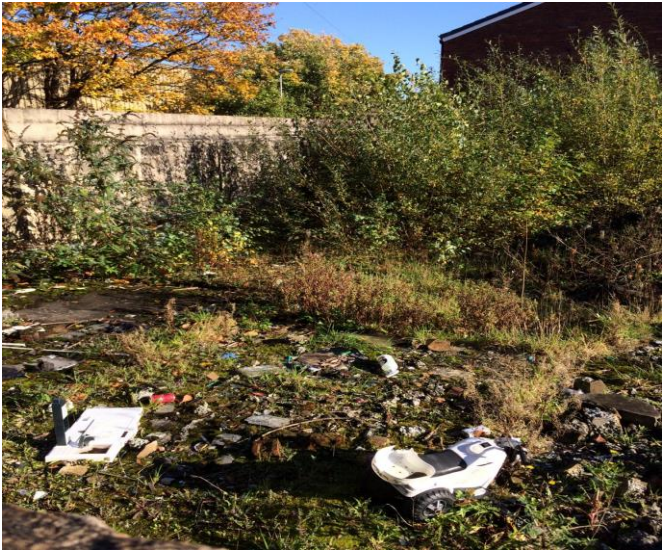
| <p>Plate 5 Viewing northeast showing different vegetation present and some litter.</p> | <p>Plate 6 Viewing south showing litter and fly tipping present within site.</p> |

- 8.7 An intrusive investigation should be undertaken to ensure the most up to date geotechnical parameters for the design foundations, floor slabs and pavement construction for the proposed new structures and surrounding area are gained.
- 8.8 As part of the ground investigation soil samples should be taken from across the site for chemical analysis.
- 8.9 Access to the site would need to be created and the site would need to be cleared of debris, vegetation and general litter prior to any intrusive investigation.

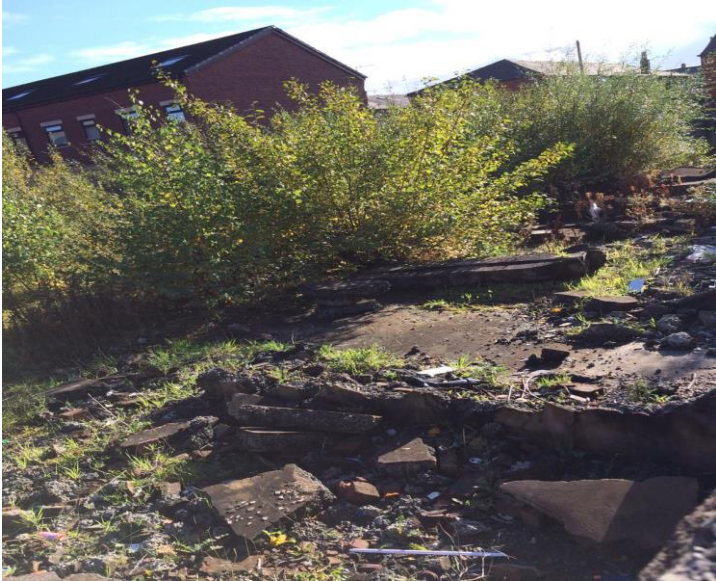
| <p>Plate 7 Viewing south showing vegetation and rubble.</p> | <p>Plate 8 Viewing east showing vegetation and rubble</p> |
