**A HISTORIC BUILDING  
RECORDING AT  
MOORGATE EAST FARM,  
THE OLD STABLE,  
BROAD LANE,  
ROCHDALE,  
GREATER MANCHESTER**

**PCA REPORT NO: R15158**

Historic Building Recording

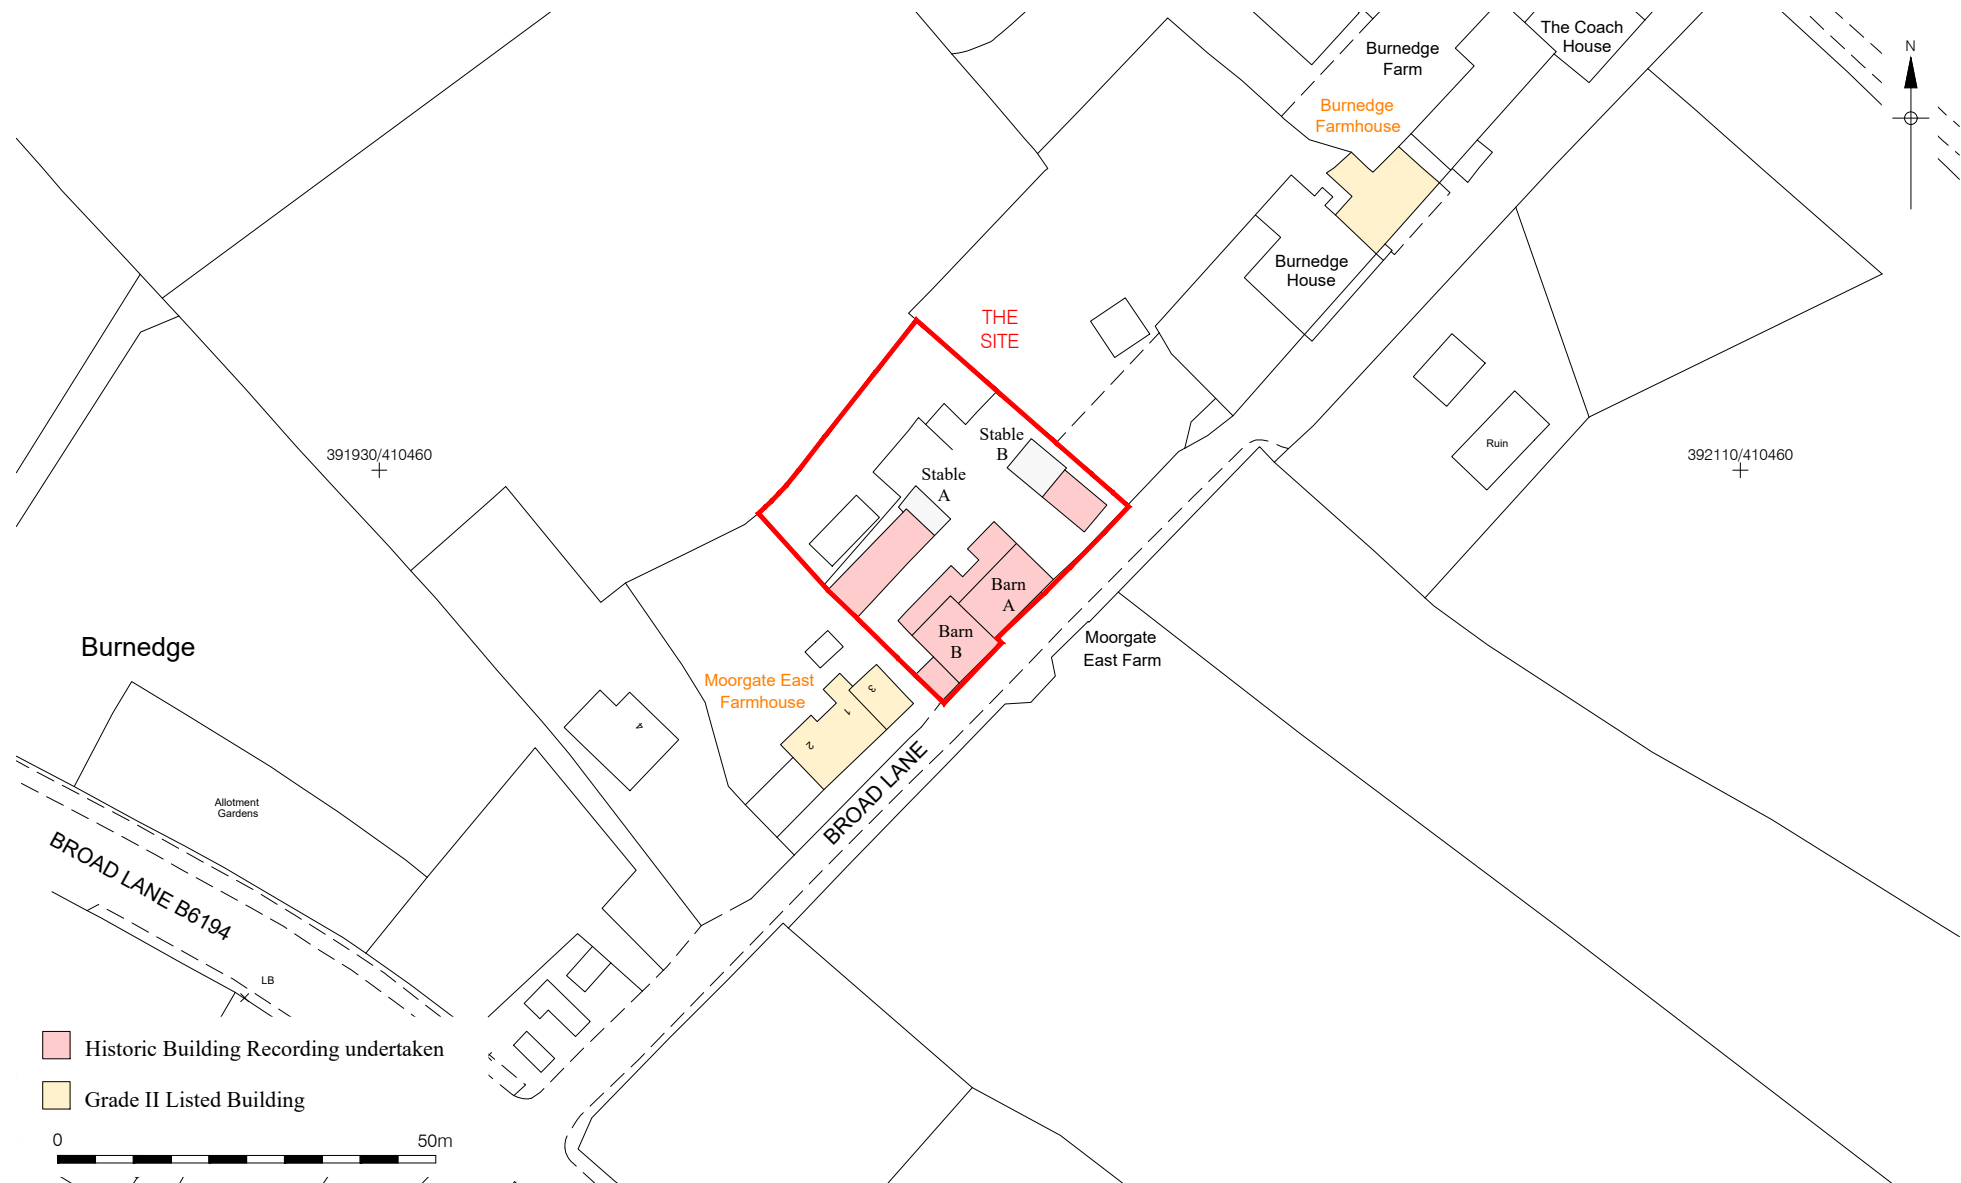
Figure 4  
Hennet's County Map, 1830  
approx 1:20,000 at A4

- 7.1.1 Yates county map of 1786 (**Figure 3**) and The Hennet's County Map of 1830 (**Figure 4**) depicts a building at the site, but it is not possible to discern if the stone barn is illustrated in its entirety.

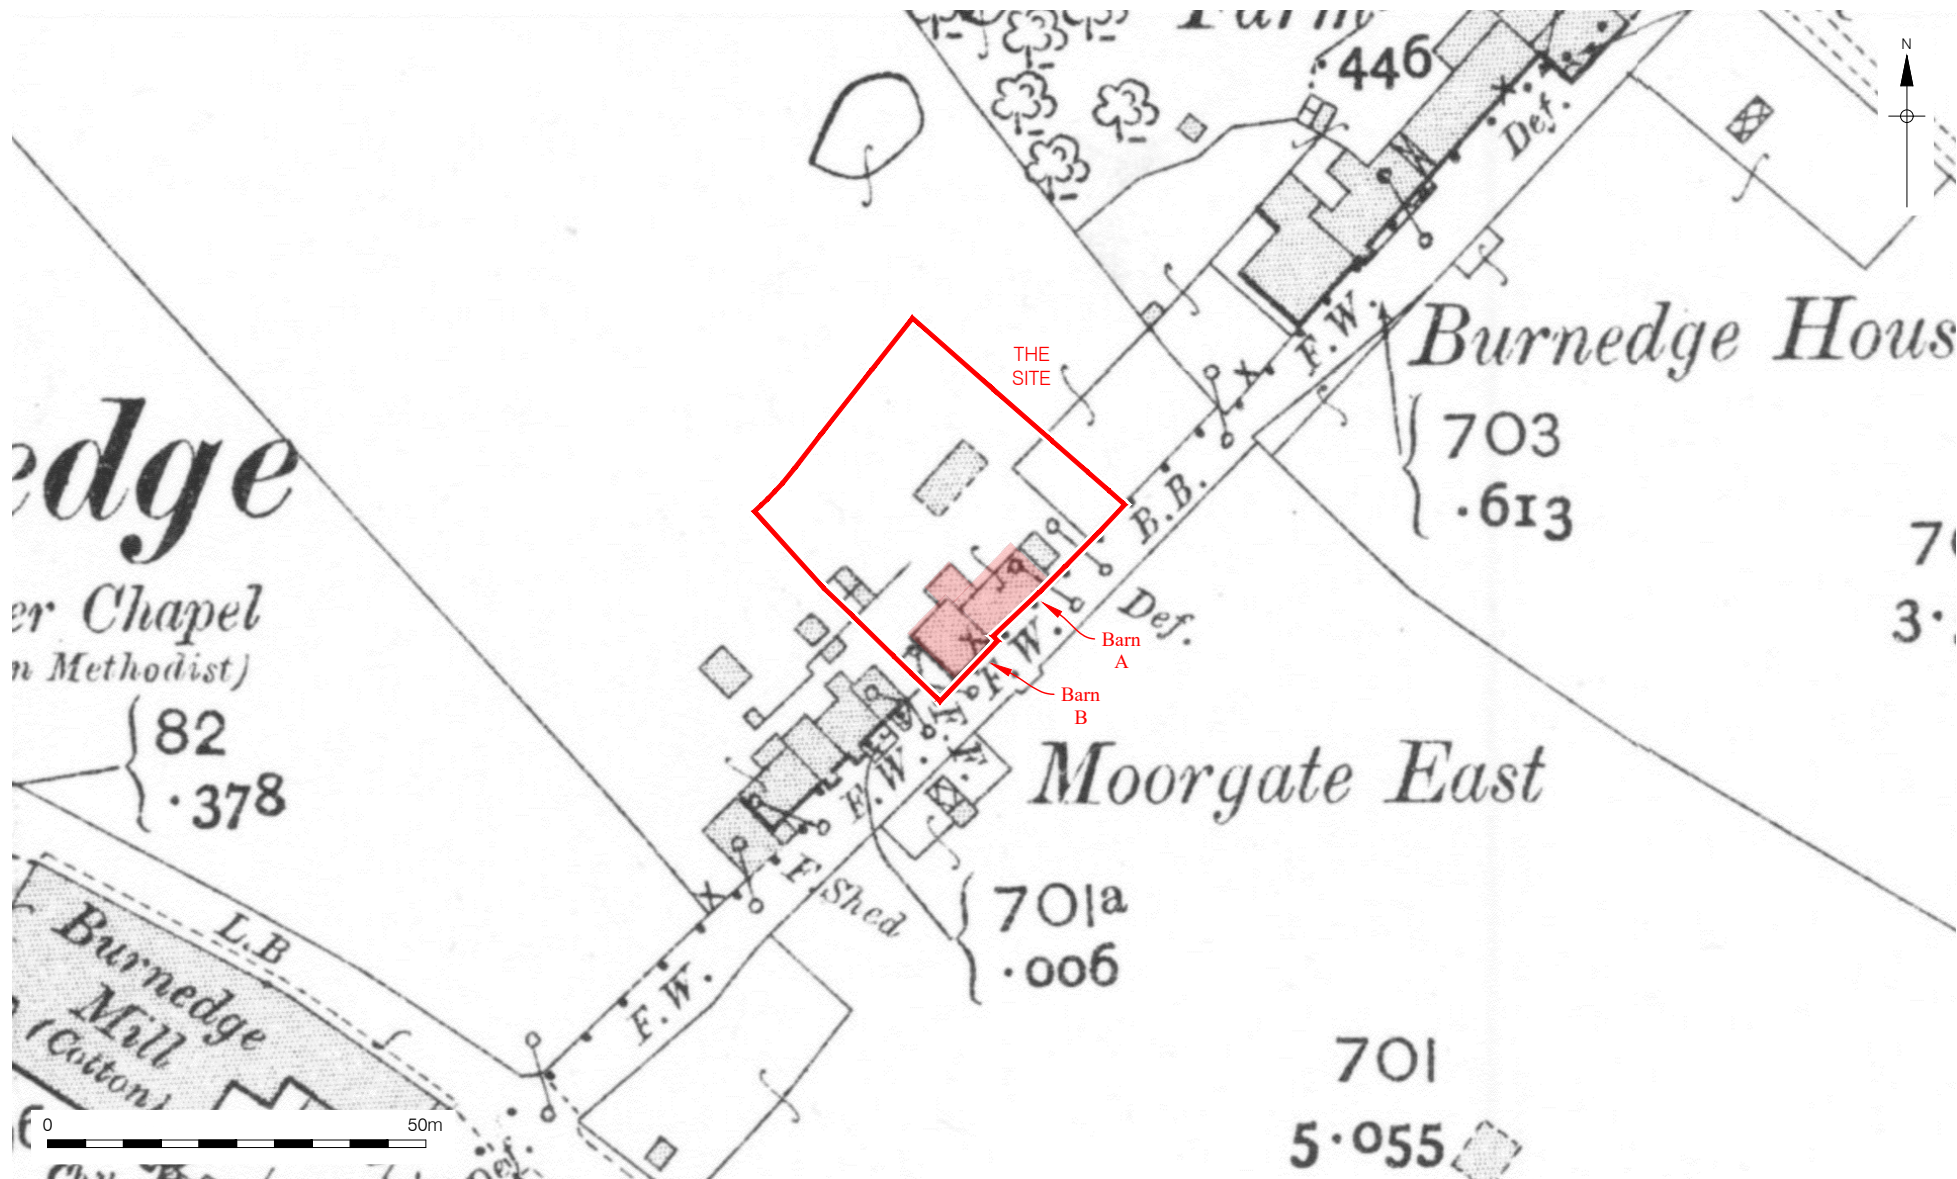
Figure 10  
Ordnance Survey, 1928  
1:1,000 at A4

- 7.1.4 A extension is noted on the west elevation of Barn B, which still remains and is expected to be demolished (Photo 13). This is depicted on the Ordnance Surveys of 1928 (**Figure 10**), 1936 (**Figure 11**) , 1954-56 (**Figure 12**) and 2004 (**Figure 13**).

- 8.4.5 The southwest elevation was largely concealed by a 20<sup>th</sup> Century lean-to structure, constructed from red brick, fully rendered and breeze blocks, and is first depicted on the 1954-6 Ordnance Survey (**Figure 12**). However, this structure replaced an earlier, larger building; there is no indication of its location on the stone wall but it is first depicted on the 1928 Ordnance Survey (**Figure 10**).

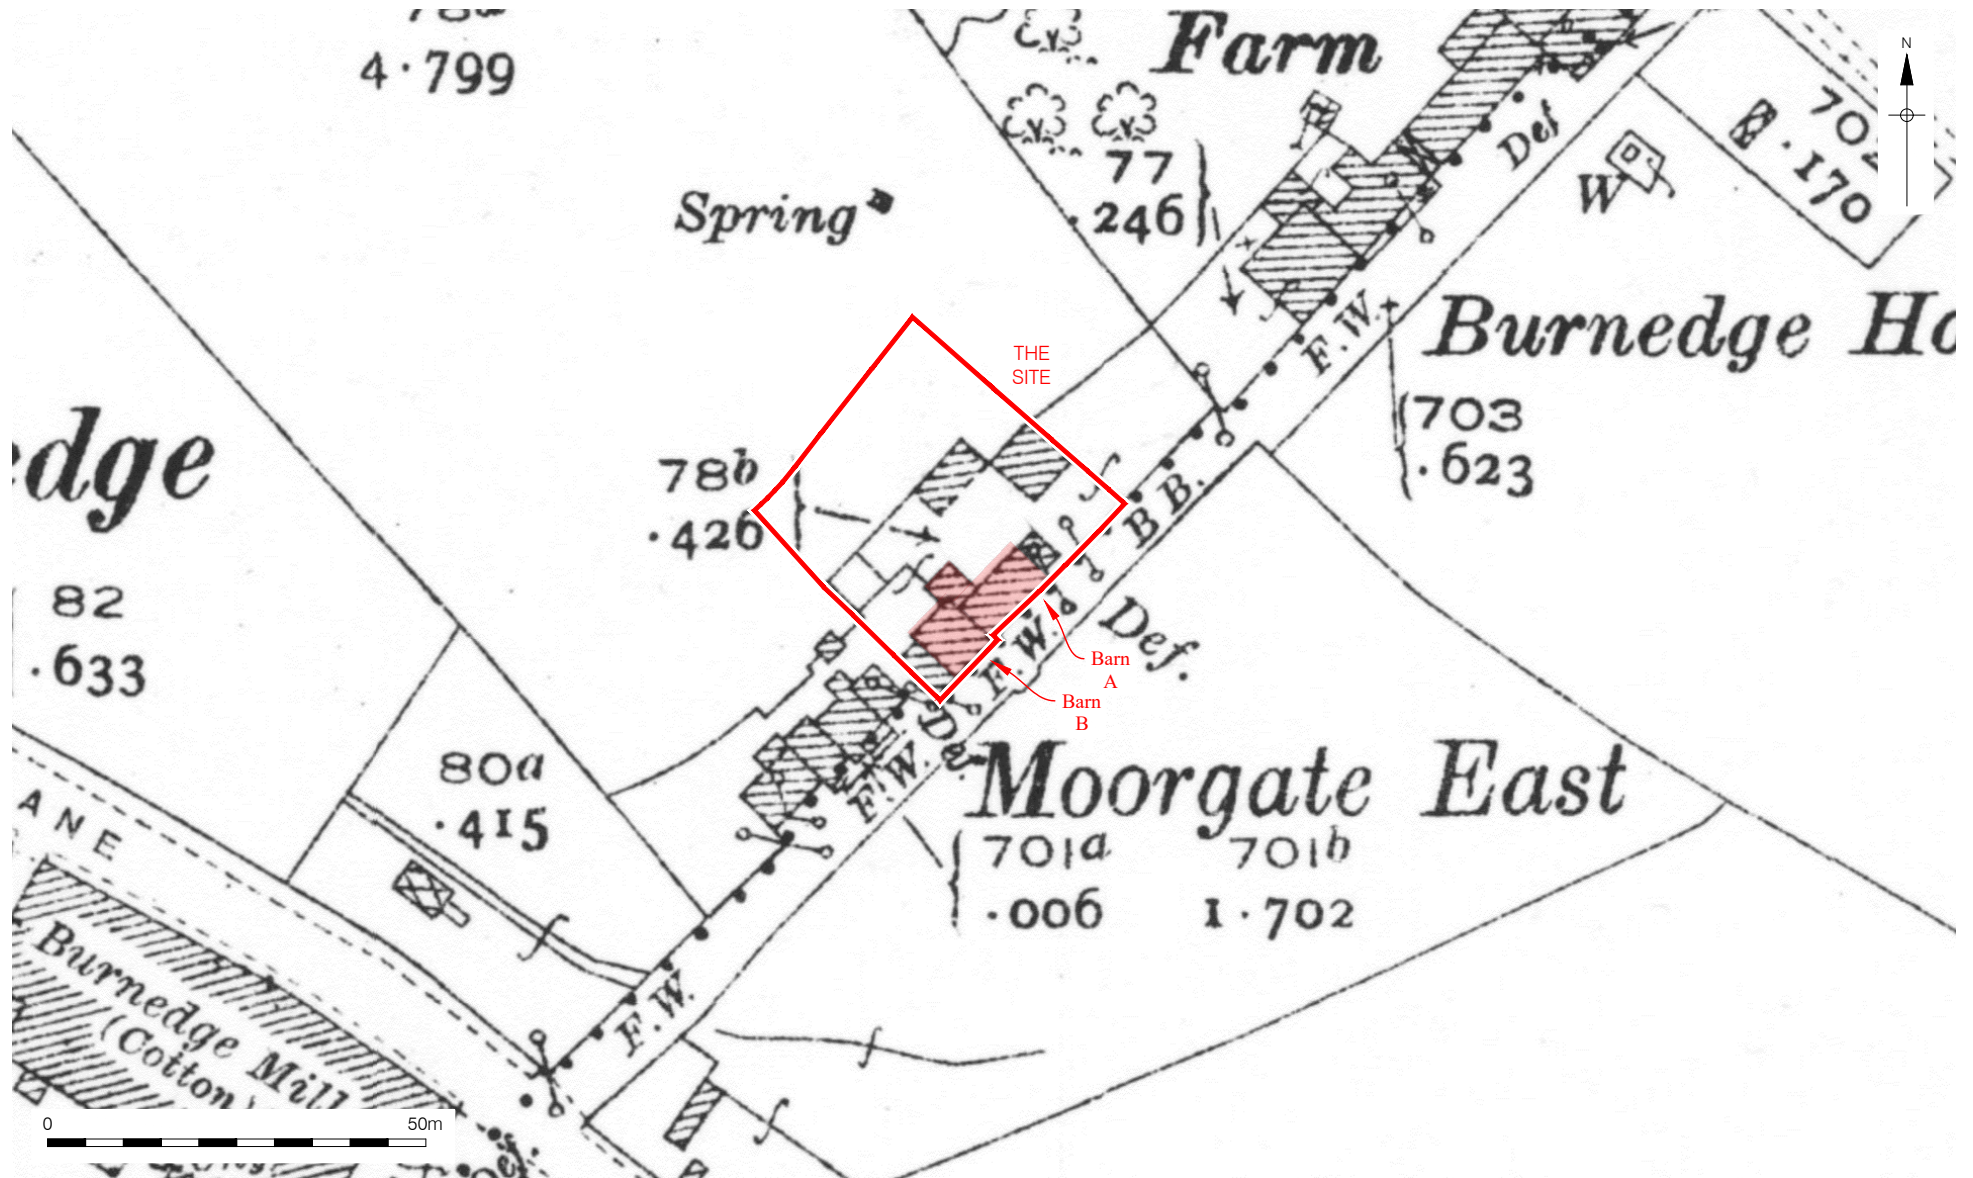
Figure 12  
Ordnance Survey, 1954-56  
1:1,000 at A4

- 7.1.6 The Ordnance survey of 1954-56 (**Figure 12**) depicts the stable blocks, north and east of the stone barn and remained identical on the Ordnance Survey of 2004 (**Figure 13**). The stables were still standing at the time of the survey, and are expected to be demolished.

- 8.2.8 According to the 1954-56 and 2004 Ordnance Survey mapping (**Figure 12 and 13**) much of the east side of the northwest elevation was abutted by a large rectangular building. The east side walls are constructed from two courses thick of mass-produced red brick in a stretcher bond and are rendered whitewash with black bitumen on the lowermost courses externally. The west side lowermost wall appears to have been a former yard wall, constructed from two courses thick of mass-produced red brick in a Flemish Garden bond, capped with a row of headers. A later addition of two courses of breeze blocks was seen. The roof was a lean-to with remnants of lead flashing, two machine cut wooden beams supporting various electric wiring and lighting.
