27<sup>th</sup> September 2022

**Subject: Norwich Mill, Rochdale – Ecology Walkover Survey, Inc. Nocturnal Bat Survey**

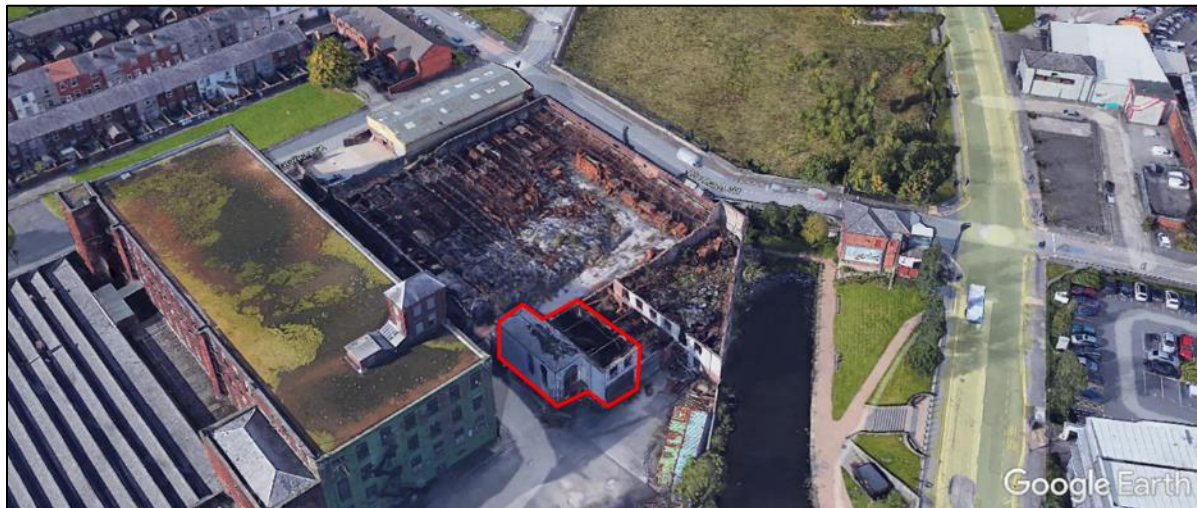
**Figure 2. Location and extent of former engine house**

The Bat Survey comprised a more detailed examination of buildings present in order to determine their bat roosting potential. The bat survey highlighted that a former engine house, present at the southern corner of the burnt out mill (see Figure 2), displayed a low level of bat roost suitability. It was recommended that a dusk emergence or dawn return survey of this building would be required in order to confidently determine bat roost presence/absence.

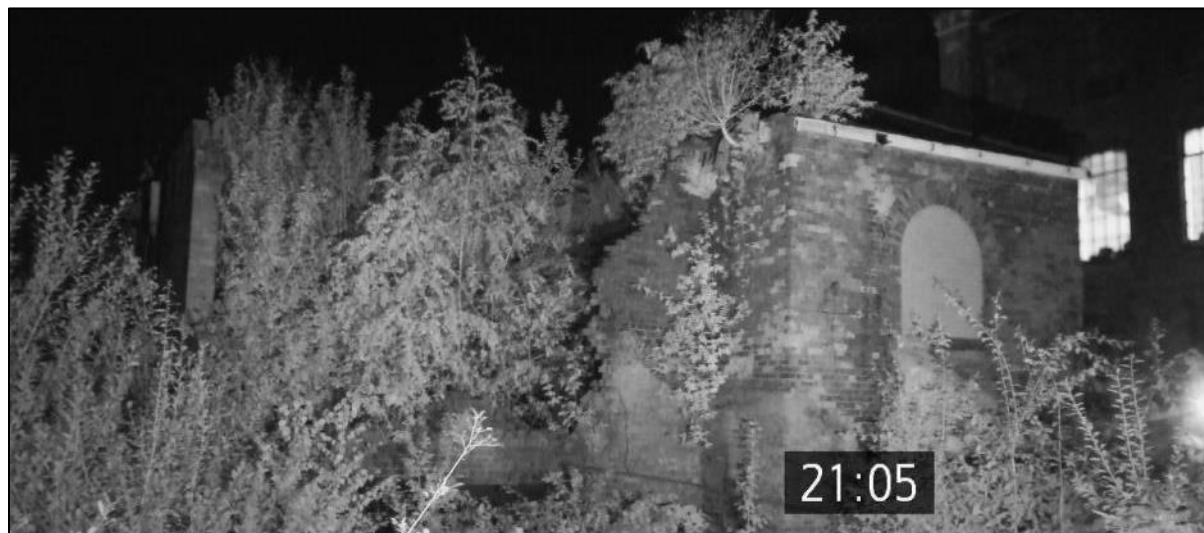
**Plate 1. Image from video camera in unmanned survey position at end of survey**

No evidence of roosting bats was recorded during the nocturnal survey. The only bat recorded comprised a common pipistrelle *Pipistrellus pipistrellus* feeding to the north of the engine house at 20:13. No other bat activity was recorded.

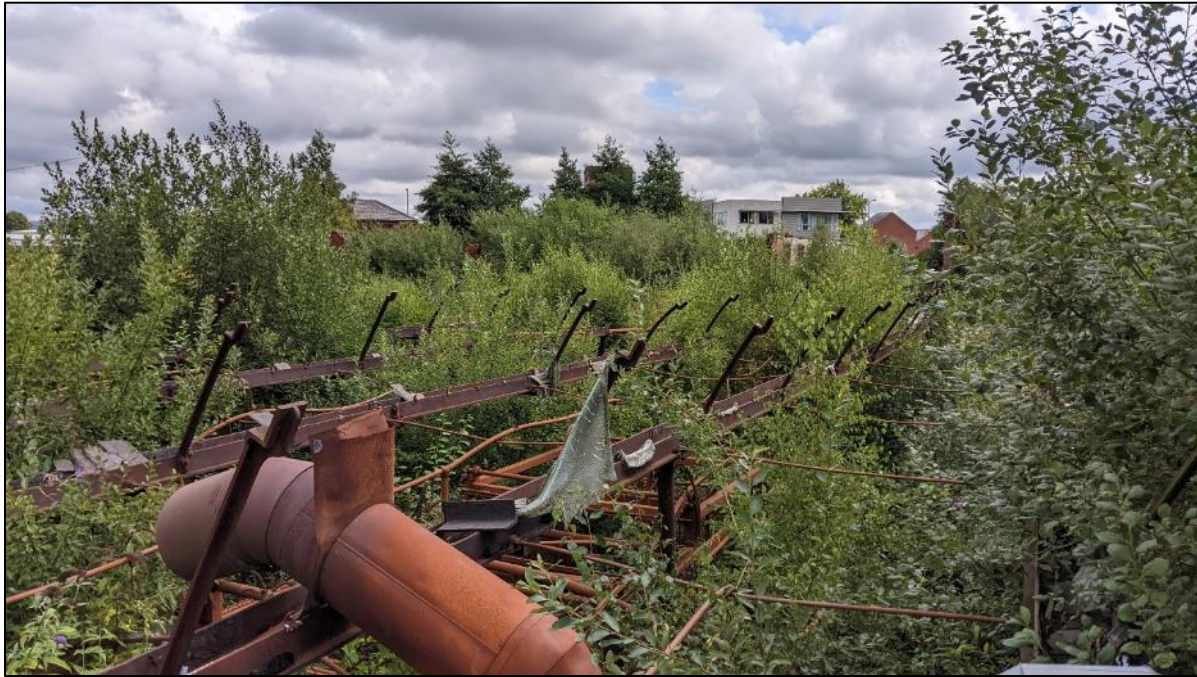
**Plate 1. Looking across the fire damaged interior of the burnt out factory**

Generally the site vegetation appeared to have developed as would have been expected on an unmanaged site of this type. The colonisation of bare ground, including the burnt remains of stored fabrics by species such as frequently occurring goat willow *Salix caprea*, silver birch *Betula pendula*, buddleia *Buddleja davidii*, rosebay willowherb *Chamaenerion angustifolium*, herb Robert *Geranium robertianum* and creeping bent *Agrostis stolonifera* has continued, with saplings growing into small trees in places. Whilst the vegetation has continued to develop, the habitats present are fundamentally the same as those recorded in 2019.

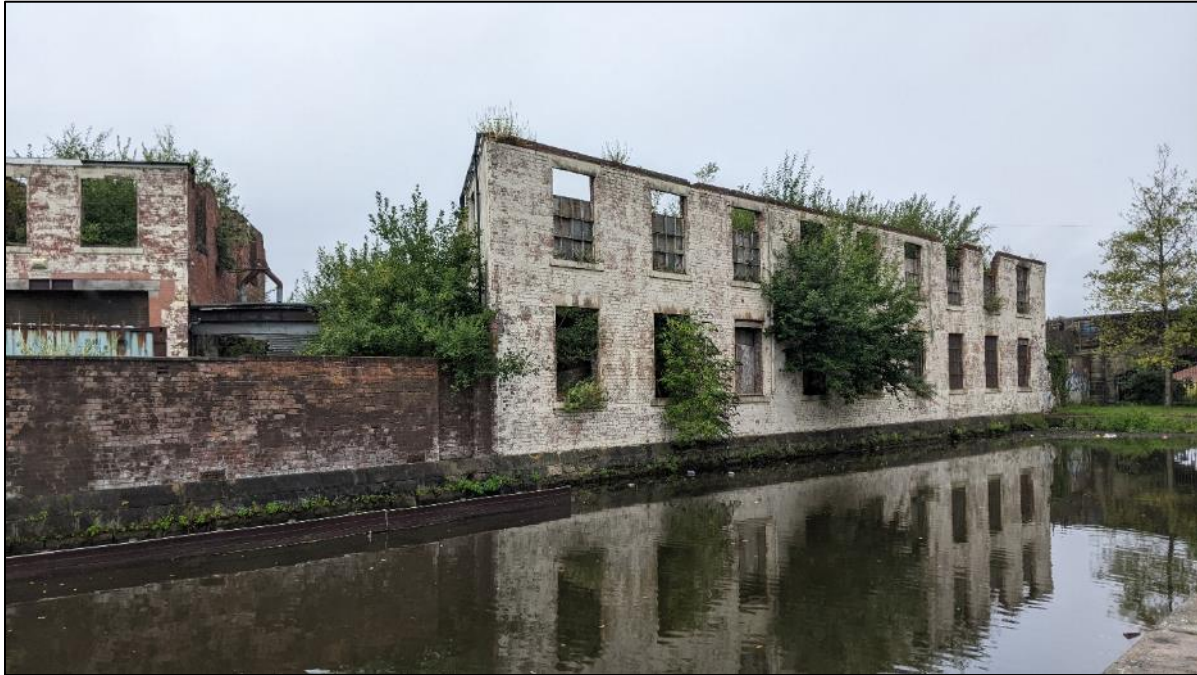
**Plate 3. Looking across eastern boundary of site from Rochdale Canal**

The remnant walls around the site boundary (i.e. Plate 3) were found to be well pointed, supporting no more than very superficial and almost universally damp crevices. These walls were not considered to display more than a negligible level of bat roost suitability.

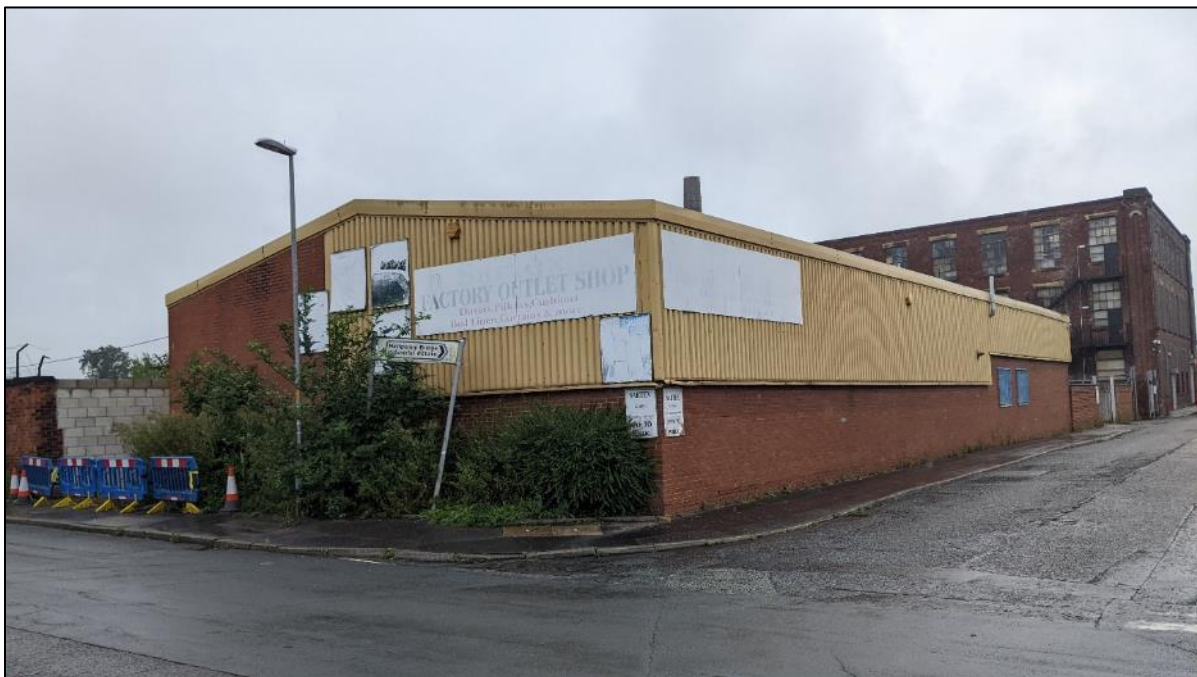
**Plate 4. Intact factory shop at northern corner of site**

The intact factory shop (Plate 4) comprises a single c.1980s brick-built unit with a pitched corrugated metal sheet roof. The verges were covered with metal coverings and wall top capping, together with some corrugated metal sheet cladding. The building was found to lack potential roost features and was considered to display a negligible level of bat roost suitability.

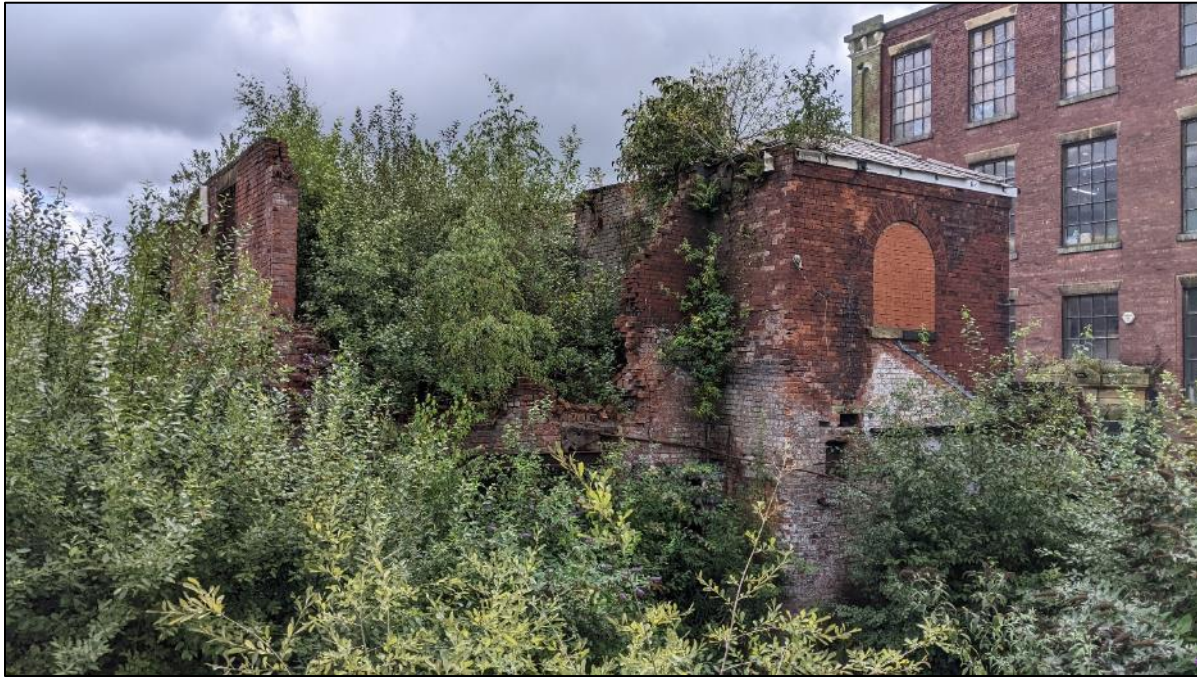
## Plate 5. The former engine house

*Building and tree inspections* - The entirety of site's built structures were subject to a ground based external visual inspection, with the former engine house also subject to a partial internal inspection. The survey findings concurred with the 2020 Bat Survey report (JCA, 2020), in finding that the only section of the site displaying more than a negligible level of bat roost suitability comprised the former engine house (Figure 2; Plate 5).

The former engine house comprised a two-storey brick built section of the former factory with the partial remnants of a pitched and hipped Welsh slate covered roof with clay ridge tiles and a uPVC plastic fascia board. Bats may potentially access the wall top of this building, with potential roosting gaps also present below ridge and hip tiles. Bats may also access crevices between the two skins of the solid brick wall for roosting. This section of the building was considered to display a low level of bat roost suitability.

No bats were recorded roosting on site during the survey works and consequently there is no compulsory requirement for mitigation. However, in order to enhance the ecological value of the site and in accordance with the aims of the National Planning Policy Framework (2021), it is suggested that two new bat roosting features be incorporated into the new factory. The features could comprise integrated bat boxes, of a design such as the Vivara Pro Build-in WoodStone Bat Box, to be fitted in the south elevation of the renovated former boiler house, close to wall top height (Figure 5).

In accordance with the aims of the National Planning Policy Framework, it is recommended that one new integrated swift *Apus apus* box (i.e. Manthorpe Swift Brick) be installed within the new factory. This box could be fitted at wall top height in the east facing elevation of the former engine house. Studies have shown that swift boxes are used by other bird species that utilise buildings and consequently this measure will provide potential nesting space for house sparrows *Passer domesticus* and starlings *Sturnus vulgaris*, in addition to potentially providing future nest space for swift.
