## Bat Presence / Absence Survey

### St. Josephs Pre-school Nursery

SJPH-EVE-RP-01

OCTOBER 2024

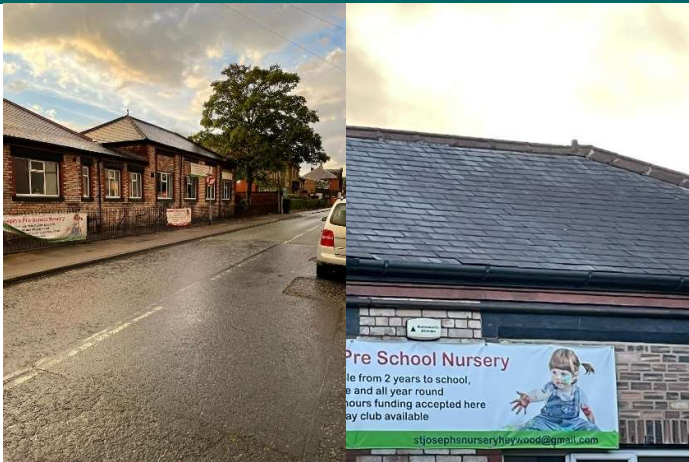
**Table 2: Description and photographs of habitats within and adjacent to the site**

- 4.3.1 The building is a one storey property currently used as a nursery. The building is of a brick construction which is in good condition and does not provide any roosting opportunities for bats. The roof is pitched with slate roof tiles and terracotta ridge tiles. The roof tiles are mostly in good condition. However, there are minor lifted and slipped tiles on the roof which have the potential to provide roosting opportunities for bats. Lead flashing also lined the edges of the roof tiles where it was against a wall structure but was in good condition with no apparent gaps present. uPVC windows are frequent along all aspects of the building which are all in good condition. No evidence of bats was found during the external inspection and, taking into account the surrounding habitats, the inspection deemed that the building was of low potential for roosting bats and therefore required a single emergence survey. Potential roosting features are illustrated in Table 2 below.

| Feature | Photograph |
|---|---|
| Some tiles lifted and gaps in ridge tiles | |

- 5.1.1 The areas surrounding St. Josephs Pre-school Nursery are of low quality habitats for foraging and commuting bats due to built up urban nature of the landscape.
- 5.1.2 The building offers a low number of possible roosting opportunities for crevice-dwelling bats which were limited to some slipped slate roof tiles and gaps between the terracotta ridge tiles.
- 5.1.3 No bats were recorded emerging from the building during the survey and the bat activity was sparse with some limited foraging activity during the survey.
- 5.1.4 Taking the desk study and field survey results into account, it is considered that bats are absent and not roosting with the building. Therefore, the roofing modifications can take place without a licence.

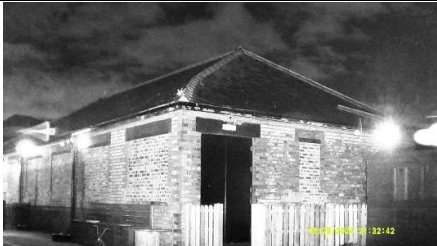
**Table 3: Bat Survey Results**

| Date | Species | Notes | Photograph |
|---|---|---|---|
| 28/08/2024 | Common pipistrelle | Foraging common pipistrelles were recorded above Surveyor 1 for part of the survey. Activity was more sporadic later into the survey and comprised mainly social calls and passes which were heard but not seen by Surveyor 1 and Surveyor 2. Surveyor 3 did not register any bats | |
