# NOCTURNAL BAT SURVEY REPORT

Hopwood Hall College,  
Rochdale Road,  
Middleton,  
Manchester,  
M24 6XH

1697B-NBR-V1-A

Seven Architecture

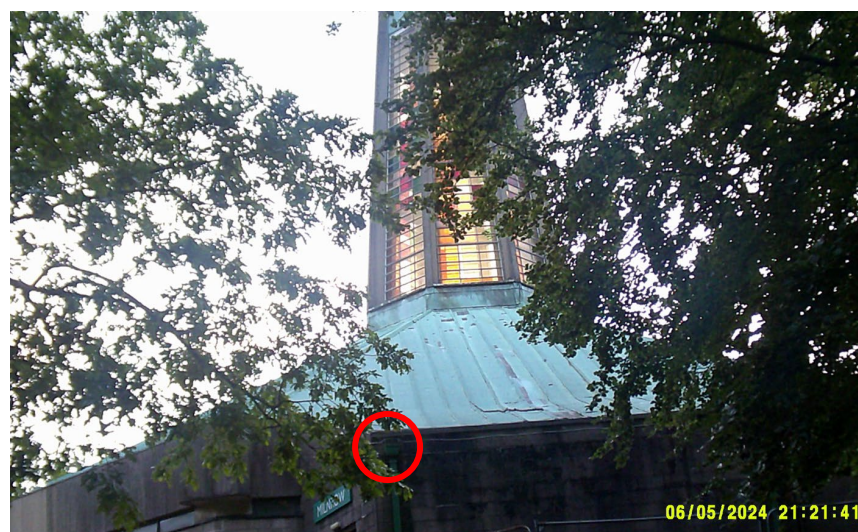
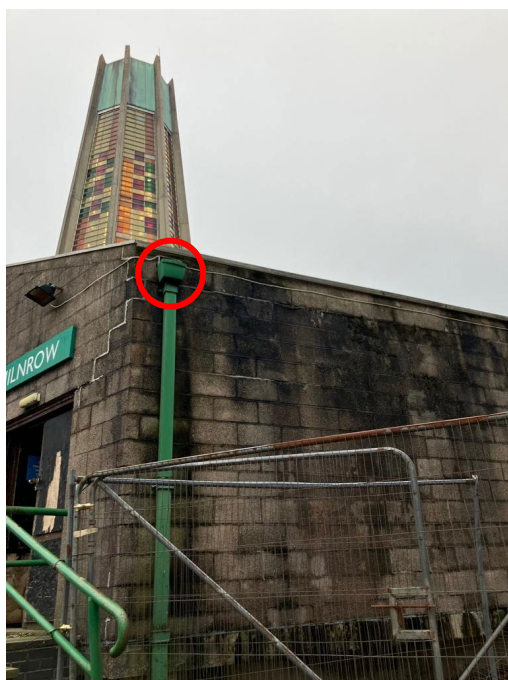
Figure 3 – Roost 1

- 3.1.5. Bat activity was recorded during the survey, there were less bats identified during the survey. The first bat was recorded at 21:49 and was identified as a common pipistrelle nearby VP5 and VP6 and it was identified from the adjacent woodland and foraging over the grassland. Bats were identified commuting around the building and into the open habitats and woodland for foraging purposes.
- 3.1.6. A review of the IRC camera footage (VP3) found one bat emerging at 22:11 from the building at Roost 1 it was located within the gutter of the building. The bat emerged without echolocation, as such the species is unknown.
- 3.1.7. **One roost location was recorded during the dusk survey.**

- 4.1.1. The proposed development works involve the refurbishment of the building. It is a listed building, and the extent of proposed works is unknown.
- 4.1.2. The nocturnal bat surveys identified one non-breeding day roost. As no echolocation was recorded during the survey, it is recommended a bat licenced ecologist inspects the location of emergence, to identify whether any bat droppings are present for eDNA analysis.

- 4.1.3. Depending on the scope of works, it is recommended that the roost is retained and protected. The roosting feature relates to an external gutter. If it is possible, it is recommended the feature is retained and unimpacted by the proposed works. A minimum 2m buffer (relating to external features, including the metal trim above the gutter) around the roost location would need to be obtained to protect the roost, and minimise risk of disturbance.
