## A1 Soakaway Test

| Site Name | Development at Greenhill Road |
| GeoAssist Ref | 6127VGH |

Soakaway test locations

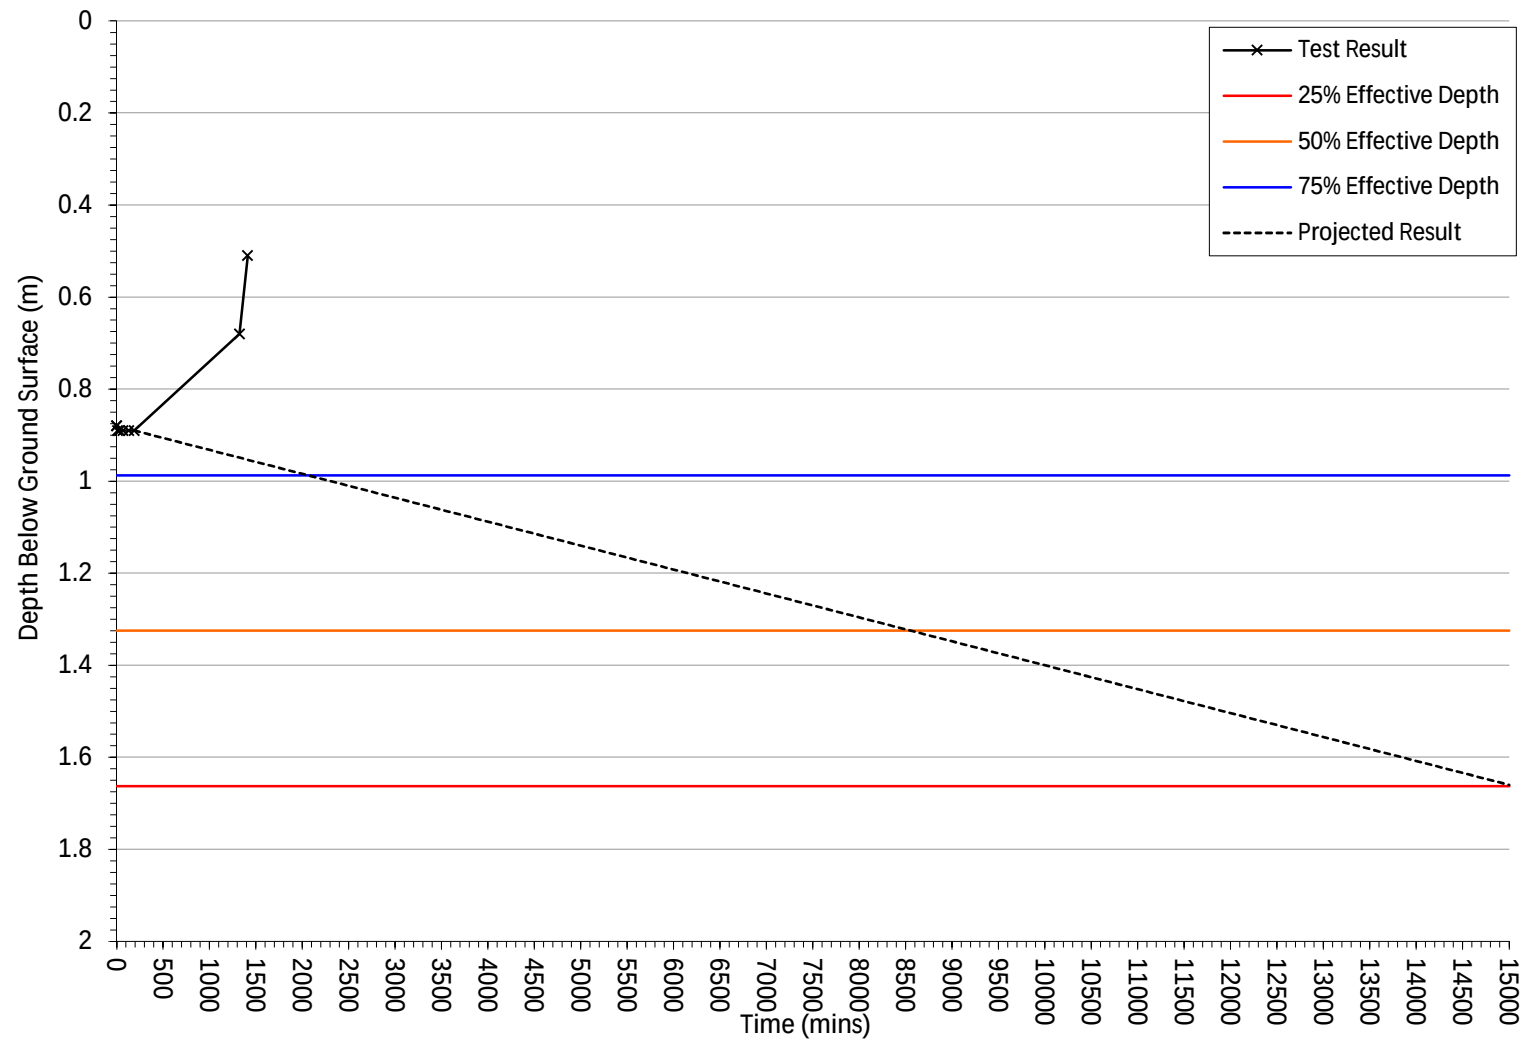
Results of Field Observations 6127 VGHM TP5 Soakaway Test 08th July 2024

Brown Sand Silty Clay with Sand Bands

Soil Infiltration Rate  $f$  from Test 1 1.9E-07 m/sec

Trail pit wall failed overnight

Trial pit failed to half empty within 24hrs, Therefore unsuitable for soakaway drainage
