# ARBORICULTURAL IMPLICATIONS ASSESSMENT

FORMER WICKEN HALL MILL  
OF OGDEN LANE  
NEWHEY

Author: C. Salisbury  
Date: 14 December 2022  
Ref: TRE/FWHMOLN

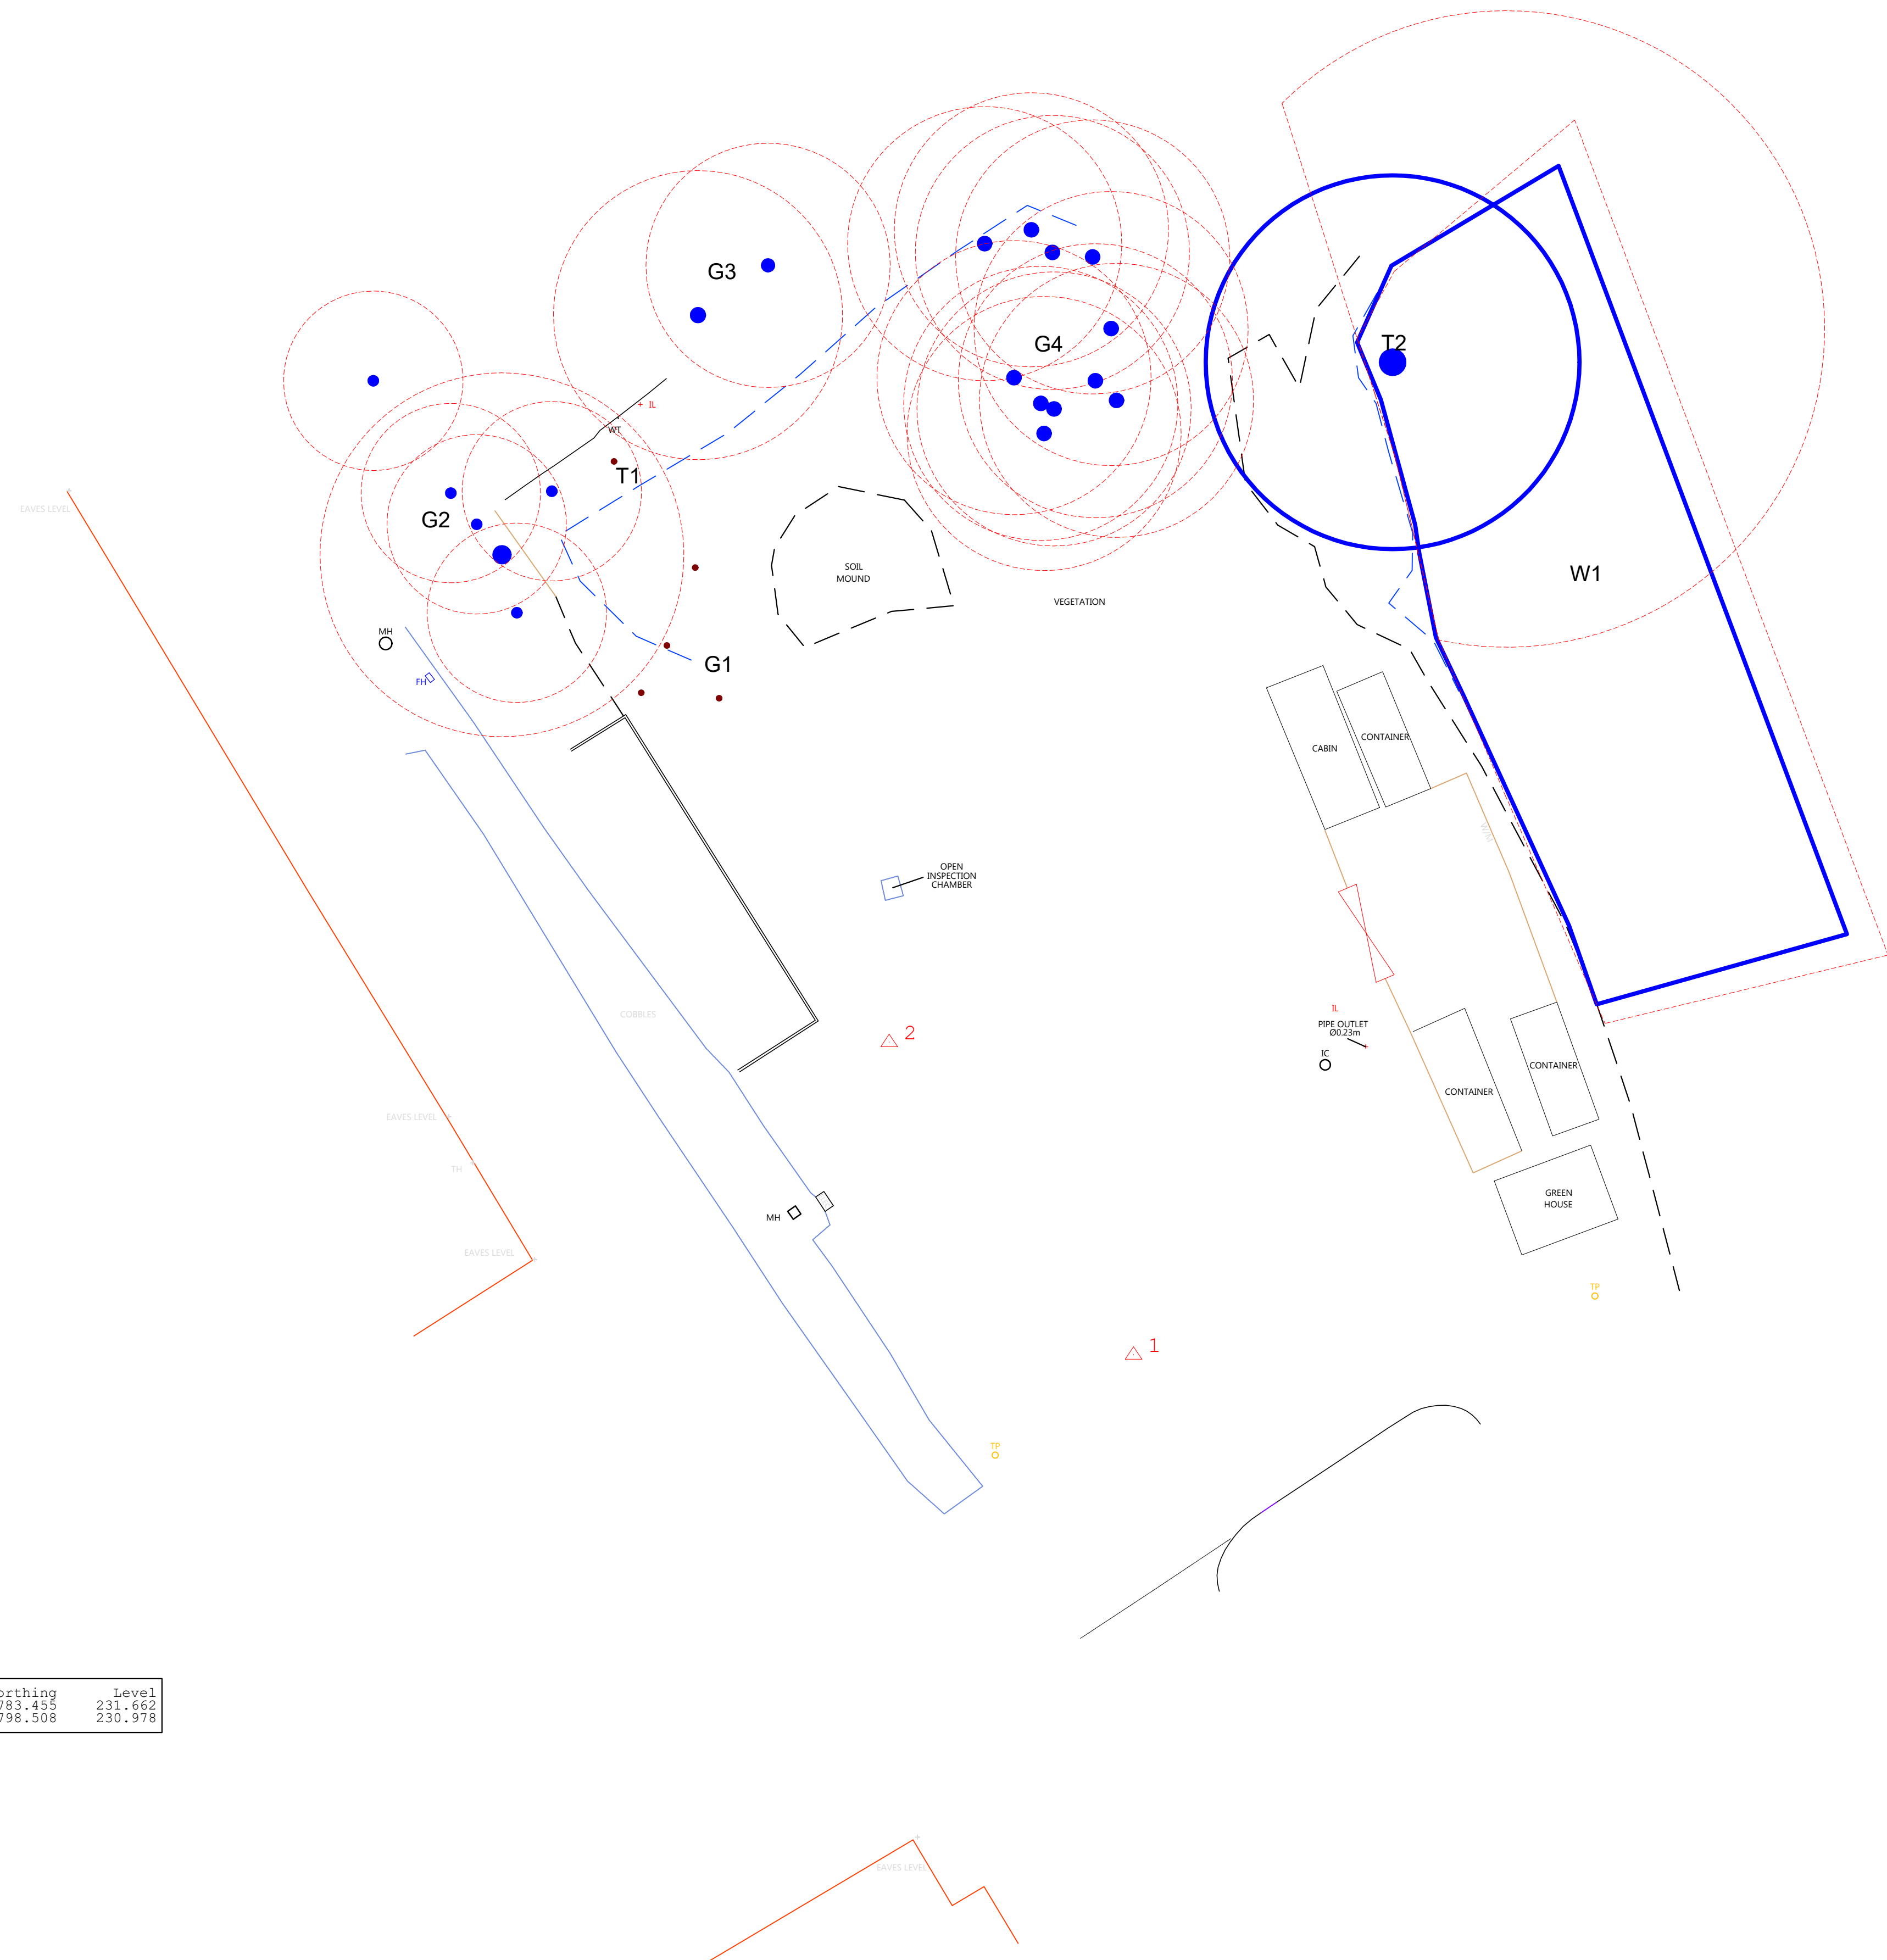
Drawing No:  
FWHM/BS/01

Drawing Title:  
BS5837 Plan

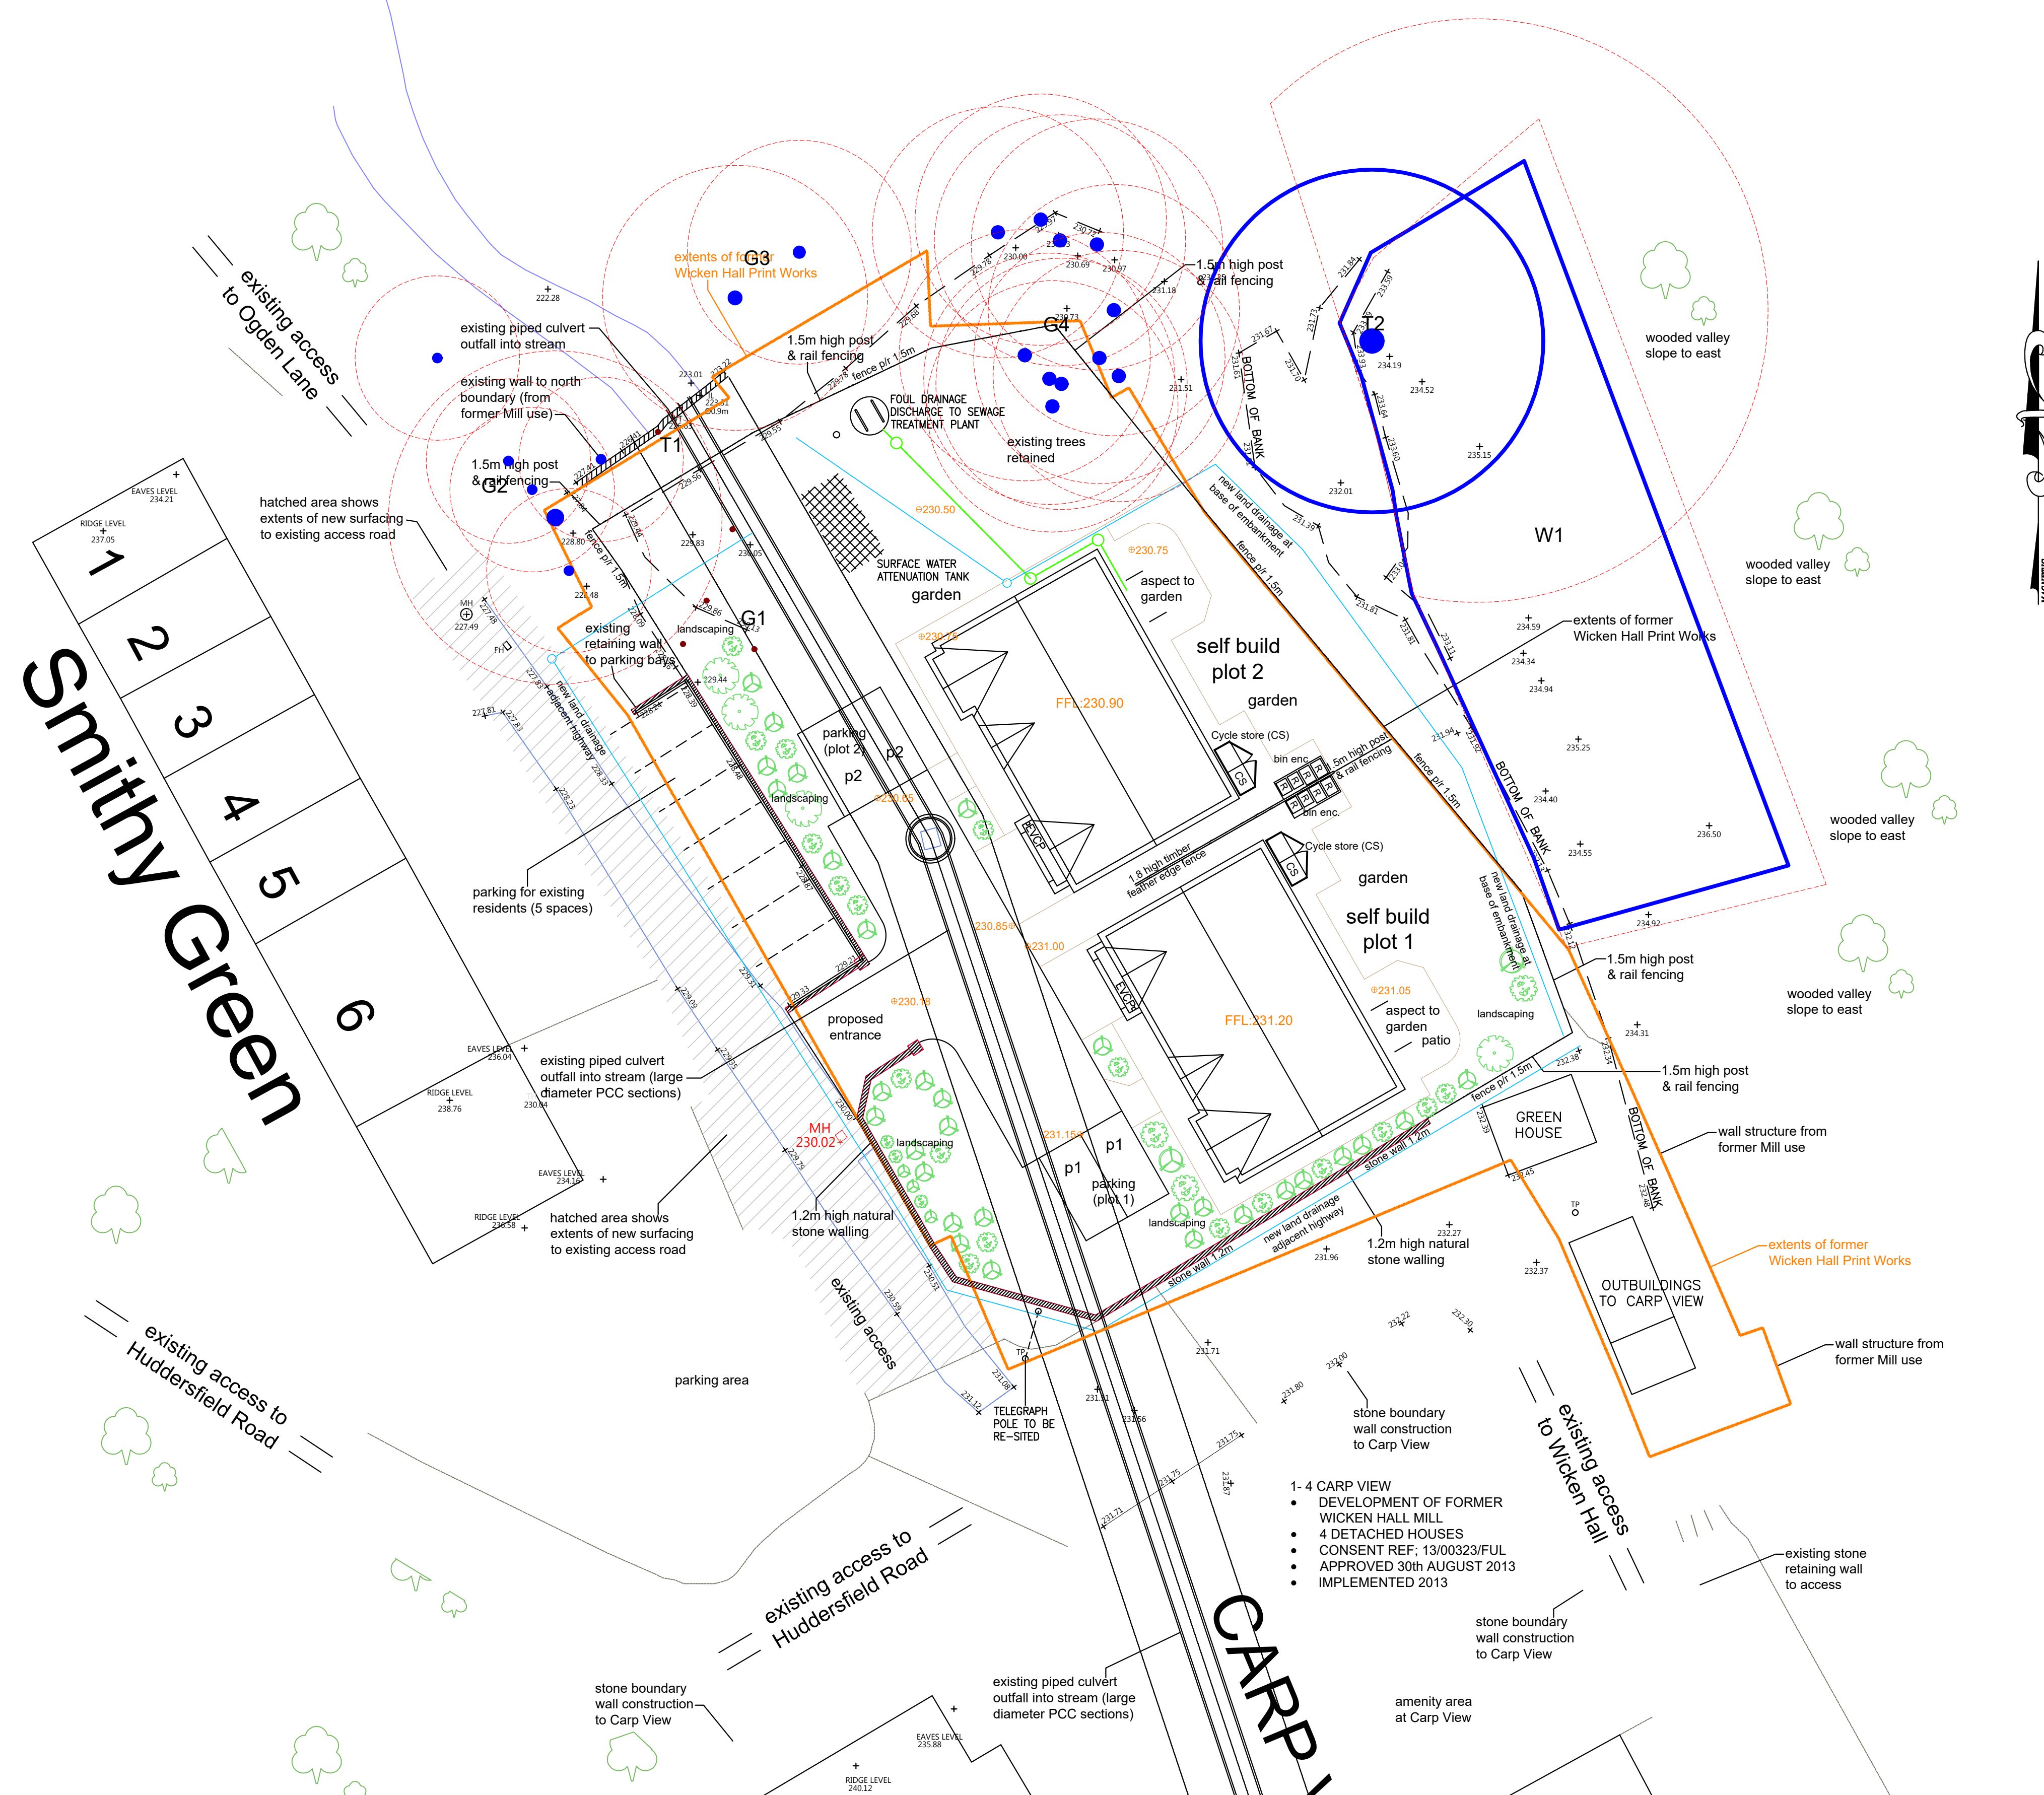
| Drawing No:<br>FWHM/AIS/01 Rev A | | |

- 3.1 Due to the proposed development and its associated infrastructure there are a number of locations where the proposals are in close proximity to the trees surveyed. The Site Layout Plan within appendix three identifies the trees in relation to the proposed development.
- 3.2 In order to fully assess the impact of the proposals an Impact Table has been created detailing each tree, which shows the proximity of the associated works to the tree.
- 3.3 This can then be assessed in accordance with BS 5837:2012 to determine whether the development will have a detrimental impact on the health of each tree. Once this has been determined remedial measures can be detailed to reduce the impact the proposals will have on the treescape.

| Drawing Title:<br>AIS Plan | | |

5.1.1 The proposed drainage has been located to sit outside the RPA of those trees shown for retention with the exception of a small encroachment into G4.

5.1.2 Due to the current ground conditions and the limited extent of encroachment it is felt that the proposed works will not have a detrimental impact upon the trees.
