# THE ARLEY CONSULTING COMPANY LIMITED

**Report No 22005/1**

**CONTAMINATION ASSESSMENT  
for land at  
38-44 TOWNLEY STREET  
MIDDLETON  
ROCHDALE**

**UNIVERSAL BARGAINS LIMITED  
35 Overbridge Road  
Salford  
M7 1SL**

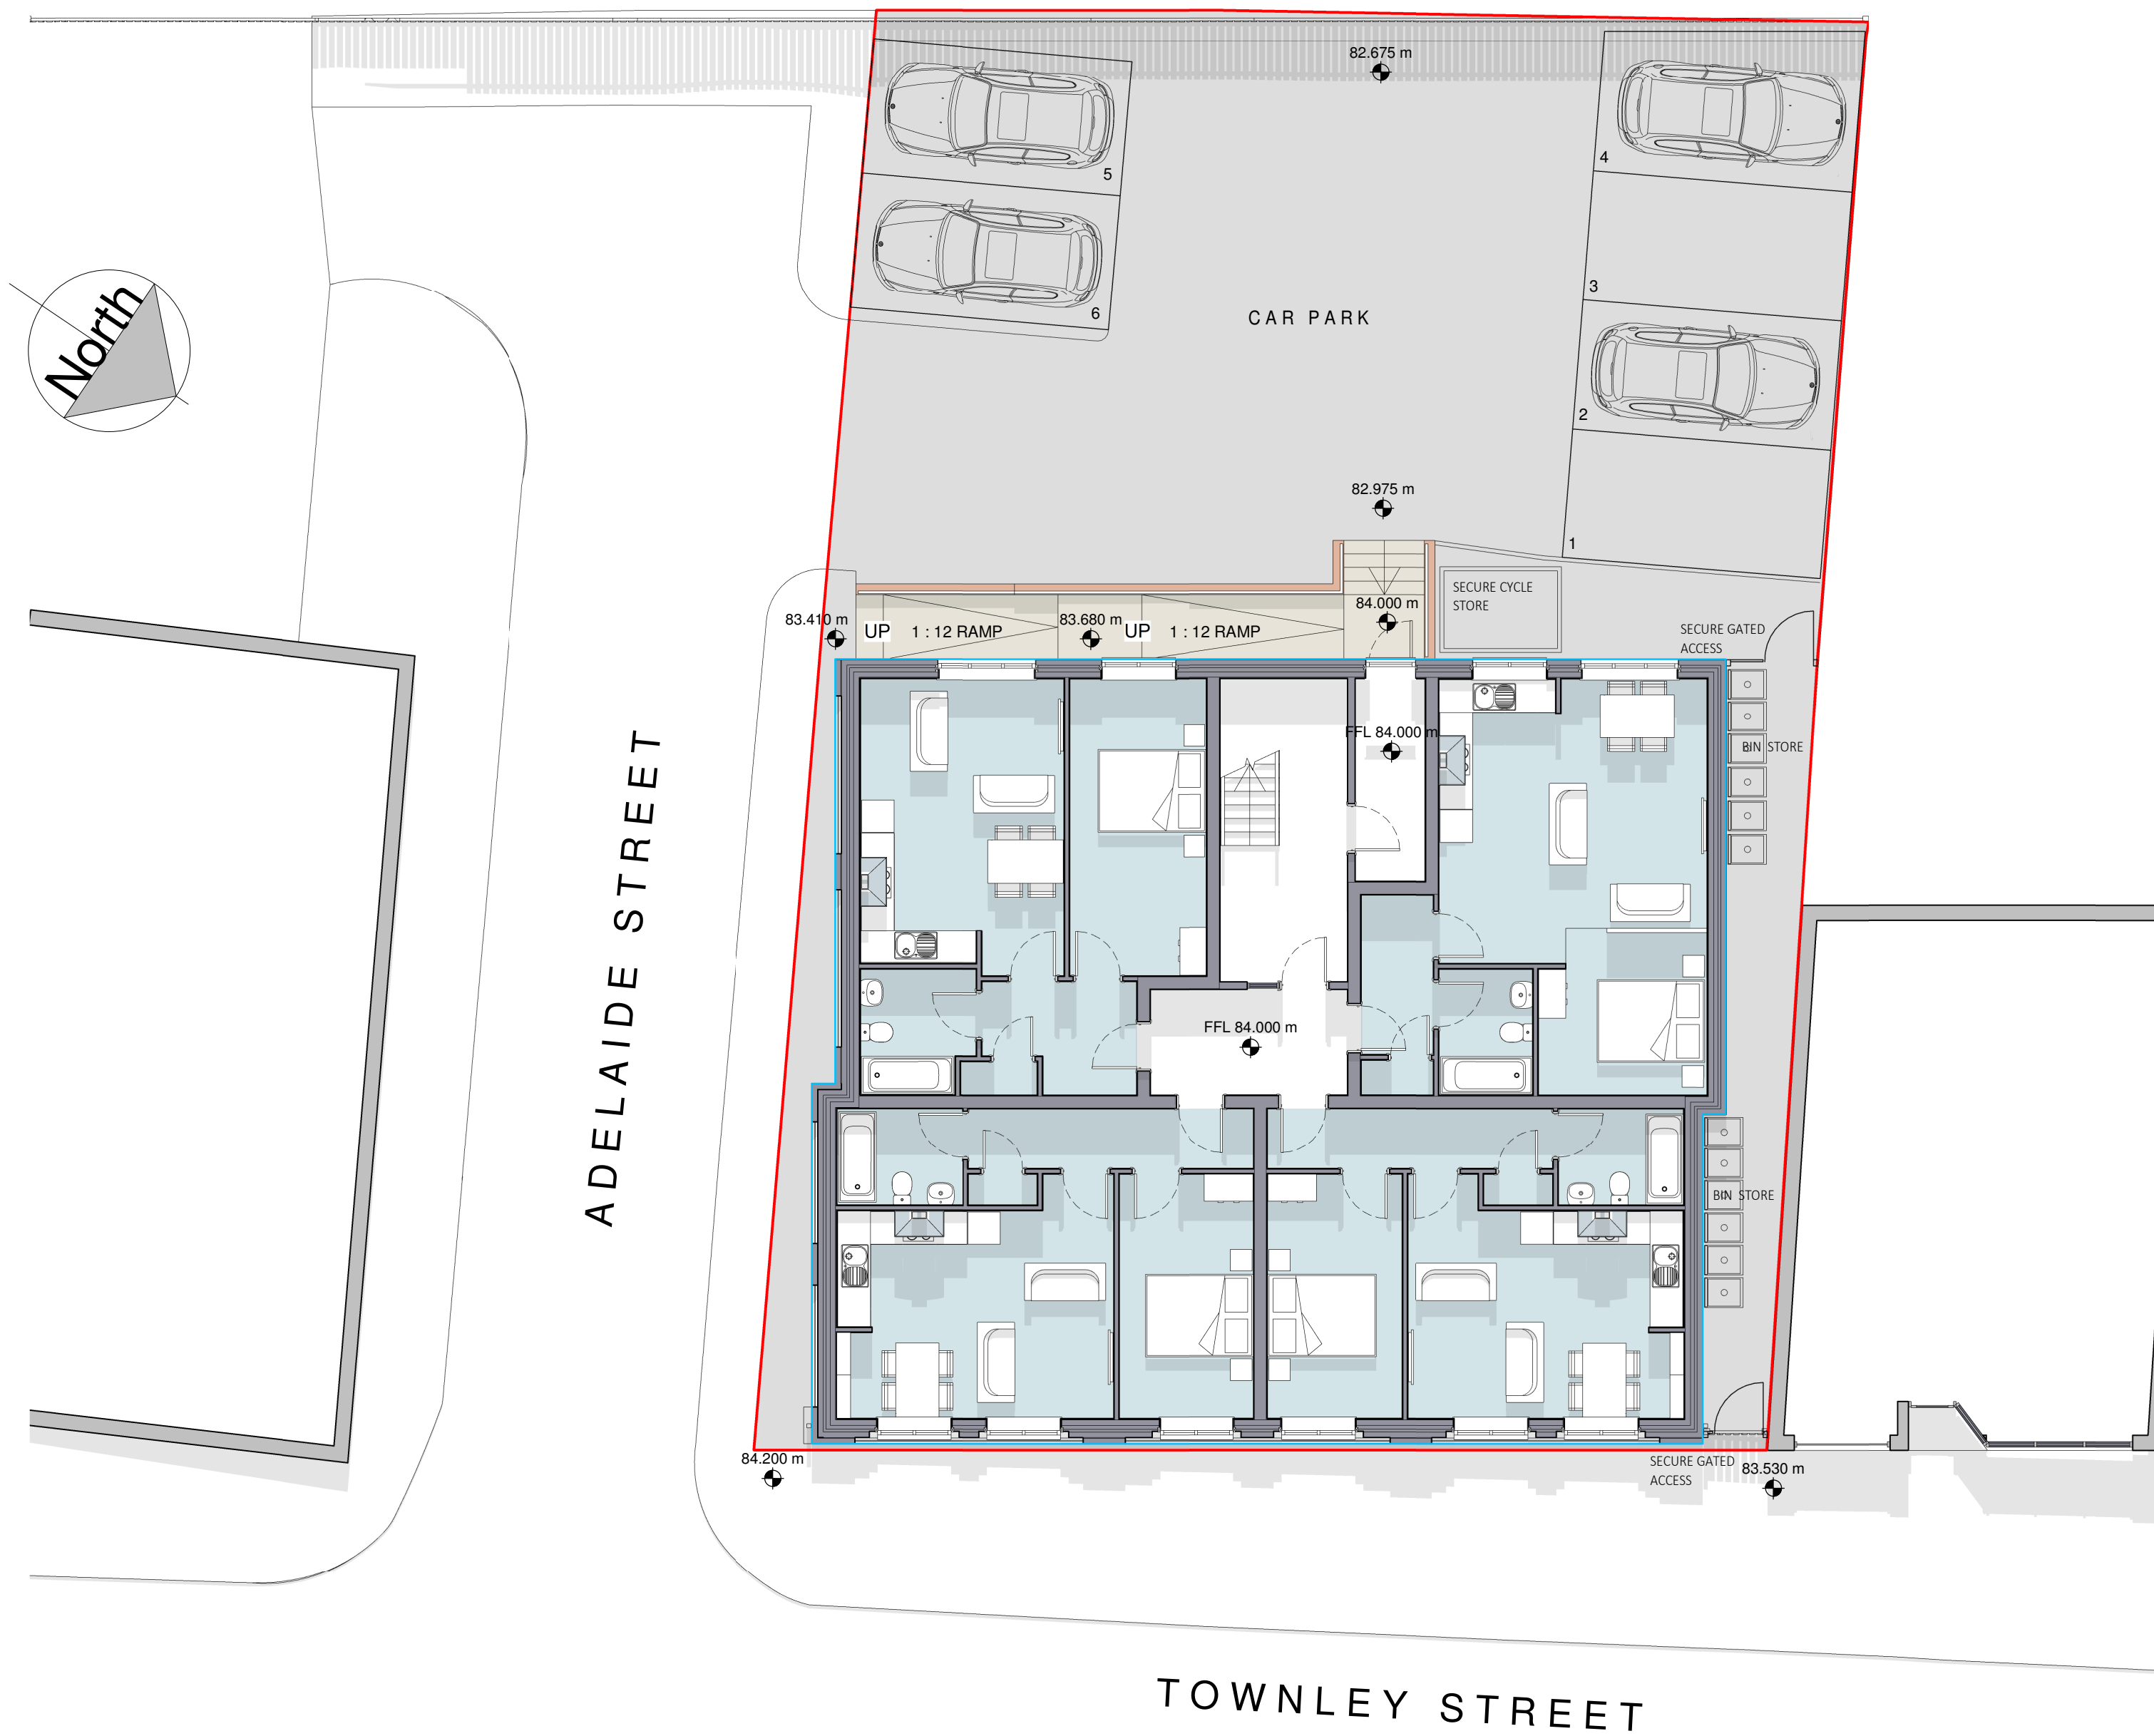
PROPOSED SITE PLAN  
1 : 100

DENOTES: SITE BOUNDARY  
SITE AREA = 495M<sup>2</sup>

DENOTES: BUILDING AREA  
BUILDING AREA = 240M<sup>2</sup>

- 6.5.1 It is proposed to redevelop the site by constructing an apartment block. The approved development layout is illustrated on Greenfield Design Services Drawing No 759-19-06 Rev A – Proposed Site Layout at Appendix H.
- 6.5.2 Potential receptors that may be exposed to contamination at the site are listed below. This list includes potential receptors listed in the planning condition (see Paragraph 6.0.1):
