## GARDEN VALIDATION – ROYLE ROAD

| <b>Project Name:</b> | Royle Road |
| <b>Project Number:</b> | 11-778 |
| <b>Plots:</b> | 19 and 91 |

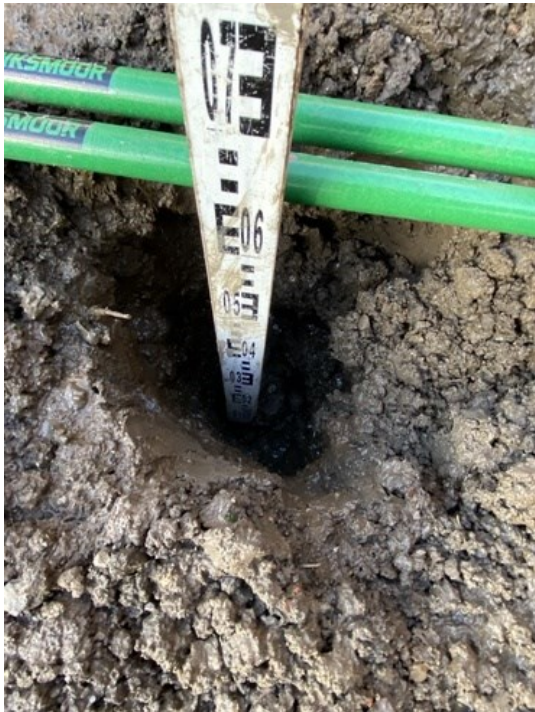
Photo 1

| <b>Plot Number</b> | 19 |
| <b>Depth of Cover System Materials (record the depth and support with Photo down the hole)</b> | 600 |
| <b>Depth of Topsoil (mm)</b> | 150 |
| <b>Depth of Subsoil (mm)</b> | 450 |

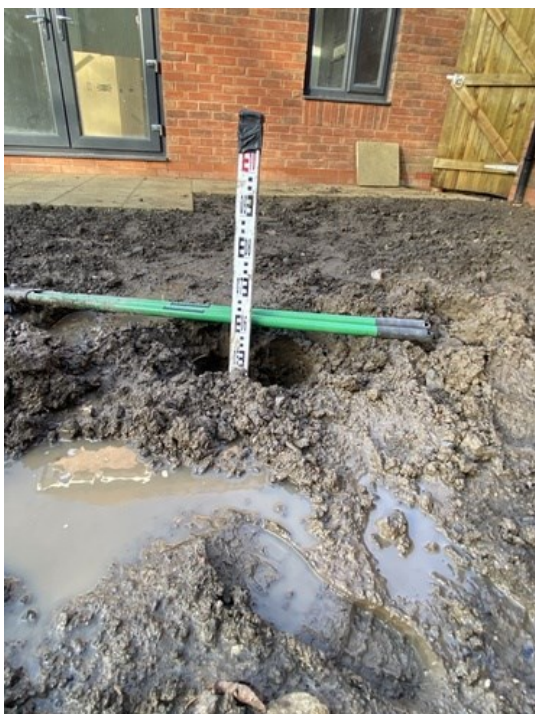
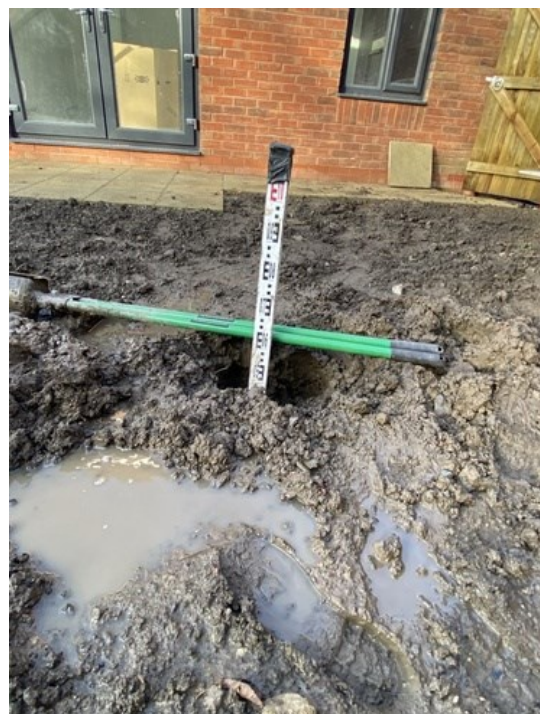
Photo 3

| <b>Depth of Cover System at Ground Level (Photo)</b> | <input type="checkbox"/> |

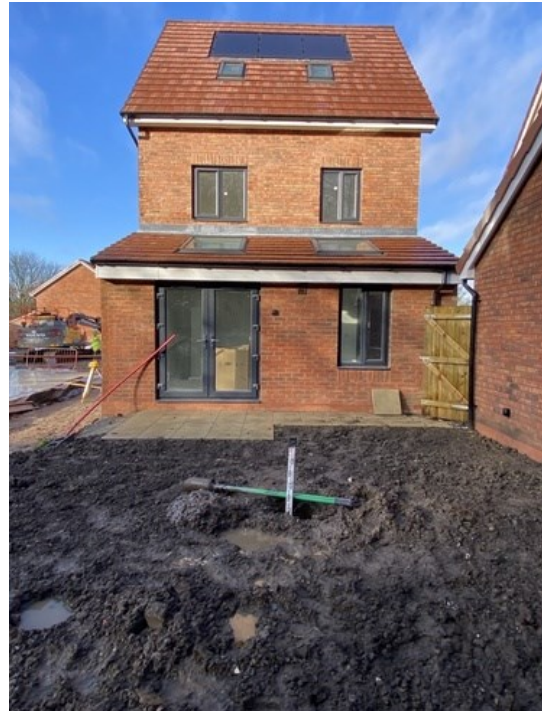
Photo 5

| <b>Depth of Cover System in Relation to Plot (Ensure the whole plot can be seen in the photo)</b> | <input type="checkbox"/> |

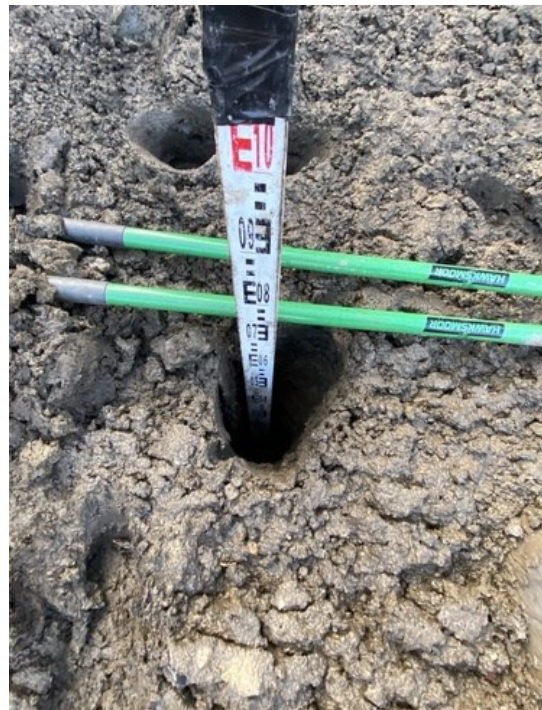
Photo 7

| Plot Number | 91 | |
| Depth of Cover System Materials (record the depth and support with Photo down the hole) | 600 | |
| Depth of Topsoil (mm) | 150 | |
| Depth of Subsoil (mm) | 450 | |

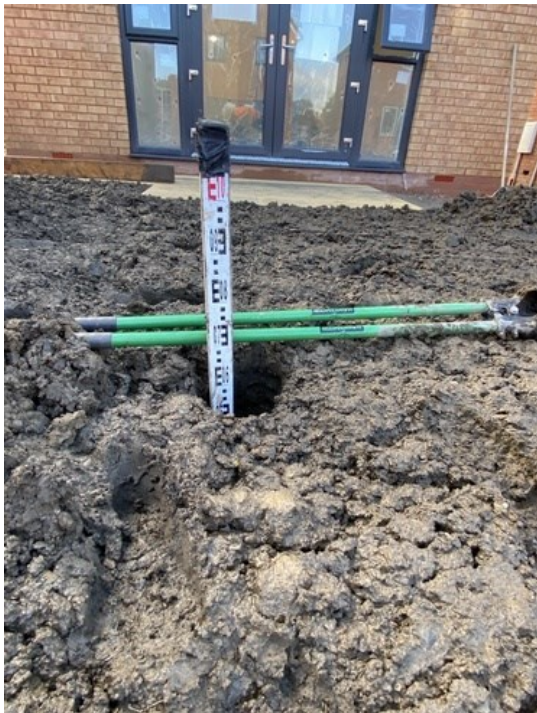
Photo 9

| Depth of Cover System at Ground Level (Photo) | ☒ | |

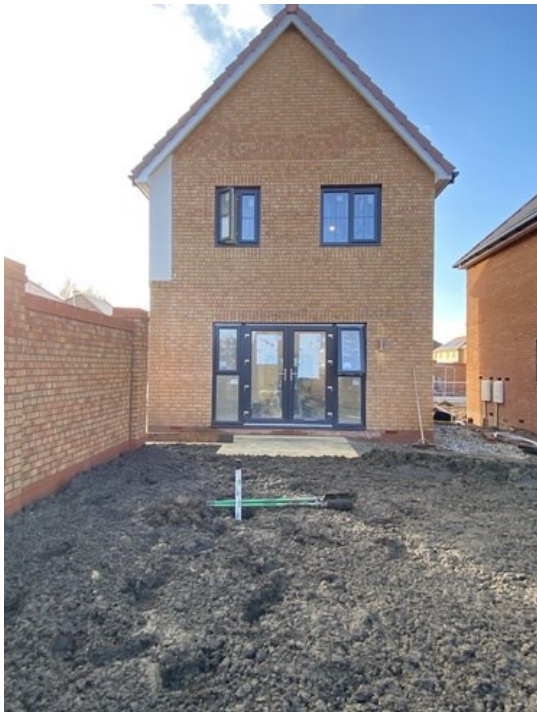
Photo 11

| Depth of Cover System in Relation to Plot (Ensure the whole plot can be seen in the photo) | ☒ | |
