## **Appendix 11.6 Otter Survey Results**

This report has been prepared by Tyler Grange Group Ltd on behalf of Northern Gateway Development Vehicle LLP (NGDV). It sets out the findings of otter *Lutra lutra* surveys undertaken at 'Northern Gateway'.

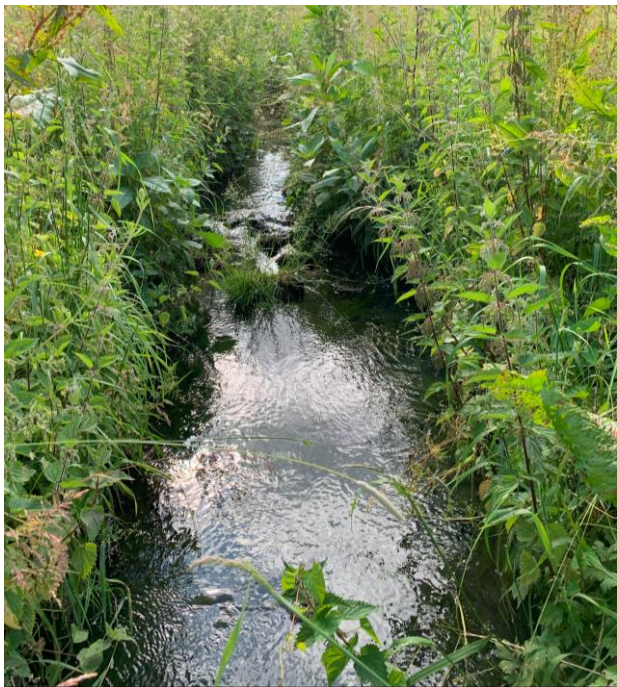
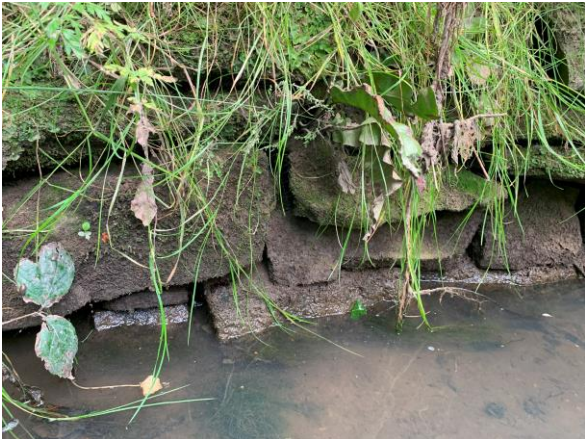
| Waterbody Reference/ Name | Watercourse Characteristics | Photo | Habitat suitability | Field Sign |
|---|---|---|---|---|
| Brightley Brook | <p>A manmade channel, flowing from Pilsworth Lake/ Fisheries. Large sections of this watercourse were stone-lined, with no natural embankment, with vegetation only present on the bank-top.</p> <p>The southern end is culverted, while there is a large man-made waterfall at the northern extent.</p> <p>The watercourse was approximately 80cm wide and 25-30 cm deep, with a fast and fluctuating flow.</p> | | Low Value | None |

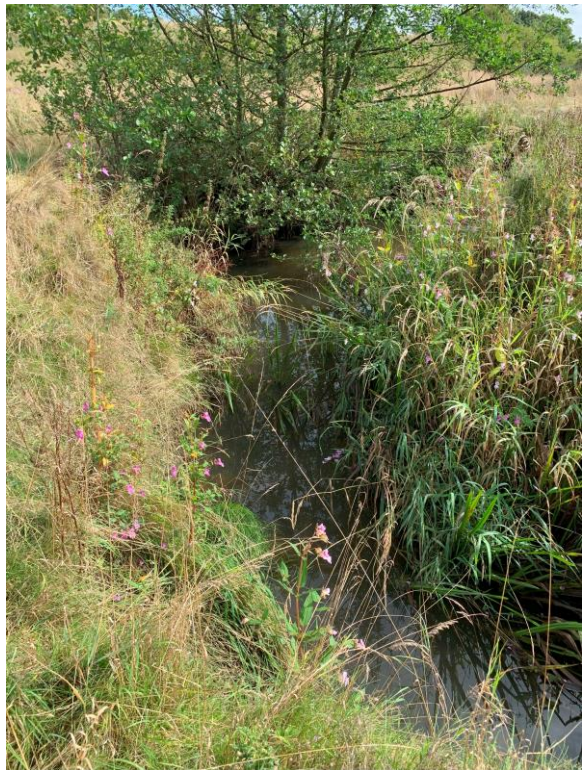
| Castle Brook | <p>A small meandering natural watercourse which forms a tributary of the larger Whittle Brook. Embankments were predominantly grass-lined with the occasional scattered tree. There was little emergent vegetation.</p> <p>In some locations the watercourse was extremely narrow, at approximately 40cm; with an average depth of 40cm, with a fast and fluctuating flow.</p> | | Low Value | None |

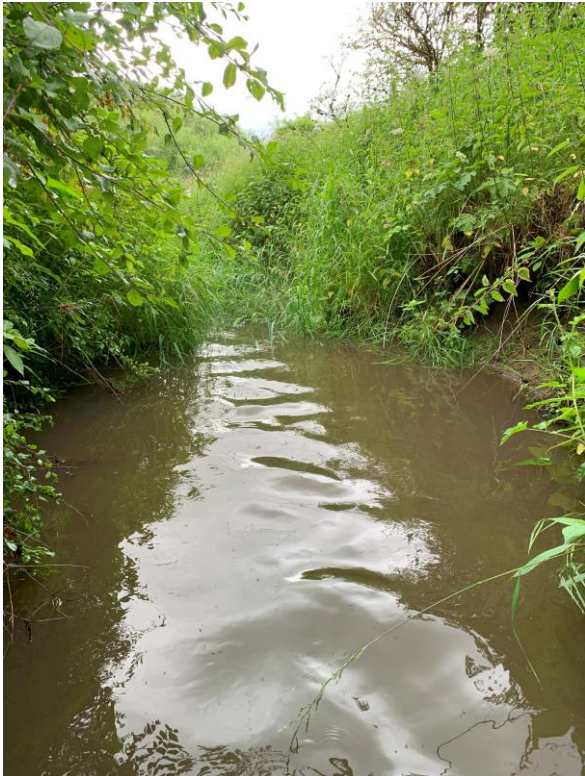
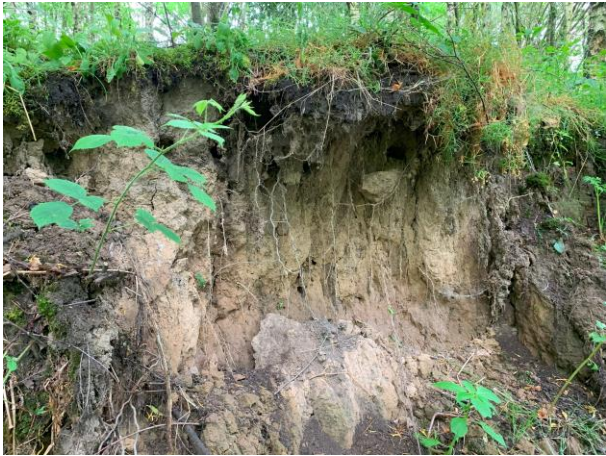
| <p>Whittle Brook</p> | <p>A large, meandering watercourse. There were areas of vegetated embankments, which were predominantly grasses, with areas of bare-earth embankment. Emergent vegetation was limited to small isolated areas.</p> <p>There were variations in hydrology, from slow flowing optimal conditions to suboptimal conditions such as fast flowing and very shallow sections.</p> <p>On average the width was 2m, although much narrower in some locations; with an average depth of 65-80cm.</p> <p>The eastern end was culverted underneath the M62.</p> | | <p>Medium Value</p> | <p>None</p> |
