**MILNROW LIBRARY,  
MILNROW, ROCHDALE**

**PRELIMINARY ROOST ASSESSMENT**

**Prepared for  
Rochdale Borough Council**

**March 2024**

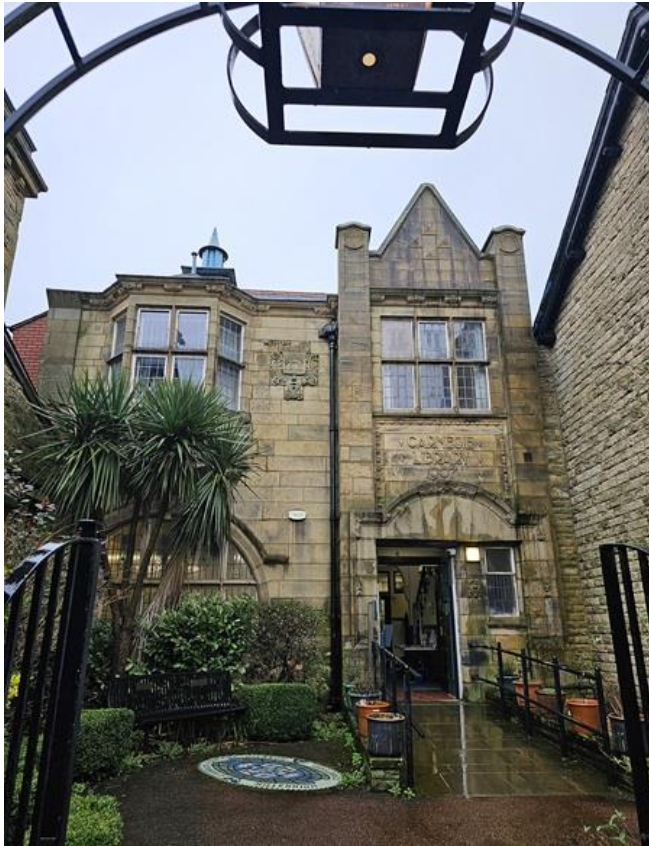
- 3.7 Section 1 is two-storey and fronts Newhey Road. The slate roof is pitched and hipped and supports a ventilation turret. The front and rear gable ends have a parapet wall with stone copings. A sloping skylight roof is present on the southeastern side, which protects an original stained-glass skylight ceiling below. Gaps are present below ridge tiles and some of the slates, as well as below lead flashing at the base of the turret where it joins the roof. Gaps are also present behind the fascia board on the southeastern wall (above the skylight roof) and potentially the northwestern wall. Gaps are also present behind roofing felt where the skylight roof adjoins the wall. The windows are stone mullion, and the lintels

**1. Milnrow Library – front elevation (Section 1)**

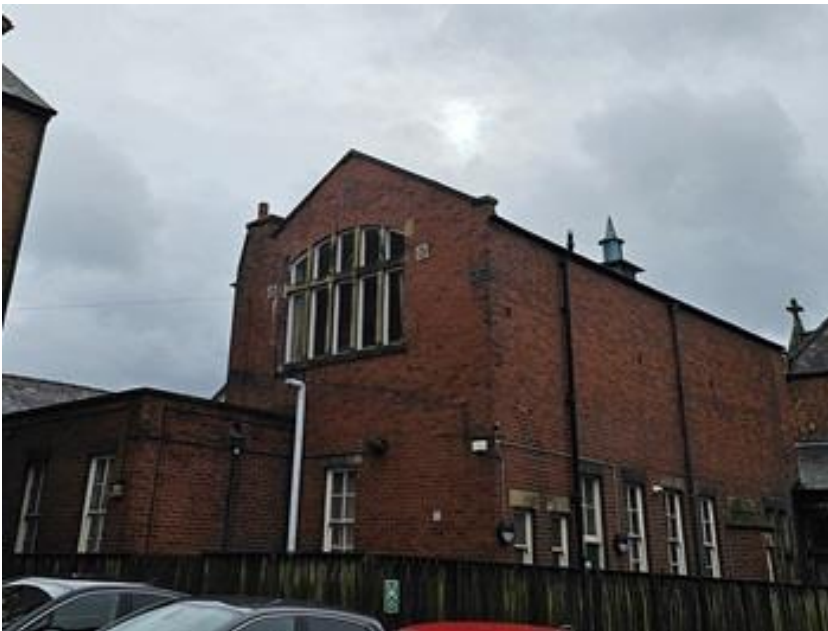
- 3.11 Section 2 is single storey. It contains a single room with a barrel-vaulted, plastered ceiling; no roof void is present. It is built from brick and has a pitched and slated roof, with a hip at the southwestern end. Several gaps are present below the ridge tiles where mortar is missing, with gaps also likely at the hips. Occasional gaps are present below the slates or where a slate has slipped or is missing. The gable ends have parapet walls with stone copings. Lead flashing lines the back of the parapet walls and in places this has lifted or buckled, and gaps are present below.

- 3.12 Section 3 connects Sections 1 and 2 and has a flat roof. Again, it is built from brick and supports parapet walls with stone copings. The copings are laid on lead flashing and appear well sealed. The flat roof is lined with lead. The brickwork is well sealed as are the stone casement windows.

**2. Section 2 (to right) with flat-roofed Section 3 (to left) – northwest and northeast elevations**

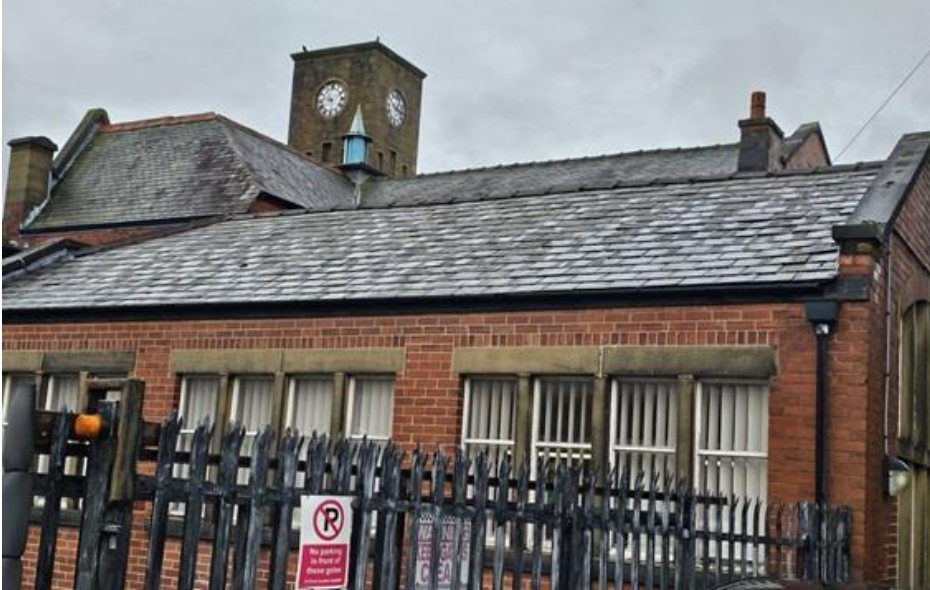
**3. Section 2 (foreground) and Section 1 behind – southeast elevations**
