# **GEO-ENVIRONMENTAL AUDIT**

## **PHASE 1 PRELIMINARY RISK ASSESSMENT**

## **PHASE 2 SITE INVESTIGATIONS**

**PROPOSED RESIDENTIAL DEVELOPMENT**  
**19 BROAD LANE**  
**BURNEDGE**  
**ROCHDALE**  
**OL16 4QQ**

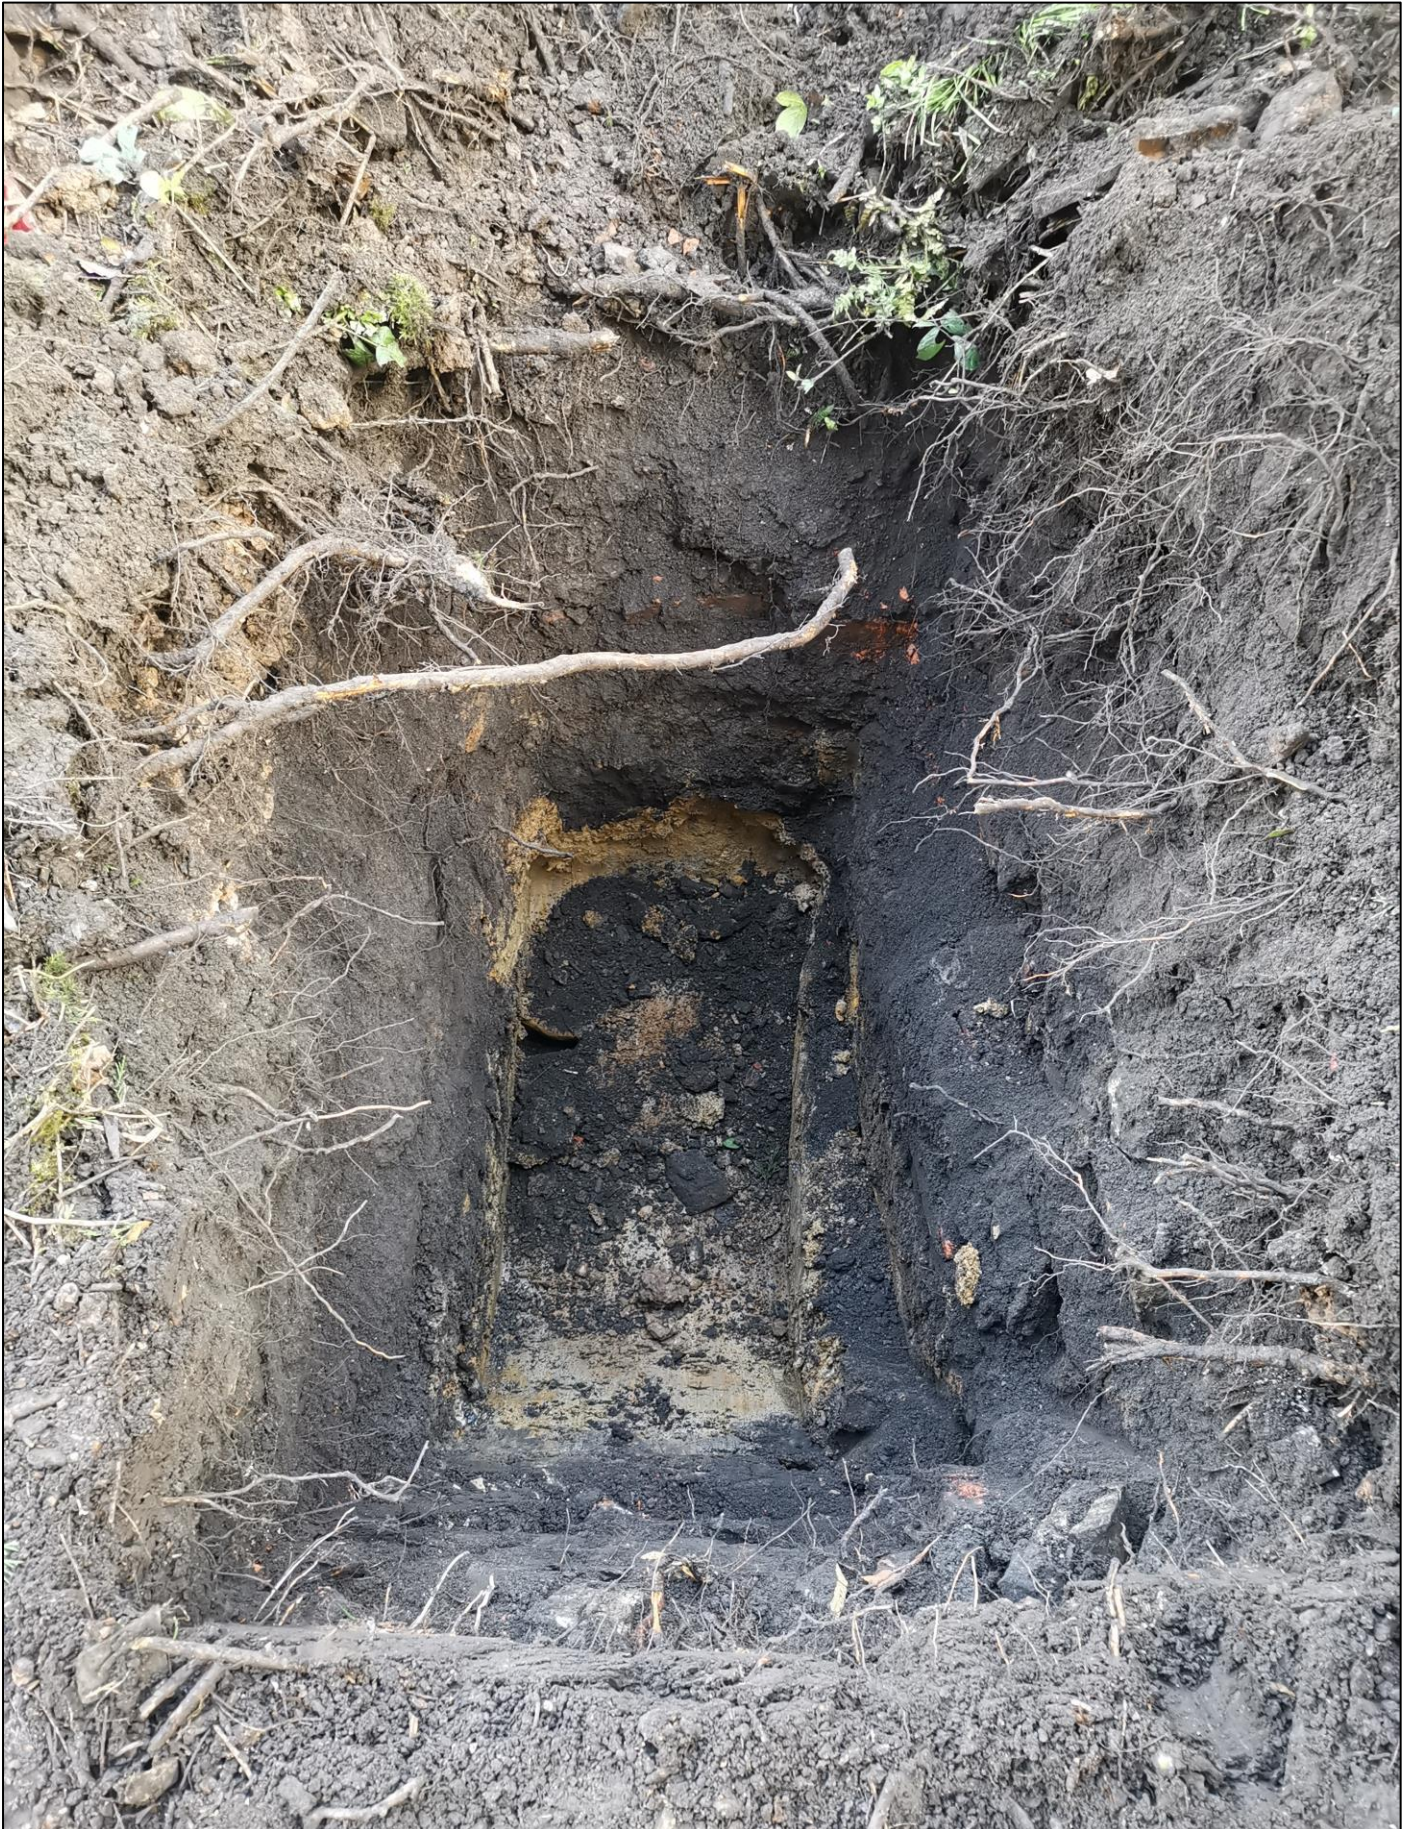
Trial Hole TH1.

### TP1

| 1250-1600 | Soft light brown/grey mottled CLAY. |
| Comments: No groundwater noted. | |

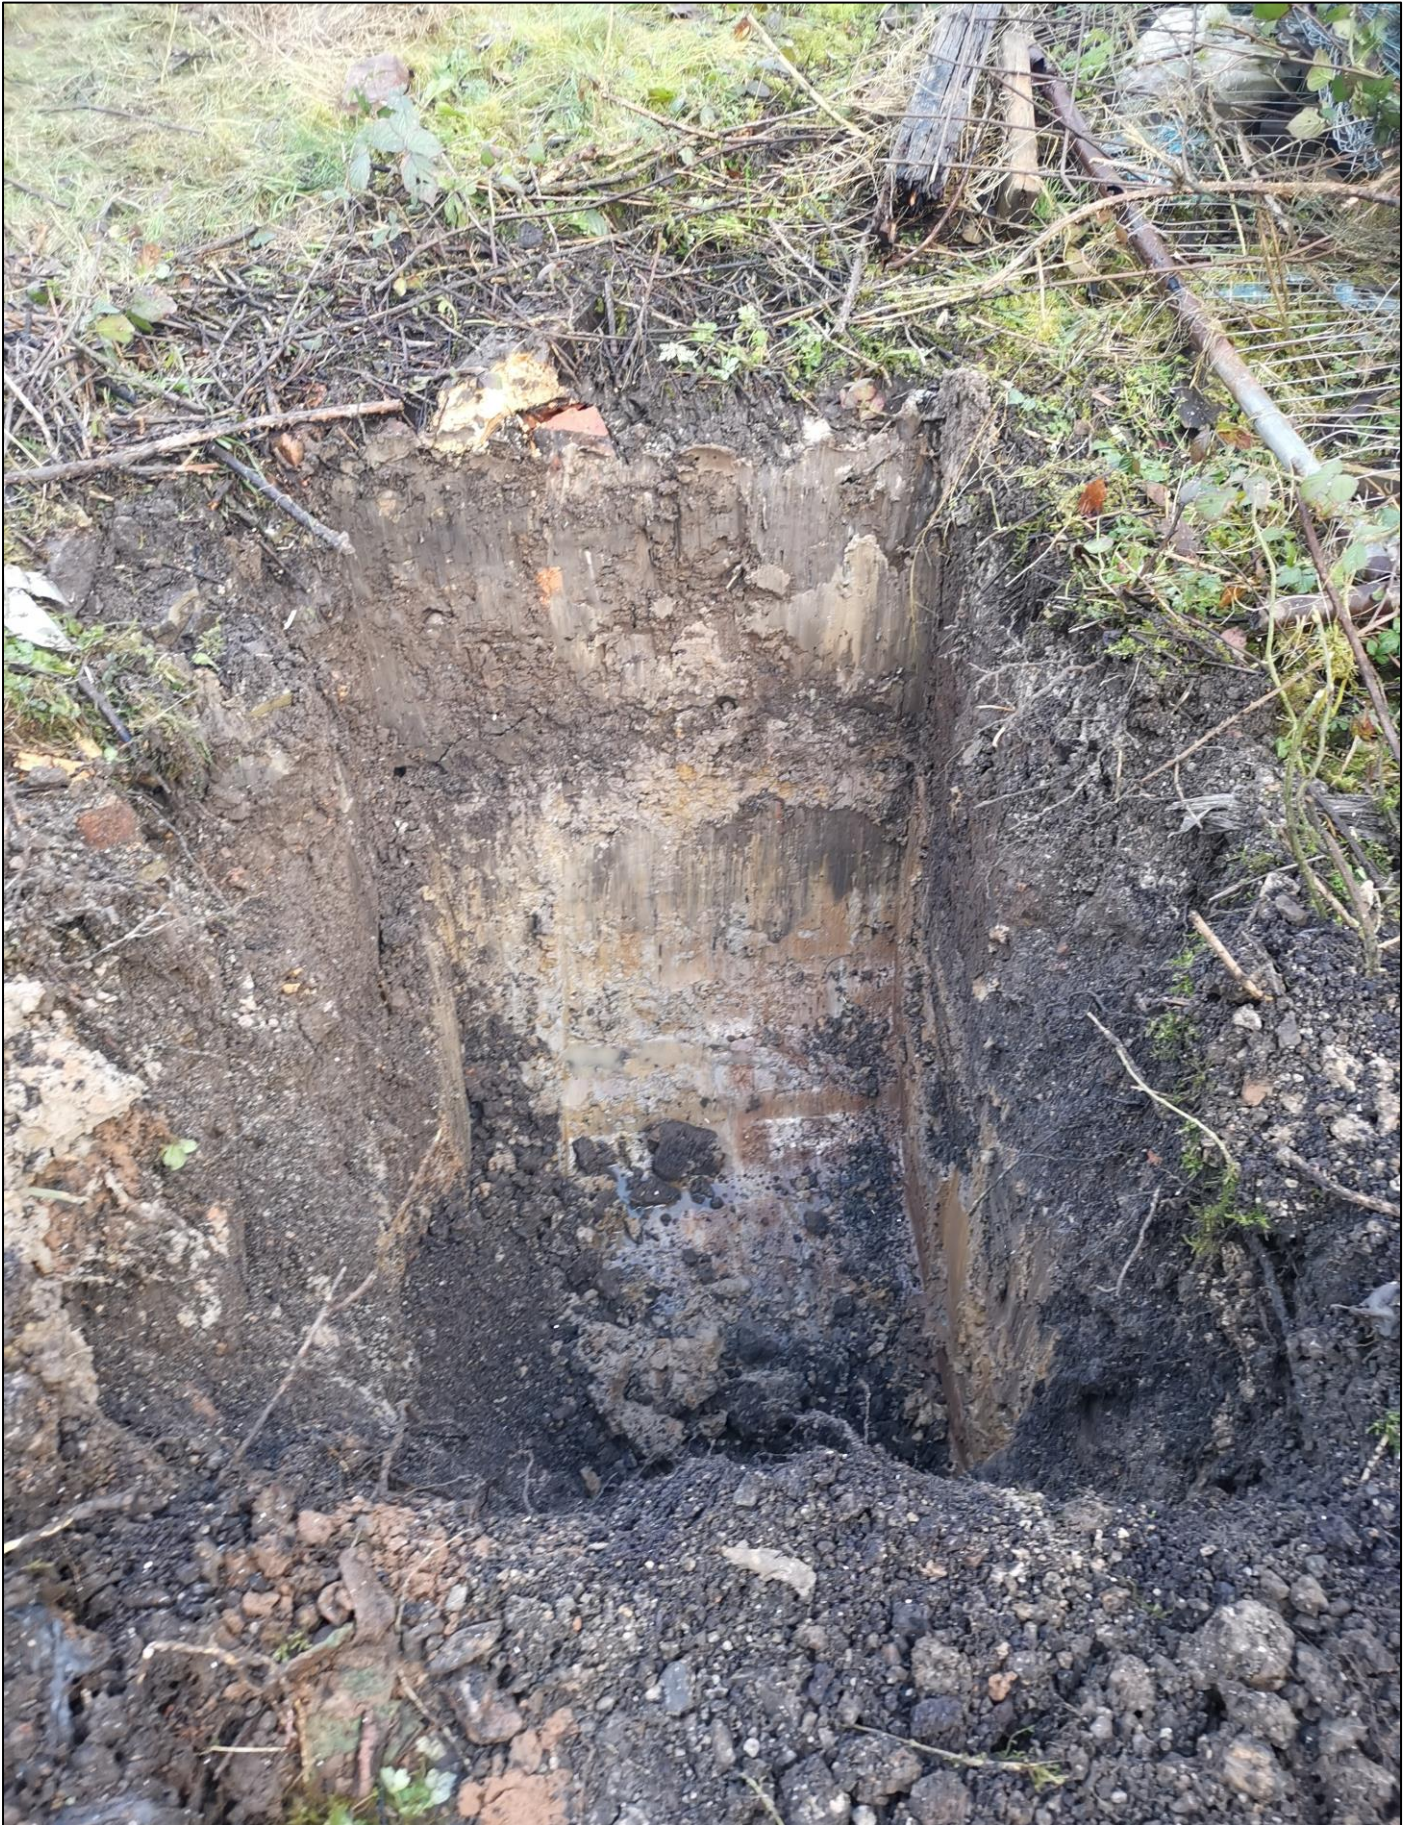
Trial Hole TH2.

### TP2

| 500-1200 | Soft to firm light brown/grey mottled CLAY. |
| Comments: No groundwater noted. | |

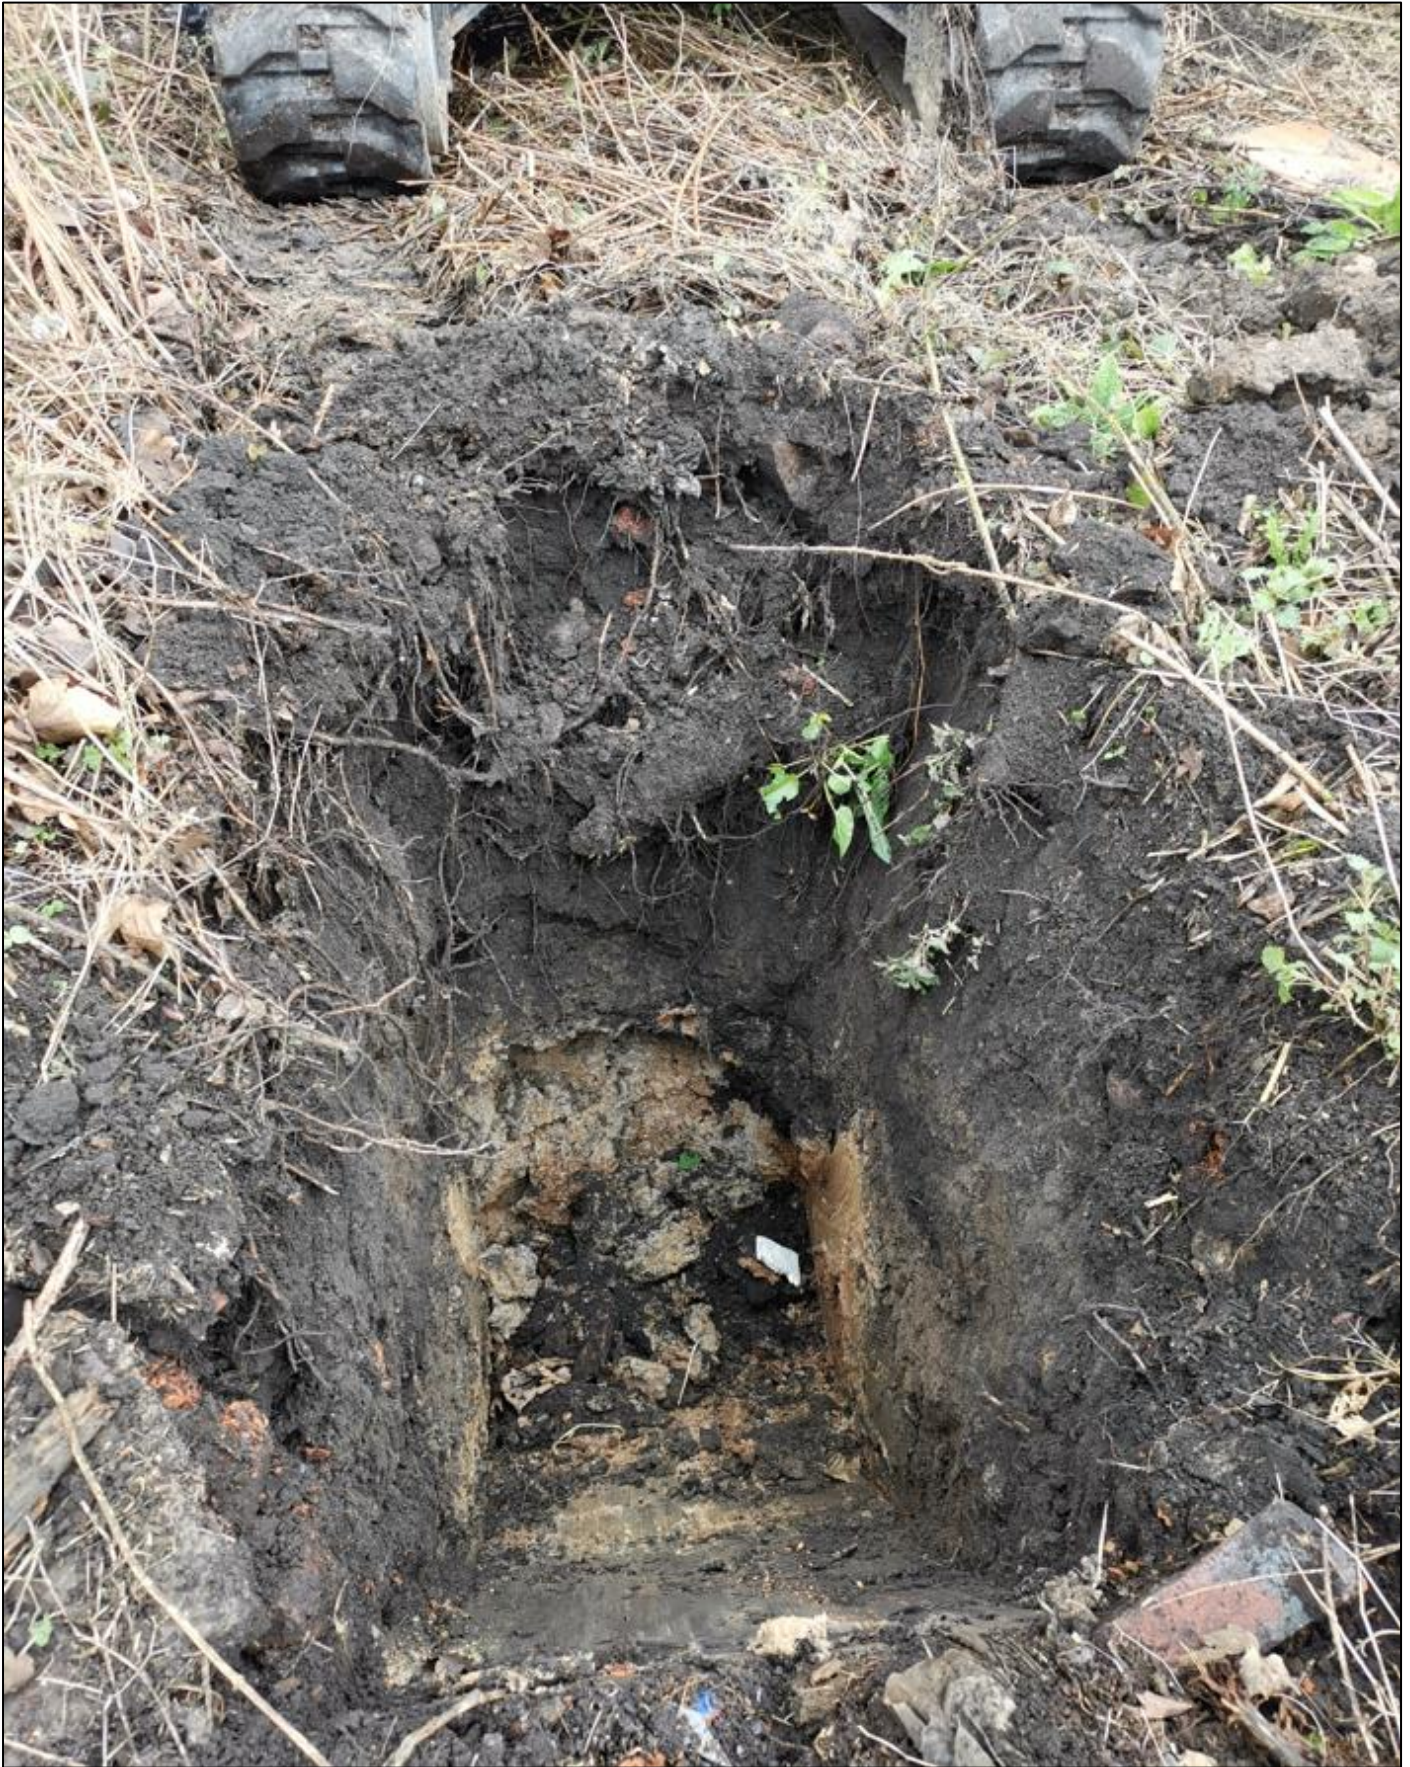
Trial Hole TH3.

### TP3

| Comments: No groundwater noted. | |
