# Living Ecosystems

## **Results of a bat scoping survey carried out at Bowlee Park Driving Range, Heywood Old Road, Middleton M24 4TH, Near Rochdale - May 2024**

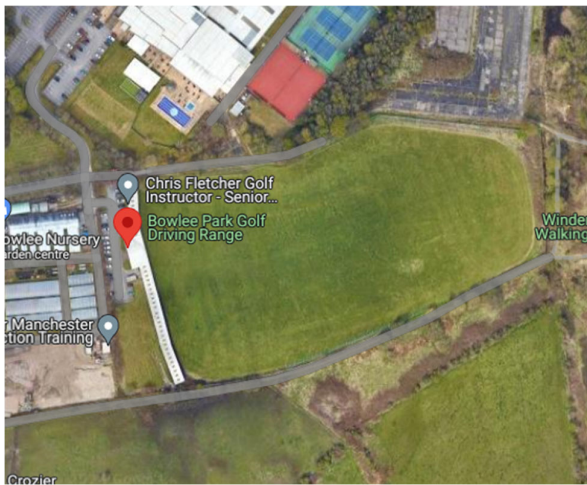
**Figure 1 The site is Bowlee Park Driving Range**

The development site is located at Bowlee Park Driving Range off Heywood old Road, Middleton, and measures 175 metres by 120 metres or approximately 2.10 hectare area of very flat close mown amenity grassland.

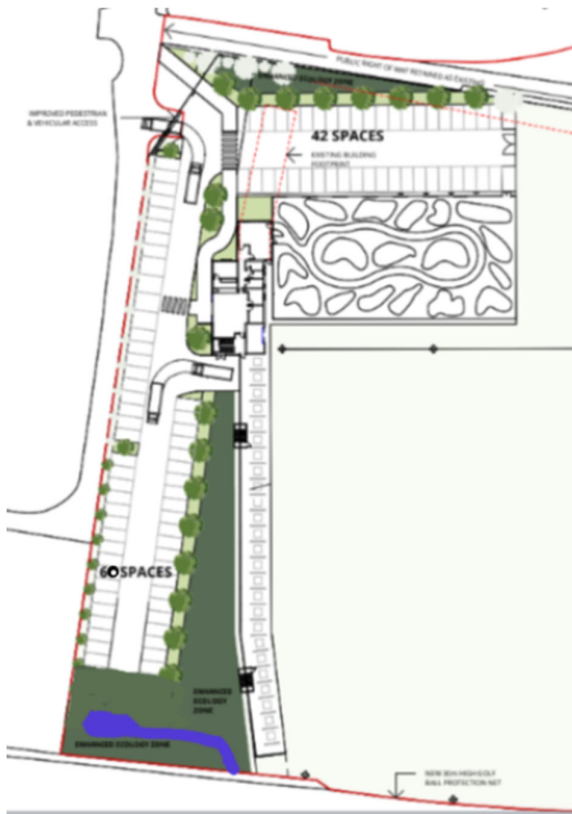
The proposed development comprises the construction of an adventure golf course, an increase in the number of car parking spaces and the addition of another storey on the existing driving range building.

**Figure 3 The current development proposals**

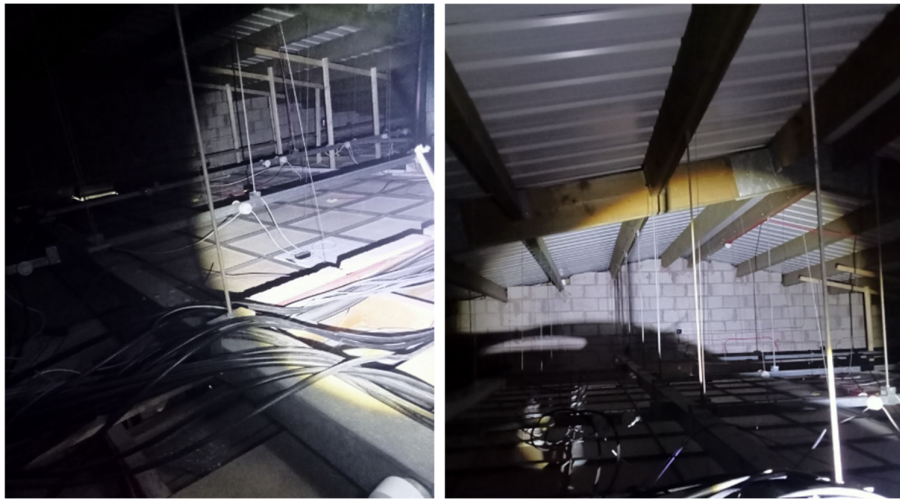
The building is a single storey modern construction, built largely of wood with a small number of brick walls in very good repair with good pointing. The building consists mostly of open fronted linear shelters built mostly of wood with a single skin corrugated roof which is in excellent repair. There is a clubhouse built of wood and brick with a single skin corrugated roof. There are no trees with bat roost potential on the site itself. The loft is in good repair and weather-tight. There was no direct or indirect evidence for bats in the loft or elsewhere inside or outside the structure. No evidence of bat presence or roosts was observed during the inspection, ie droppings, carcasses, urine staining, etc.

**Figure 5 The loft space of the property at Bowlee Park Driving Range, Heywood Old Road, Middleton M24 4TH, Near Rochdale**

**There was no direct or indirect evidence for bats in the loft or elsewhere inside or outside the structure. There was no evidence of bat presence or roosts seen during the inspection, ie droppings, carcasses, insect wings, urine staining, etc. The property is considered to have a very low suitability for bats partly because of its open structure and single skin un-insulated roof; but also because of the continual use, disturbance and strong lighting throughout the structure as a function of it's purpose.**

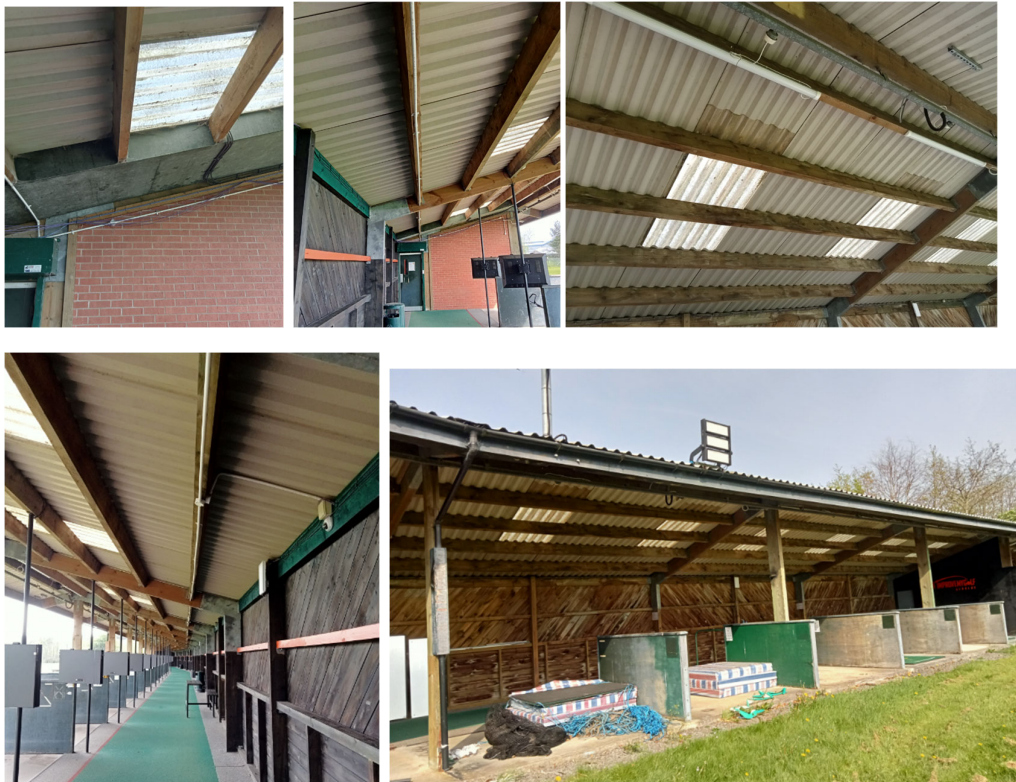
**Figure 6 Internal structure of the driving range structures**

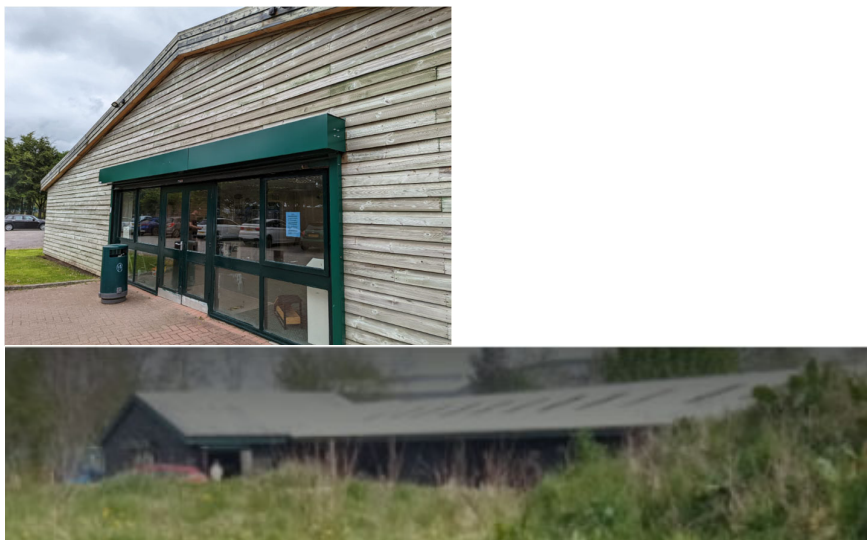
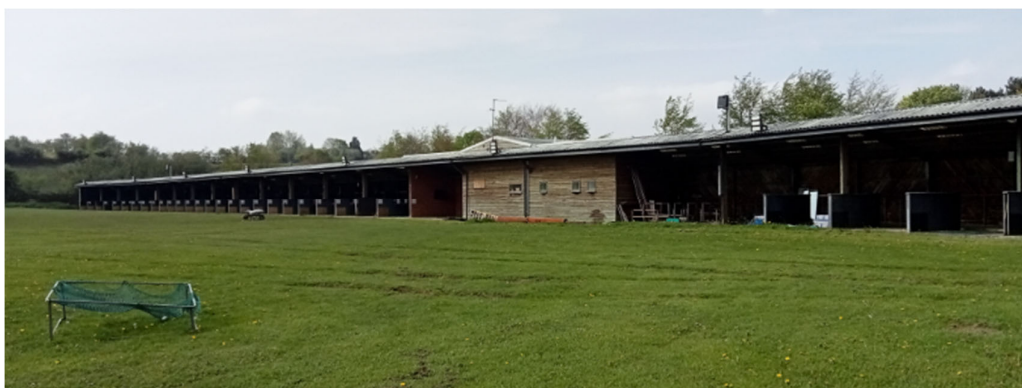
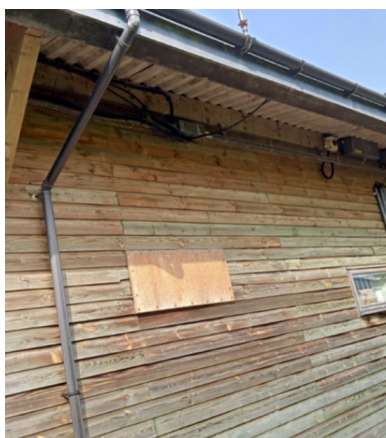
**Figure 7 The elevations of Bowlee Park Driving Range are below**

**West facing**

**East facing**

**South facing**

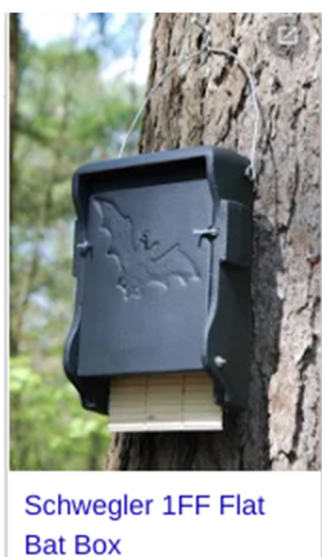
**Figure 8 Suitable bat boxes would include the Schwegler 1FF Flat bat box**

It is further recommended; that new roosting opportunities for bats be provided at the site as part of the proposals. A total of 3 suitable bat roost boxes should be attached onto the building as high up as possible facing east.

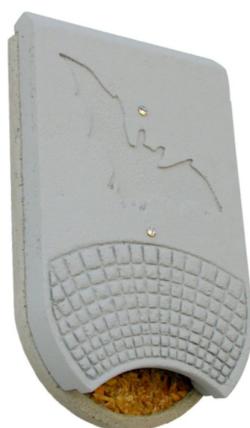
**Figure 9 1FQ Schwegler Bat Roost (For External Walls) is another good example which meets industry standards.**
