**Subject: Land Rudman St, Shawclough, Rochdale, OL12 6LJ.  
Ground Stability Assessment.**

Further to the Local Planning Authority's request for a slope stability assessment to accompany the planning application for the above Site, please find our report to support the application.

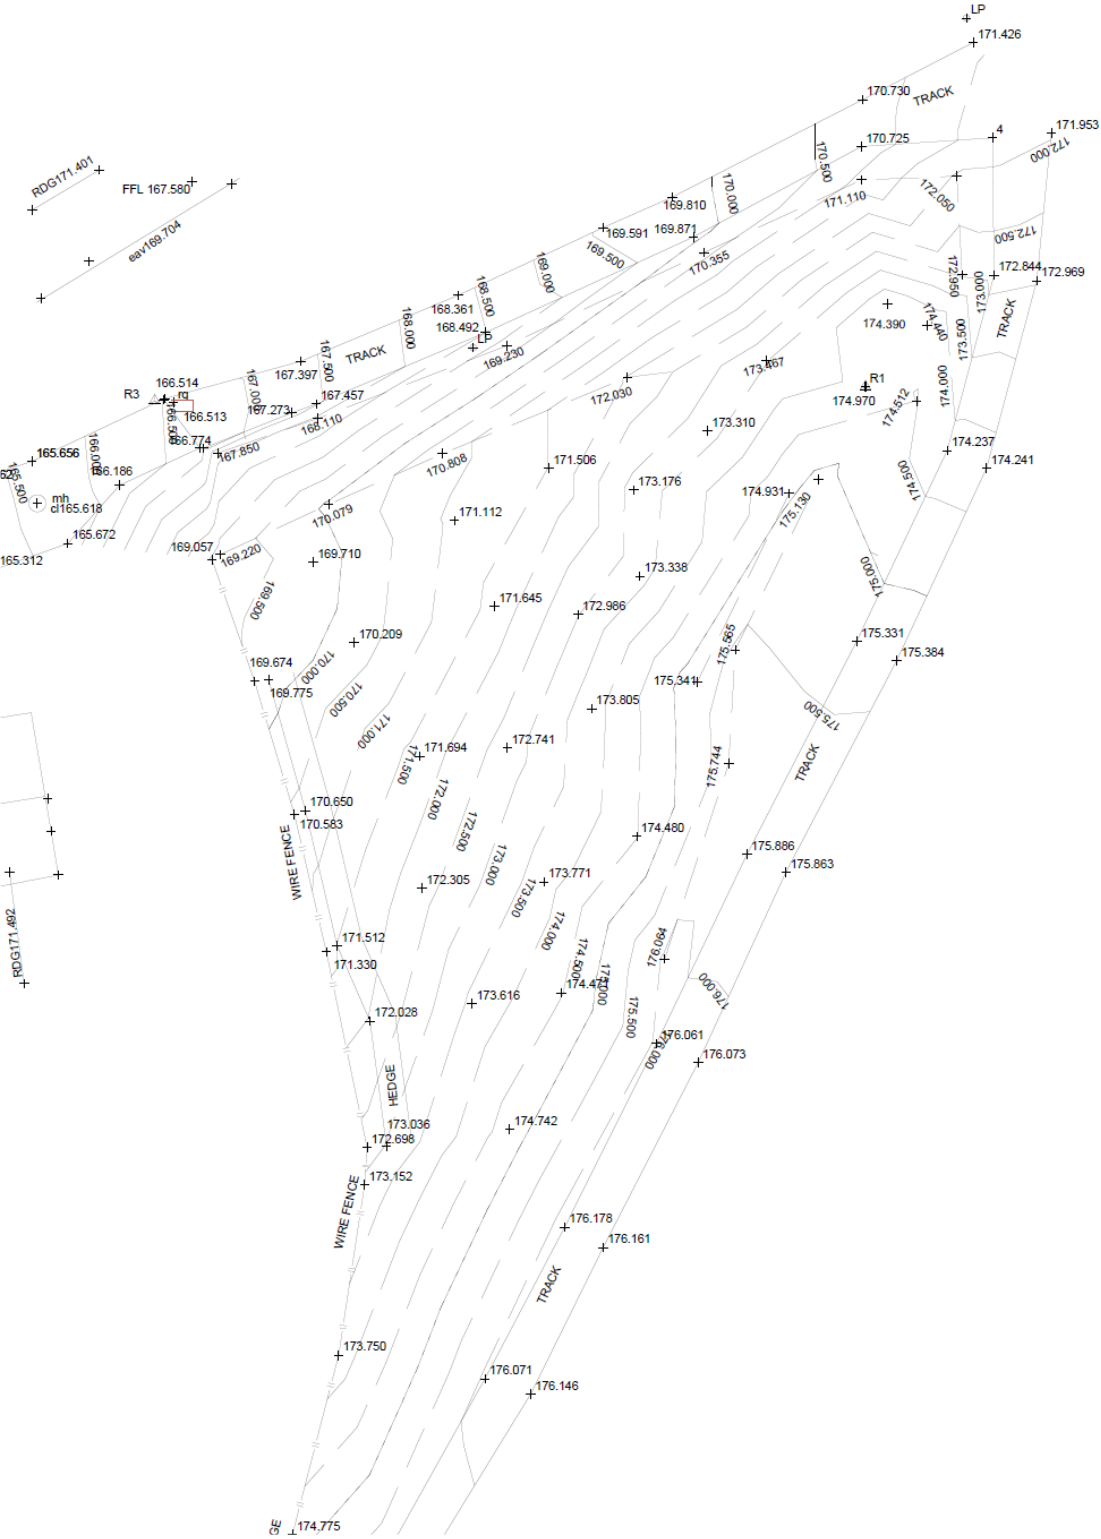
Existing/Topographic Plan.

The Site comprises a vegetated N facing slope set off the S side of Rudman St and varies in elevation nominally 167m aOD from NW corner, and 175m aOD to the SW. The surrounding land uses to the N & W are predominantly residential with public open space to a footpath along the S & E boundaries.

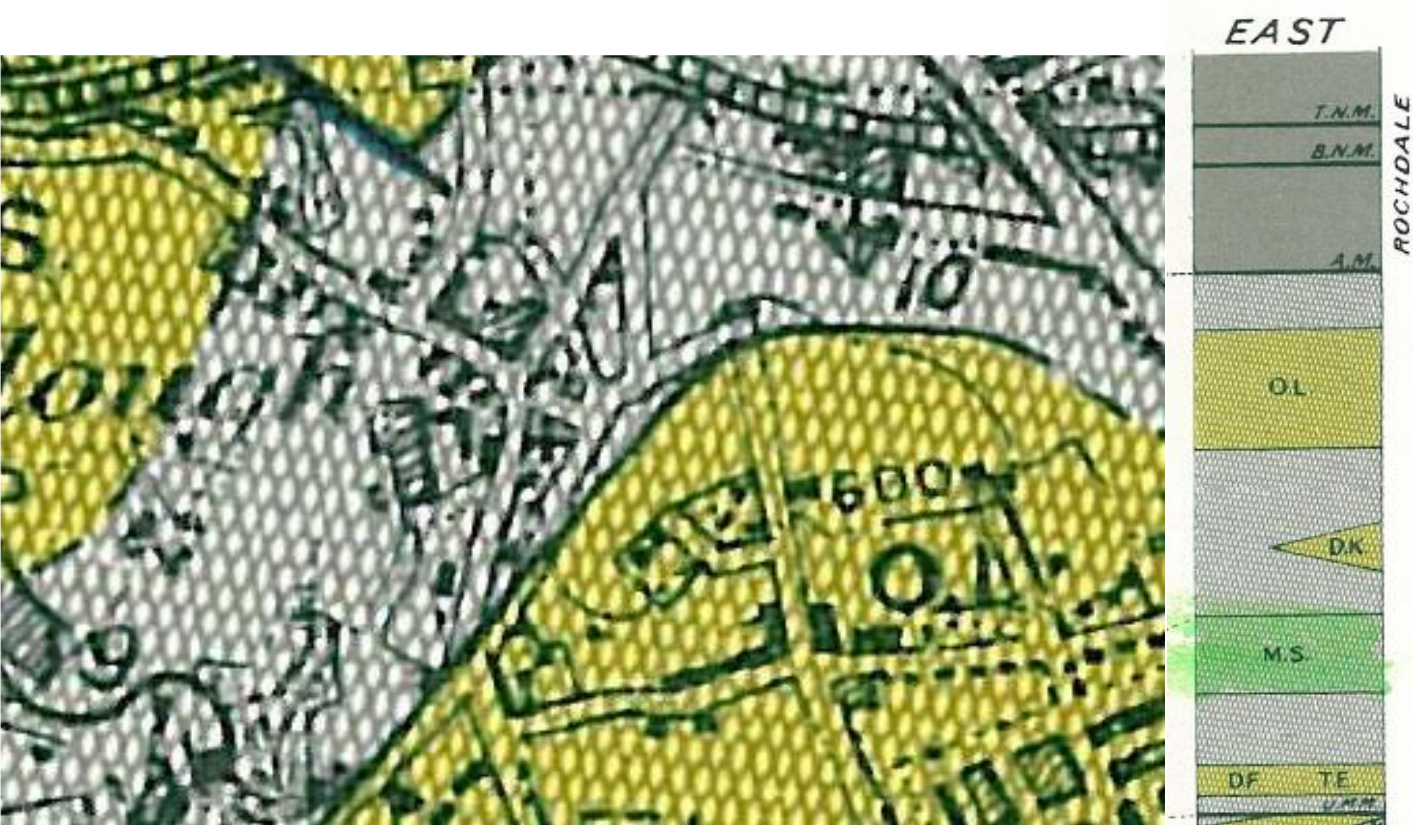
Solid Geology of England Sheet 76.

The superficial geology of the Site comprised exposed Lower Coal Measures with Boulder Clay cover to the N and S. The solid geology was undifferentiated carboniferous MUDSTONES beneath the Site dipping 10 degrees to the S with Old Lawrence Rock SANDSTONE outcropping to the S and Milnrow Sandstone outcropping to the N.

Reference was made to the solid and superficial Geological Maps of England 1:50k sheet 76, refer to the Appendix for excerpts from the area.
