## **Arboricultural Impact Assessment & Method Statement**

### **St Johns CE (Thornham) Primary School**

**THE CRANMER TRUST**

April 2024

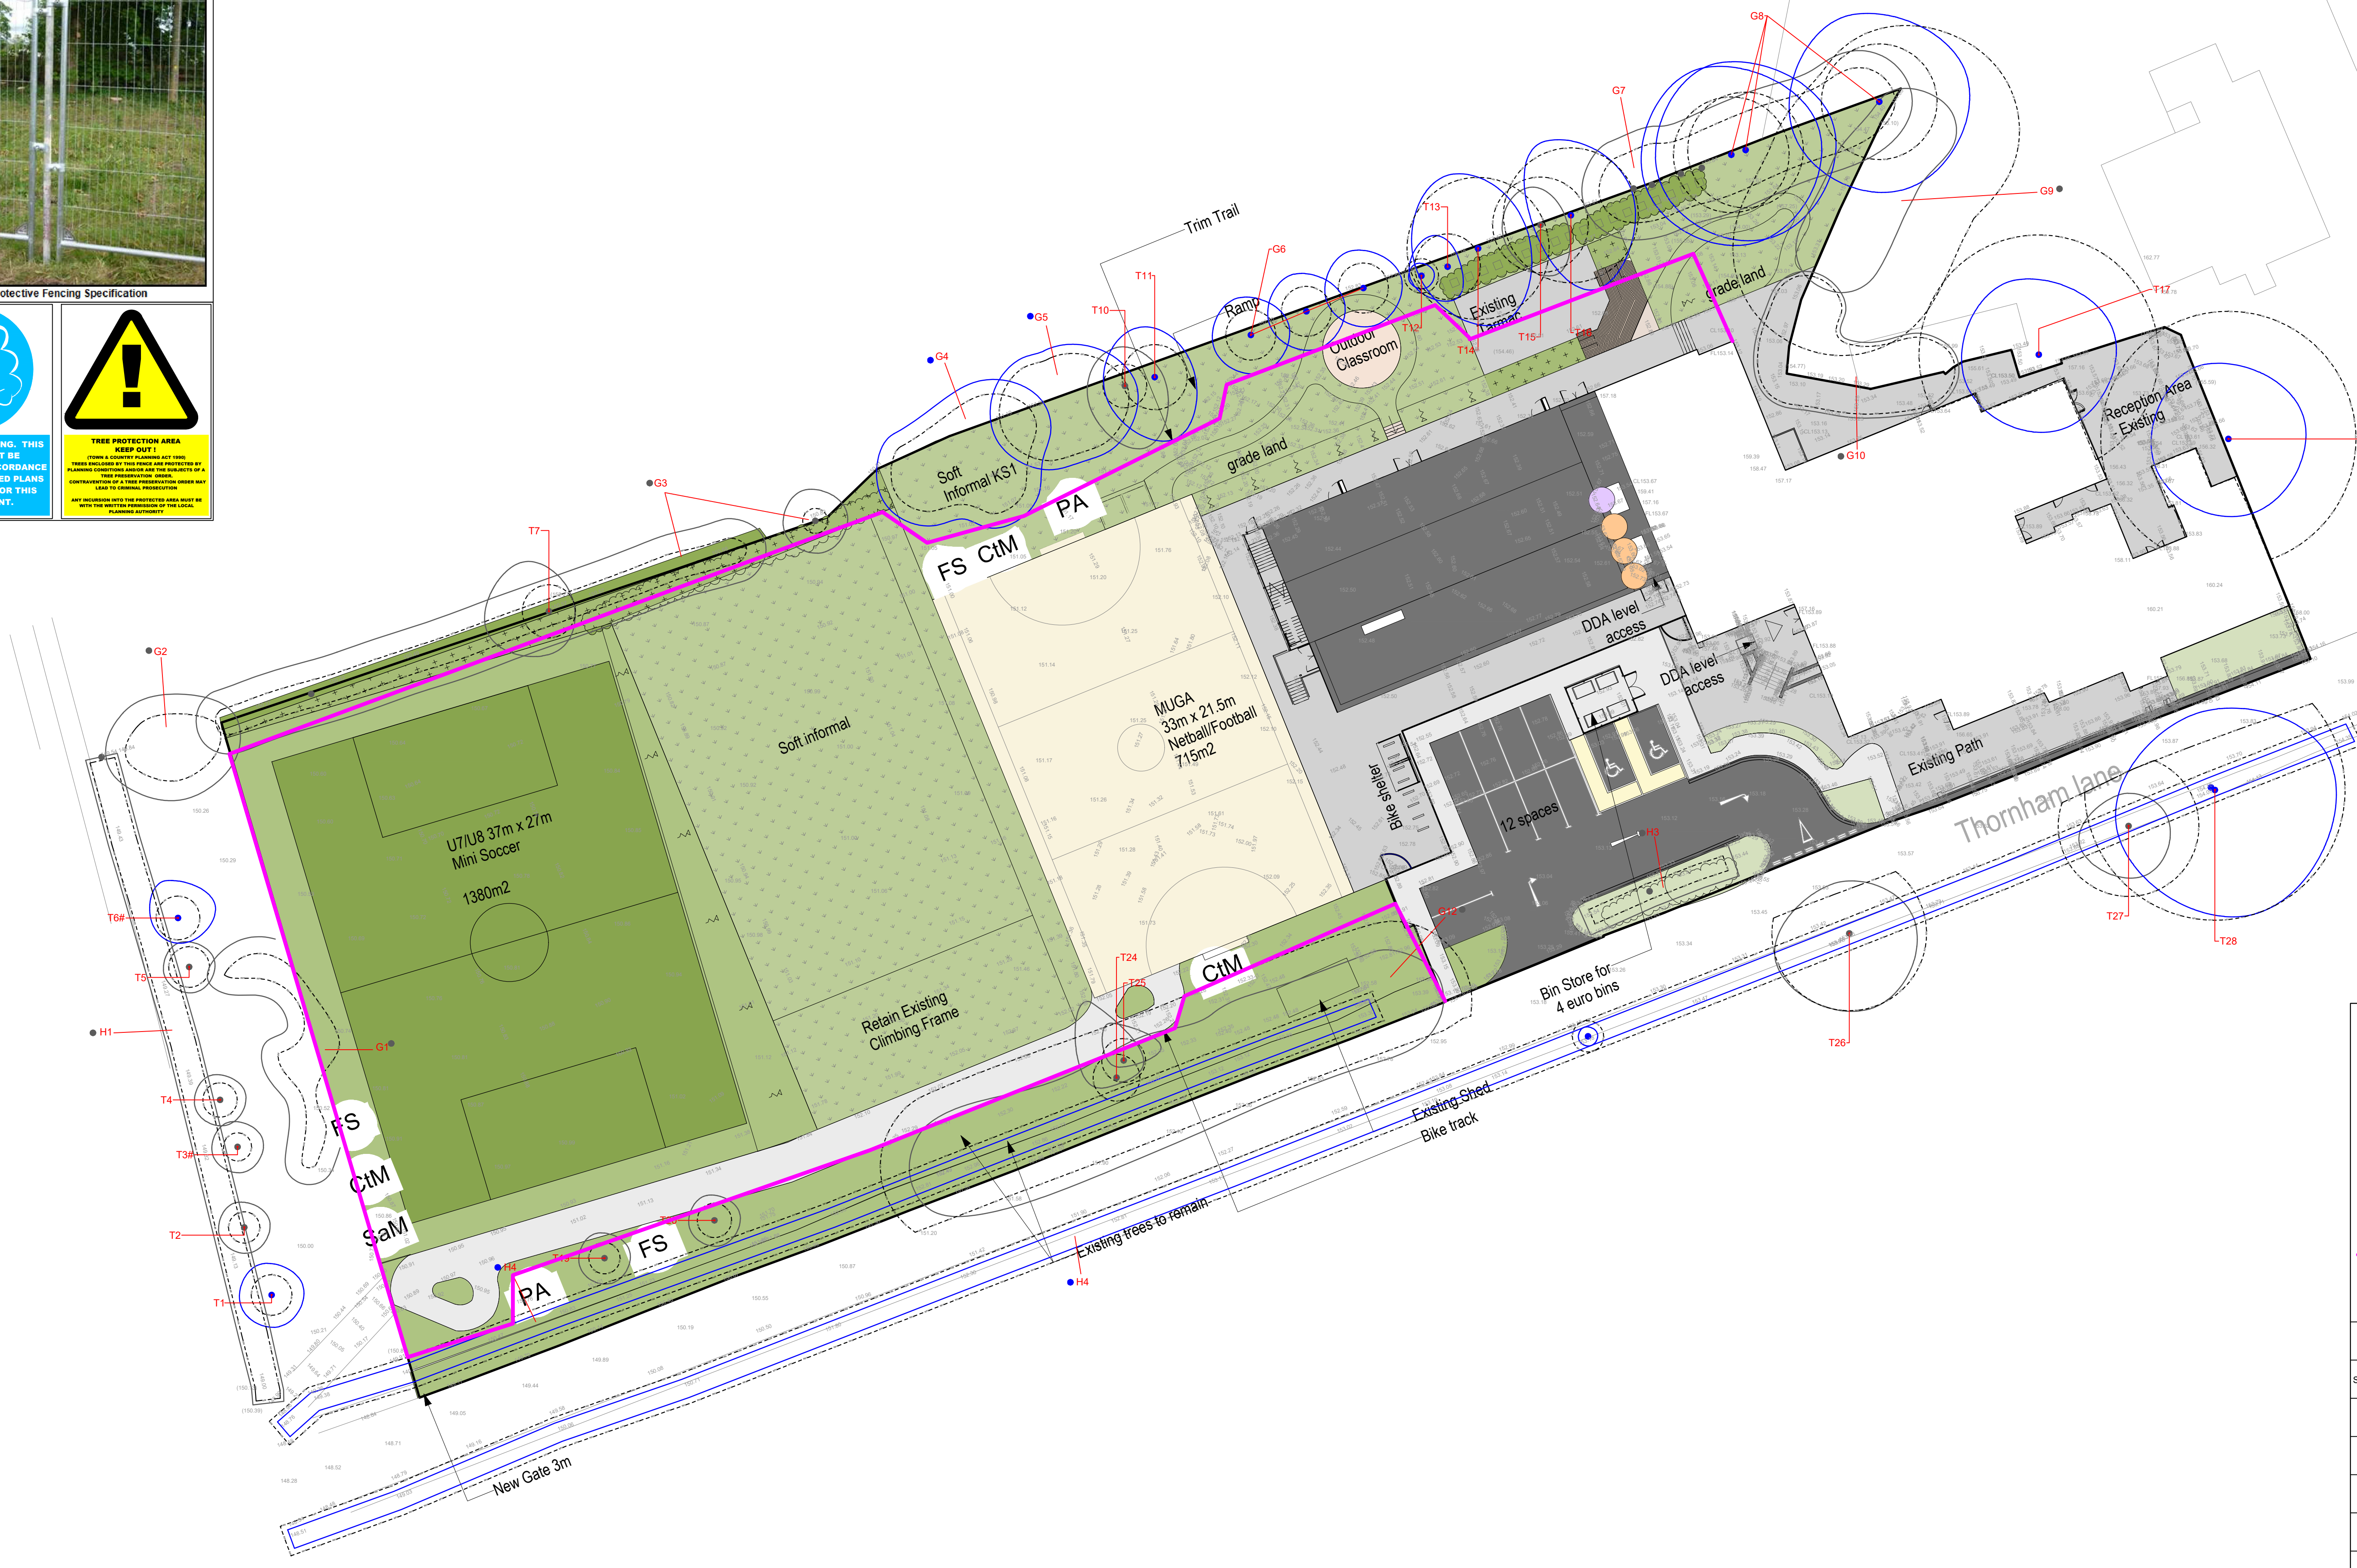
### **Tree Protection Plan**

5.2.3 The means of protecting the RPA will include the installation of tree protective fencing prior to the start of any demolition or construction work on site. The prohibition of various activities within the RPA must be adhered to (e.g. mechanical excavation, soil stripping, fire lighting, material storage, lowering levels and creating excessive sealed surfacing) and may include the use of temporary ground protection and/or special engineering solutions where construction is proposed near to retention trees or within the RPA.

5.3.1 All development and associated construction work is clear of retained tree canopies such that access facilitation pruning is not required to undertake the proposed works. Tree protective fencing will be erected at the full extent of all canopies to ensure no contact and subsequent damage occurs.

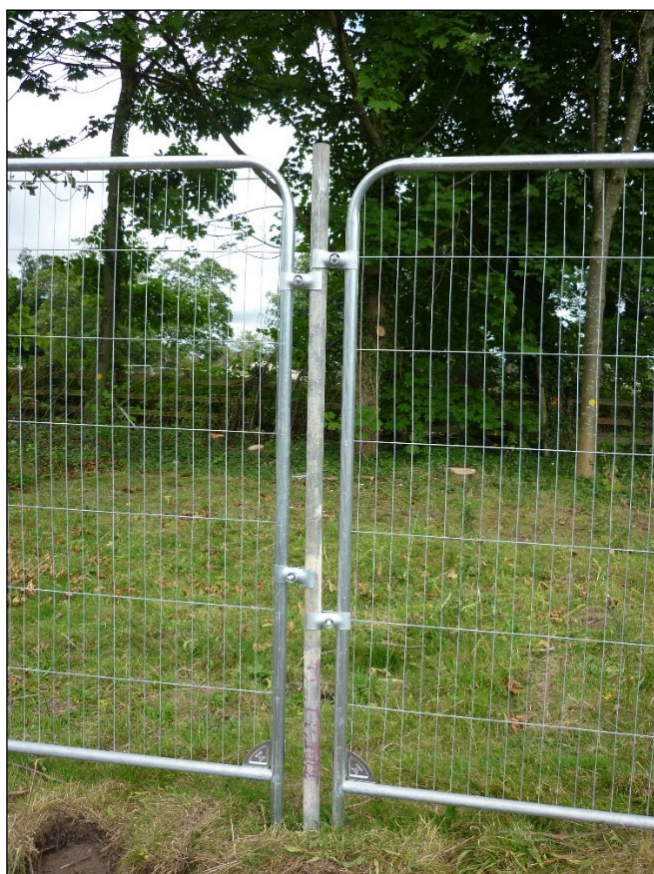
**Tree Protective Fencing Specification**

2.0M high heavy-duty Heras panels (with extra central support bar) mounted on scaffold poles (driven into the ground) and secured with anti-tamper bolts – as illustrated below.
