## Phase I GeoEnvironmental Desk Study

Lowther Crescent

Middleton

**Report No. A4832/22**

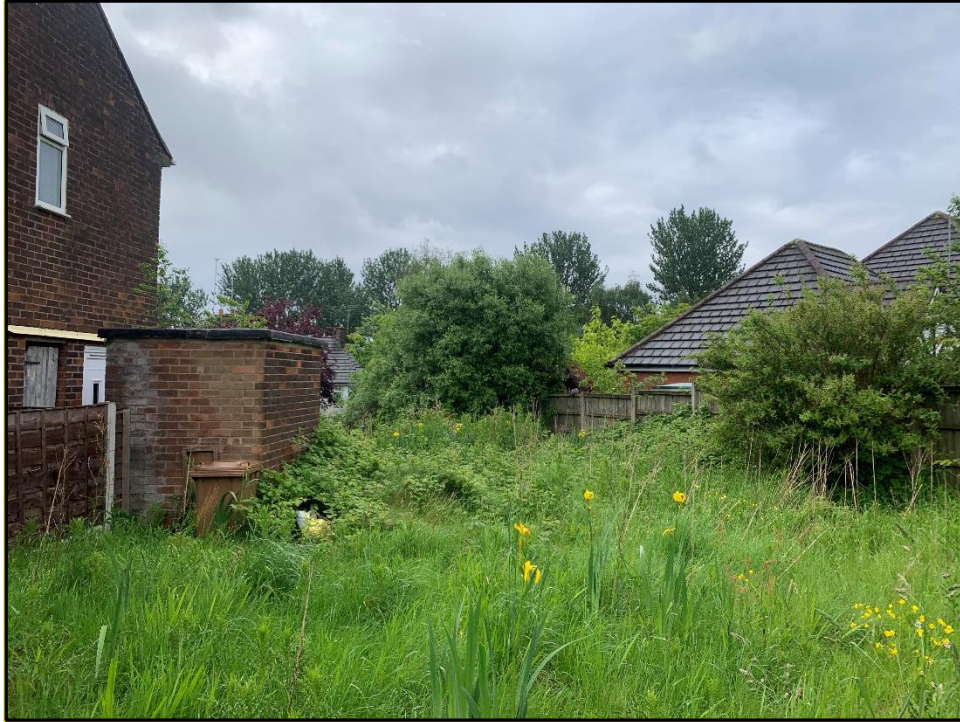
**Figure 3 Site Photograph**

- 2.3 The site is fenced and covered in weeds and brambles with a few small saplings and ornamental trees. The ground is uneven, and slopes to the southeast. There is a small brick outbuilding on the site which is accessed from No. 3. There is a telephone exchange box and an electricity substation on the pavement adjacent to the site.

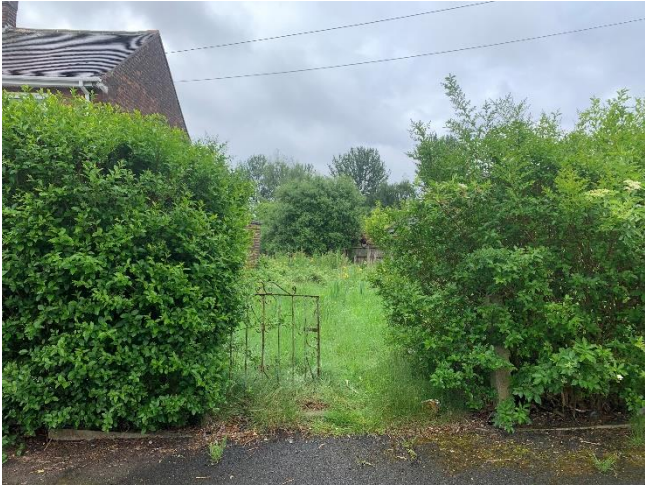
| <p><b>Plate 1 Viewing south at the site entrance from Lowther Crescent.</b></p> | <p><b>Plate 2 Viewing south showing No3 Lowther Crescent on the left with outbuilding to be demolished.</b></p> |

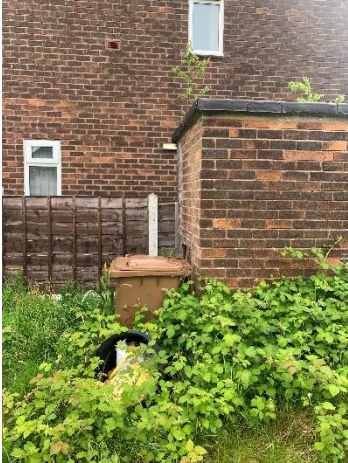
| <p><b>Plate 3 Viewing East at small brick shed with felt roof.</b></p> | <p><b>Plate 4 Viewing south down the slope towards narrowing part of site. Note trees and shrubs.</b></p> |

| Source | Pathway | Receptor | Probability | Consequence | Risk | Comment |
|---|---|---|---|---|---|---|
| Asbestos Containing Material (ACM) | | Current Site Users | Unlikely | Moderate | Low | Asbestos was not observed on site however there is a small brick building that requires demolition. Given the age of the building, ACM may also be present inside. Asbestos is only harmful when disturbed. The risk to current site users is <b>LOW</b> . |

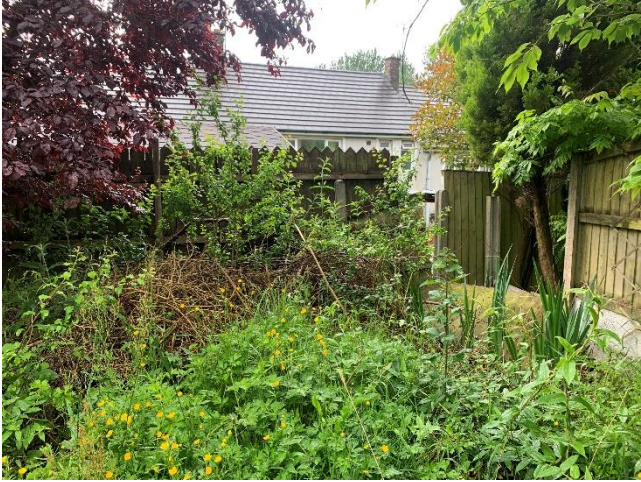
| <p><b>Plate 5 Viewing south at the end of the plot with broken fence, garden waste and plastic litter. Note rear of property on Yewdale Drive.</b></p> | <p><b>Plate 6 Viewing north at the rear of no 3 Lowther Crescent.</b></p> |

- 5.2 The site access is from a pedestrian gate on the south side of Lowther Crescent.
- 5.3 The site slopes (1:17) to the southeast and is fenced on all sides with a hedge on the street frontage and wooden panel fencing (1.2 – 1.8 m) with concrete base boards and posts for the remainder. The fence is broken in the far southern corner.

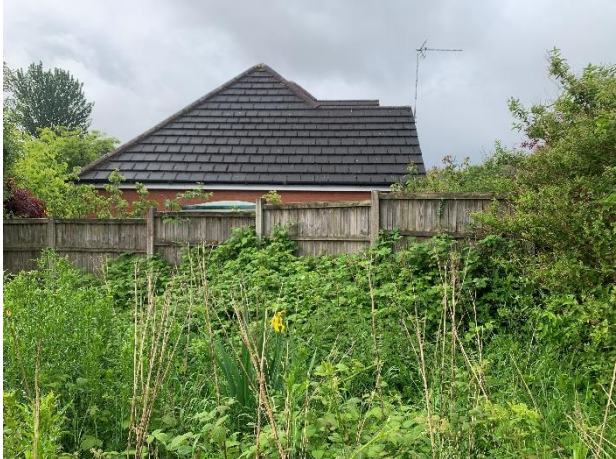
| <p><b>Plate 7 Viewing west at adjacent property on Eycott Drive.</b></p> | <p><b>Plate 8 Viewing south at telephone exchange box on corner of Lowther Crescent and Eycott Drive.</b></p> |
