# DALE STREET, MILNROW

## Nocturnal Bat Survey Report

*September 2025*

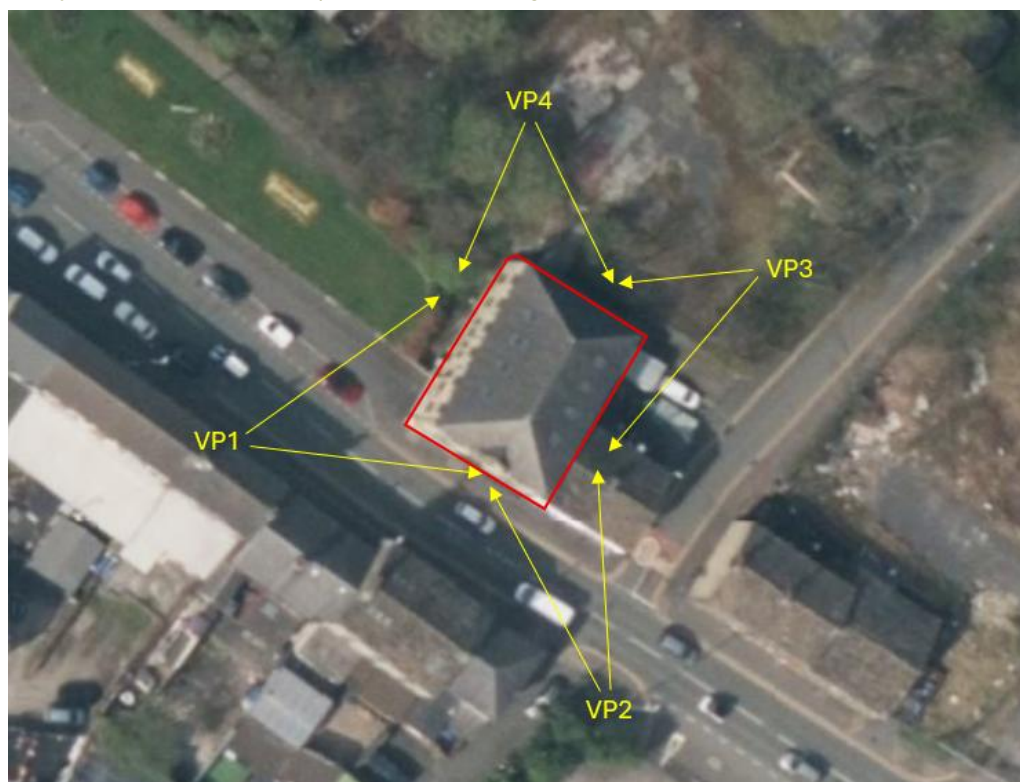
Figure 2.1 Surveyor Locations – Red line depicts the onsite building

2.1.2. Please refer to Figure 2.1 for locations of vantage points used during the surveys.

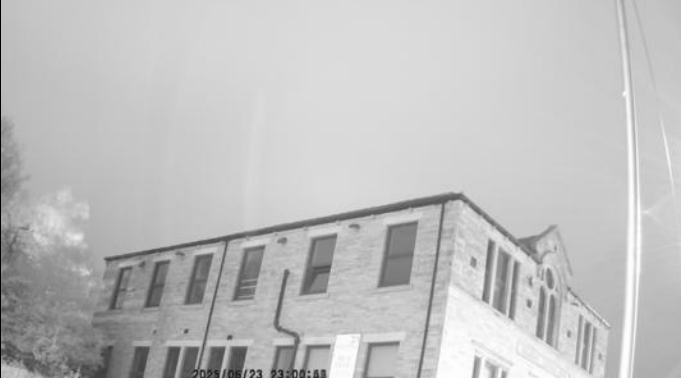
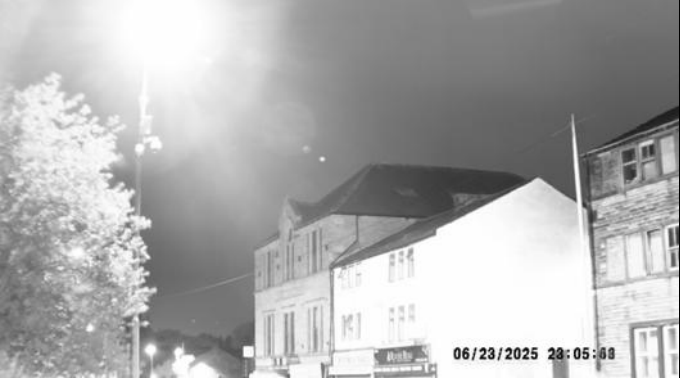
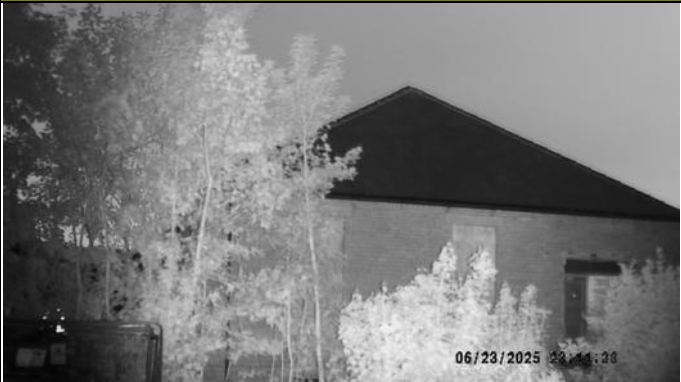
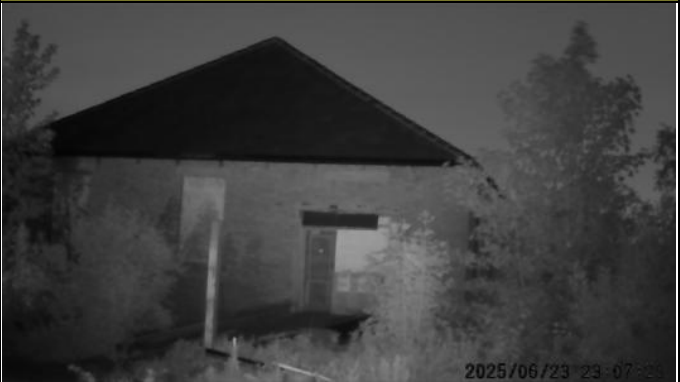
Table 3.3 – Images of Camera Footage at the Darkest Point

- 3.1.1. Bat activity was recorded minimally throughout the survey, with common pipistrelle (*Pipistrellus pipistrellus*) recorded or observed commuting across all vantage points.
- 3.1.2. The first bat was recorded at 21:44 (approximately two minutes after sunset) in the vicinity of VPs 3 & 4, and was identified as a common pipistrelle. This bat was observed foraging. Another common pipistrelle was observed foraging in the same vicinity at 22:03 and was then observed commuting from this location towards VP1 at 22:05. This instance of commuting was recorded across all VPs, and observed by surveyors at VP3 and VP1.
- 3.1.3. A single instance of noctule (*Nyctalus noctula*) was recorded at VP2 at 22:12. This bat was heard but not seen.
- 3.1.4. No roost locations were observed during the survey.

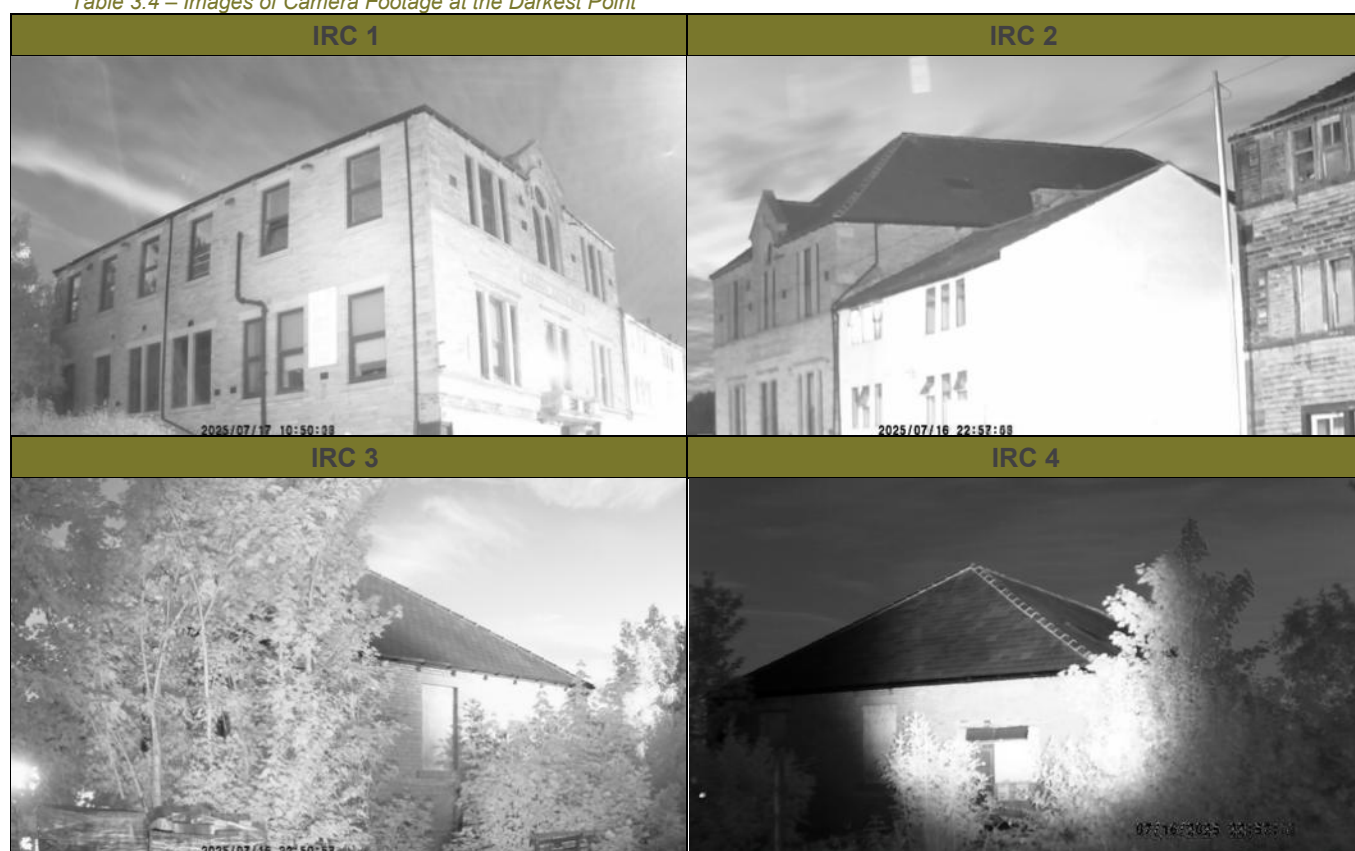
Table 3.4 – Images of Camera Footage at the Darkest Point

- 3.2.1. Bat activity was recorded intermittently throughout the survey, with common pipistrelle (*Pipistrellus pipistrellus*) recorded or observed across all vantage points.
- 3.2.2. The first bat was recorded at 22:02 (approximately thirty-four minutes after sunset) in the vicinity of VPs 3 & 4 and was identified as a common pipistrelle. This bat was heard but not seen. Further instances of common pipistrelle were recorded across all VPs intermittently, with the final recording occurring at 22:52. Several instances of commuting common pipistrelle were observed; by VP1 at 22:19 and 22:26, by VP2 at 22:14, and by VP3 & 4 at 22:35.

3.2.3. One instance of soprano pipistrelle (*Pipistrellus pygmaeus*) was recorded in the vicinity of VP1 at 22:20.

3.2.4. No roost locations were observed during the survey.
