# **GEO-ENVIRONMENTAL AUDIT**

## **PHASE 2 Site Investigation & Risk Assessment**

## **PHASE 3 Remediation Statement**

### **Proposed Residential Development**

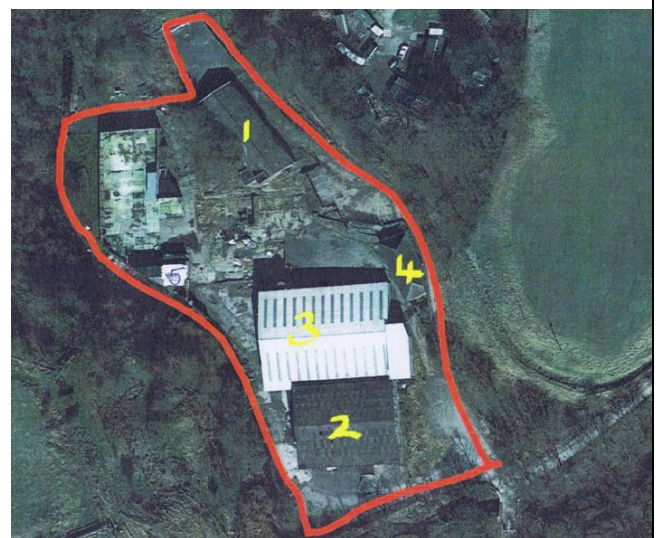
**2017.** The remaining Site buildings except for the substation & utility part of the former mill to the northwest were proposed for demolition under a building notice, ref: DEM/17/0122, 'Demolition of Existing Buildings'. The buildings were numbered as per the inset image.

Building 1 was noted to have an asbestos cement roof, and Building 2 to comprise clad asbestos cement sheet walls & roof. Building 3 was also noted to contain asbestos cement sheeting. Documentation indicates that asbestos had been surveyed, managed, risk assessed, and removed prior to demolition.

**2018.** Buildings 1, 2, 3 & 4 were subsequently demolished under the above building notice. All materials were separated for recycling and salvage where possible. Remaining demolition material was crushed on-site and stockpiled close to the Site entrance to the south corner of the Site for later removal (supported by photographic evidence in the Appendix C).

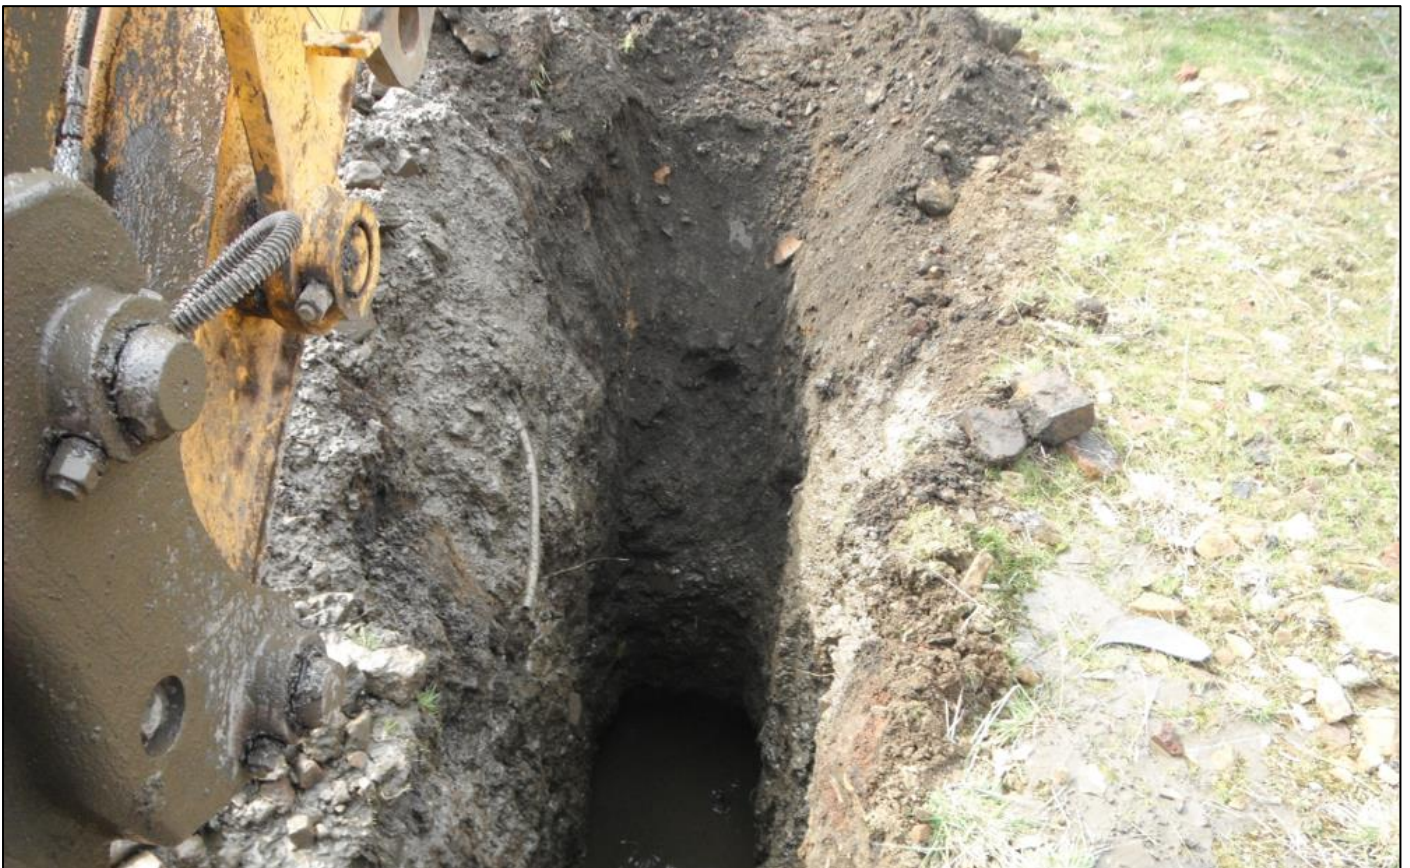
Trial Hole 4.

- TH4 around the location of the historic part of the mill. Depths in excess of 4m of brick & stone rubble fill was noted without reaching bedrock noted everywhere else across the Site. The depth is assumed to be due to basements within the historic mill dating back to & built in the 1850s.
- TH7 to the northwest corner of the Site (lower site) noted hydrocarbon contamination at depth which appeared to be local only. No visual or olfactory evidence of contamination was noted in either TH6 or TH8, both close by. The location is of TH7 was local to the former tanks.

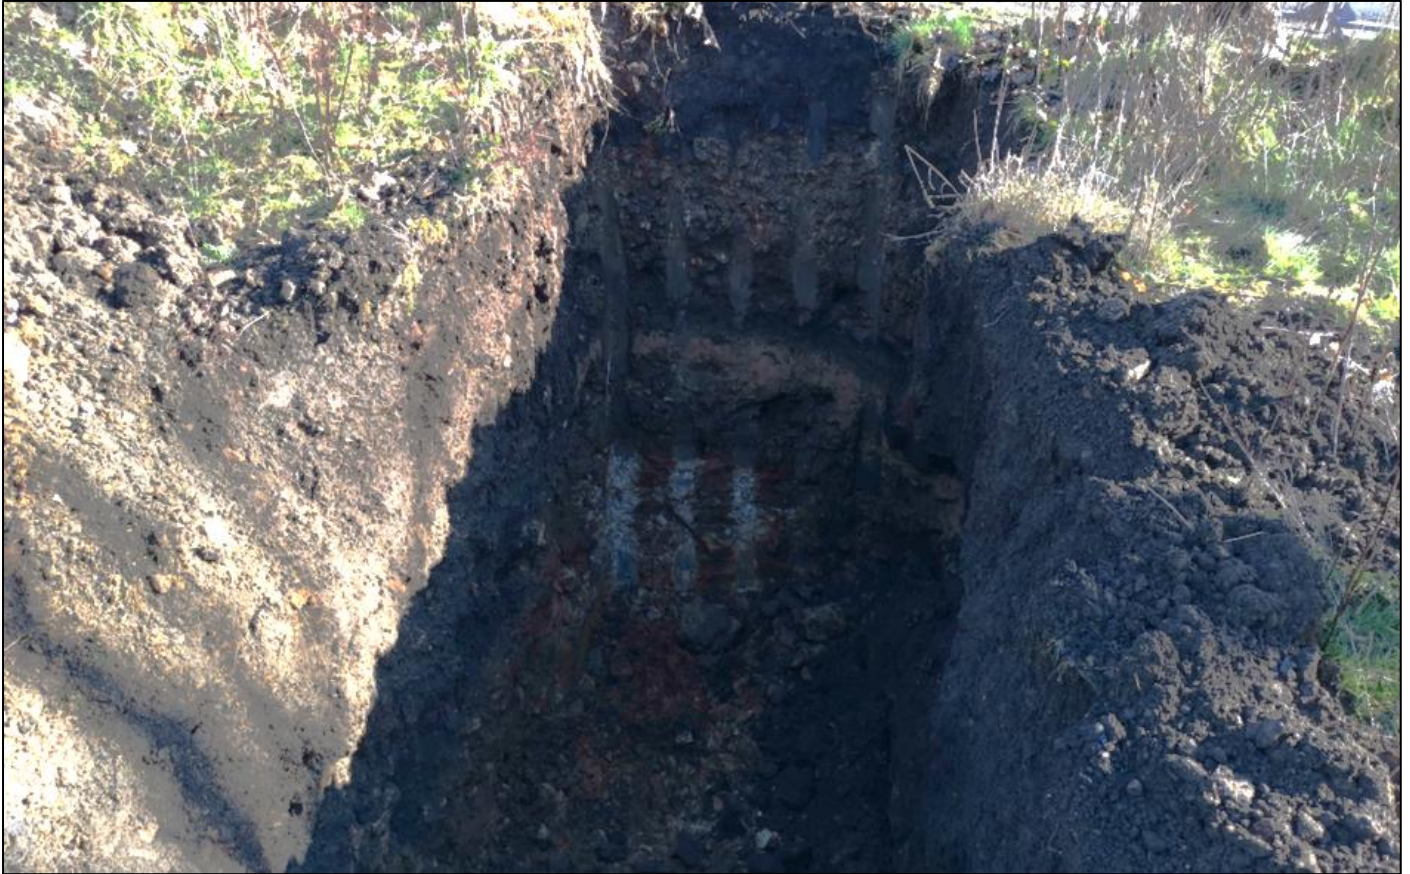
Trial Hole 11

In particular, trial holes 11, 12, 13 were located within the former 'refuse tip' area with trial hole 14 just on the boundary. A loose sand & gravel made ground (sand & gravel of brick, stone, concrete, ash) was noted confirming earlier investigations that the fill in this area is generally inert demolition fill.

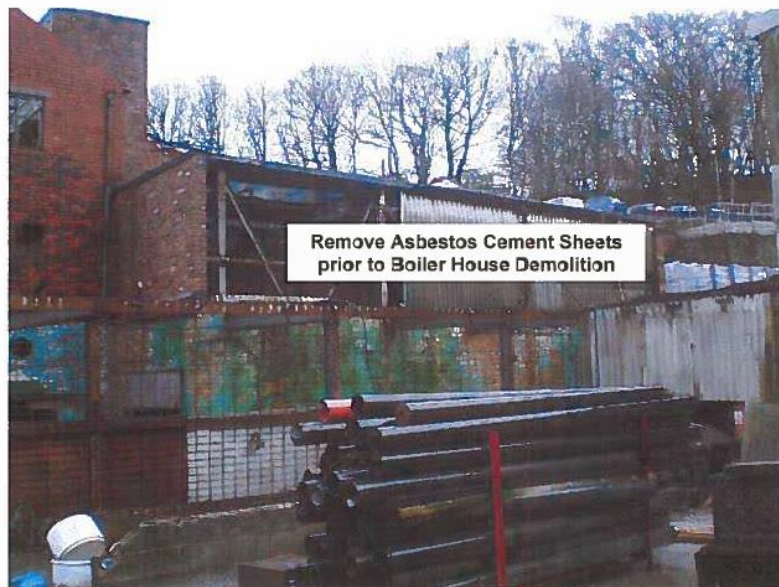
Asbestos Cement Sheets to be removed prior to Boiler House Demolition

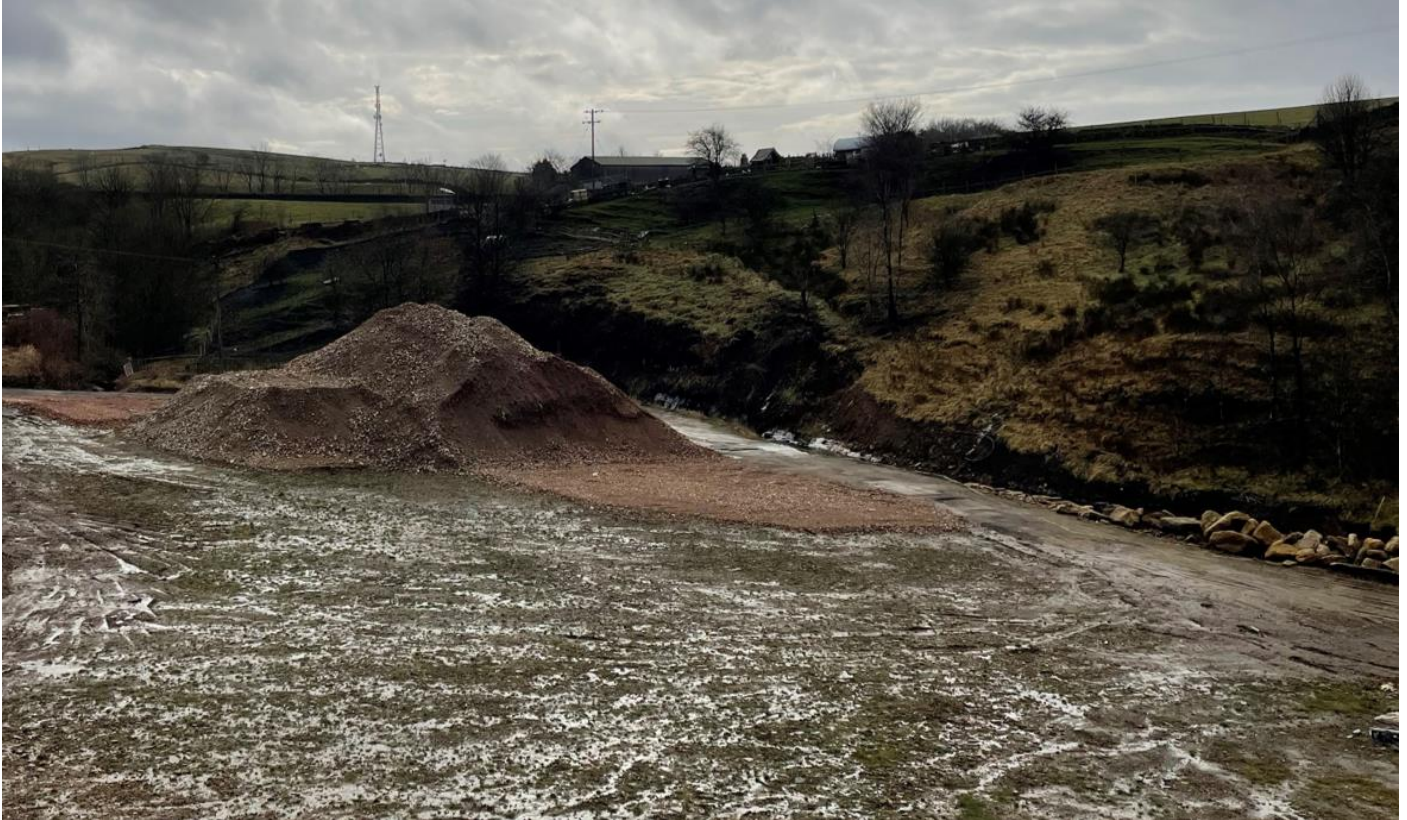
Demolition crush which has now been removed from Site.

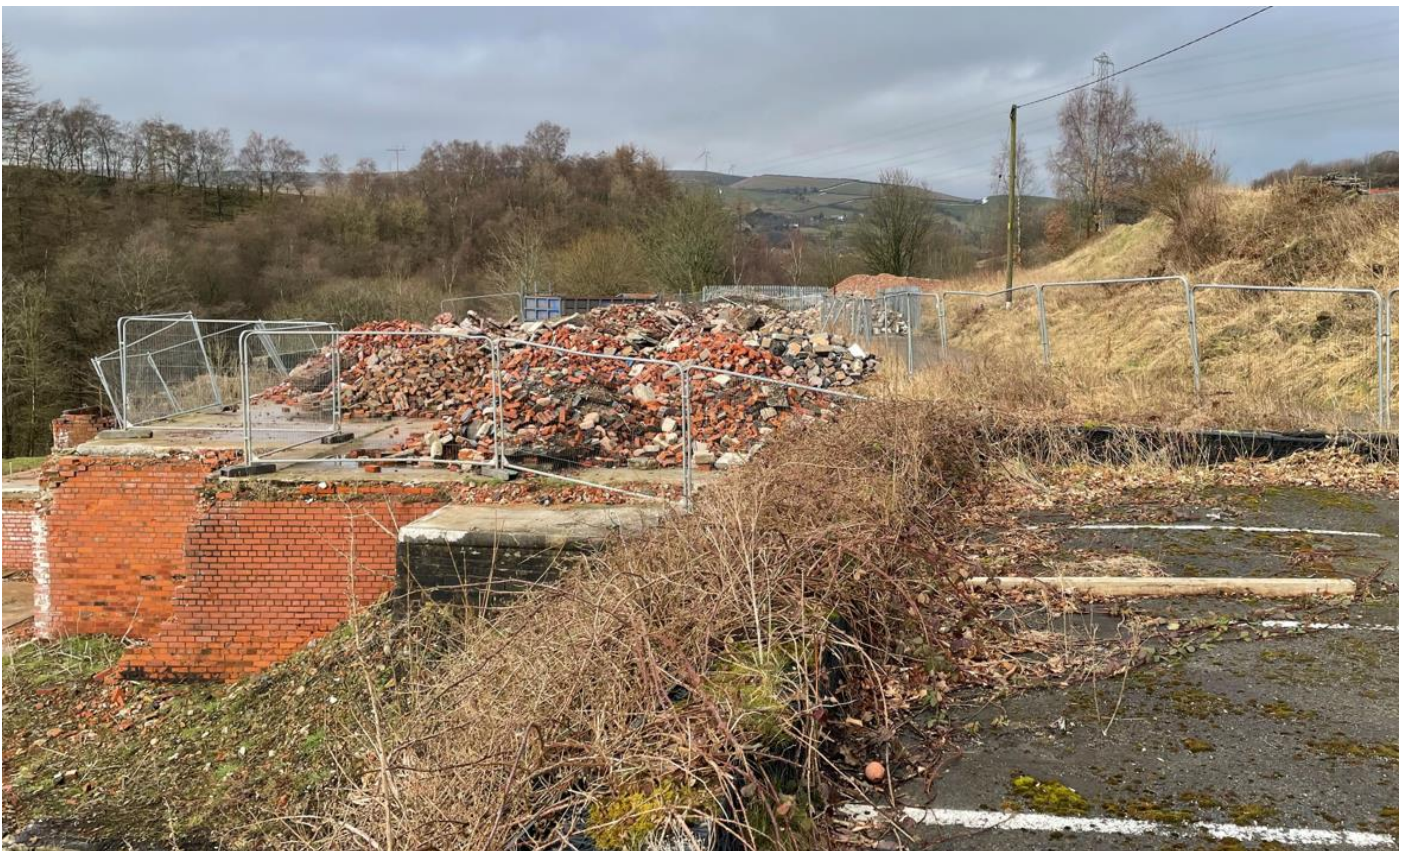
Demolition materials separated for removal.
