**Job title:** Whitworth Road, Rochdale

**Report type:** Supplementary Geo-  
Environmental Appraisal

**Prepared for:** Cornerstone Place

**Date:** April 2023

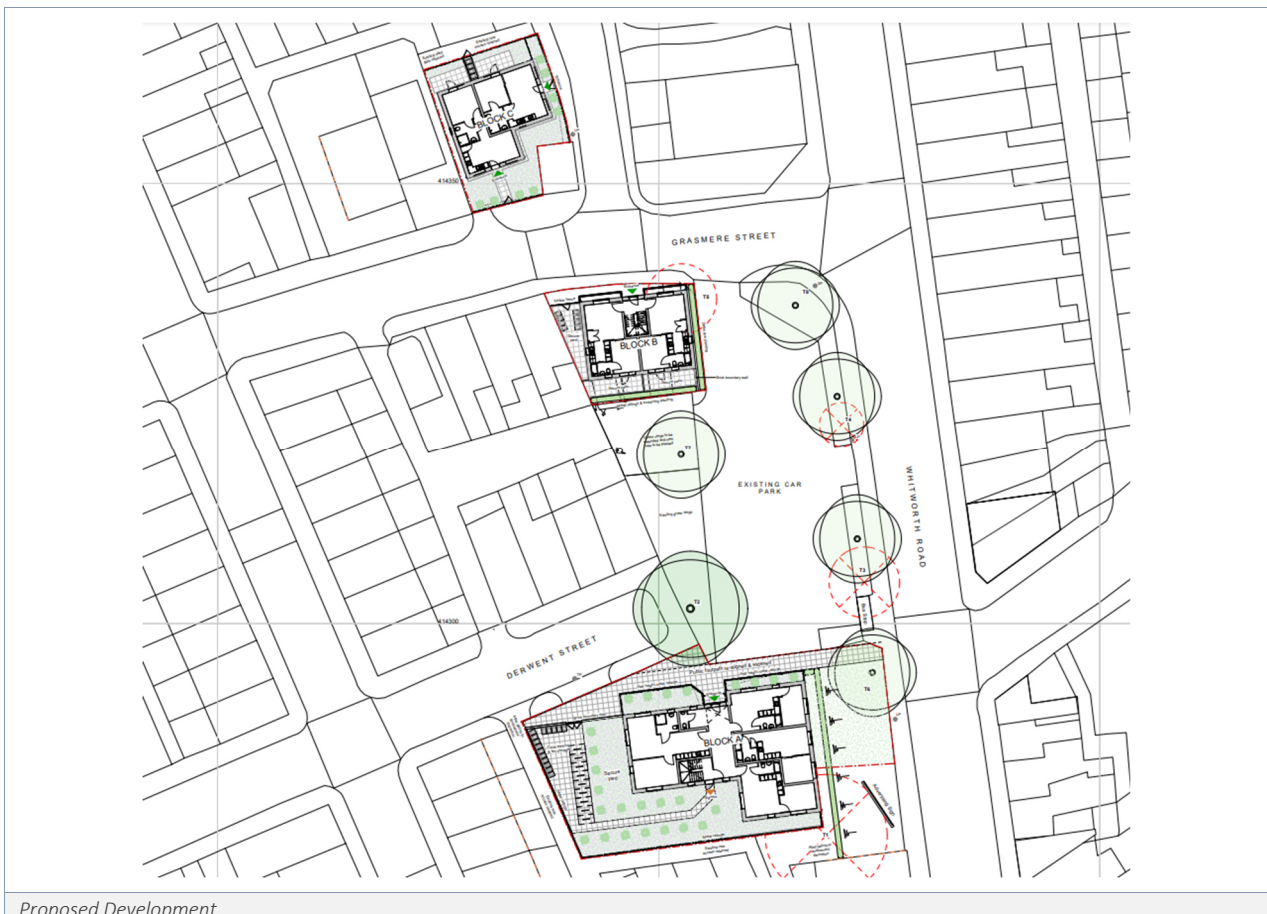
Block A is located on the southern plot of land and comprises a two-storey building with eight apartments, Block B is situated on the central area and will contain a two-storey building with four apartments, and Block C is on the northern plot of land and will contain two apartments within a single storey building.

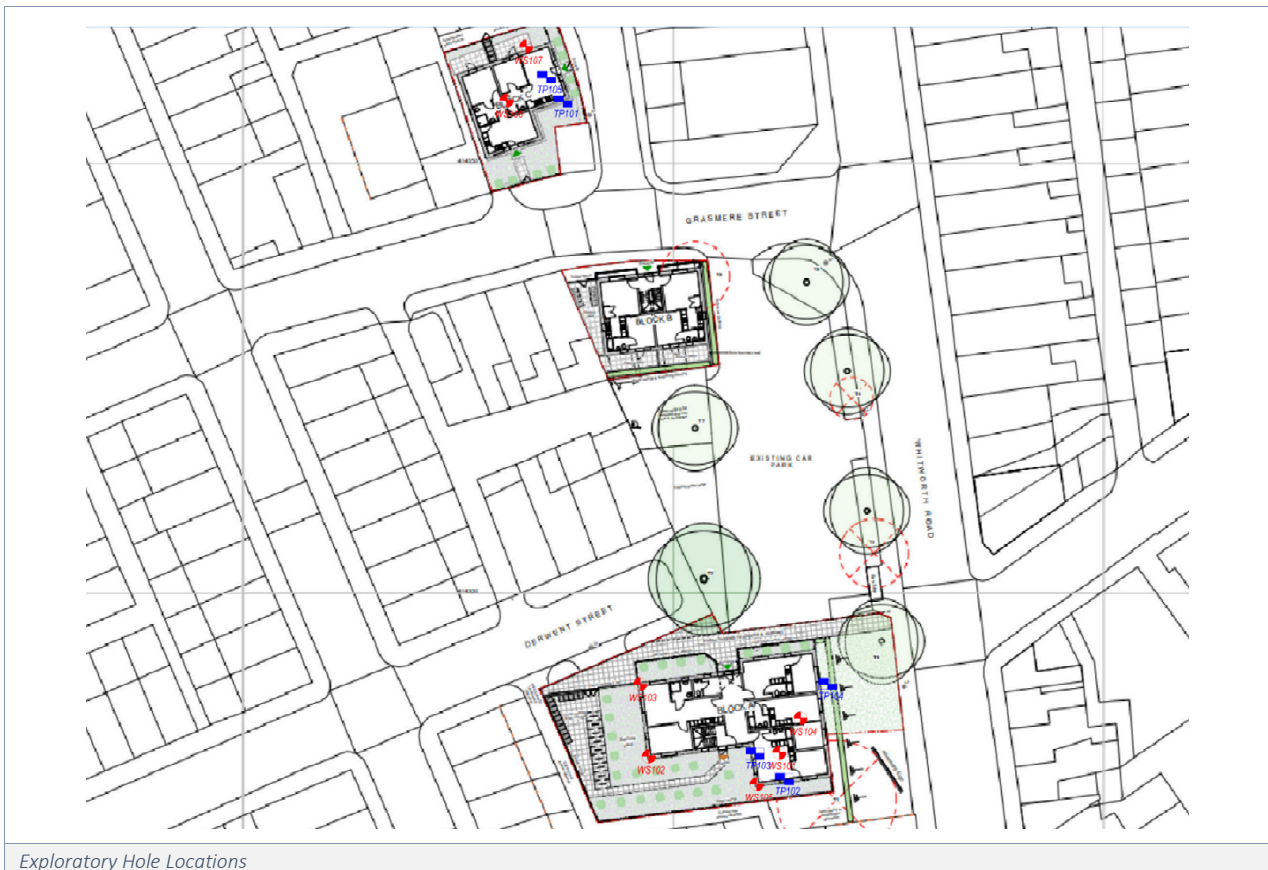
One main Made Ground population was encountered during the investigation. Dark brown black gravelly sand with constituents of brick, tarmac, sandstone, concrete, ceramics, plastic, glass, wood, metal, fabric, and chert was encountered in all exploratory holes from depths between 0.1m and 0.3m bgl to depths between 0.5m and 2.0m bgl.

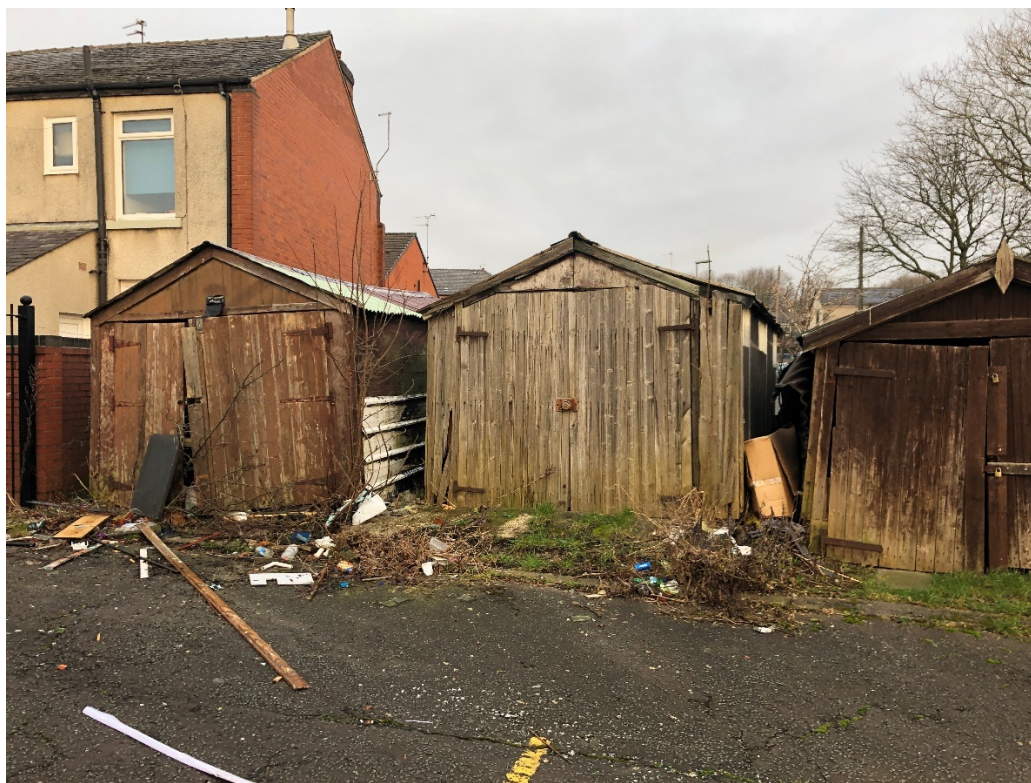
Photograph 1 – Sheds currently present on Block B.

The site is currently occupied by four storage sheds which are in very poor condition. Three sheds are located along the southern edge with a fourth in the north west corner. It is possible that this fourth shed has asbestos cement sheeting for its roofing. There is a thin strip of tarmac located along the eastern boundary with the remainder of the Block Being covered by grass and scrub. The deciduous tree noted in the original Ground Investigation in the north east corner is no longer present. Evidence of fly tipping is noted in the northern area of the site due to the presence of general and household waste heaps.

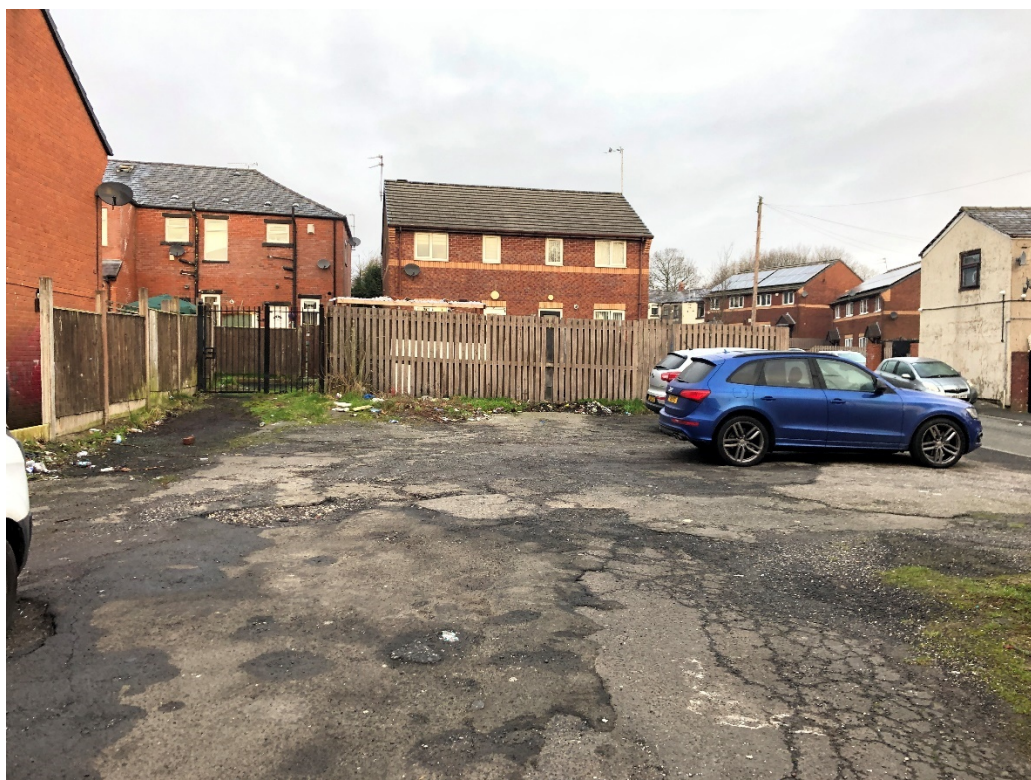
Photograph 2 – Block C in the north.

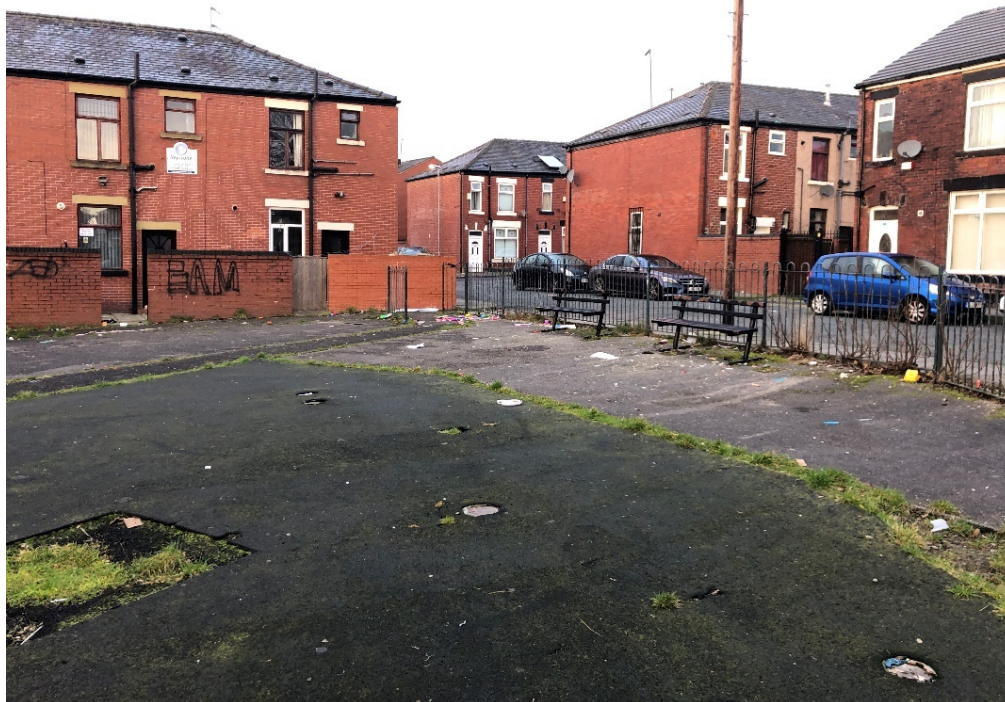
Photograph 3 – The former children's playground on Block A.

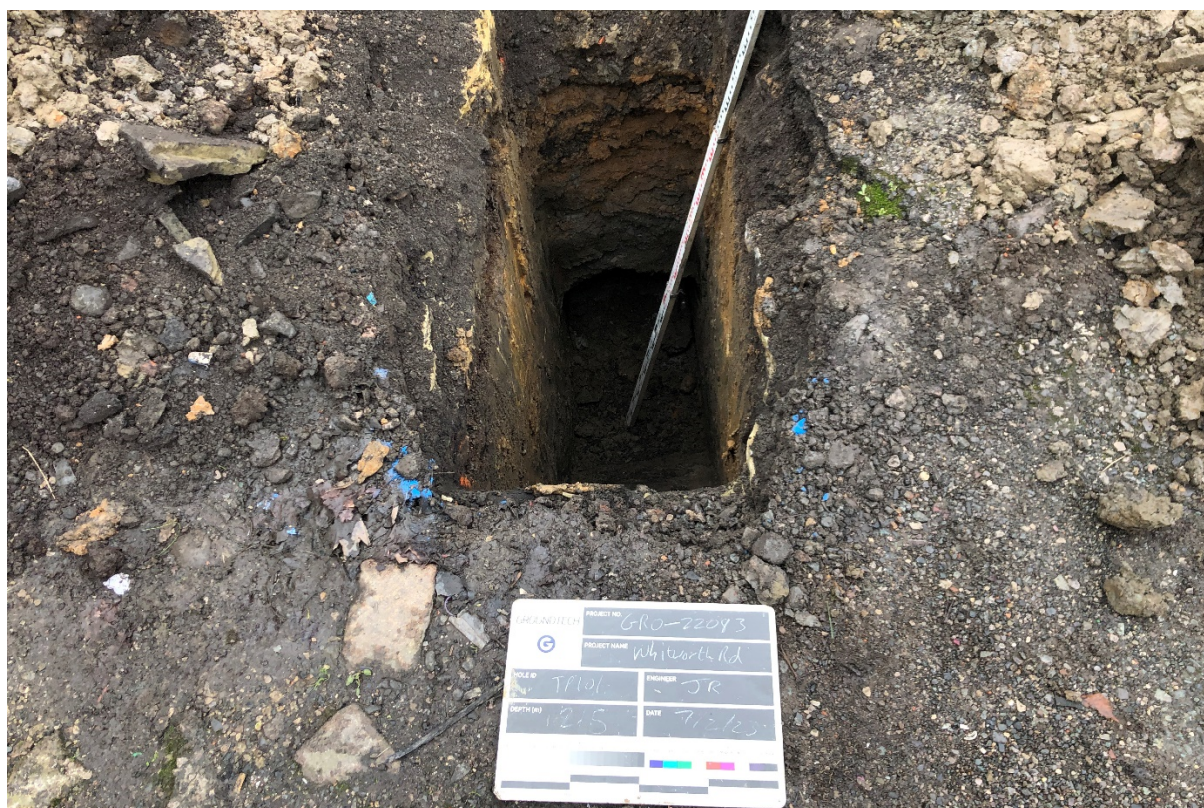
Photograph 4 – TP101

Locally to TP101, grey brown silty Sand was observed from a depth of 2.2m to 2.5m bgl.

Visual evidence of potential contamination was noted at locations TP101 and WS106 where ash was present in the Made Ground.

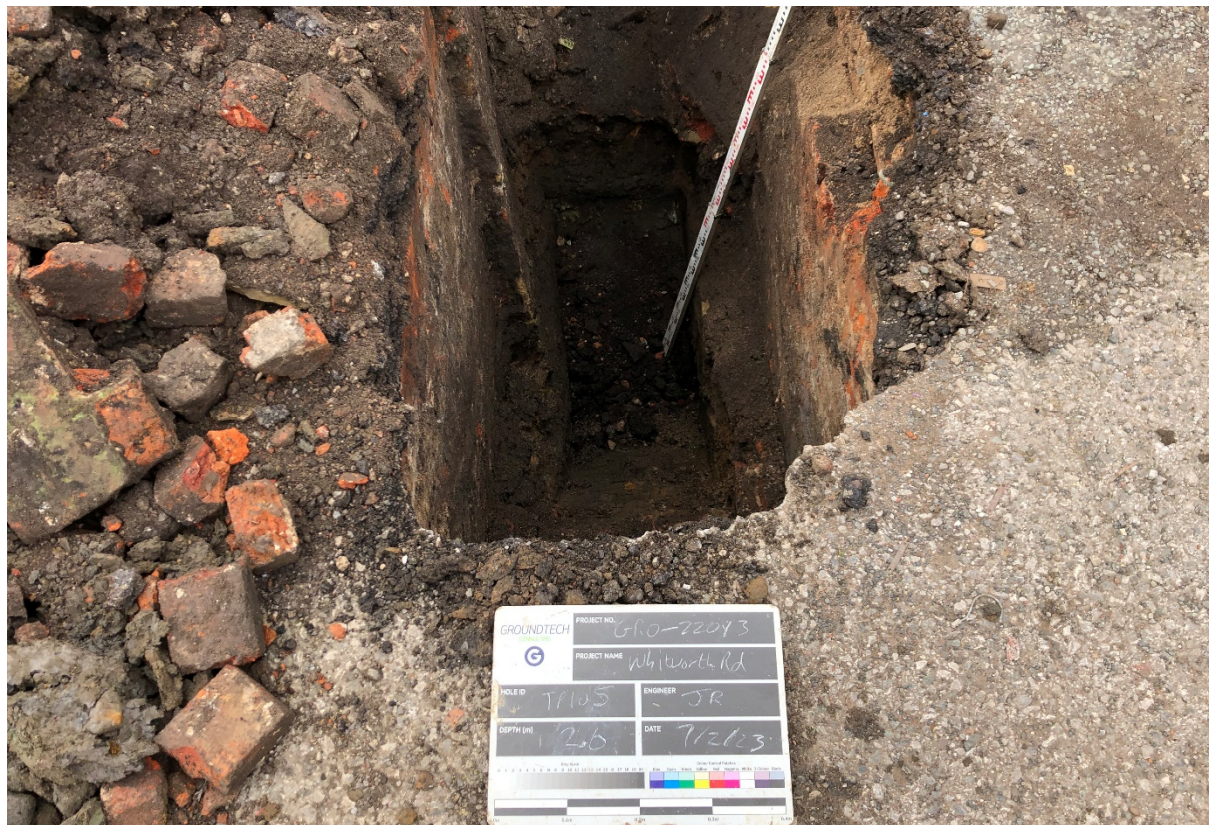
Additionally, relic foundations and a basement have been encountered in the vicinity of Block C and Block A which will require grubbing out.

Photograph 8 – TP105 Showing basement walls

Tracked high specification plant is recommended to maintain the build programme. Breaking equipment may also be required locally to penetrate obstructions identified by the site investigation such as the basement structures in Block A, B and Block C.

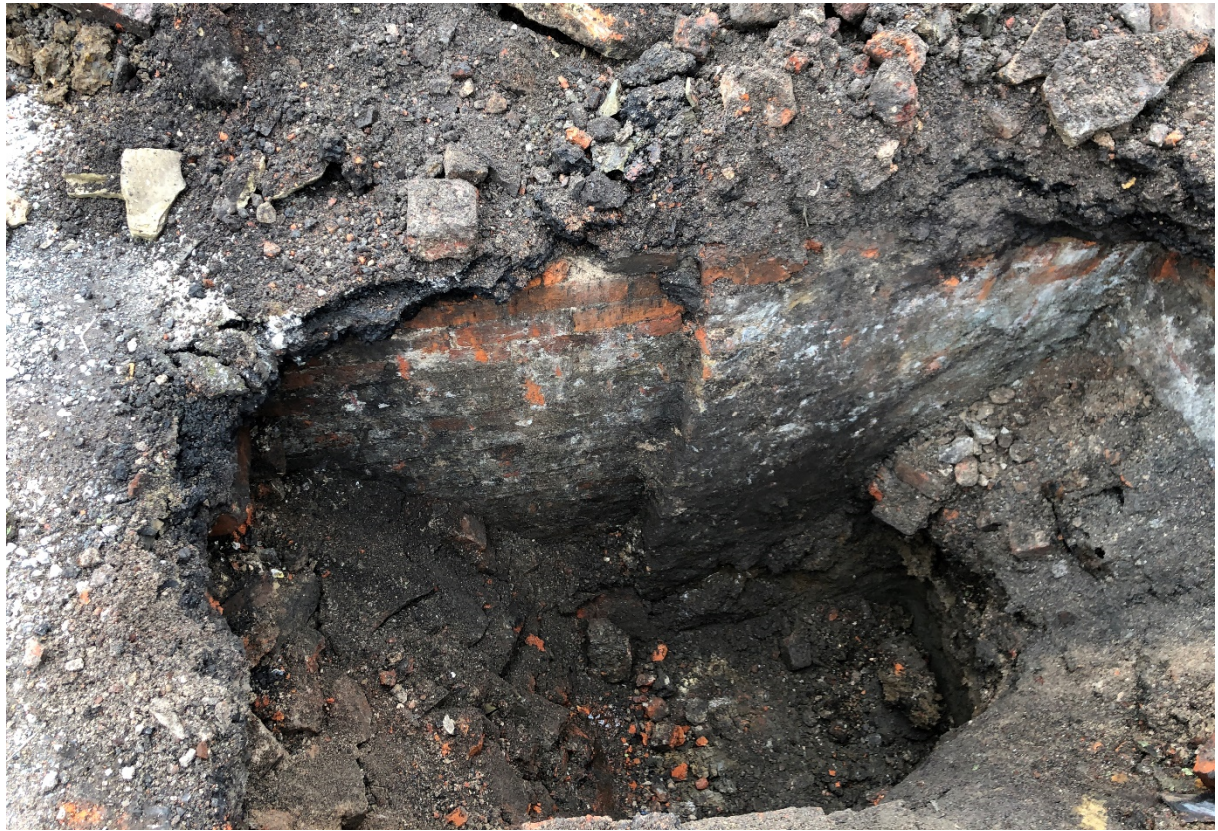
Photograph 9 – Brick wall in side of TP105
