**PHASE 2 SITE INVESTIGATION &  
GEO-ENVIRONMENTAL APPRAISAL**

**LAND  
AT  
RIVERSIDE BUSINESS PARK  
TODMORDEN ROAD  
LITTLEBOROUGH  
OL15 9EG**

Job N° MGEO 2410 OL15 9EG ph2

Date: November 2024

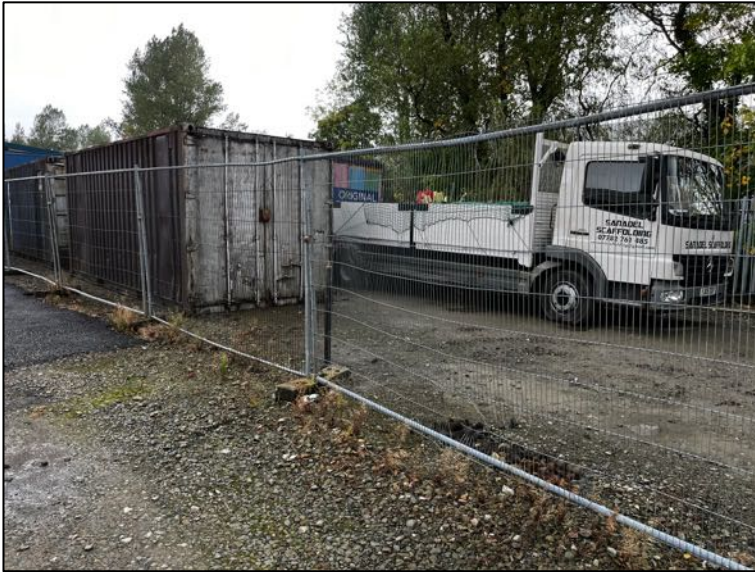
View to north east towards WS1 in the north east of the site

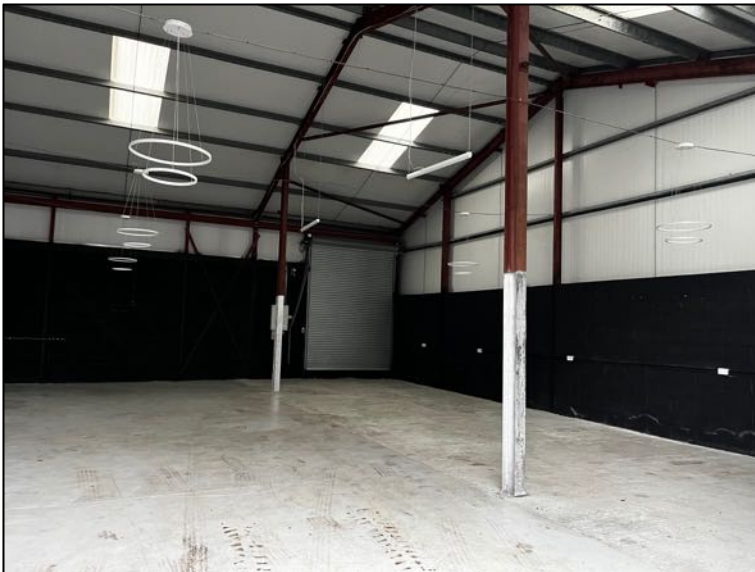
View of existing development immediately north of the development site showing interior of unit with concrete slab

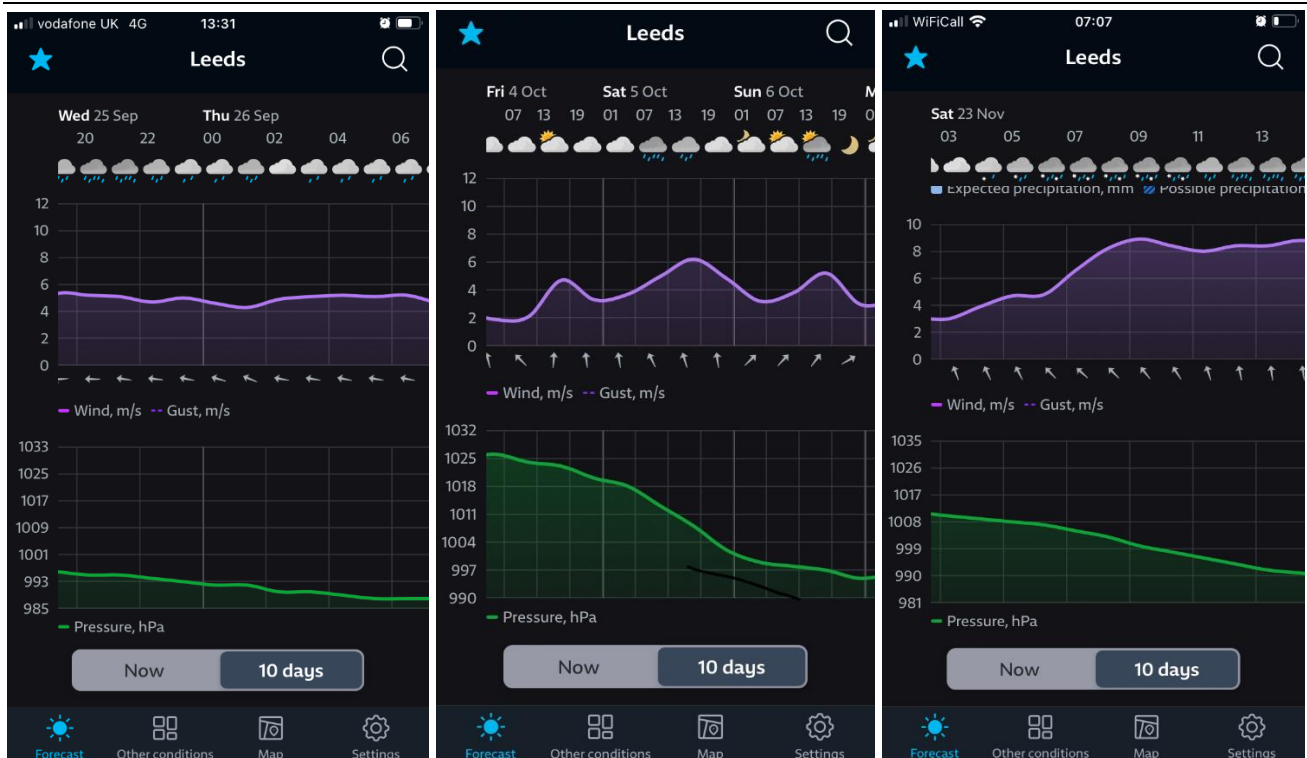
Visit 1 Worst Case estimation to onsite readings: Low barometric situation:

Indicative readings and trends are observed on a daily basis to attempt to catch a good event demonstrating a near worst case scenario.
