**Job Title**                      **Balderstone Park**

**Document Title**                      **A Report for the Development of Two Pitches at Balderstone Park**

**Document Reference**      **L/001/RBC/1541/R/190131**

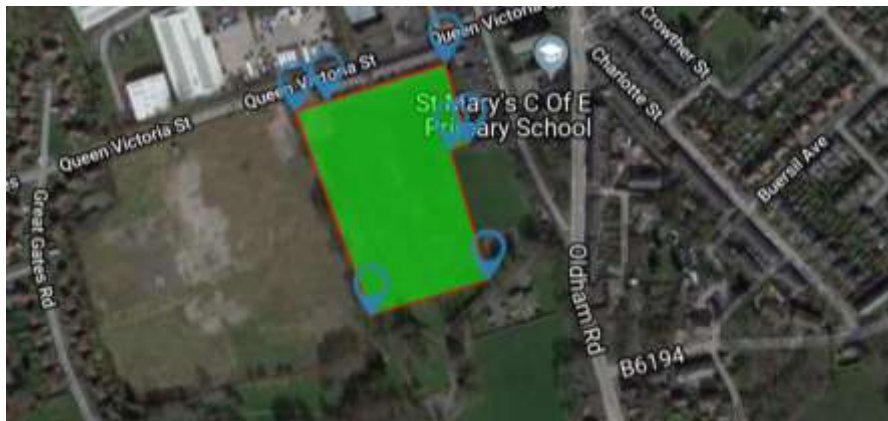
Location of proposed pitches hatched in green

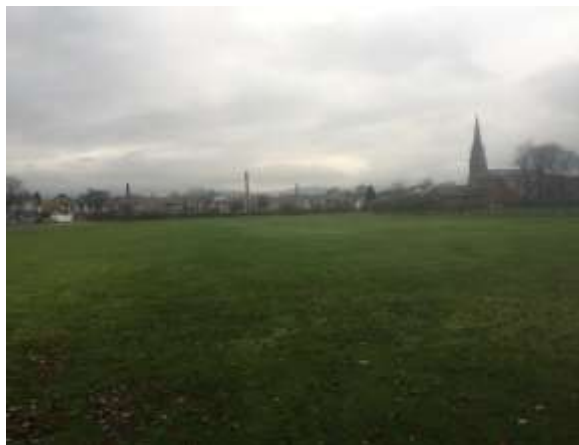
In terms of surface levels, although overall gradients were observed to be within guideline tolerances, the site possesses undulations, some of which are significantly outwith SE/NGB tolerances.

Plate 1: General view looking north

The site requires cut/fill earthworks to create a smooth, uniform plateau marrying in to existing peripheral levels. Existing topsoil should be harvested and stockpiled on site for re-application following completion of the subsoil formation levels, which will add significant cost to the improvement works.

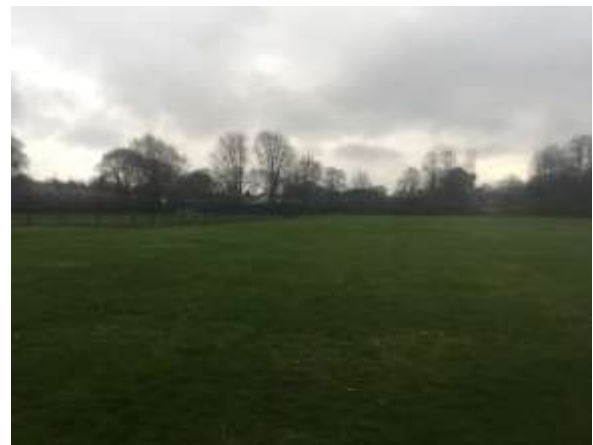
Plate 2: General view looking south

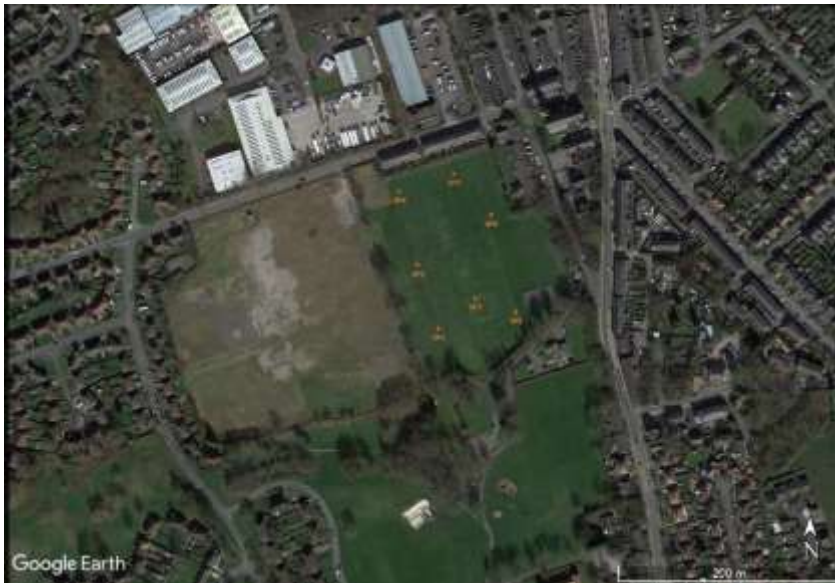
Plate 3: Approximate location of soil profile excavations.

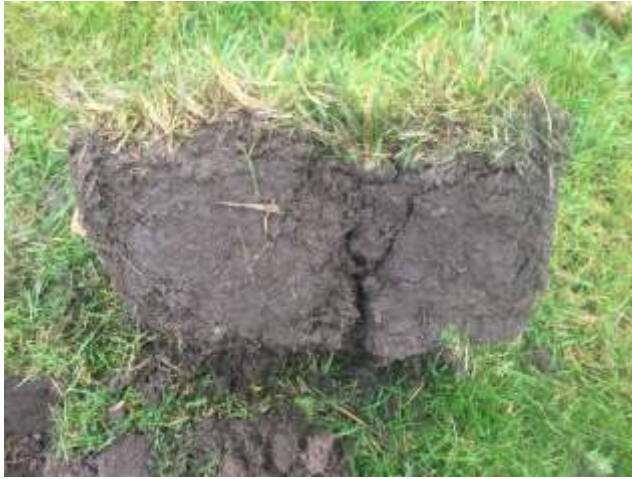
- 250-300mm deep, dark brown sandy loam, compaction noted in the upper 80-100mm; dense angular blocky structure with some vertical fissures, turning crumbly when handled; occasional stone/debris and earthworms observed; some slight iron staining of root channels evident.
- A layer of fibrous organic matter 5-10mm thick was present at the immediate surface of the topsoil.
- Laboratory analysis (see Table 3 below and Appendix 2) classified the topsoil as a **Sandy Loam**.

**In summary, the existing topsoil will behave as a very fine textured soil, with reduced drainage characteristics in the winter months and susceptible to structural damage (compaction) during play in wet conditions.**

Plate 4: Typical topsoil profile and condition

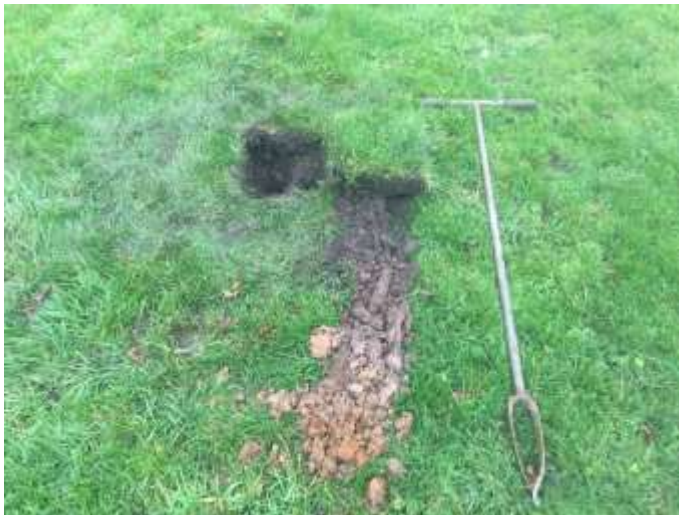
The subsoil was found to be a grey clay loam/clay of variable depths to between 500-650mm. Below this was generally found to be an orange/yellow clay to between 800-1000mm depths, although a yellow/orange fine sand was observed in trial pits 3, 4, and 6, with some stone/grit content found at locations 1, 5, 6, and 7.

Plate 5: Typical subsoil profile

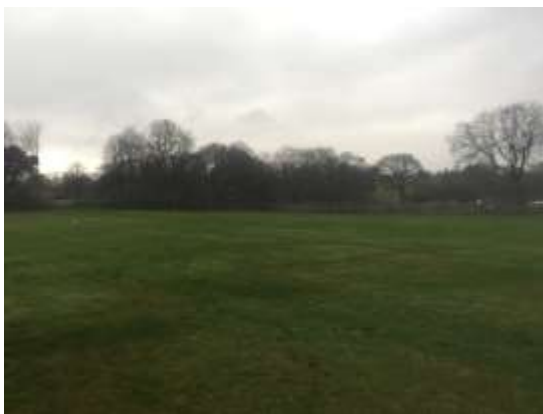
Through lack of use and regular maintenance regimes, the area was observed to possess a variety of grass species, including perennial rye grass, annual meadow grass, some fescue/bent species along with significant volumes of coarse meadow grasses and some moss and weed invasion.

Plate 6: Typical ground cover

As part of any improvement proposals, the existing sward will be desiccated and killed off, therefore, existing grass quality should be disregarded.

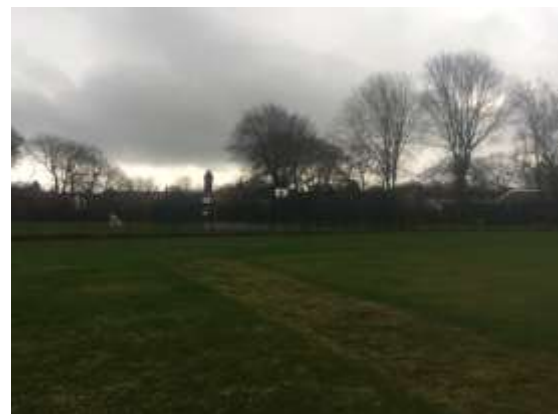
Plate 7: Old cricket wicket observed on site

An old cricket wicket was observed on the site which will need to be removed with the excavation of the clay loam material and replacement with suitable topsoil harvested from peripheral areas of the field.
