Wham Street, Heywood

Preliminary Roost Assessment (PRA)

31<sup>st</sup> May 2023

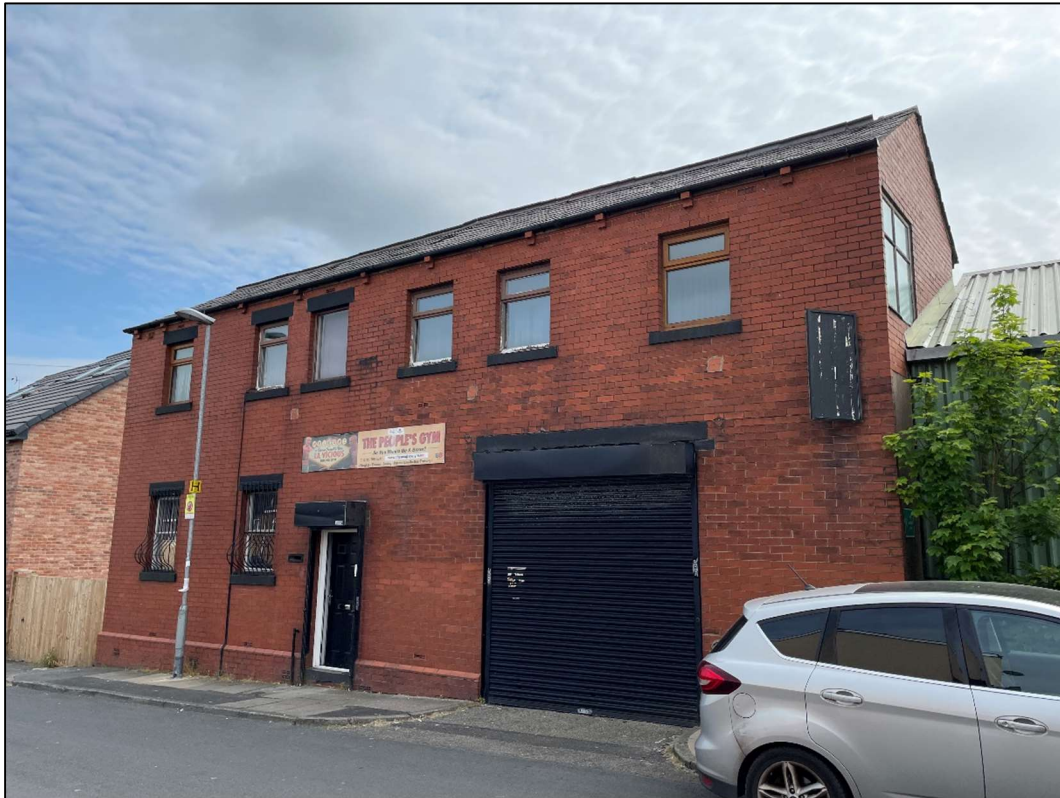
2.2.2.2. The walls of the building comprise brick cavity walls with the gutter supported on brick corbels with a small wooden fascia board above. The windows and doors around the building are a mixture of uPVC and wood framed units.

Figure 2: The front (western) elevation of Building 1.

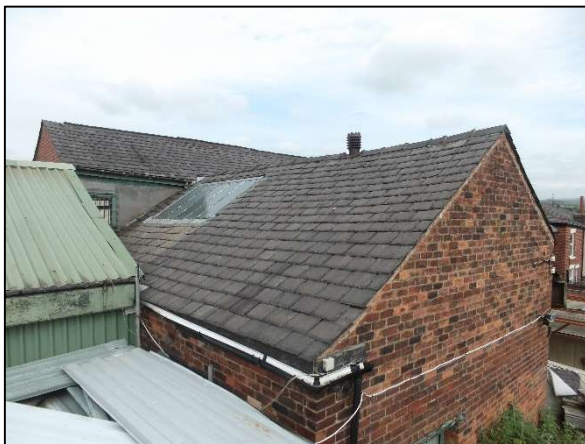
2.2.2.3. The roof of the building comprises a tiled pitched roof.

Figure 3: The rear (eastern) elevation and roof of Building 1.

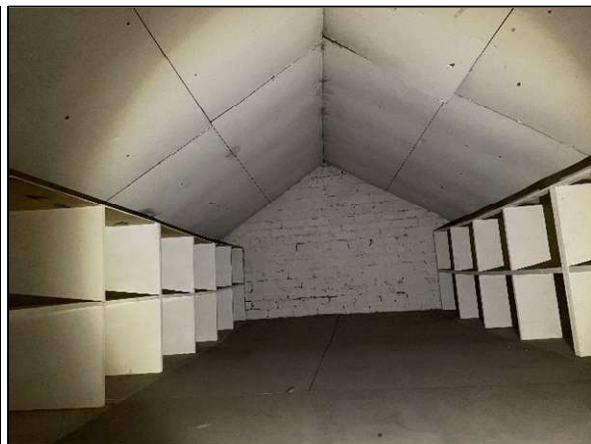
Figure 4: The lined loft space within Building 1.

2.2.2.4. Internally the building displays two loft spaces extending throughout the roof void of the two-storey sections of the building. One loft space displays exposed rafters with a partial bituminous felt lining with the other loft space being fully boarded out for storage.

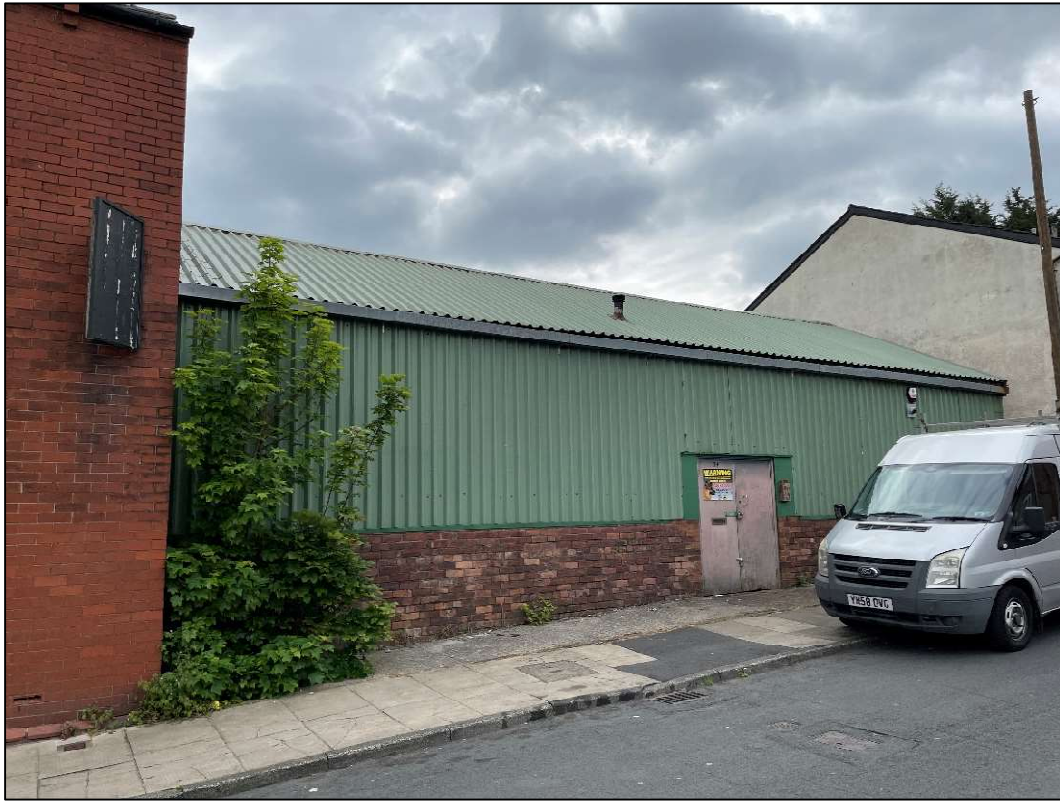
2.2.3.2. The walls of the building comprise brick to 1m with corrugated metal above. The building has metal guttering and open eaves.

Figure 5: The front (western) elevation of Building 2.

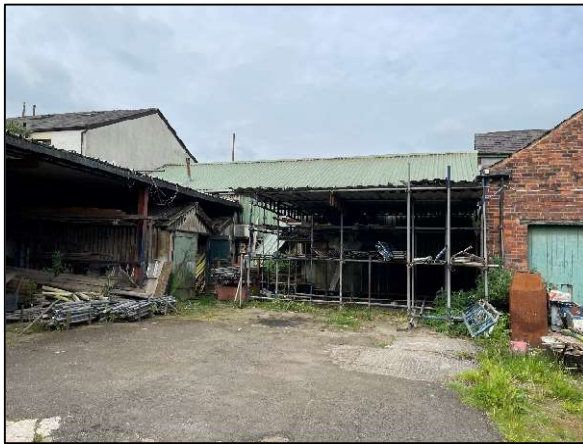
Figure 6: The rear (western) elevation of Building 2.

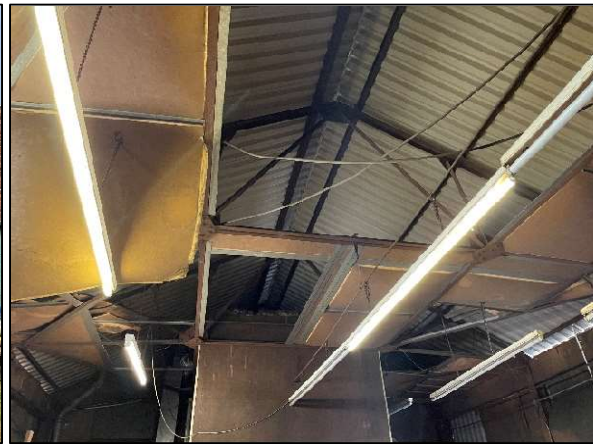
Figure 7: The interior of Building 2.

2.2.3.4. Internally the building predominantly comprises a single room that is open to the inside of the walls and roof with an exposed metal frame. To the south of the building there are a series of separated rooms, although these do not extend into the roof void.

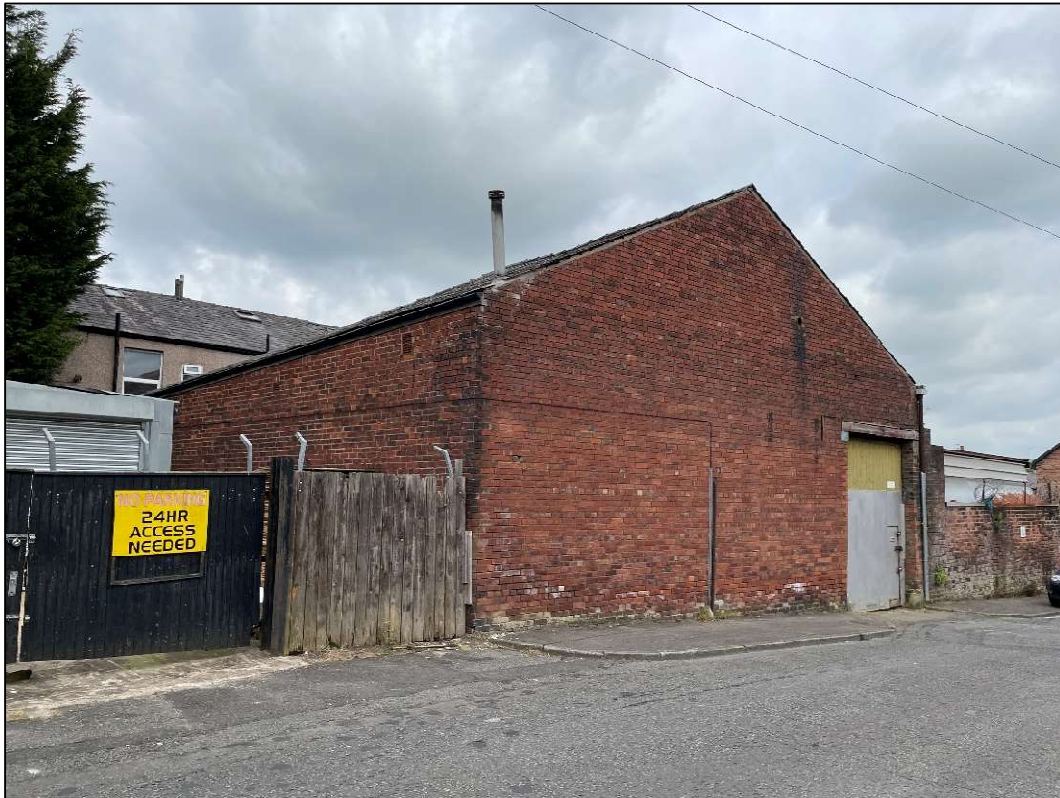
2.2.4.2. The walls of the building comprise solid brick walls with the only door being a large metal door in the eastern elevation. Wooden fascia boards are present along the top of the walls around the building.

Figure 8: The eastern elevation of Building 3.

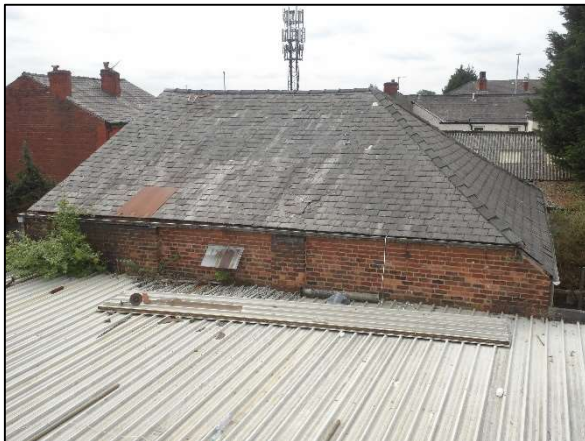
2.2.4.3. The roof of the building comprises a pitched and hipped tiled roof.

Figure 9: The roof of Building 3.

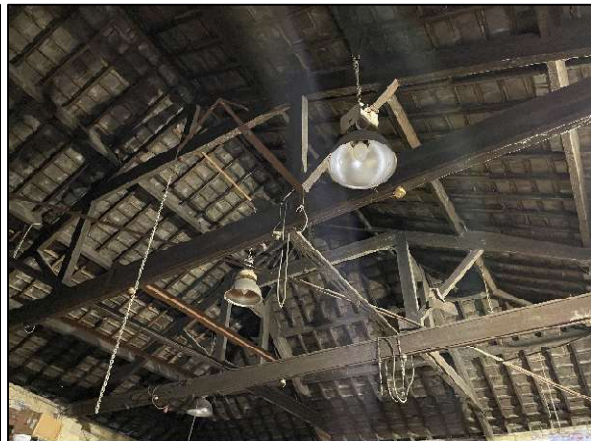
Figure 10: The interior of Building 3.

2.2.4.4. Internally the building comprises a single room that is open into the roof void with exposed queen post timbers and no lining on the inside of the tiles.

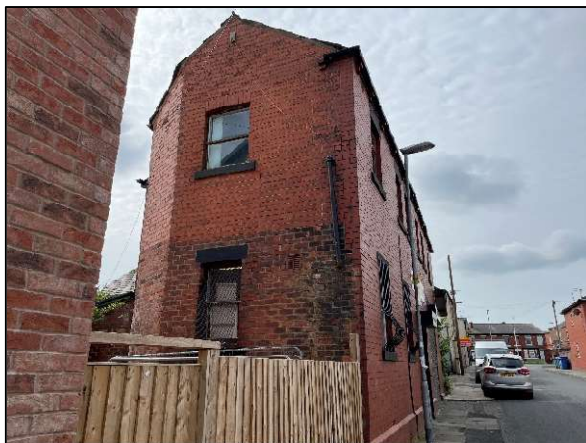
4.2.2.1. The walls of Building 1 were generally found to be in a good condition with no visible cracks or voids. The window and door frames were also found to be tightly sealed into the brickwork.

Figure 12: The northern elevation of Building 1.

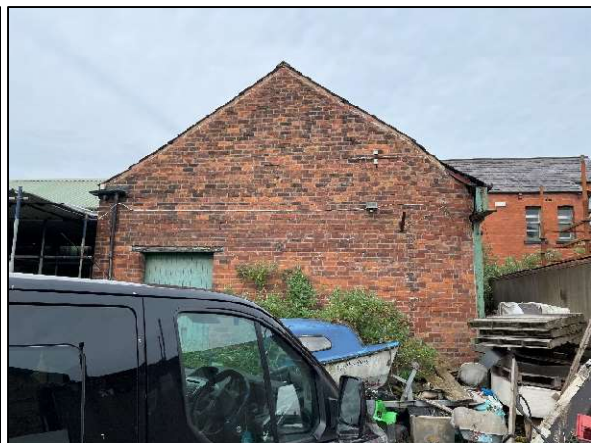
4.2.2.2. The wooden fascia boards on the building were found to be tightly sealed to the brickwork.

Figure 13: The eastern elevation of Building 1.

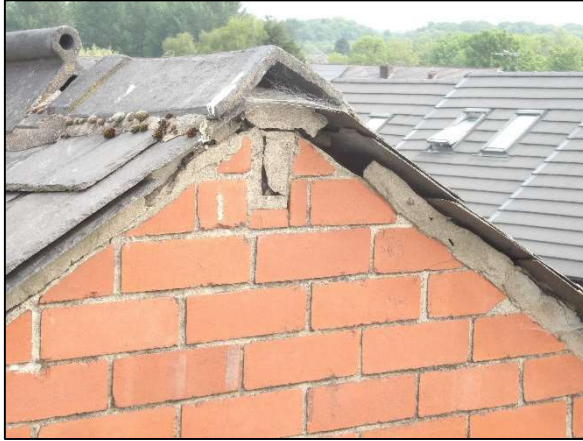
4.2.2.3. The verges of the building displayed occasional areas of missing mortar leaving voids that would allow bats access to the wall tops or roof voids. The voids were covered with cobwebs at the time of this survey with no bat field signs visible on the walls below the voids.

Figure 14: Voids in the verge to the south of Building 1.

5.2. Building 1 was assessed to provide a low potential to support roosting bats. Therefore, it is recommended that no works commence on this building prior to further bat surveys being carried out, in line with the Bat Conservation Trust (BCT) Good Practice Guidelines (2016).

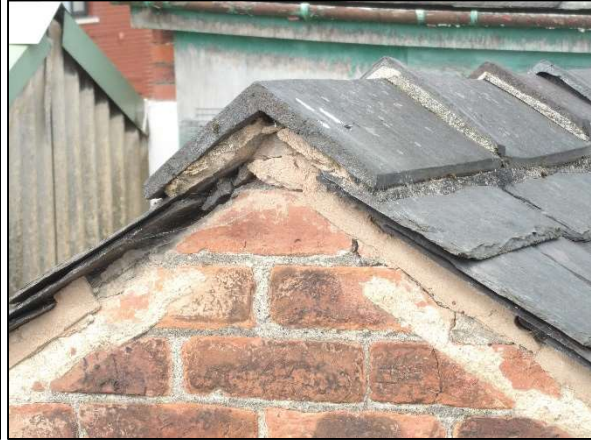
Figure 15: Voids in the verge to the east of Building 1.

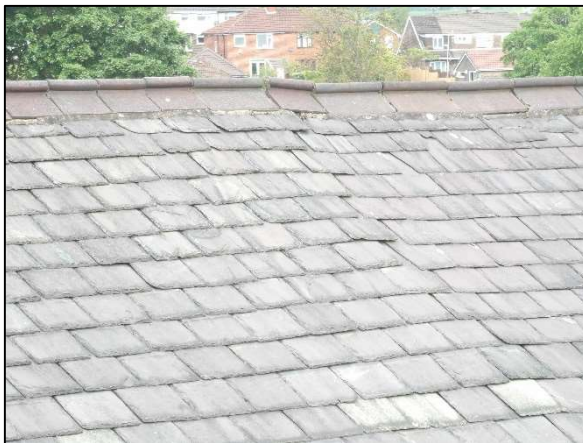
4.2.2.4. The roof of the building was found to display some minor movement in the centre of the building creating small voids underneath the tiles. The remaining areas of the roof were found to be in a good condition with tight fitting roof tiles and the ridge tiles in place and mortared.

Figure 16: Signs of movement in the roof of Building 1.

4.2.2.6. Overall, Building 1 was assessed to provide a low potential for roosting bats due to the voids in the verges and roof of the building. Therefore, the proposed demolition of Building 1 will potentially have a significant impact on any bats or bat roosts present in the building.

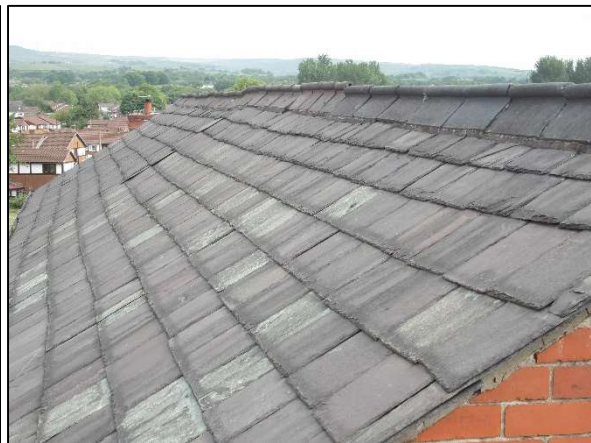
Figure 17: Looking along the roof of Building 1.

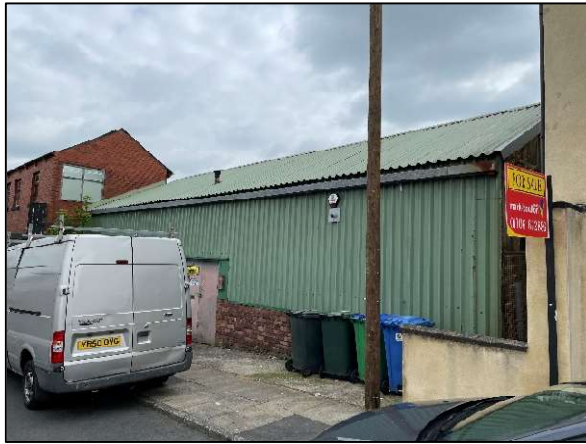
4.2.3.1. The walls and roof of Building 2 were found to be in a good condition with the construction of the building providing no cracks or crevices suitable for roosting bats, although the open eaves provide opportunities for bats to access the interior of the building.

Figure 18: The exterior of Building 2.

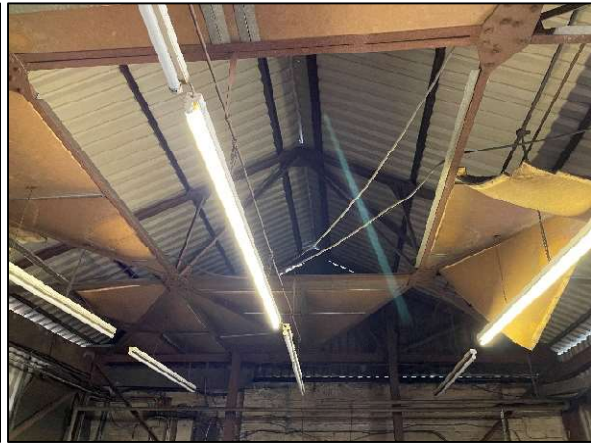
4.2.3.2. The interior of the building was found to be open to the inside of the wall and roof sheets with an exposed metal frame. No bat field signs were identified throughout the interior of the building.

Figure 19: The interior of Building 2.

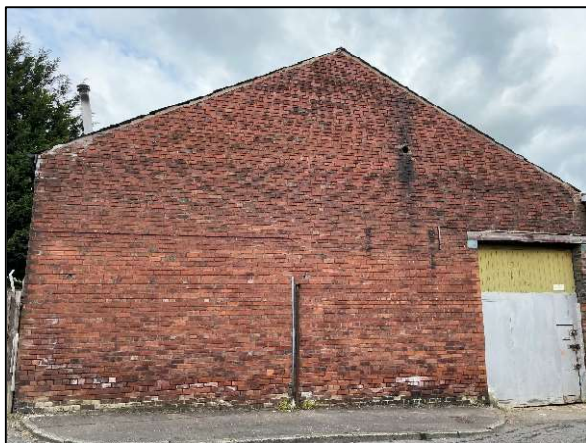
4.2.4.1. The walls of Building 3 were found to be in a generally good condition with occasional minor cracks and voids but no significant voids that would provide opportunities for roosting bats.

Figure 20: The brickwork of Building 3.

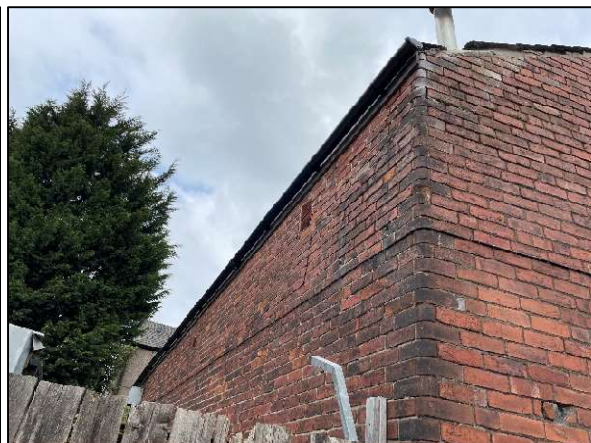
4.2.4.2. The fascia boards around the building were found to be intact and tightly sealed to the brickwork.

Figure 21: The brickwork and fascia board of Building 3.

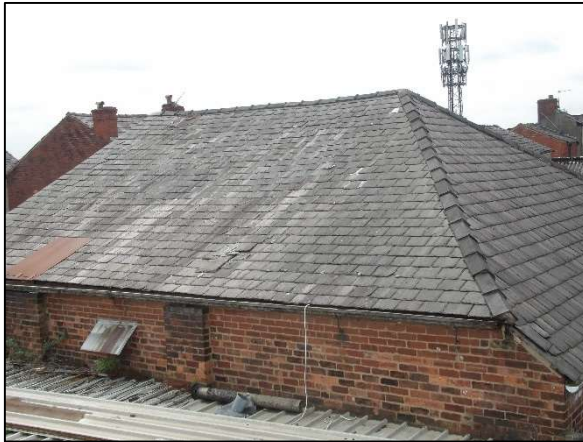
4.2.4.4. The roof of Building 3 was found to be in a generally in a good condition with tight fitting roof tiles and the ridge/hip tiles in place and mortared. Occasional broken or slipped tiles were identified although due to the lack of an internal lining these were assessed to provide minimal potential for roosting bats.

Figure 22: The roof of Building 3.

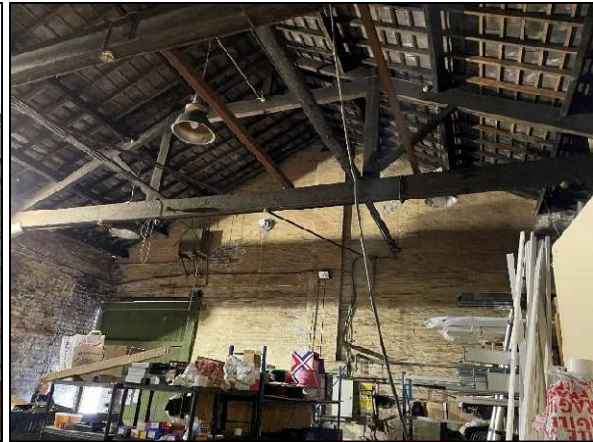
4.2.4.5. The interior of the building was found to be regularly disturbed with no bat field signs identified. The eaves of the building were open displaying light from the exterior and the timbers were predominantly tight fitting, leaving no visible voids around the joints.

Figure 23: The interior of Building 3.

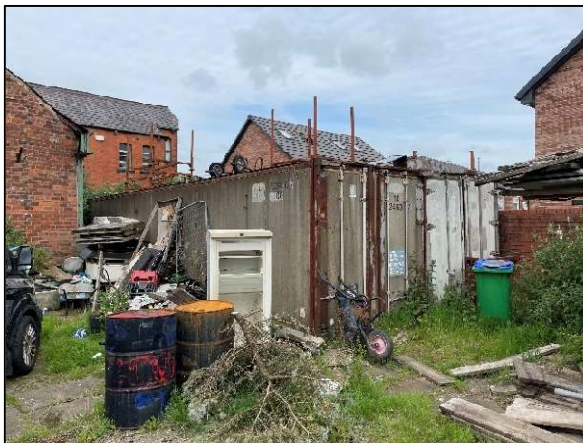
4.2.5. In addition to the permanent structures on the site occasional non-permanent structures were also present in the form of cargo containers and large areas of covered metal racking. These buildings were assessed to provide negligible potential for roosting bats and therefore the removal of these buildings will not impact on roosting bats.

Figure 24: Cargo containers present on the site.

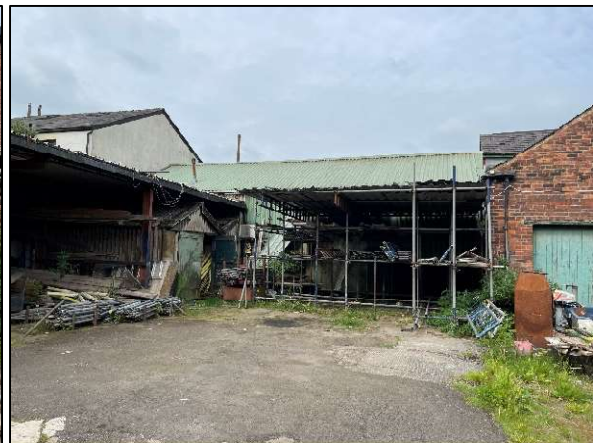
Figure 25: Areas of metal racking behind the buildings.
