## Bat Emergence and Re-Entry Surveys (BERS)

1 Redcross Street, Rochdale, Greater Manchester, OL12 0NZ

‘Demolition of the on-site building’

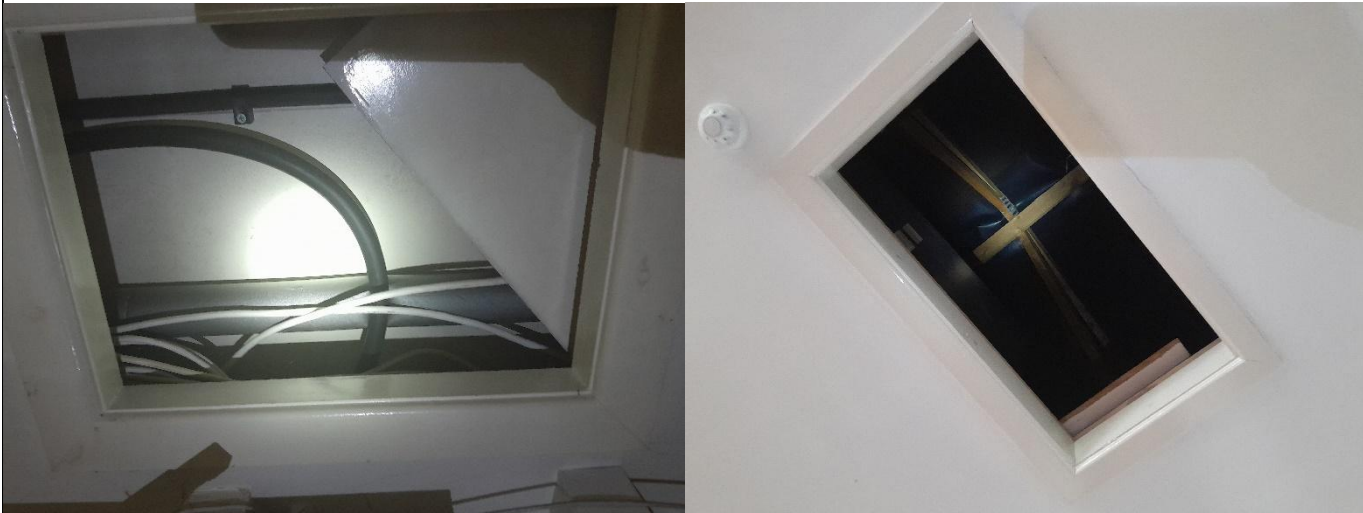
| Field Survey | |
|---|---|
| <i>Building inspection prior to survey</i> | <p>An internal check was conducted by Kayleigh Davies, Graduate Ecologist (Accredited Agent on Natural England Bat License Number. 2019-41480-CLS-CLS) prior to the bat emergence and re-entry survey, inspecting the loft hatch and overview of the site interior which was observed to be the same as the PRA conducted by Arbtech in 2023. No bat evidence was observed, internal humidity was 57% and temperature recorded at 12°C.</p> <p>Internal inspection of the site:</p> <p>Loft hatches:</p> <div></div> |

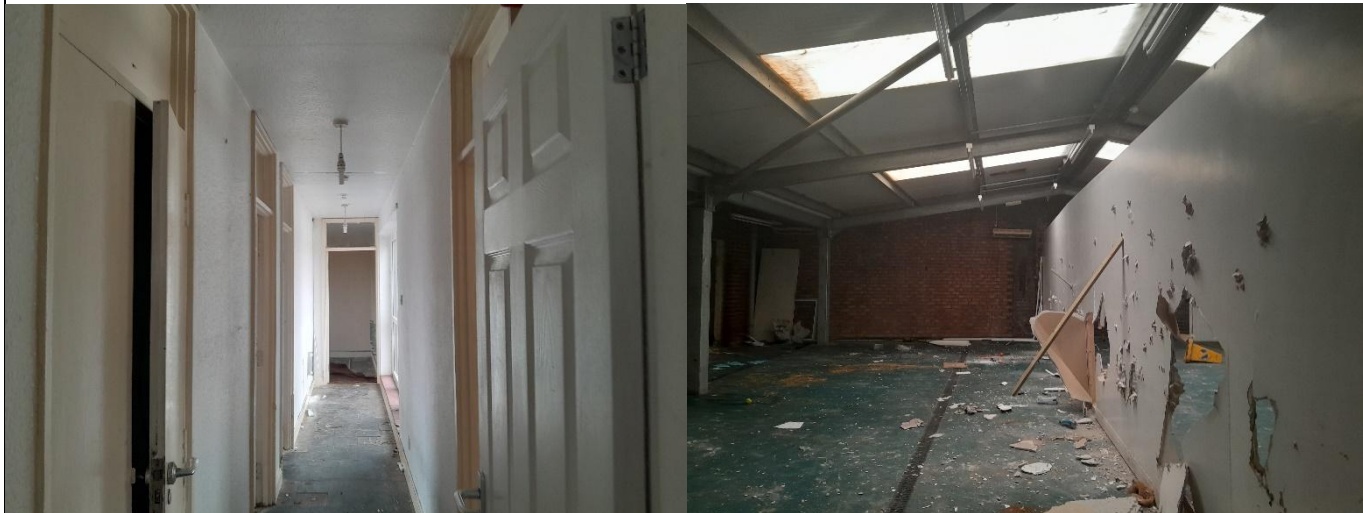
| | | Overview of internal space: | | | | | |

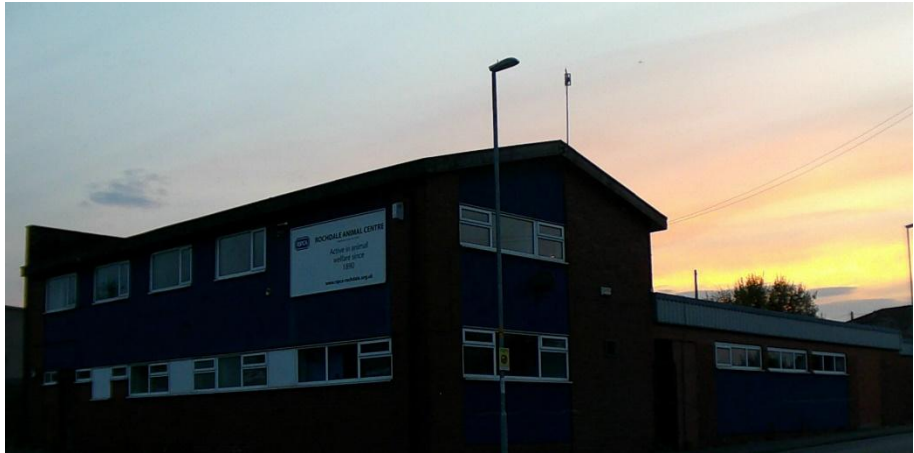
| <i>Surveyor 1</i> | <b>No emergences.</b><br>No activity was seen or heard throughout the survey. | | | | | | |

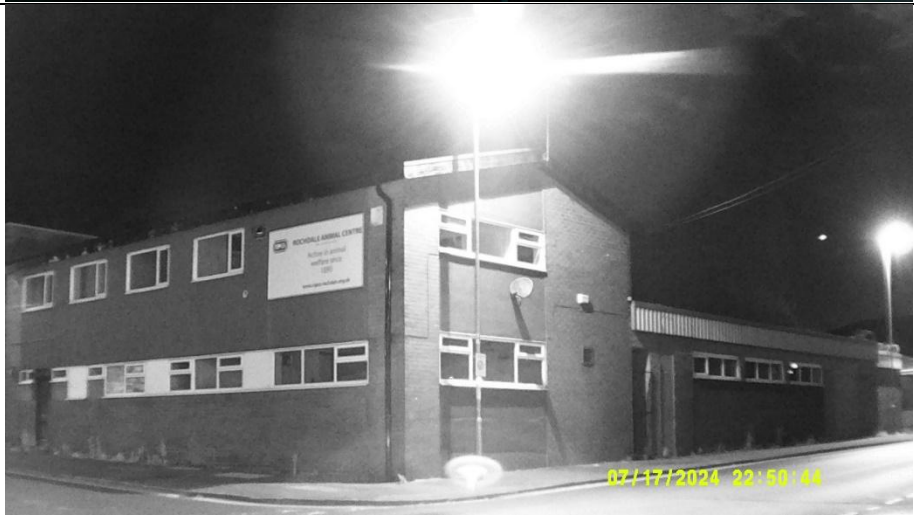
| <i>IR positioned next to surveyor 1</i> | The IR footage showed the same results as recorded by surveyor 1, with no additional bat activity recorded. | | | | | | |

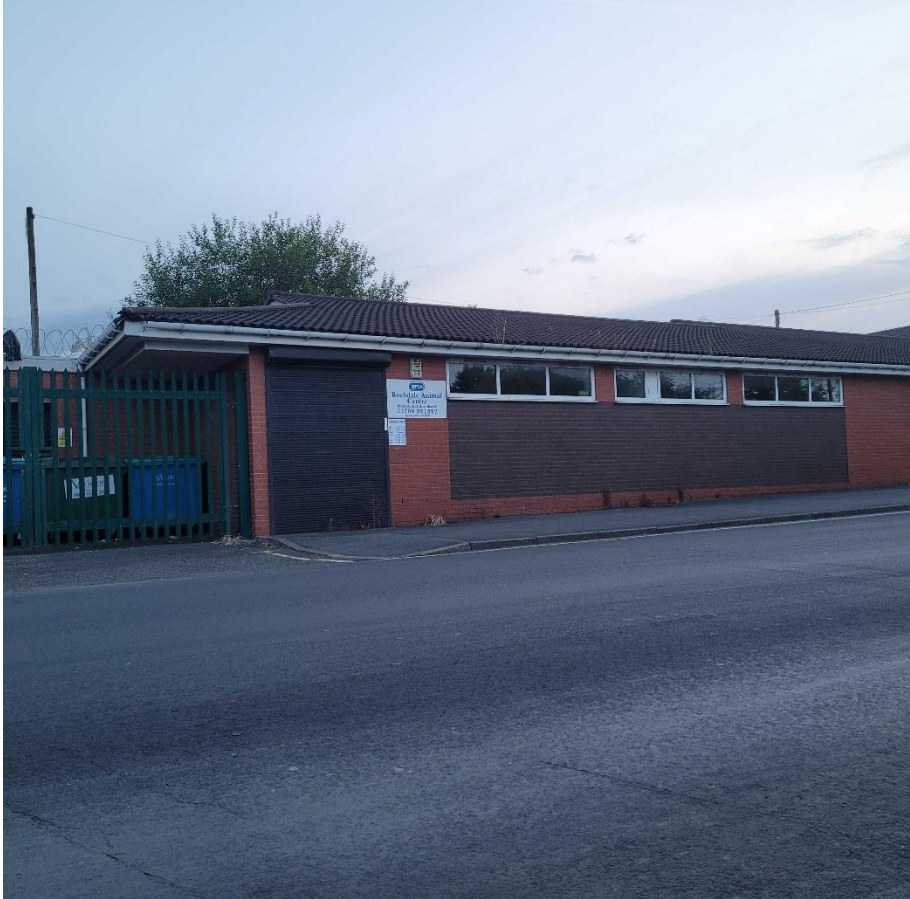
| <i>Surveyor 2</i> | <b>No emergences.</b><br>One common pipistrelle was heard not seen foraging in the distance at 22:06. | |

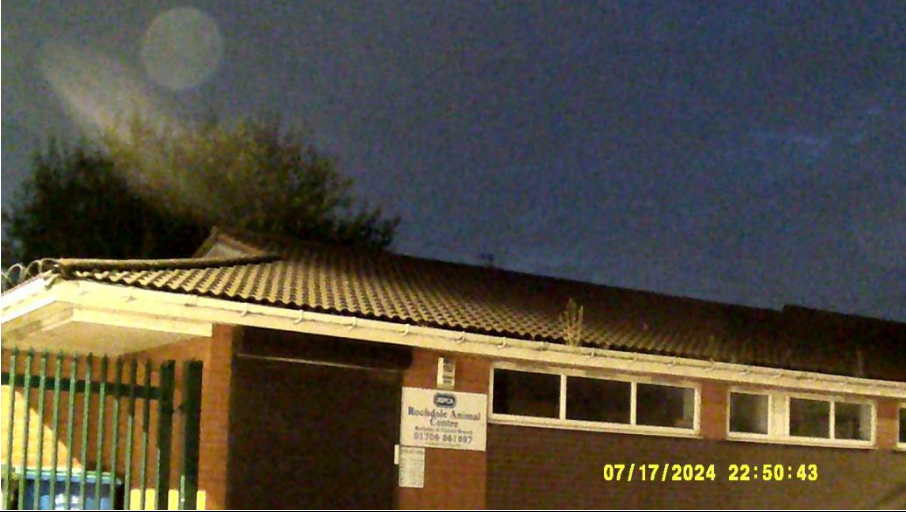
| <i>IR positioned next to surveyor 2</i> | The IR footage showed the same results as recorded by surveyor 2, with no additional bat activity recorded. | |

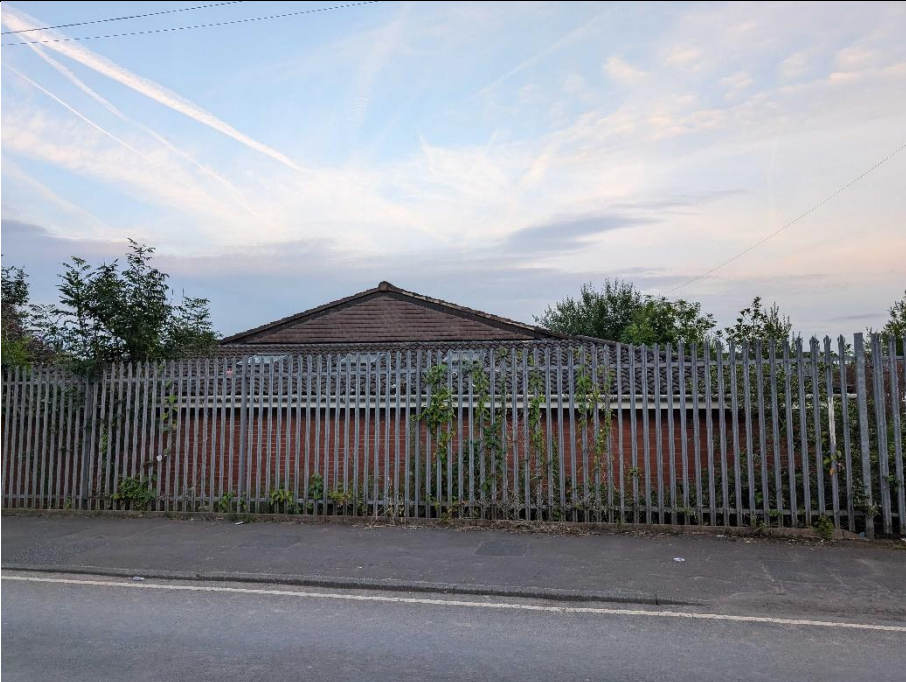
| Surveyor 3 | <b>No emergencies.</b><br>First activity was a common pipistrelle commuting off site from east to west at 21:52 to the north of the building.<br>Sporadic foraging and commuting continued from 21:58 to 22:08 until the last activity at 22:48. | |

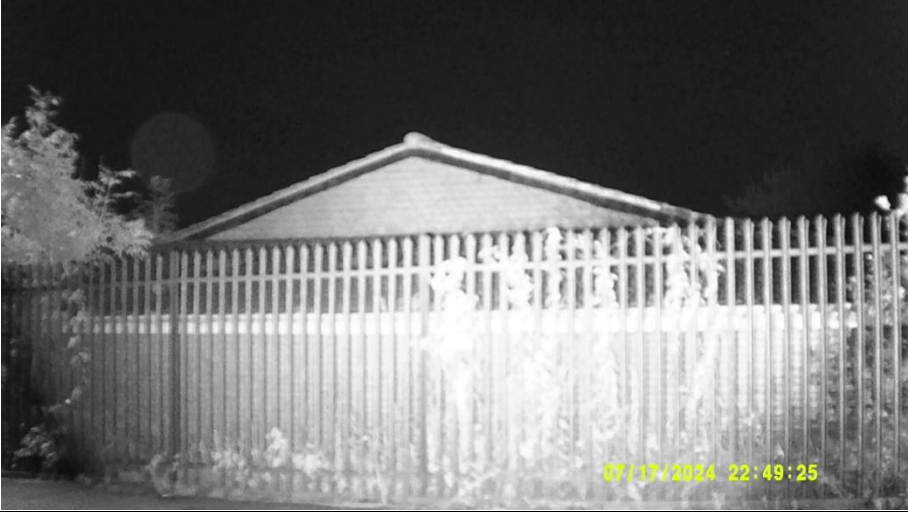
| <i>IR positioned next to surveyor 3</i> | The IR footage showed the same results as recorded by surveyor 3, with no additional bat activity recorded. | |

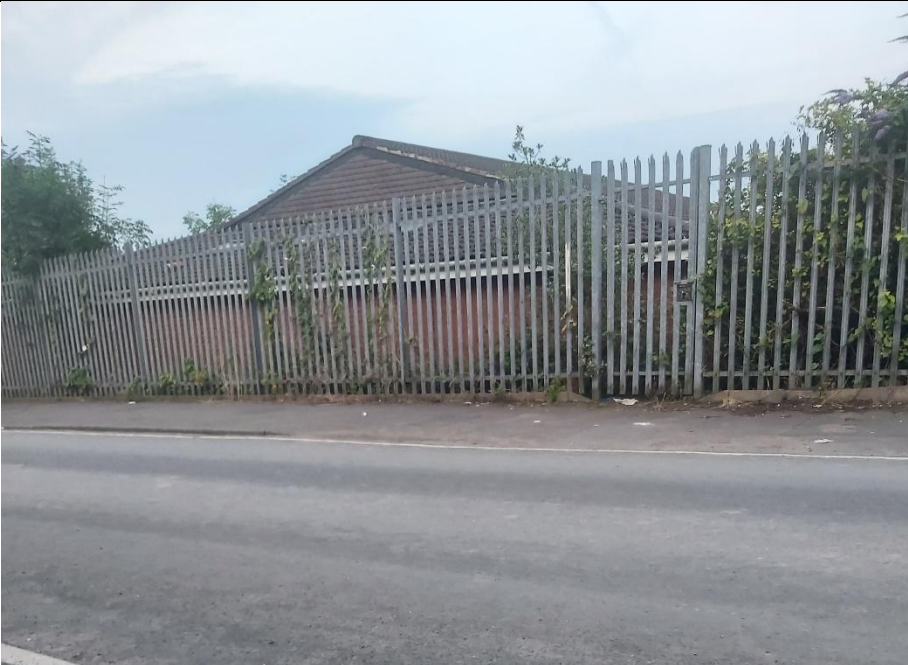
| Surveyor 4 | <b>No emergences.</b><br>First activity was a common pipistrelle at 21:51 heading northeast to southwest on site above B1. Foraging behaviour of common pipistrelles was then observed off site, around the flats and ornamental tree behind the surveyors at 21:58, 22:02 and 22:08. | |

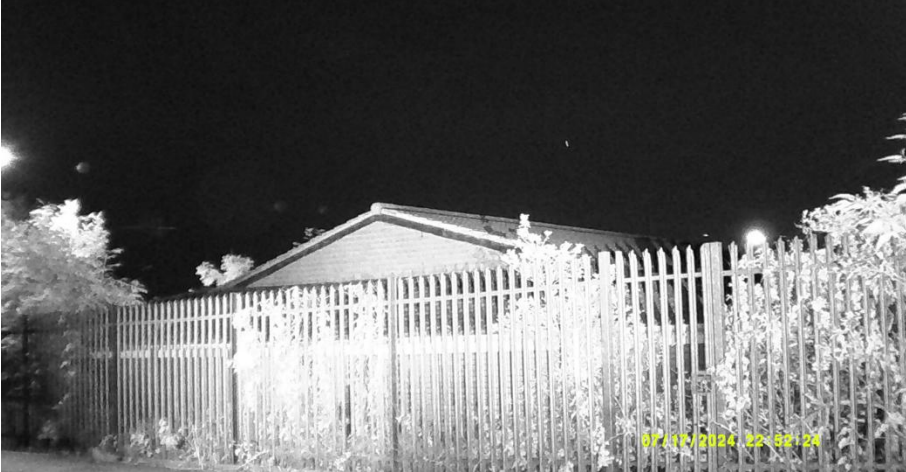
| <i>IR positioned next to surveyor 4</i> | The IR footage showed the same results as recorded by surveyor 4, with no additional bat activity recorded. | An infrared (IR) night vision image showing a building with a gabled roof and a white picket fence in the foreground. The scene is illuminated by IR light, making the fence and foliage appear bright white against a dark background. A yellow timestamp in the bottom right corner reads "07/10/2024 22:52:24". |

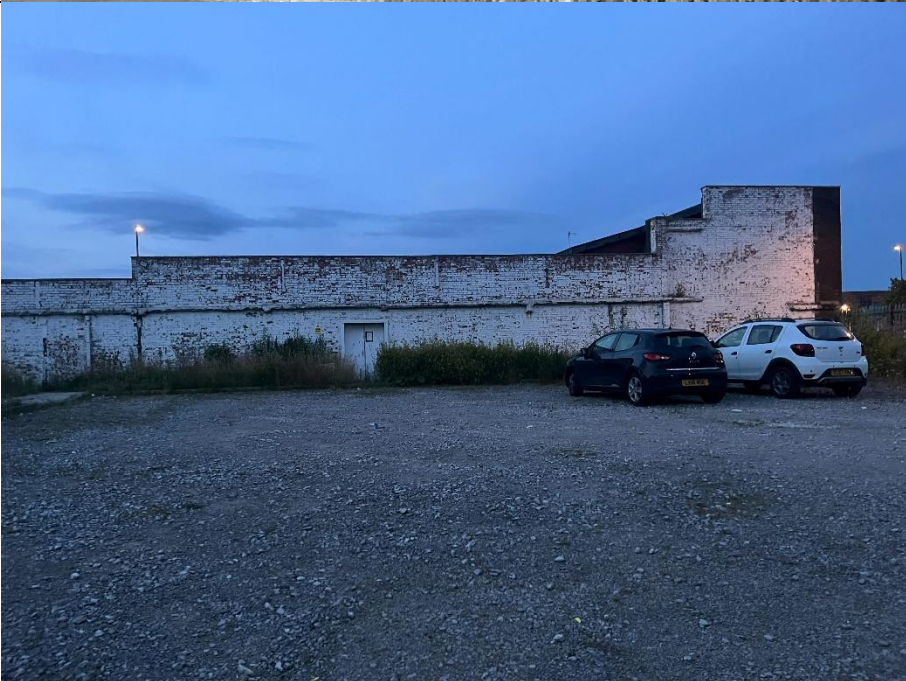
| <i>Surveyor 5</i> | <b>No emergencies.</b><br>First activity was a common pipistrelle at 22:00 commuting west to east on site and then quickly turning to the north of B1.<br>Three more passes were observed by common pipistrelles flying along the scrub area to the north of surveyor 5.<br>Final activity was a common pipistrelle heard but not seen at 22:50. | A daytime photograph of a long, single-story building with a light-colored, possibly white, facade. Two cars are parked in a gravel lot in front of the building: a dark-colored car on the left and a white car on the right. The sky is a clear blue. |

| Conclusions, Impacts and Recommendations | |
|---|---|
| <i>Survey Results Summary</i> | <p>No bats were observed emerging from the building during the emergence survey, and no evidence of bats was found during the preliminary assessment survey.</p> <p>A notable pathways was identified by surveyor 5 along the hedgerow towards the building which was highlighted to be a foraging pathway.</p> |

| Conclusions, Impacts and Recommendations | |
|---|---|
| <i>Recommendations</i> | <p>The hedgerow on stie should be retained if possible. Moreover, a low impact lighting strategy will be adopted for the site during and post development, which will include light spill on to the hedgerow being avoided as this has been observed as a foraging route.</p> <p>A precautionary working method will be implemented during and post-development. This will include the following measures:</p> |

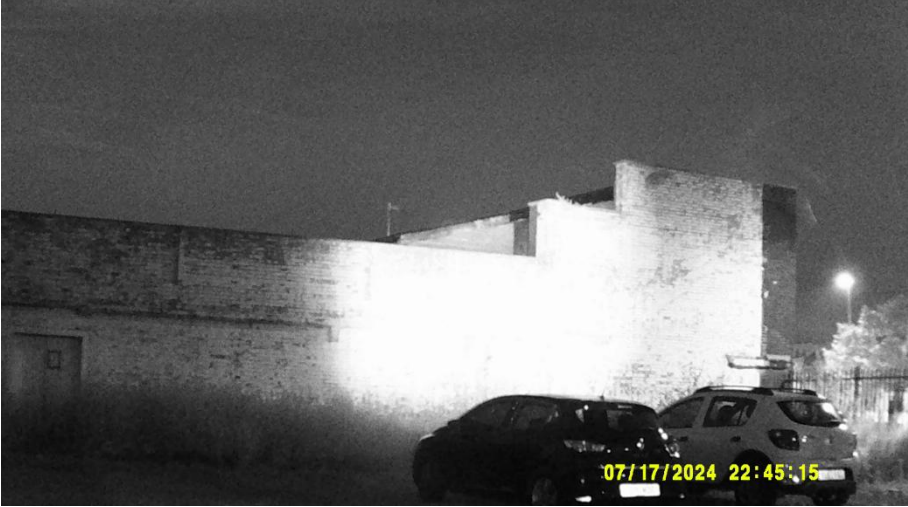
| <i>IR positioned next to surveyor 5</i> | The IR footage showed the same results as recorded by surveyor 5, with no additional bat activity recorded. | A black and white infrared (IR) photograph of a building at night. The building is a multi-story structure with a flat roof and a prominent chimney. A bright light source, likely a spotlight, illuminates the side of the building, creating a strong contrast with the dark sky. In the foreground, two vehicles are parked: a dark sedan on the left and a white SUV on the right. A yellow timestamp in the bottom right corner of the image reads "07/17/2024 22:45:15". |
