## INNINGS WAY, CASTLETON PRELIMINARY SUMMARY LETTER – GEO-ENVIRONMENTAL SITE ASSESSMENT

Further to the completion of our recent Ground Investigation works, review of historical data, geological mapping and environmental Site sensitivity information, E3P has prepared an initial Geo-Environmental Site Assessment summary that has been issued as a precursor to the full Interpretive Geo-Environmental Report.

| <b>Site Address</b> | Innings Way, Castleton, Rochdale, OL11 3DE | |

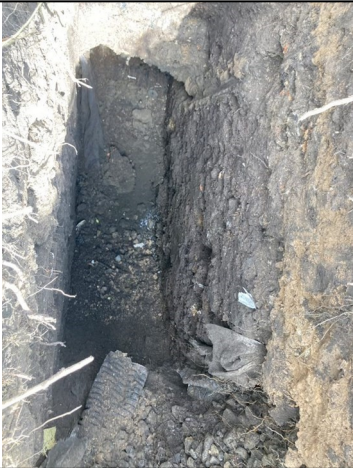
Trial Pit 101

Remarks: 1. Complete. 2. Stable. 3. Water strike encountered as slow seepage at 3.10 m bgl. 4. Full depth of Made Ground unproven.

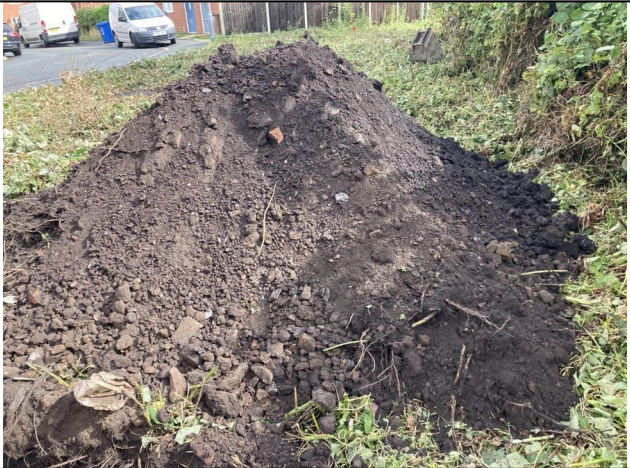
Trial Pit 101 Spoil

| | | | | <h1 style="text-align: center;">Trial Pit Log</h1> | | | TrialPit No<br><b>TP101</b><br>Sheet 1 of 1 | | |
|---|---|---|---|---|---|---|---|---|---|
| | | | | 0.80 | | | MADE GROUND: Light brown very gravelly fine to medium sand with occasional cobbles. Gravel is fine to coarse angular to subrounded of brick, concrete, ash, plastic, sandstone, and mudstone. Cobbles are angular to subrounded of brick and concrete. | | |
| | | | | | | | MADE GROUND: Black slightly clayey sandy gravel with occasional cobbles. Gravel is fine to coarse, angular to subrounded of ash, brick, plastic, glass, mudstone and sandstone. Cobbles are angular to subangular of glass, plastic and brick. | | |

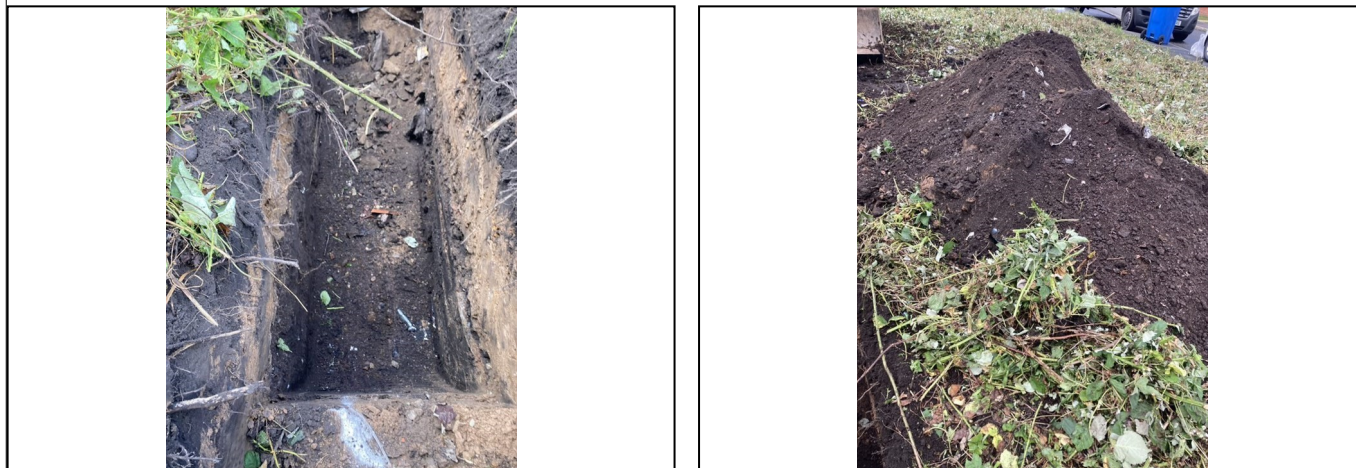
Trial Pit 102

| Water Strike | Samples & In Situ Testing | | | Depth (m) | Level (m) | Legend | Stratum Description | |
|---|---|---|---|---|---|---|---|---|
| | 1.20 | ES | | | | | MADE GROUND: Light brown very gravelly fine to medium sand with frequent cobbles. Gravel is fine to coarse, angular to subrounded of plastic, glass, brick, mudstone, cloth, and sandstone. Cobbles are angular of plastic and brick. | 1 |

Remarks: 1. Terminated due to potential service. 2. Stable 3. No groundwater encountered. 4. Full depth of Made Ground unproven.

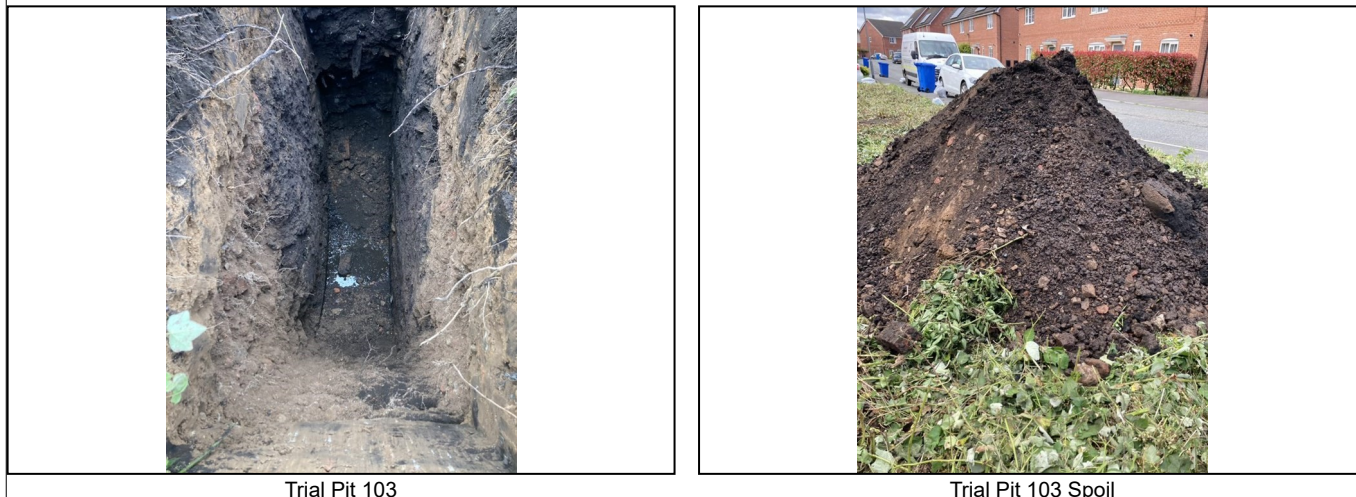
Trial Pit 103

| Water Strike | Samples & In Situ Testing | | | Depth (m) | Level (m) | Legend | Stratum Description | |
|---|---|---|---|---|---|---|---|---|
| | | | | | | | MADE GROUND: Black sandy gravel with occasional cobbles. Gravel is fine to coarse, angular to rounded of brick, coal, plastic, metal, ash, timber, sandstone and mudstone. Cobbles are angular to subangular of brick. (Strong hydrocarbon odour from 2.60 m bgl). | 1 |

Remarks: 1. Complete. 2. Stable. 3 Strong hydrocarbon odour encountered at 2.60 m bgl. 4. No groundwater encountered. 5. Full depth of Made Ground unproven.

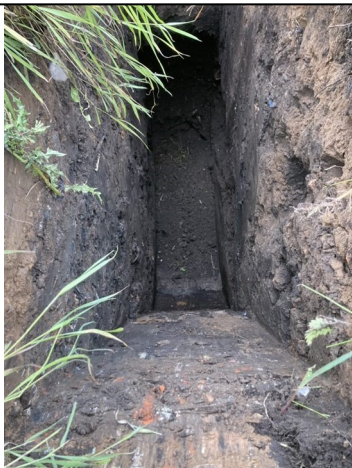
Trial Pit 104

Remarks: 1. Complete. 2. Stable. 3. Slight organic odour encountered from 2.80 m bgl. 4. Very strong organic odour encountered from 3.40 m bgl. 5. No groundwater encountered.

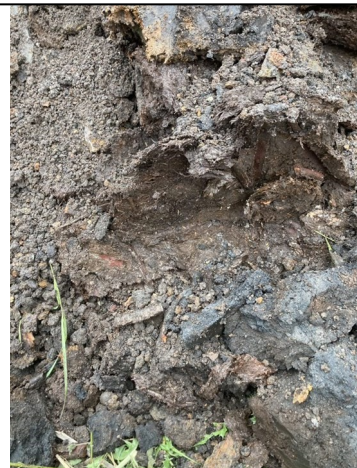
Trial Pit 104 Spoil

| Water Strike | Samples & In Situ Testing | | | Depth (m) | Level (m) | Legend | Stratum Description | |
|---|---|---|---|---|---|---|---|---|
| | | | | 2.40 | | | MADE GROUND: Black very gravelly fine to medium sand with frequent cobbles. Gravel is fine to coarse, angular to subrounded of tile, ash, mudstone, sandstone, plastic, and coal. Cobbles are subangular of brick. (Slight organic odour encountered from 2.80 m bgl). | 3 |
| | 3.40 | ES | | 3.40 | | | Grey very silty fine to medium SAND with pockets of blackish brown fibrous PEAT. (Very strong organic odour). (Potential Pond Material). | |

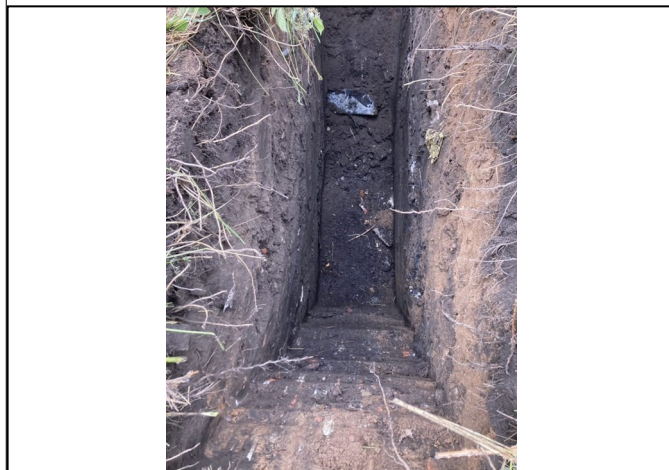
Trial Pit 105

Remarks: 1. Complete. 2. Stable. 3. Strong organic odour encountered from 2.30 m bgl. 4. No groundwater encountered.

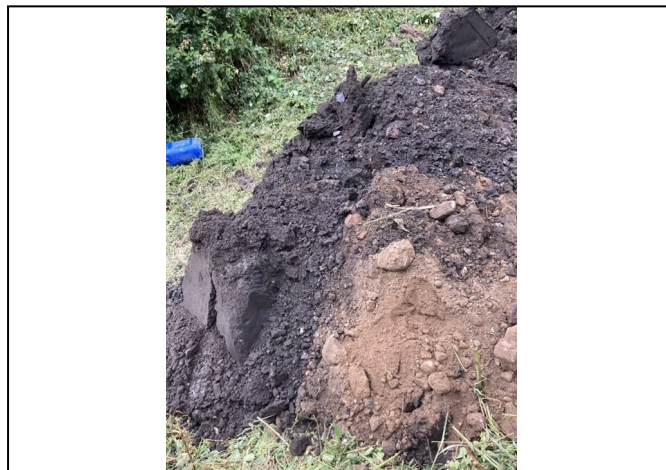
Trial Pit 105 Spoil

| Water Strike | Samples & In Situ Testing | | | Depth (m) | Level (m) | Legend | Stratum Description | |
|---|---|---|---|---|---|---|---|---|
| | | | | 1.30 | | | MADE GROUND: Soft black silty very gravelly clay. Gravel is fine to coarse, angular to subrounded of ash, brick, concrete, timber, sandstone and mudstone. | 2 |
| | | | | 2.30 | | | Very soft black very silty CLAY interbedded with blackish brown fibrous PEAT. (Strong organic odour) | |

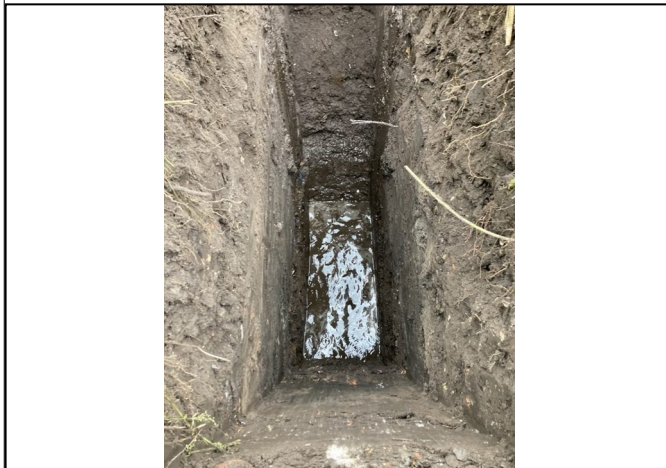
Trial Pit 106

Remarks: 1. Complete. 2. Stable. 3. Very strong organic odour encountered from 3.30 m bgl. 4. Water strike encountered as moderate ingress at 3.40 m bgl (pooling at base of trial pit).

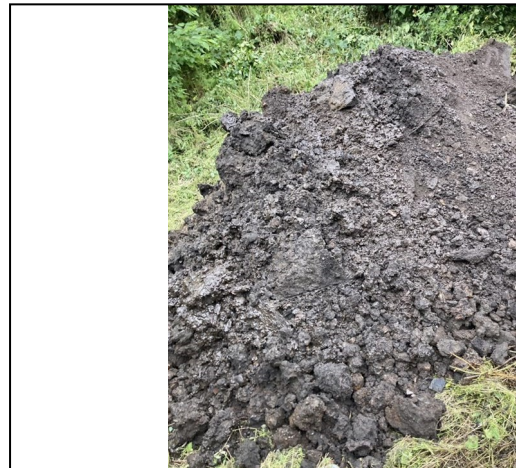
Trial Pit 106 Spoil

| Water Strike | Samples & In Situ Testing | | | Depth (m) | Level (m) | Legend | Stratum Description | |
|---|---|---|---|---|---|---|---|---|
| | | | | 3.60 | | | Grey very silty fine to medium SAND with pockets of blackish brown fibrous PEAT. (Very strong organic odour). (Potential Pond Material). | |

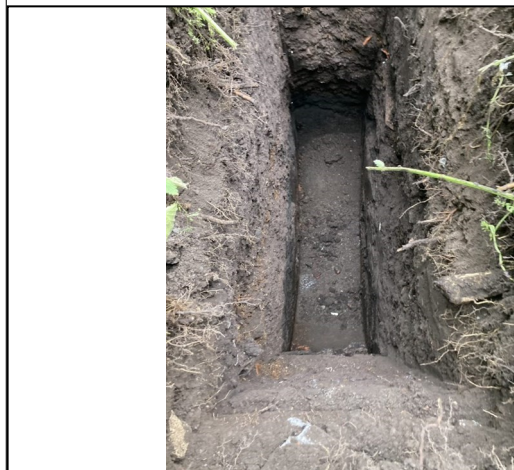
Trial Pit 107

Remarks: 1. Complete. 2. Stable. 3. Very strong organic odour encountered from 3.10 m bgl. 4. No groundwater encountered.
