# EXTENDED PHASE 1 HABITAT SURVEY & DAYTIME BAT SURVEY

## 342 HEYWOOD OLD ROAD, BOWLEE

FEBRUARY 2022

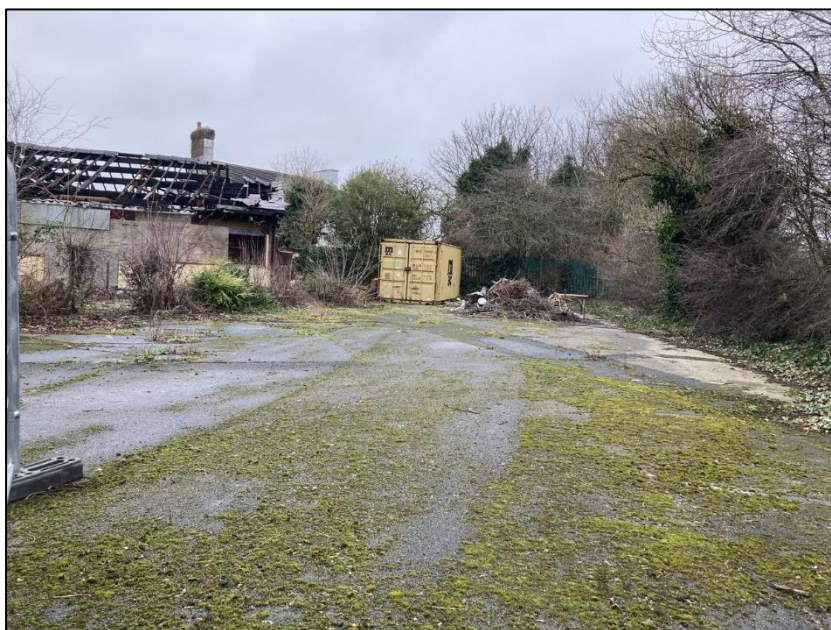
- 3.2 The majority of the site is covered with hardstanding, surrounding the building and used as car parking (see Photograph 1). This has been mapped as bare ground.

Photograph 1 showing the hardstanding

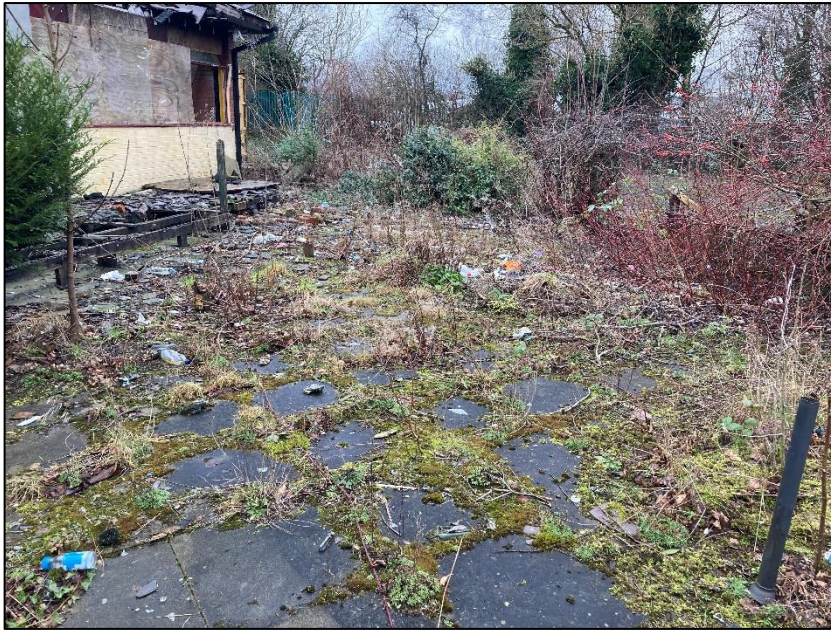
- 3.3 Ephemera Short Perennial vegetation has started to colonise the edges of the hardstanding (see Photograph 2). This is composed of Yorkshire Fog *Holcus Lanatus*, Annual Meadow-grass *Poa annua*, Ivy *Hedera helix*, Broad-leaved Willowherb *Epilobium montanum*, Common Nettle *Urtica dioica*, Bramble *Rubus fruticosus* agg. and Bryophytes.

Photograph 2 showing the ephemeral short perennial

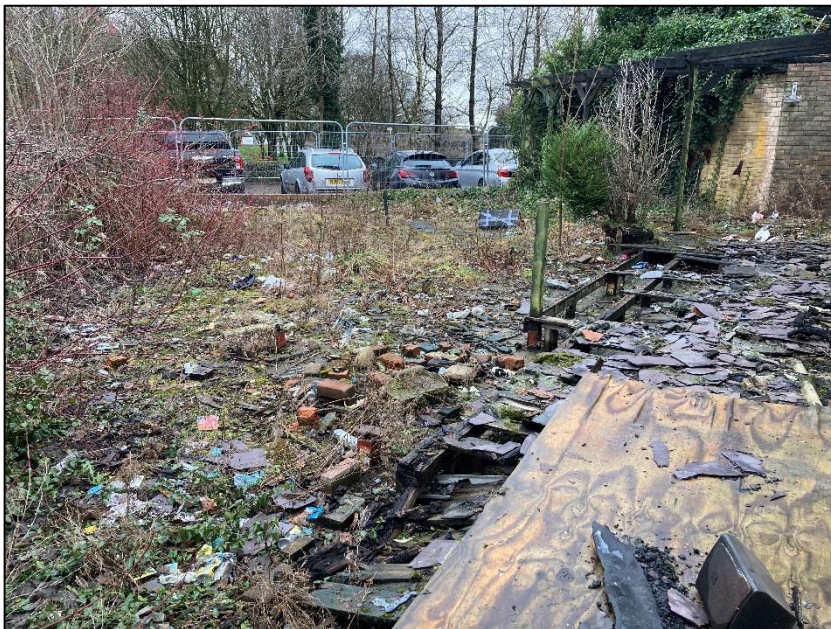
- 3.4 Scattered scrub is present on the northern site boundary and within the ephemeral vegetation (see Photograph 3). This is composed of young Elder *Sambucus nigra*, Field Rose *Rosa arvensis*, Leyland Cypress *Cupressus leylandii* and Sycamore *Acer pseudoplatanus*.

Photograph 3 showing some of the scattered scrub

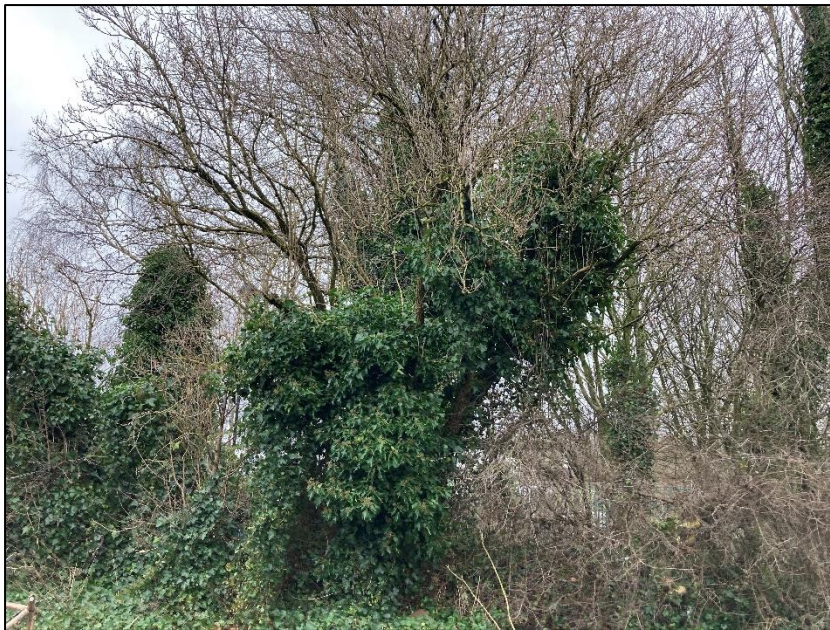
- 3.6 Scattered trees occur on the site, on the eastern boundary within the species-poor hedgerow (see Photograph 4). The sole tree species present was Elder *Sambucus nigra*.

Photograph 4 showing some of the scattered trees on site

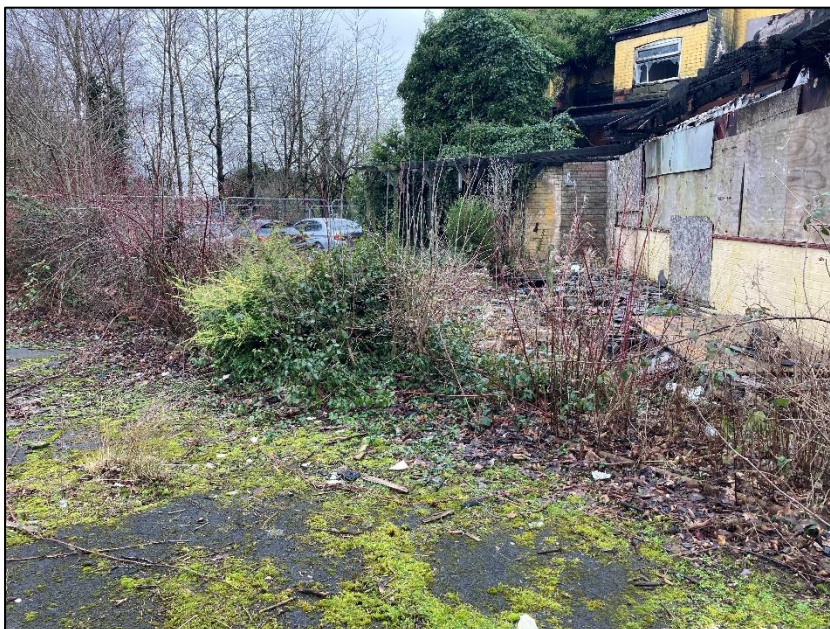
- 3.7 A flower bed is present at the rear of the building and as large planters at the front of the buildings (see Photograph 5). Species include Wilsons Honeysuckle *Lonicera nitida* Bramble *Rubus fruticosus* agg Hawthorn *Crataegus monogyna* Holly *Ilex aquifolium* and Blackthorn *Prunus spinosa*.

Photograph 5 showing the introduced shrub to the rear of the building

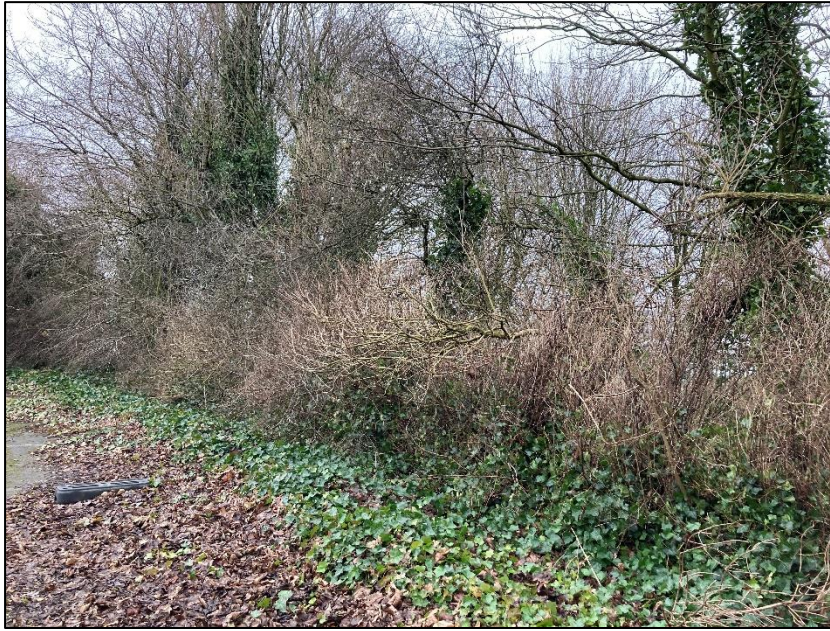
- 3.8 A species-poor hedgerow exists on the eastern boundary of the site (see Photograph 6). The dominant species is Blackthorn *Prunus spinosa* with occasional Sycamore *Acer pseudoplatanus*, English Elm *Ulmus procera* and Holly *Ilex aquifolium*.

*Photograph 6 showing the hedgerow*

- 4.7 The hedgerow on site could provide bat foraging and commuting habitat, if the hedgerow is retained as a part of the development, it is recommended that soft lighting is used in this area.

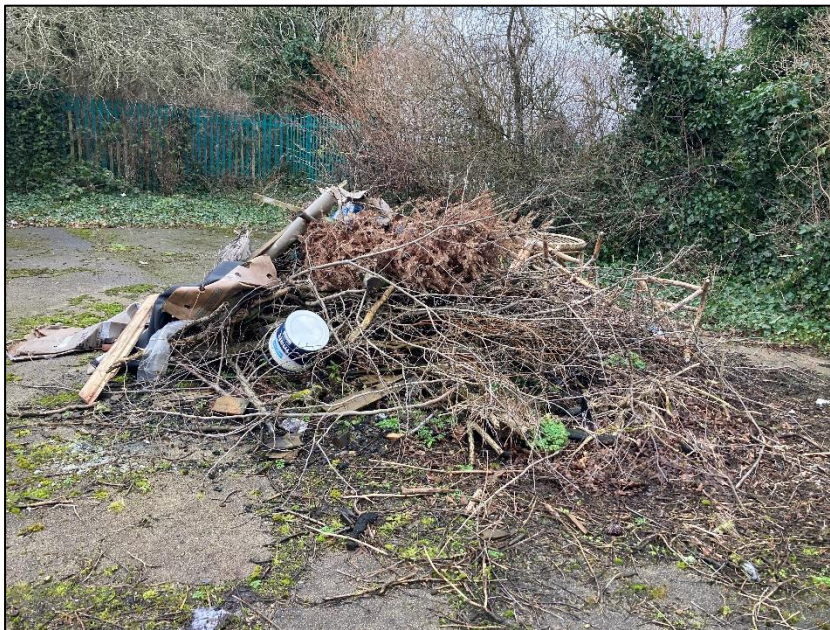
- 3.9 The former restaurant building is present on the site along with a shipping container. On the hardstanding to the rear of the building is a spoil heap composed of building materials and vegetation (see Photograph 7).

*Photograph 7 showing the spoil heap*

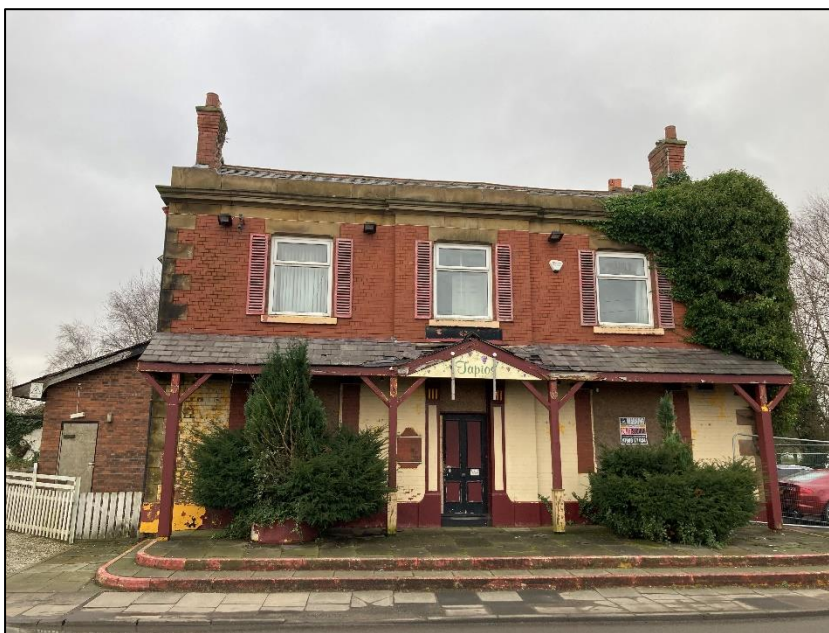
- 3.13 The former restaurant building was the subject of a daytime bats survey. There was not internal access at the time of the survey as extensive fire damaged am resulting in the building being unsafe, as a result an external assessment only was carried out.
- 3.14 The main building is a two-storey former pub/restaurant and is of brick construction with a pitched tiled roof (see Photograph 8). Single-story extensions exist on the northern and eastern elevations which are in a poor condition, extensively fire damaged (see Photograph 9). The brickwork on both the main building and the extensions are generally complete with no missing or damaged sections of brickwork/mortar that could provide potential roosting opportunities for bats.

Photograph 8 showing the exterior of the main building part of the northern extension

- 4.5 The building on site was the subject of a daytime bat survey, there was no internal access at the time of the survey due to the extensive fire damage. The main section of the building is complete externally with potential access points created via the damaged windows, small gaps under the roof tiles and the small number of damaged/missing roof tiles. As there was no internal access and the building supports potential access points is considered to offer **low potential** to support a bat roost and a precautionary dusk emergence survey is recommended. The rear of the building is completely damaged by the fire and offers **negligible potential** to support a bat roost.

- **Nesting Birds** - If any work to the scattered scrub needs to be carried out within the bird nesting season (which is generally March to August), then a nesting bird survey will be required immediately prior to work commencing.
- **Bats** – further survey is required to determine if an active roost is present, and if so, the species of bat and the type of roost present. It is recommended that a minimum of one dusk emergence/dawn re-entry surveys are undertaken at the building at an optimal time of year (between May and September).

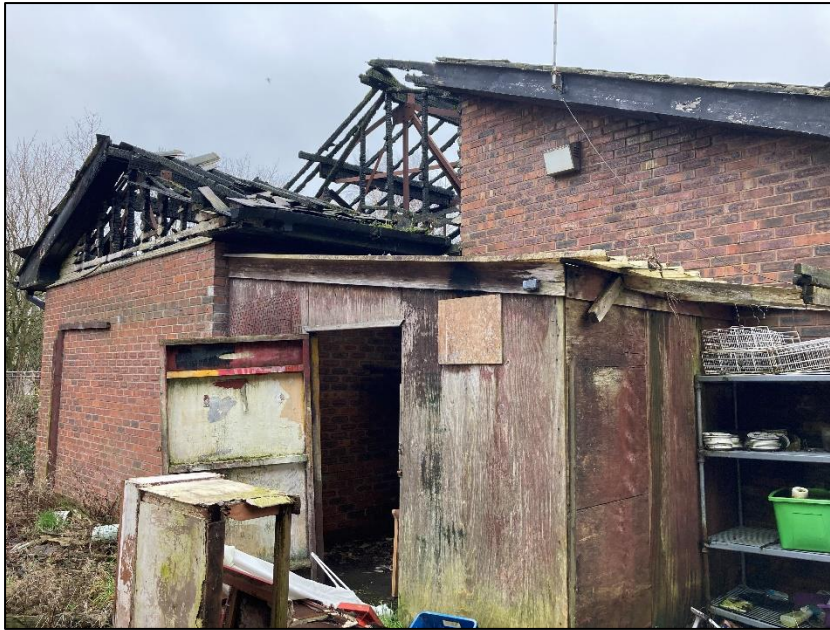
*Photograph 9 showing the fire damaged eastern extension*

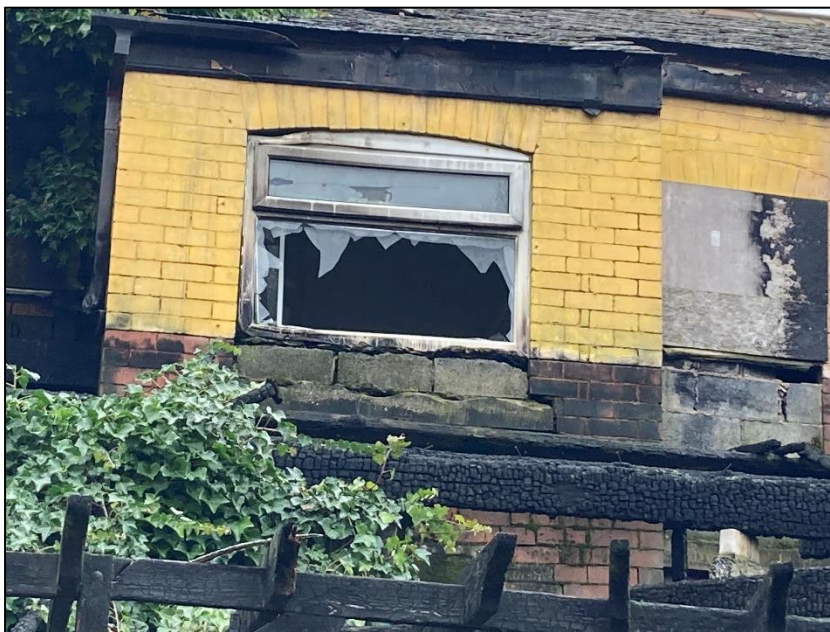
- 3.15 The windows and door frames on the front facing elevation of the main property are all complete and boarded up for security on the lower floor. At the rear of the property and on the extensions the uPVC window frames are damaged by fire resulting in them melting and no longer lying flush with the surrounding brickwork and damaged glass panes or being missing entirely.

*Photograph 10 showing the fire damaged windows at the rear of the property*

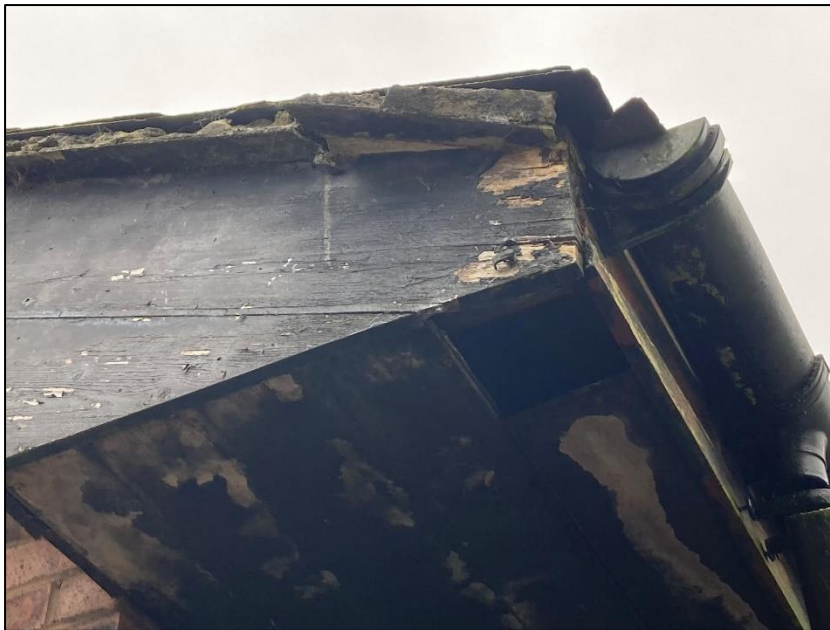
- 3.16 The extensions support wooden soffit and bargeboards throughout these have been affected by the fire and are mostly missing at the rear of the building, the sections that do remain support potential access points (see Photograph 11).

*Photograph 11 showing a potential access point within the soffit boards*

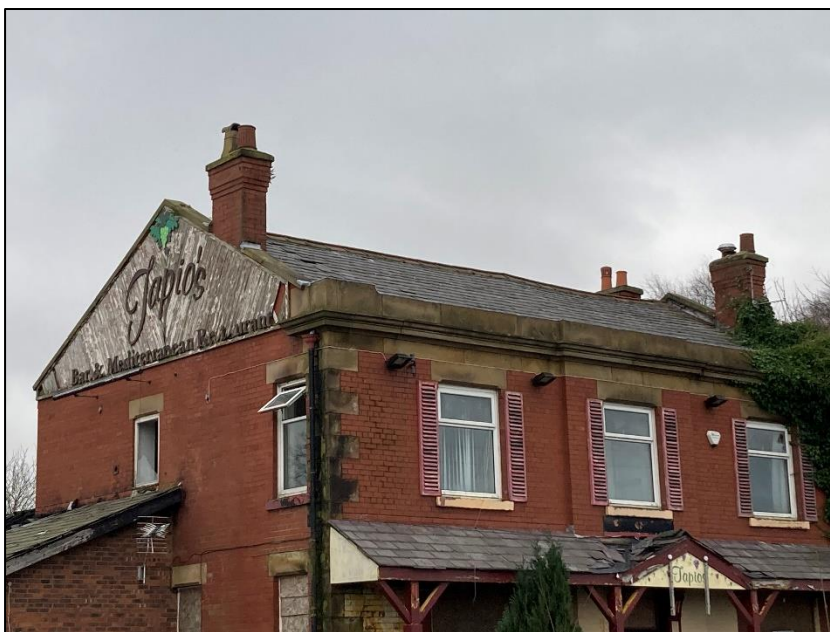
- 3.17 The building has a pitched, slate-tiled roof covering the main building, the roof is mostly intact with only a small number of slipped tiles (see Photograph 12). Small gaps occur under the tiles which could provide potential roosting opportunities or access to the internal space for bats. The ridge tiles are intact and in good condition. Lead flashing exists around the chimney and where the lower extension meets the main house. Decorative stone coping stones are present on the main building these are all complete and intact sealing the edges of the roof. The roof over the extensions has been completely damaged by the fire with only very small section remaining (see Photograph 13).

*Photograph 12 showing the roof of the main building*

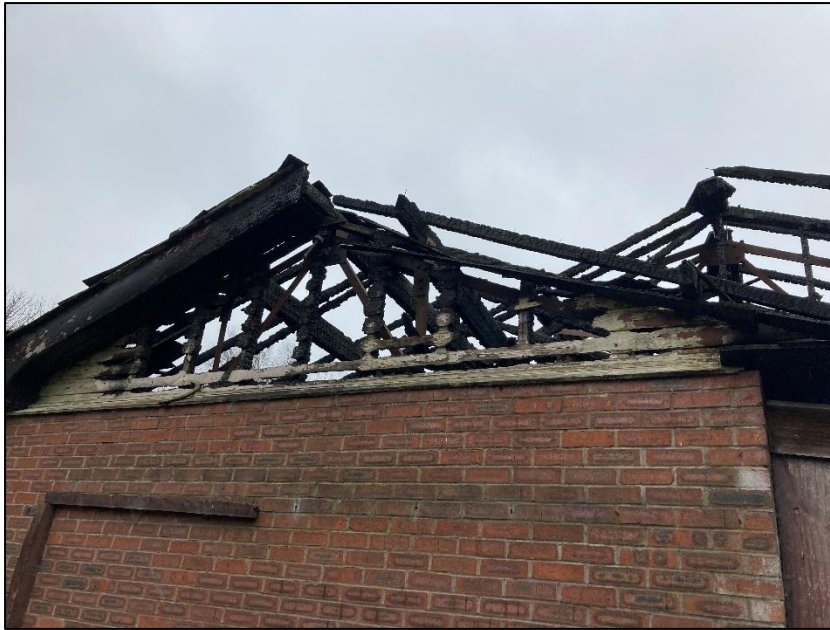
*Photograph 13 showing the roof of the extension*

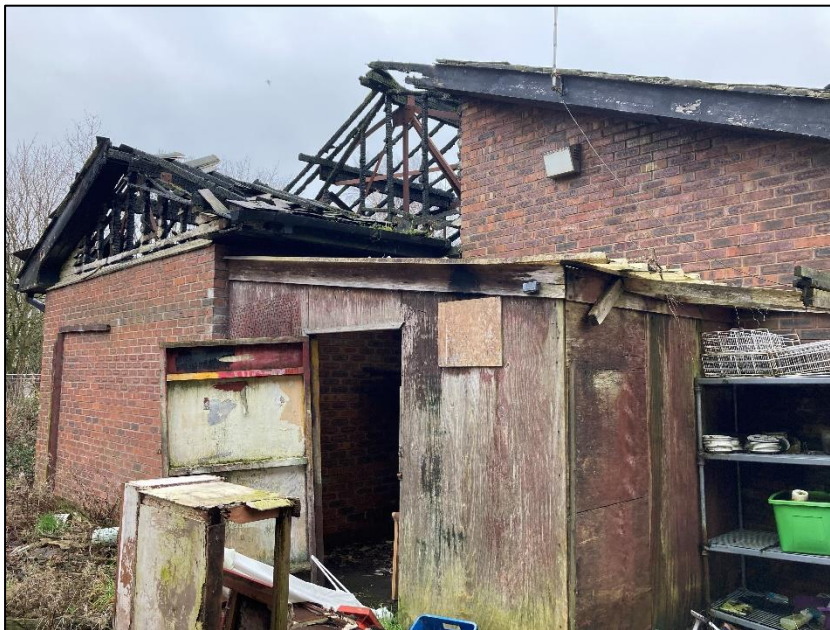
- 3.18 There is a shed at the eastern side of the building, which is a rectangular, single-storey structure (see Photograph 14). It is constructed from wood with a clear fibreglass roof. The interior of the shed is well-lit, and the walls and roof beams are intact. No roof void exists. No interior cavities suitable for bats exist and no evidence of bat activity was found within the shed.

*Photograph 14 showing the shed*

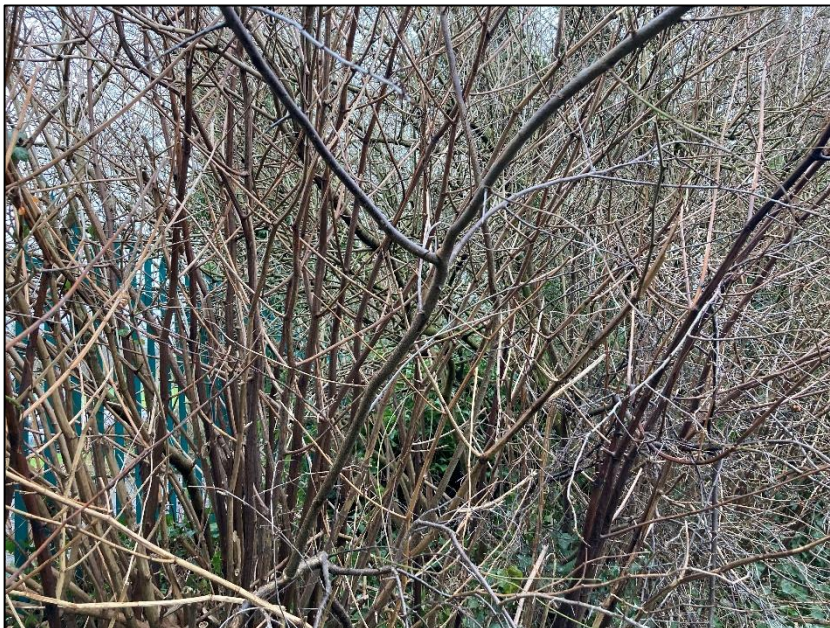
- 3.25 Japanese Knotweed *Reynoutria japonica* is present on the north-east boundary of the site growing within a section of the hedgerow, this is an invasive non-native species as listed on Schedule 9 of The Wildlife & Countryside Act 1981 (as amended) are present on or immediately adjacent to the site.

Photograph 15 showing the Japanese Knotweed

- 4.10 The Japanese Knotweed which is an invasive non-native as listed on Schedule 9 of The Wildlife & Countryside Act 1981 (as amended) should be eradicated from the site using a suitable methodology for this species.

- 5.2 The Japanese Knotweed should be eradicated from the site using a suitable methodology as a part of the proposed development.

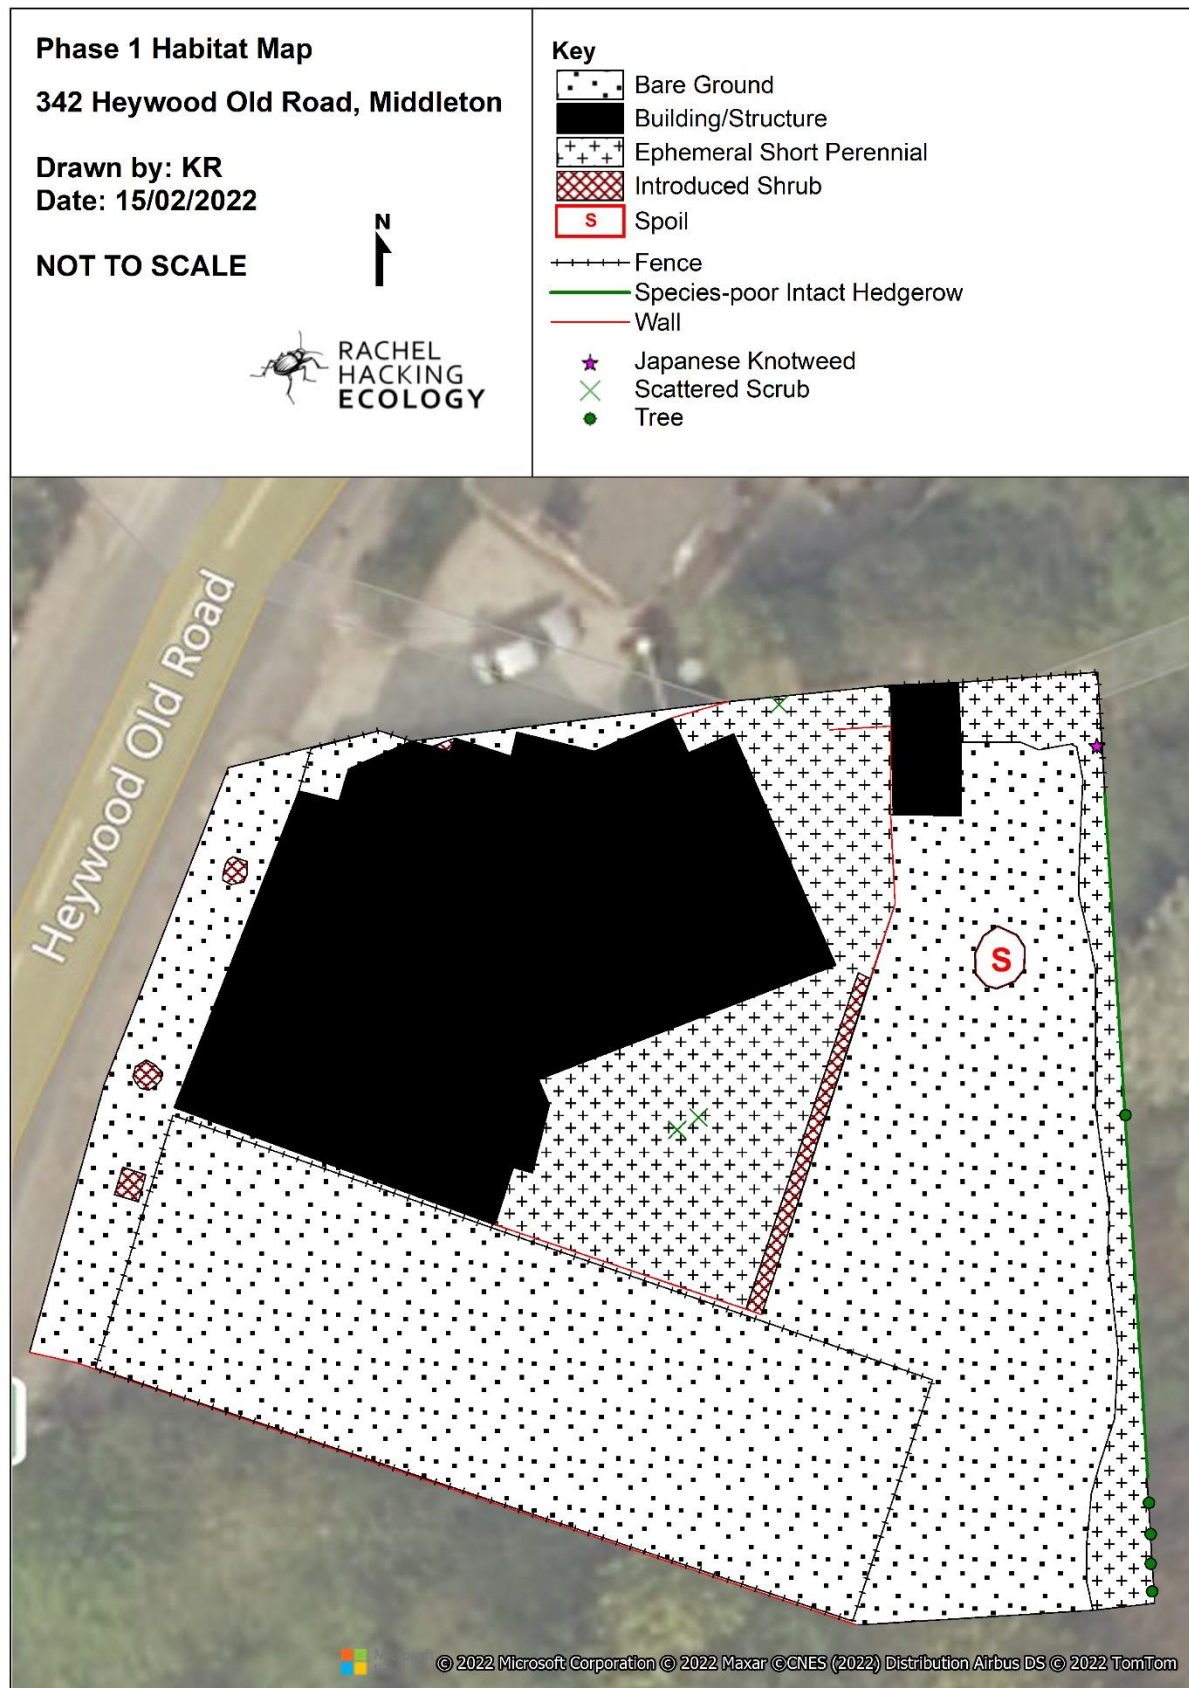
## APPENDIX A PHASE 1 HABITAT MAP

- 3.1 The Phase 1 Habitat Map can be found at the back of the report. The habitats on the proposed development site are described below.
