# BAT SURVEY REPORT

## Corner Plot Junction of Station Road & Maclure Road Rochdale

A bat survey was commissioned by Rochdale Development Agency to inform proposals to change the use and extend the corner plot circular building on the Junction of Station Road and Maclure Street, Rochdale and to demolish the tow-storey building adjacent to Fire Station Yard, which is attached to the adjoining building. This is a report of the survey.

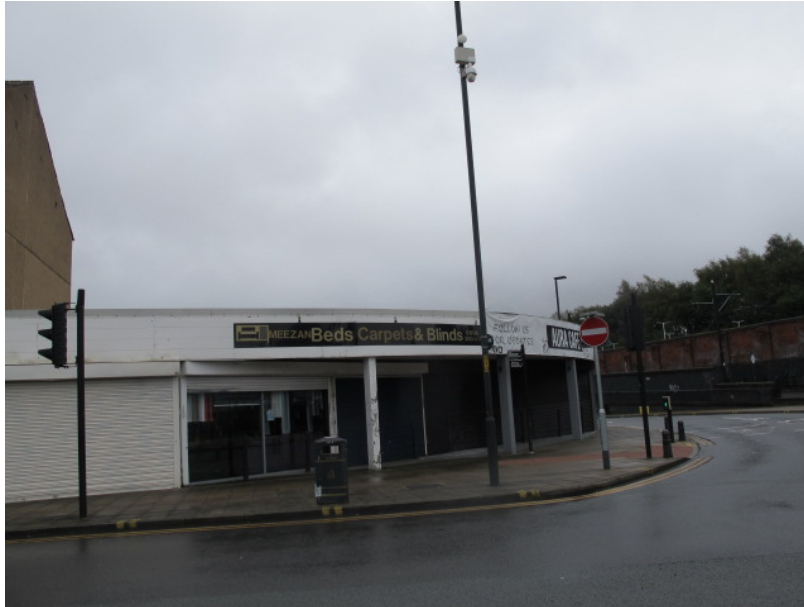
*Photo 1 – Circular Building*

- 4.1 The desktop search shows a number of bat activity records within the 1km buffer zone, none of the records are associated with the building. There are eleven bat roost records within the area of search, the closest is located approximately 143 metres to the west of the site (see Appendix 1).
- 4.2 The building to be altered is a single storey circular shaped building containing a number of retail units.

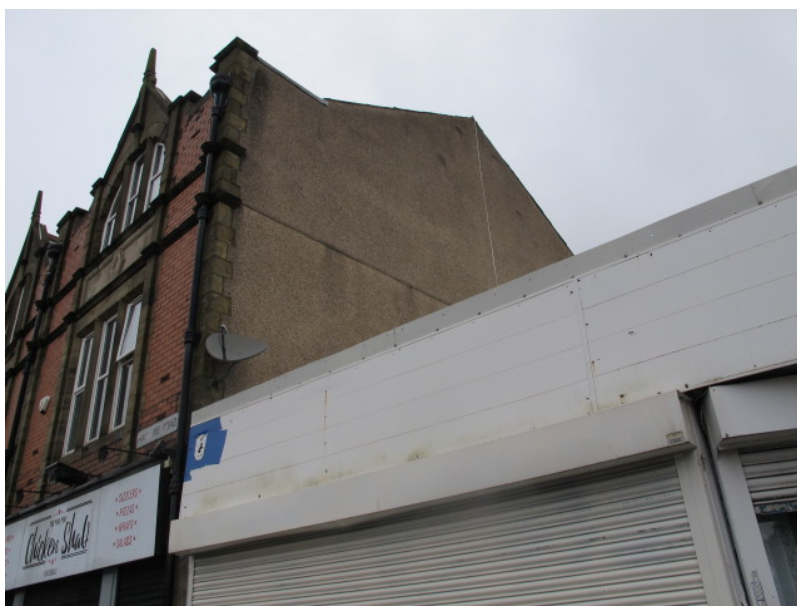
*Photo 2 – Metal cladding to the roof and metal shutter*

- 4.3 The building is metal clad to the roof line, the roof is flat. The retail units are all shuttered in metal. Internally there is no roof space.

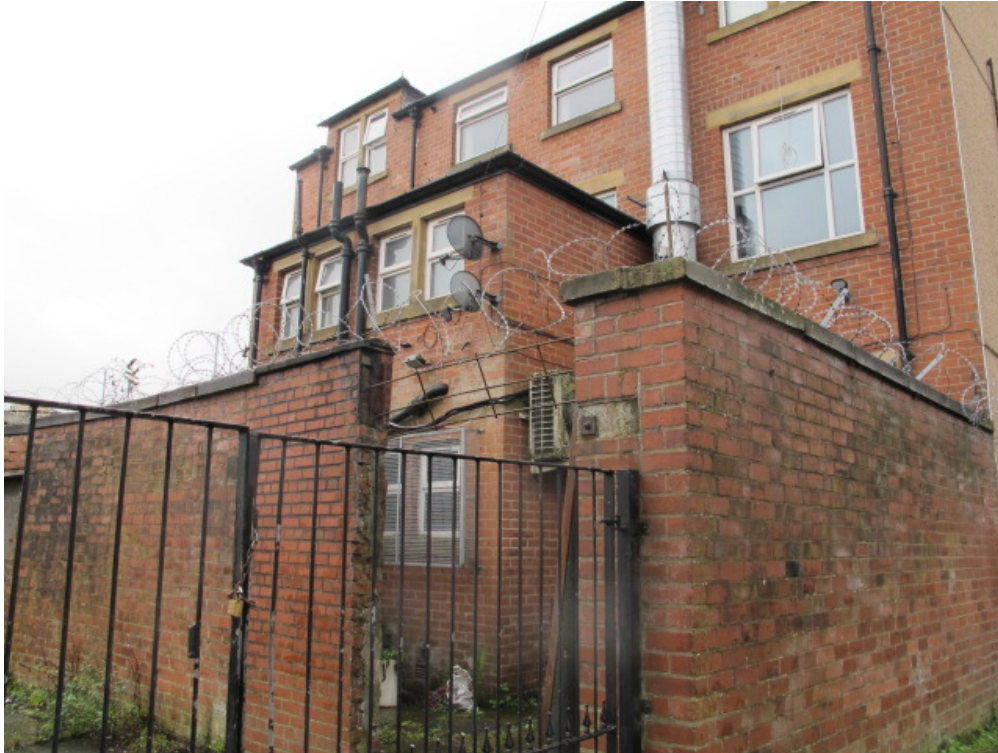
*Photo 3 – Two-storey building proposed for demolition*

The two-storey brick building was assessed as having a very low potential to support a bat roost, however the occasional bat can never be discounted. Recommendations are made for the roof tiles to be removed by hand with care, prior to demolition.

- 4.4** The two storey brick building at the rear of the adjoining building and adjacent to Fire Station Yard is proposed for demolition. This building has a hipped tiled roof, which is separate from the main roofline of the four-storey building.

- 7.1** Due to the mobile habits of bats, the occasional bat can never be discounted. We would therefore recommend, as a precautionary measure that the roof tiles on the two-storey building be removed by hand, with care with the presence of bats borne in mind.
- 7.2** All contractors should be reminded of their legal responsibilities regarding bats prior to works commencing.
- 7.3** **If bats are found or suspected at any time then work must cease immediately and advice sought from GMEU or a suitably qualified bat worker.**
