# Contaminated Land Phase Two Intrusive Investigation for proposed residential development on land at 13&15 Exeter Street, Rochdale, OL11 1JN.

Prepared for:

January 2025

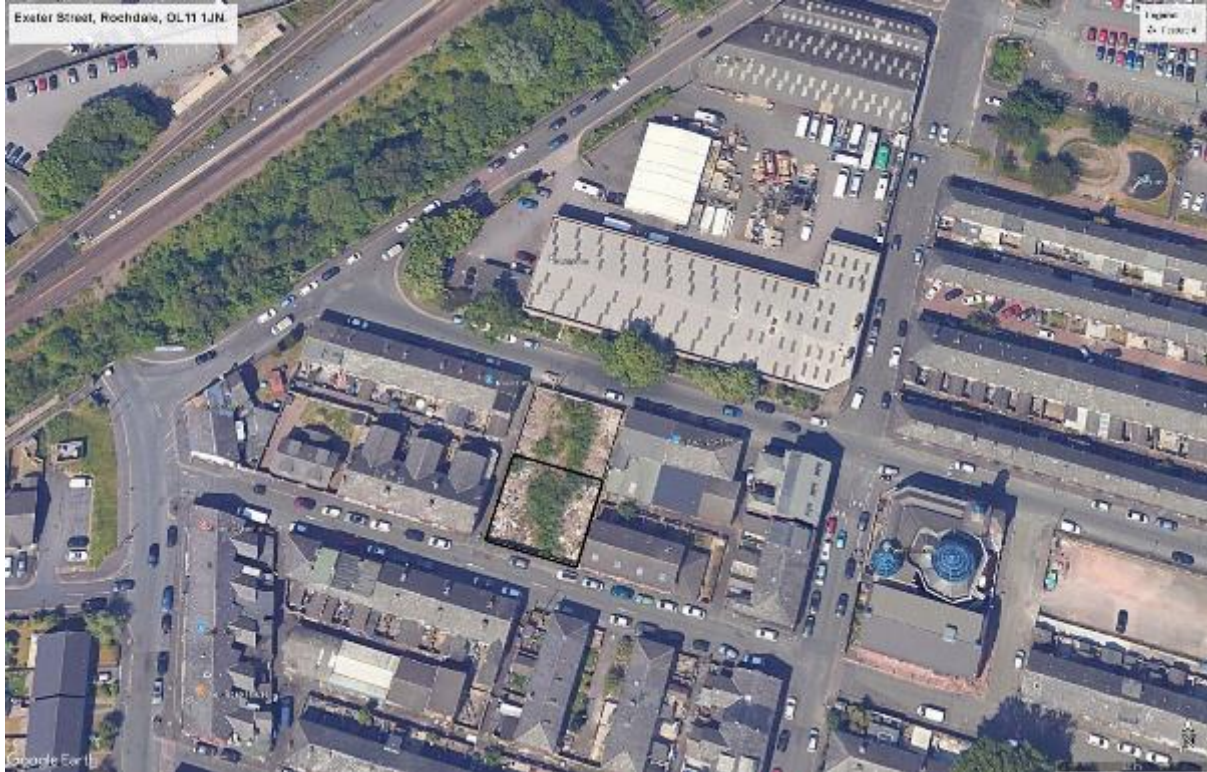
**Figure 1 – Aerial Photograph**

An aerial photograph of the site is included in Figure 1, with proposed plan in Figure 2.

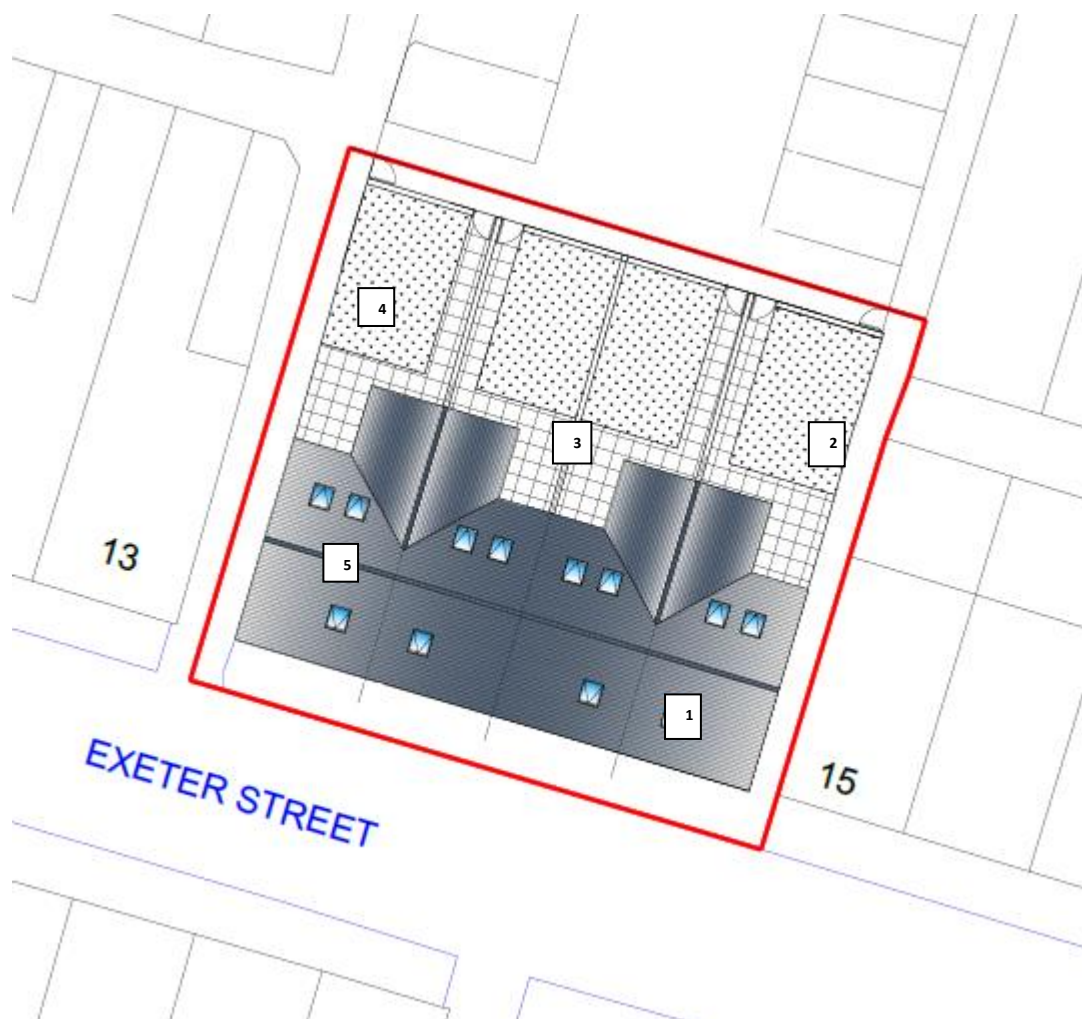
**Figure 2 – Sampling Locations**

A site visit was conducted on the 9<sup>th</sup> January 2025 to undertake an intrusive investigation. Five trail pits were dug across the site with two samples taken from each location, identified in Figure 2.

Sampling locations were spread across the site including under the former garage footprints, the central corridor of the site and the rear gardens of the four proposed dwellings.

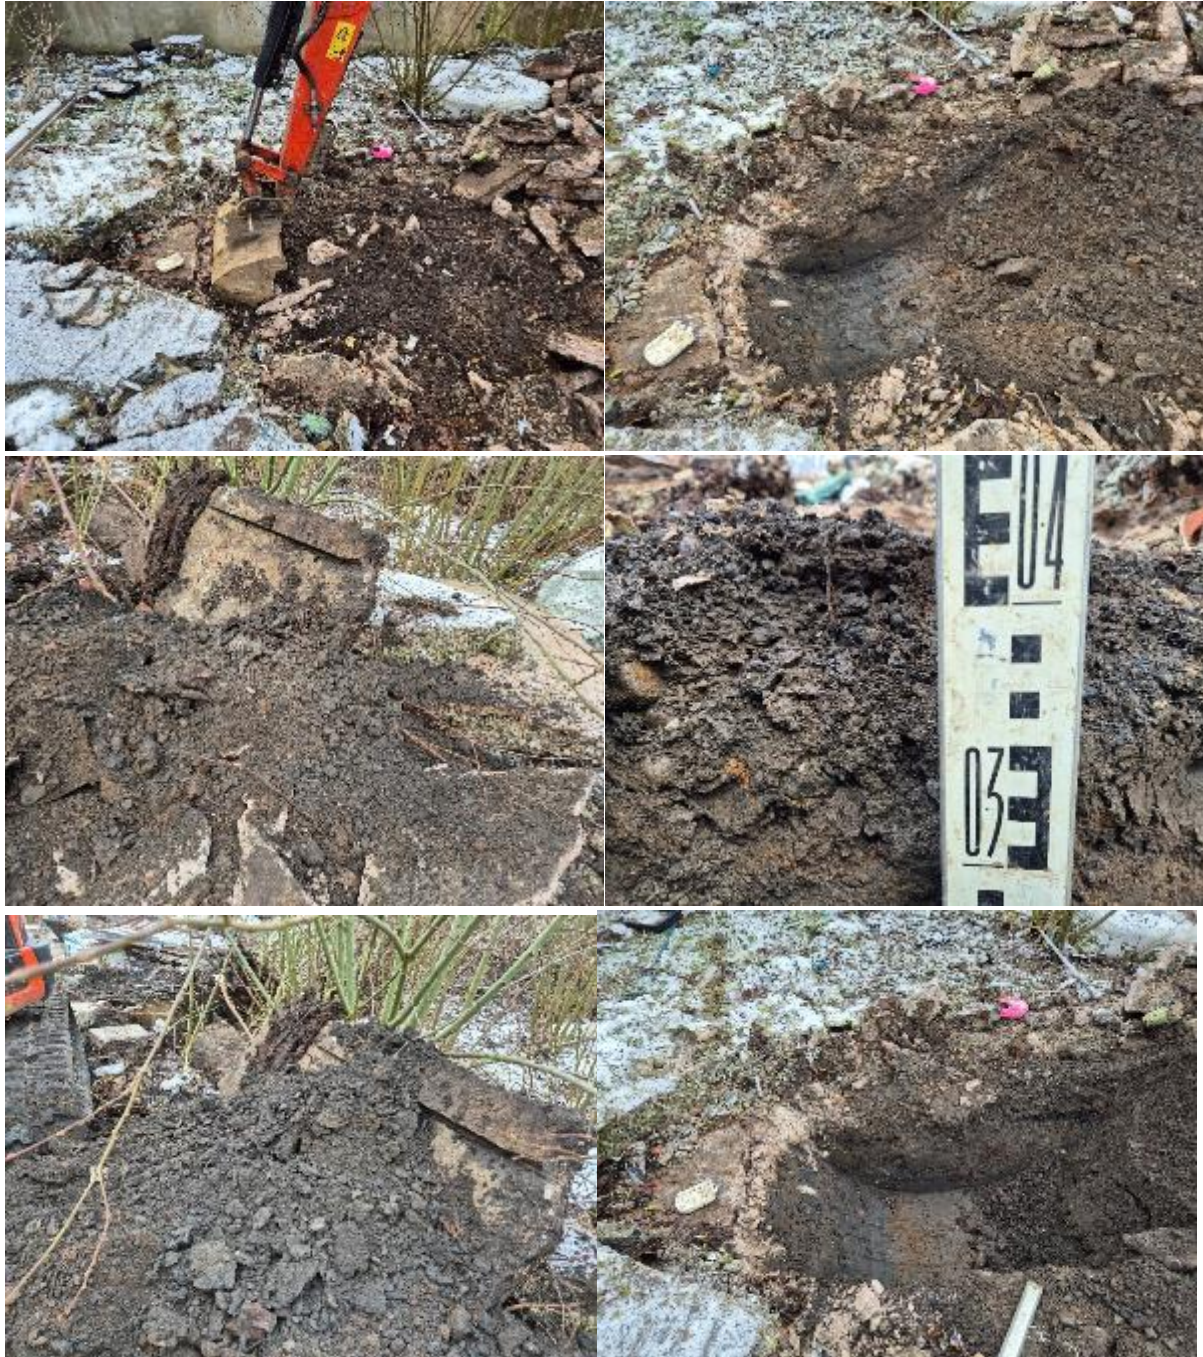
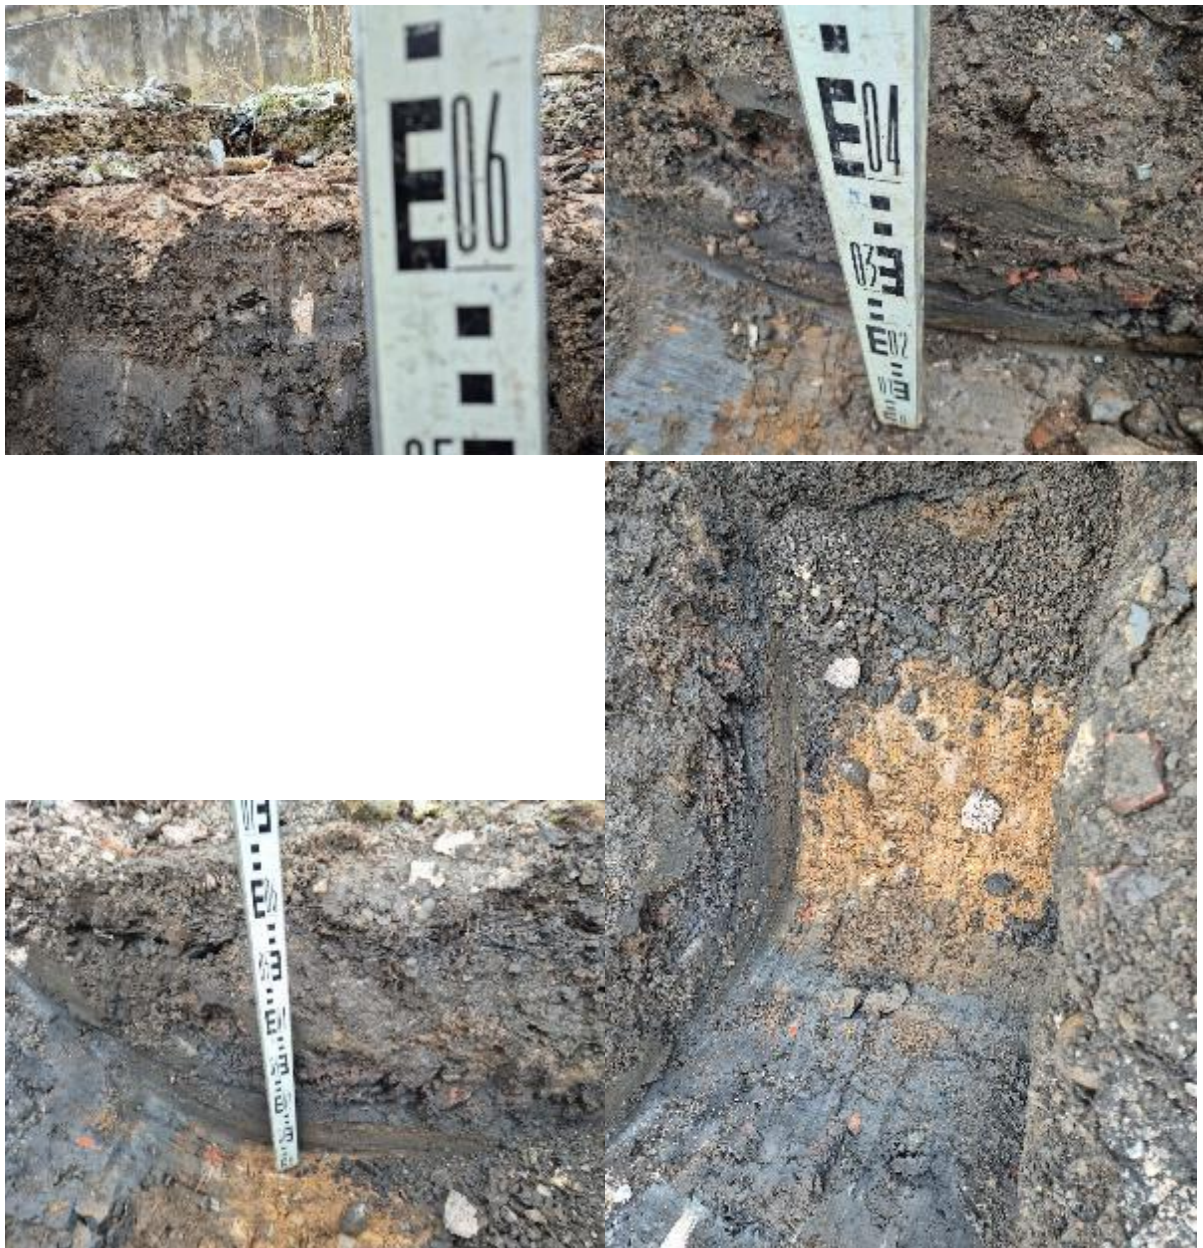
### TP1 –Southeast corner

TP2 and TP4 are located within the proposed rear gardens of the development, while TP1 is located to the southeast corner, under one of the proposed dwellings.

Trail Pit 1 – southeast corner

| 0.00-0.1m | Concrete |
| 0.40-0.60m | brown sandy loam with gravel, some stone. |

In addition, localised **removal of material to the southeast corner** down to 600mm should be undertaken to remove any PAH contamination under the former garage footprint.

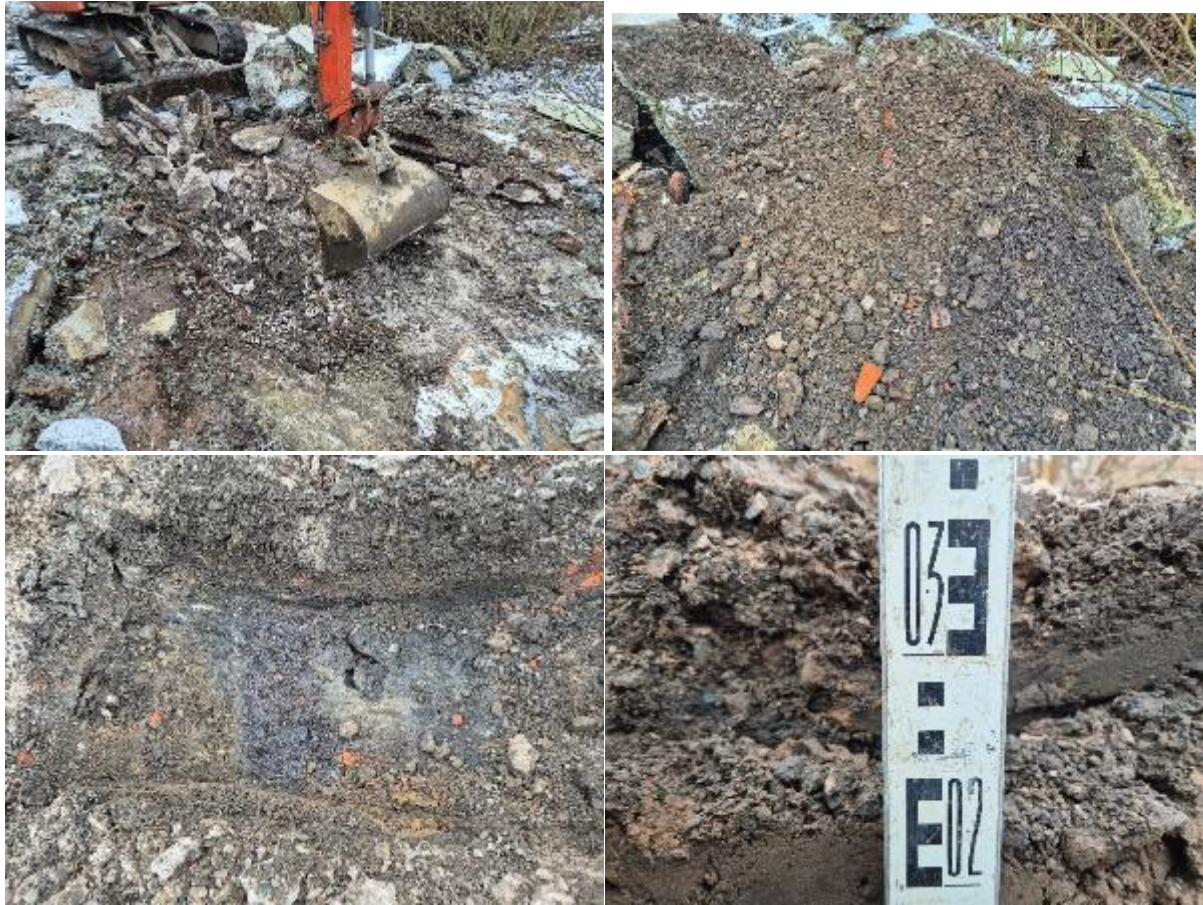
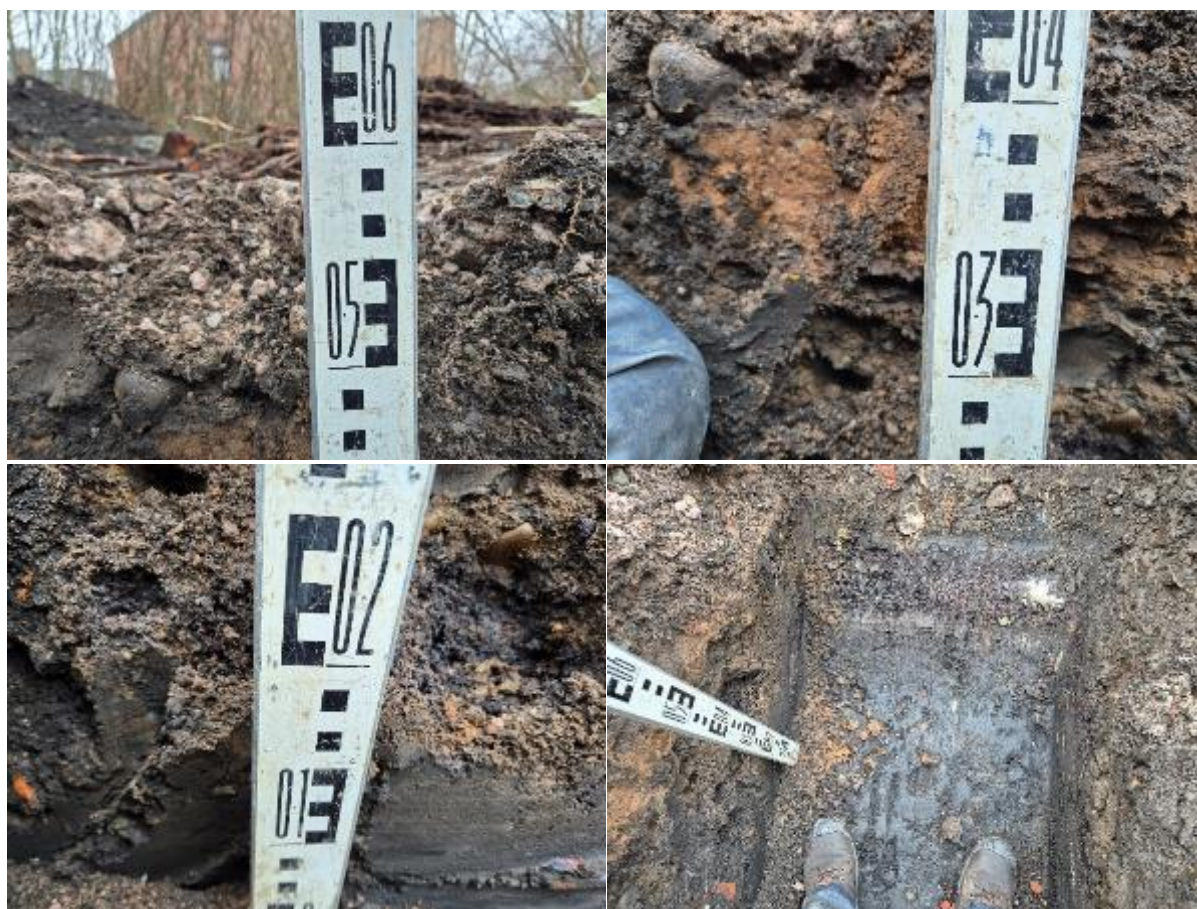
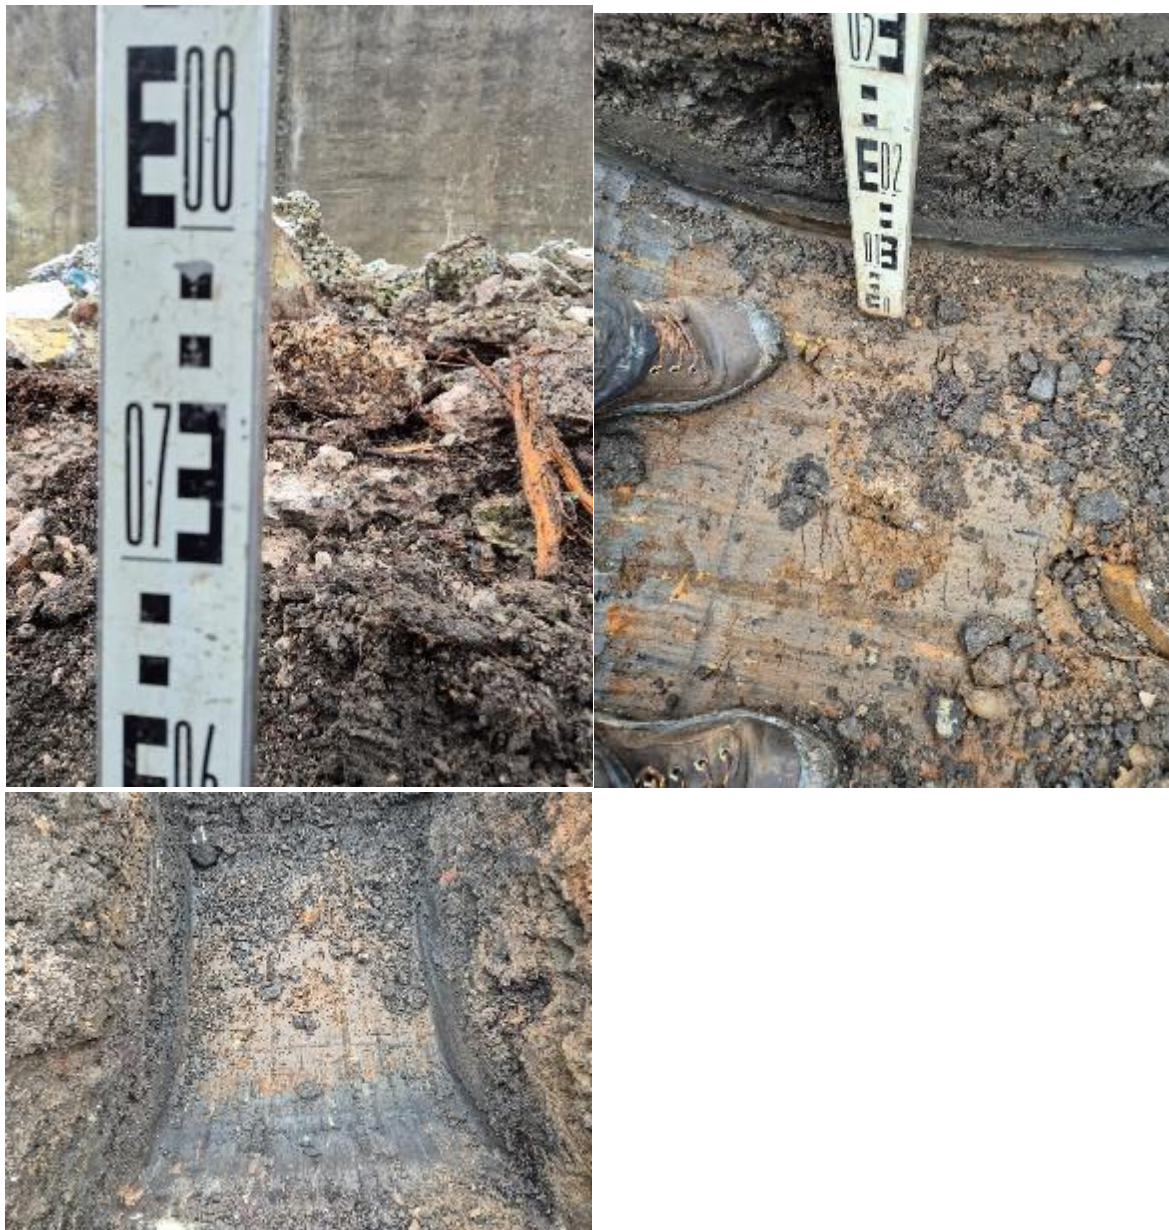
**TP2 – Northeast corner – proposed garden**

Trail Pit 2 – eastern boundary historic watercourse

| 0.00-0.1m | Concrete |
| 0.6-0.75 | Clay |

It is proposed that material is removed from across the rear of the site (proposed garden areas) to enable a **600mm clean cover system** to be placed over the gardens. Typically, 450mm subsoil and 150mm topsoil for landscaping areas. A suitable no dig barrier should be installed below the 600mm clean imported cover system.

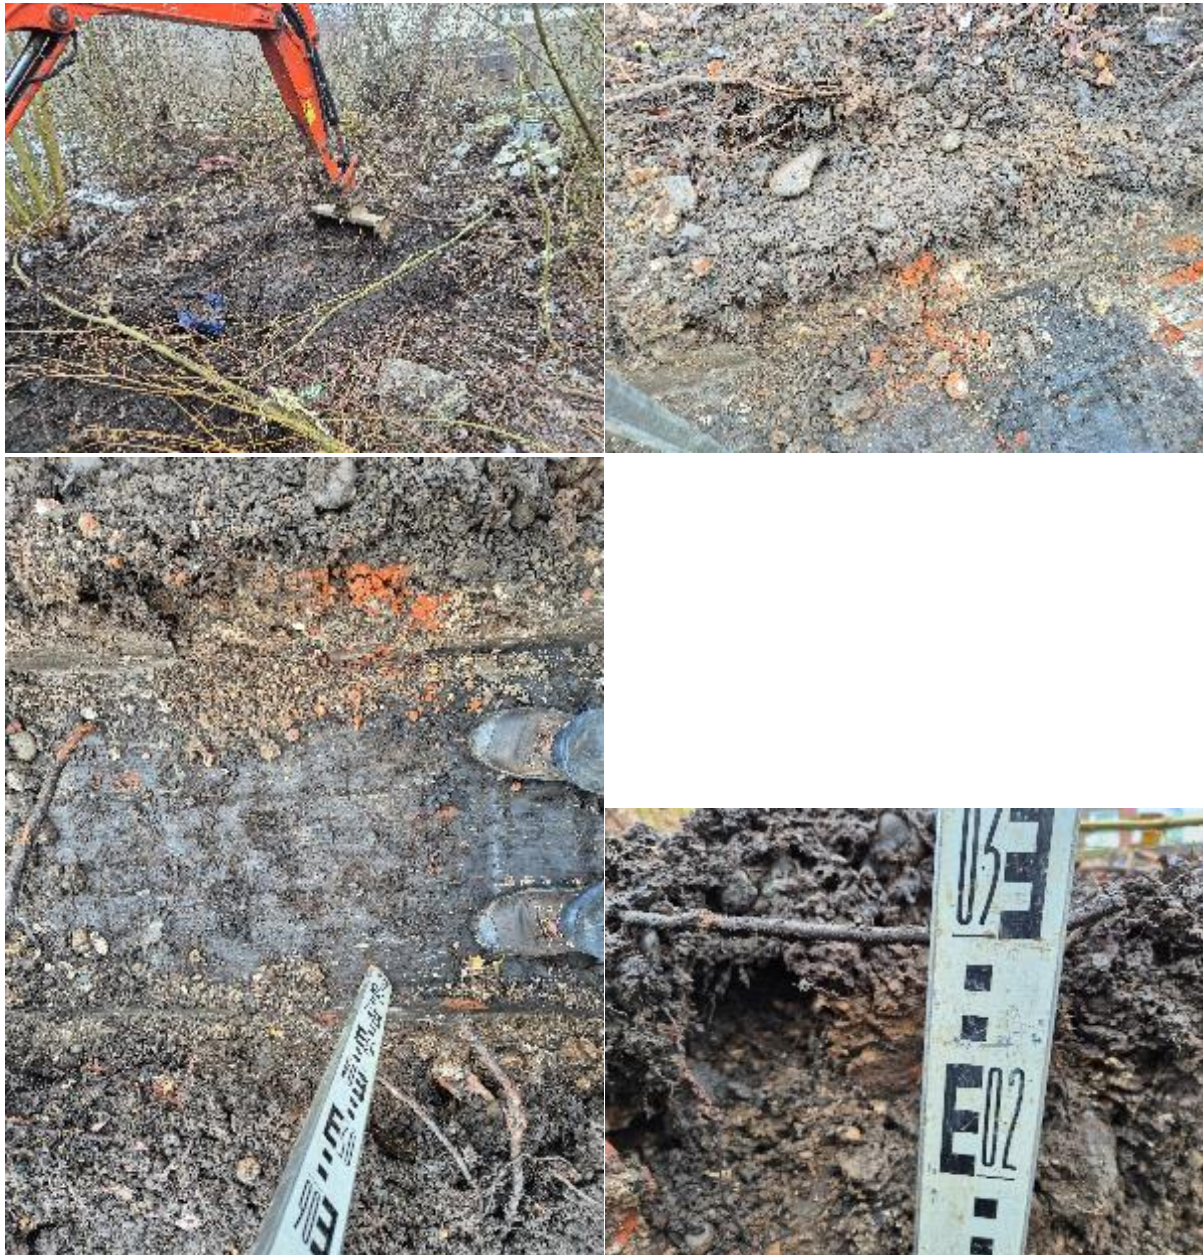
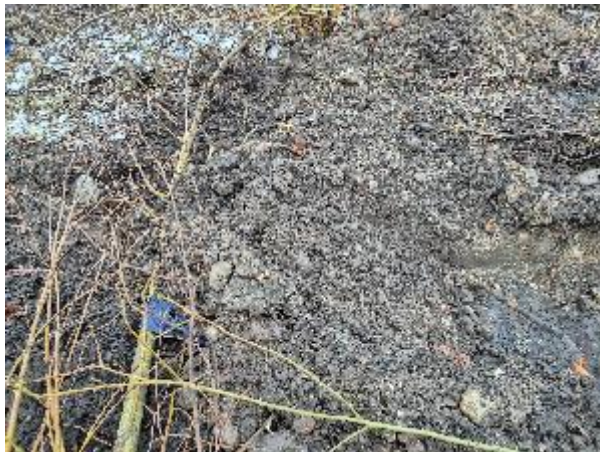
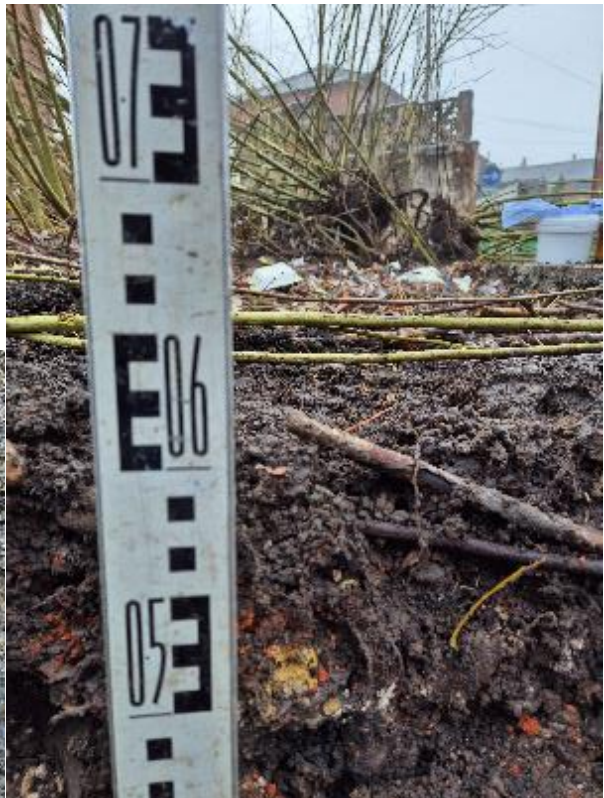
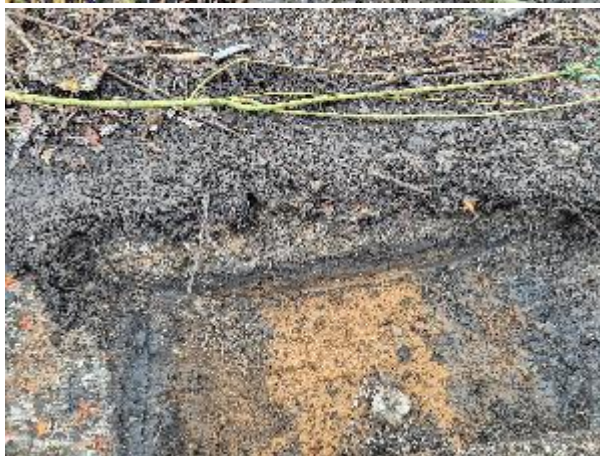
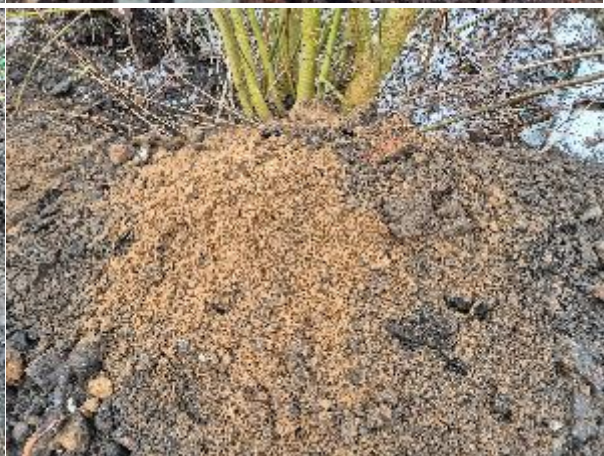
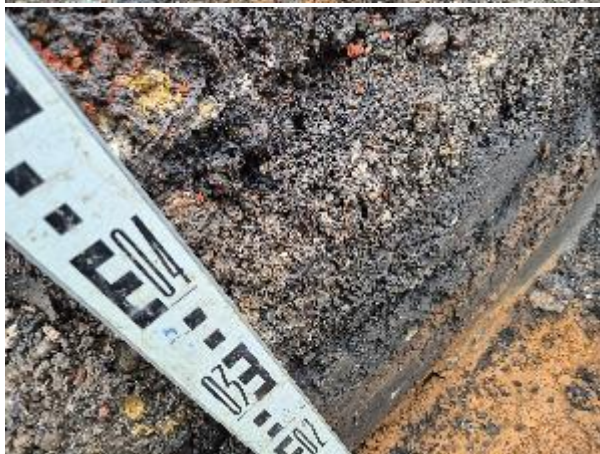
**TP3 – Centre of site**

Trail Pit 3 – centre of site,

| 0.00-0.05m | vegetation, roots |
| 0.5- | Sand |

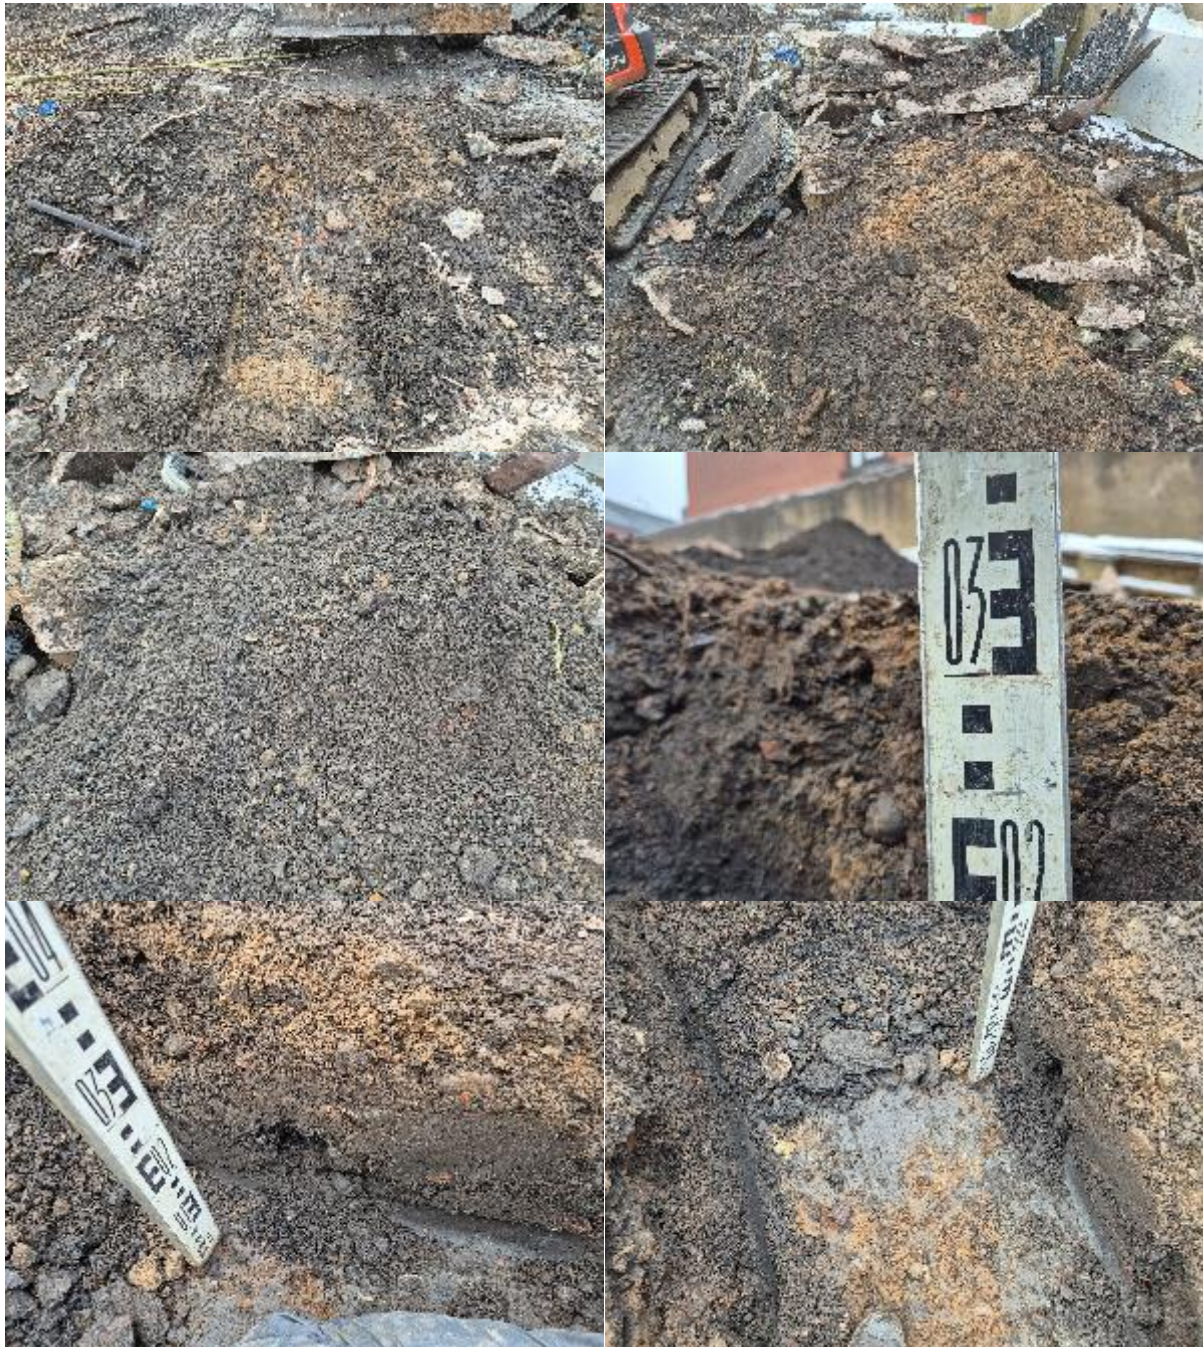
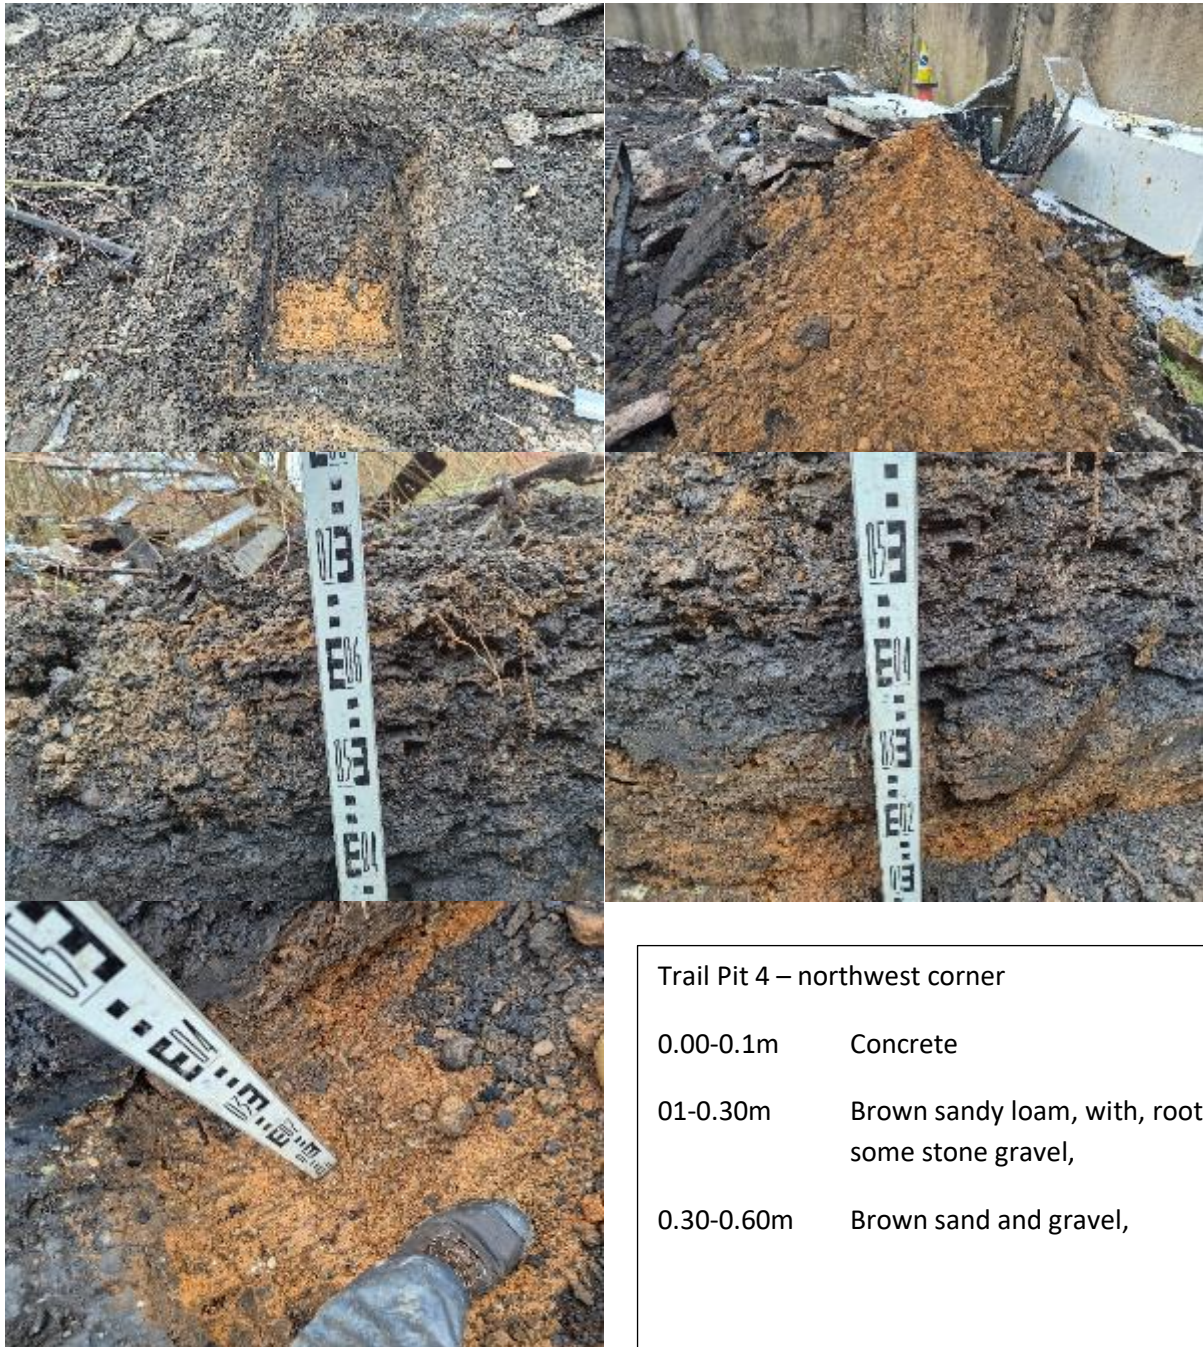
**TP4 – northwest corner of site**

The specific PAH's identified were Benzo(b)fluoranthene, Benzo(a)pyrene, Dibenzo(a,h)anthracene in each with Benzo(a)anthracene in TP4A.

Trail Pit 4 – northwest corner

| 0.00-0.1m | Concrete |
| 0.30-0.60m | Brown sand and gravel, |
