# **WATERFOLD BUSINESS PARK, BURY PHASE I ENVIRONMENTAL SITE ASSESSMENT**

## PHASE I ENVIRONMENTAL SITE ASSESSMENT WATERFOLD BUSINESS PARK, BURY, BL9 7BR

Project No. **1620016197**  
Issue No. **03**  
Date **10 October 2023**  
Made by **George Black**  
Checked by **Sophia Passmore**  
Approved by **Jon Eudall**

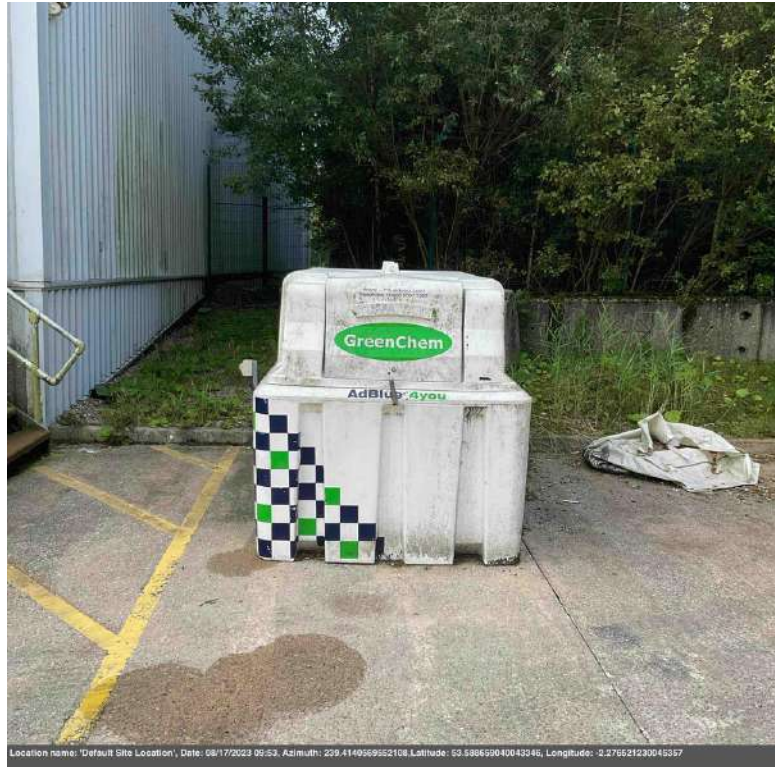
**Description:** 2,500L bunded AdBlue AST, with some staining located adjacent on the hardstanding.

| <b>Tank Name/No.</b> | <b>Contents &amp; Capacity</b> | <b>Location</b> | <b>Construction and Containment</b> |
|---|---|---|---|
| <b>1</b> | AdBlue<br>2,500 litres | Adjacent north-west of the Warehouse | Used by diesel vehicles on-site. An integrally bundled plastic tank, observed to be in good condition, located on level ground. The dispensing hose and fill point are located inside the tank, accessed by a hatch at the front. A small amount of diesel had pooled within the bund. No signs of heavy staining observed. The tank is refilled as required. |

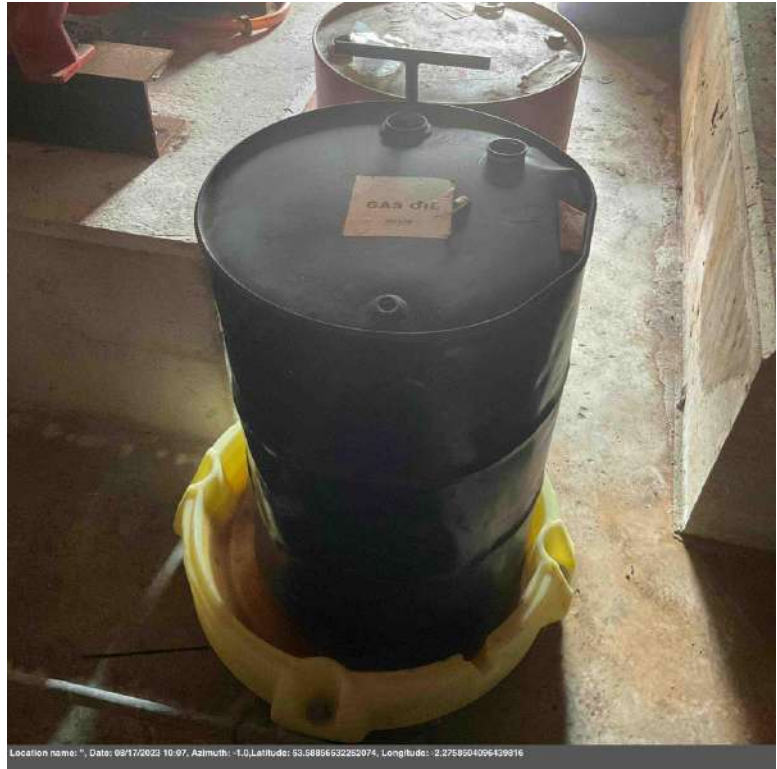
**Description:** 205L gas oil drum stored on a drip tray within the sprinkler tank pump house Oily liquid was noted in the bottom of the tray.

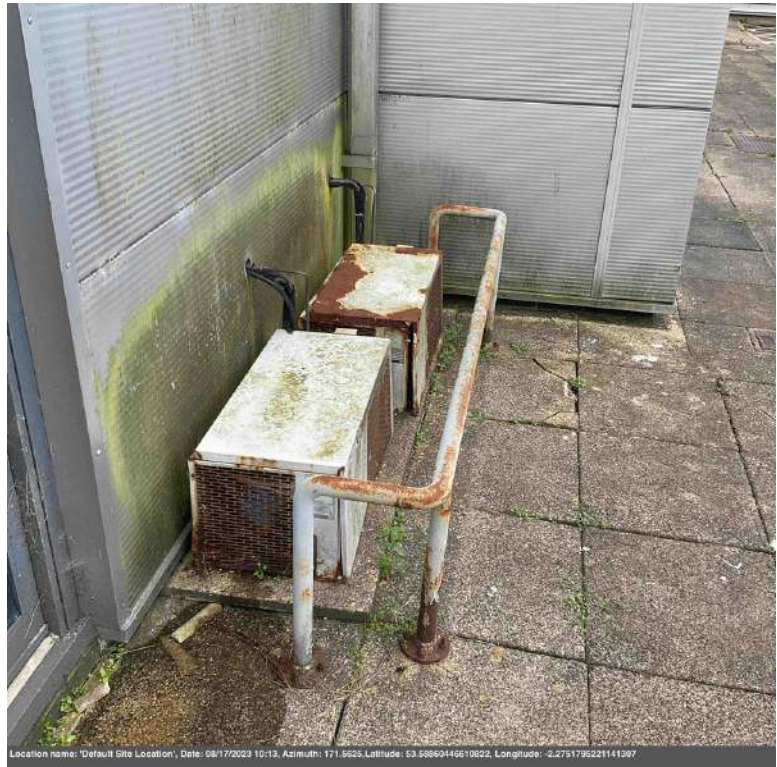
**Description:** Corroded external R404A air conditioning units.

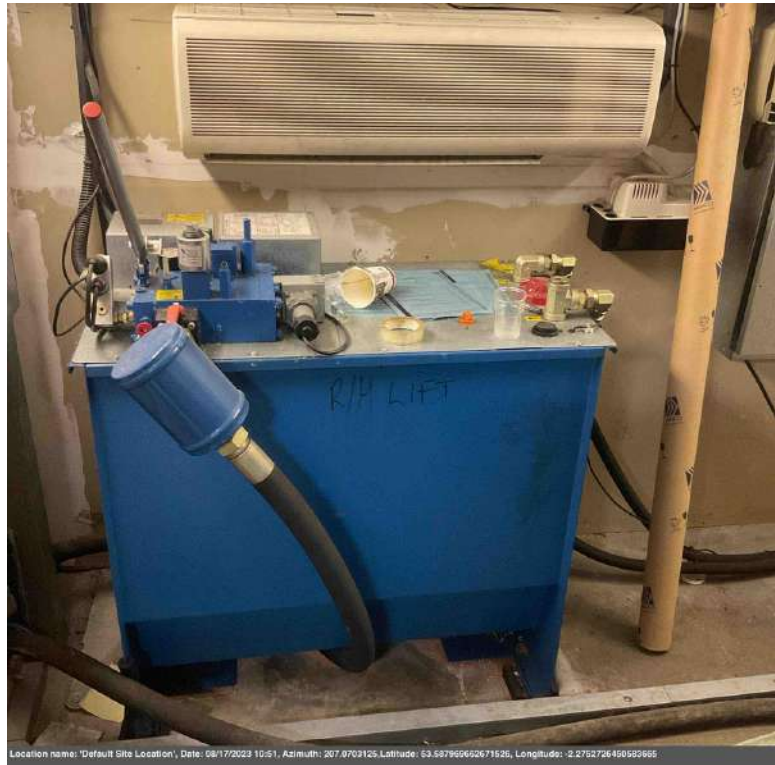
**Location:** Default Site Location  
**Photo date:** 08/17/2023  
**Photo time:** 10:51  
**Photo direction:** N  
**Description:** Lift room, adjacent to the lift shaft in the third floor plant room.  
**Latitude:** 53.58797  
**Longitude:** -2.27527

An electricity substation operated by Electricity North West is located adjacent north of the warehouse. Responsibility for PCB oils (if present) would be expected to lie with Electricity North West. A lift motor room was also observed in the third-floor plant room, serving the out of use hydraulic lift. No other potential PCB-containing equipment was identified during the site visit.

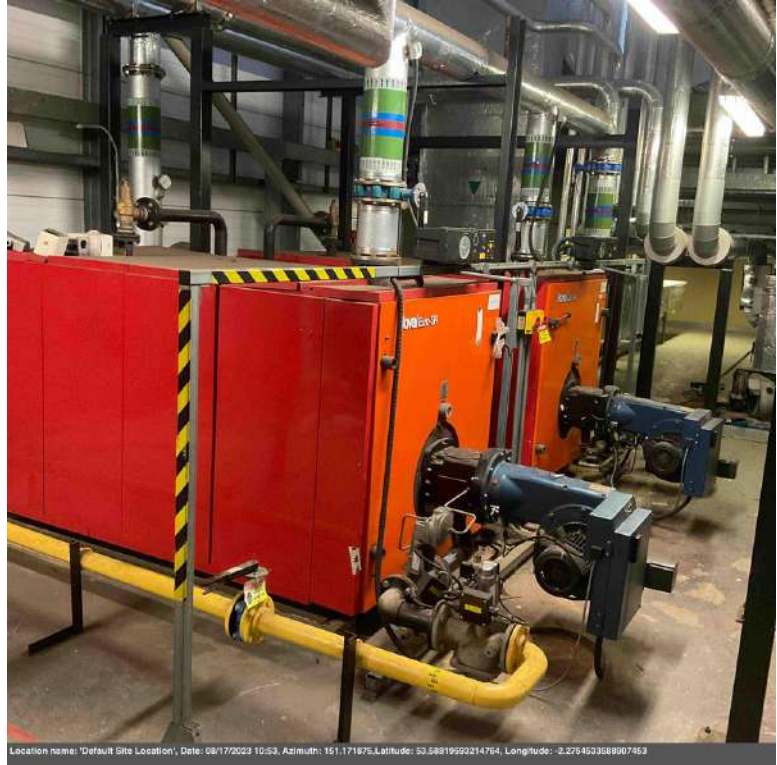
**Location:** Default Site Location  
**Photo date:** 08/17/2023  
**Photo time:** 10:53  
**Photo direction:** N  
**Description:** Gas fire Hoval boilers in the third floor plant room.  
**Latitude:** 53.5882  
**Longitude:** -2.27545

No significant emissions to air were noted. Emissions are limited to gas boilers, vehicles and kitchen exhaust emissions. The site contact reported that the warehouse area is not heated, although gas-fire heating systems were noted in the third floor plant room.

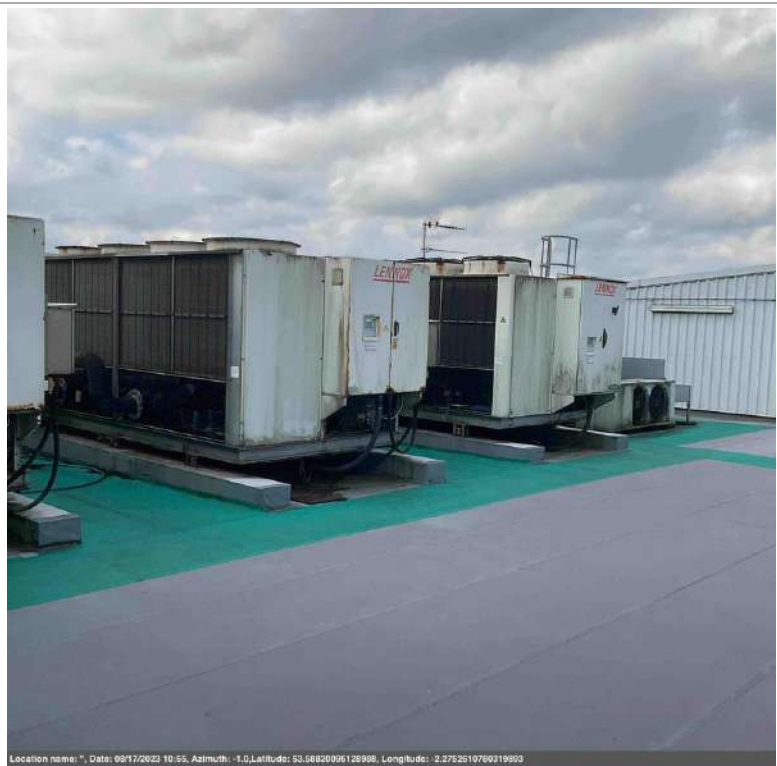
**Location:** Default Site Location  
**Photo date:** 08/17/2023  
**Photo time:** 10:55  
**Photo direction:**  
**Description:** Three Lennox Chillers on the third floor roof external plant area, noted to contain R407C.  
**Latitude:** 53.5882  
**Longitude:** -2.27526

additional small external units were located on the ground floor and noted to contain R404A (a non-ODS and F-Gas). Three chillers were located in the external roof plant area, noted to contain R407C (a non-ODS and F-Gas)

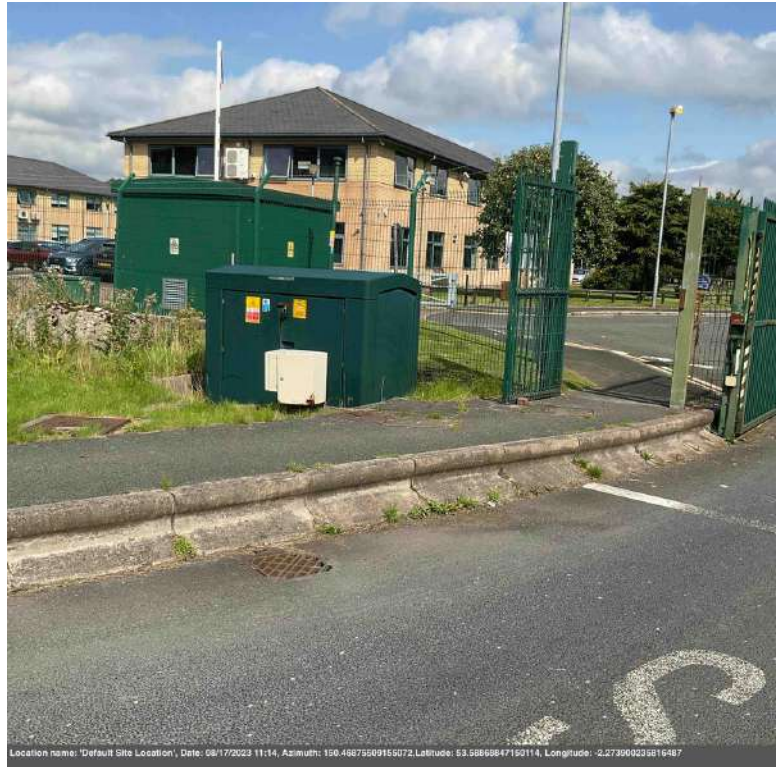
**Location:** Default Site Location  
**Photo date:** 08/17/2023  
**Photo time:** 11:14  
**Photo direction:** N  
**Description:** Gas Governor Station by site entrance  
**Latitude:** 53.58869  
**Longitude:** -2.2739

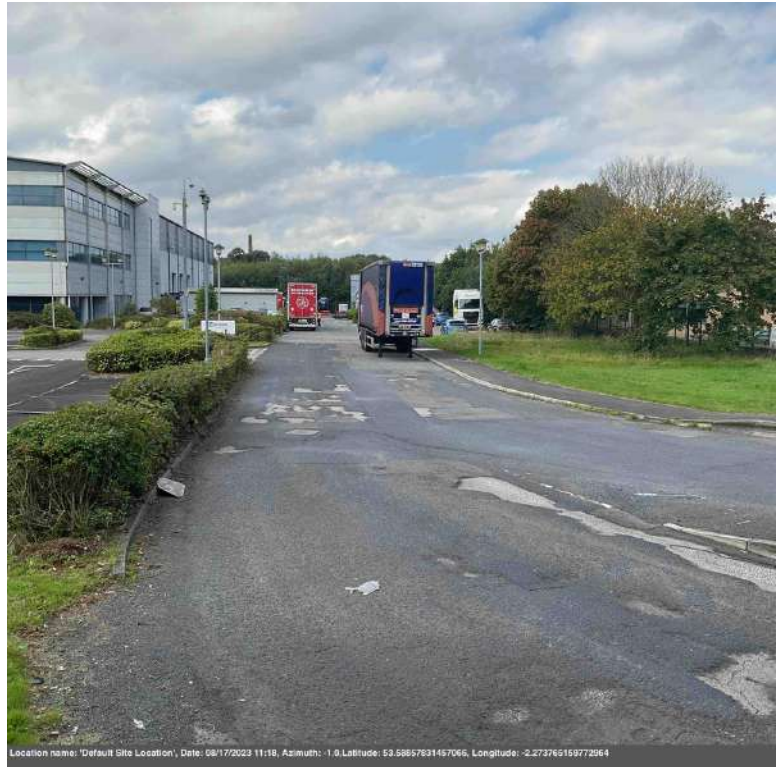
**Description:** View from north-east corner by the site entrance looking west along the access road, with damaged hardstanding.

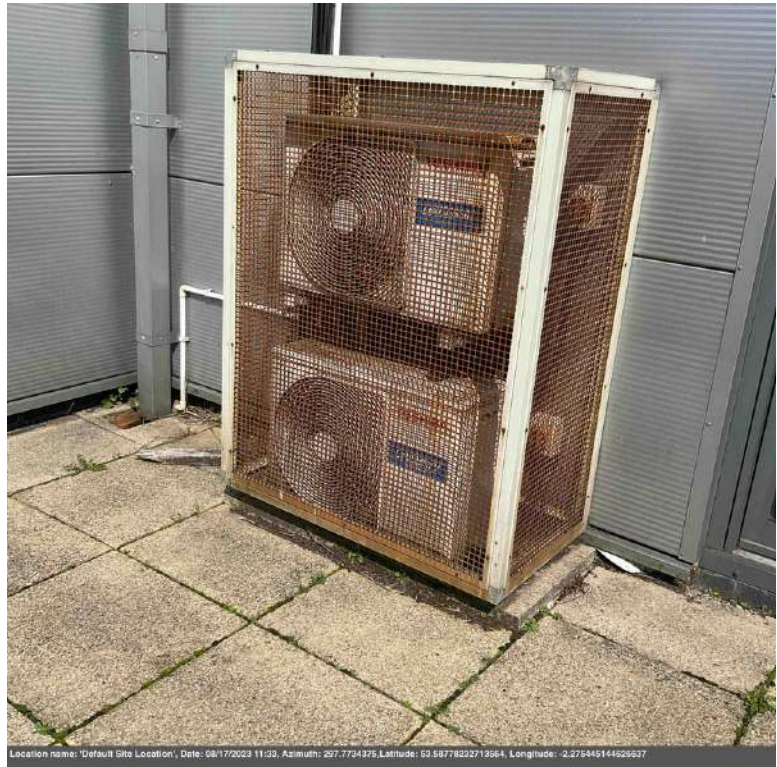
**Description:** View of externally wall-mounted air conditioning units, noted to contain R410A
