# Heritage Impact Statement

Client: Hopwood Hall College

Project: HHC – Animal Management – Change of Use

Reference: 20672 | P501

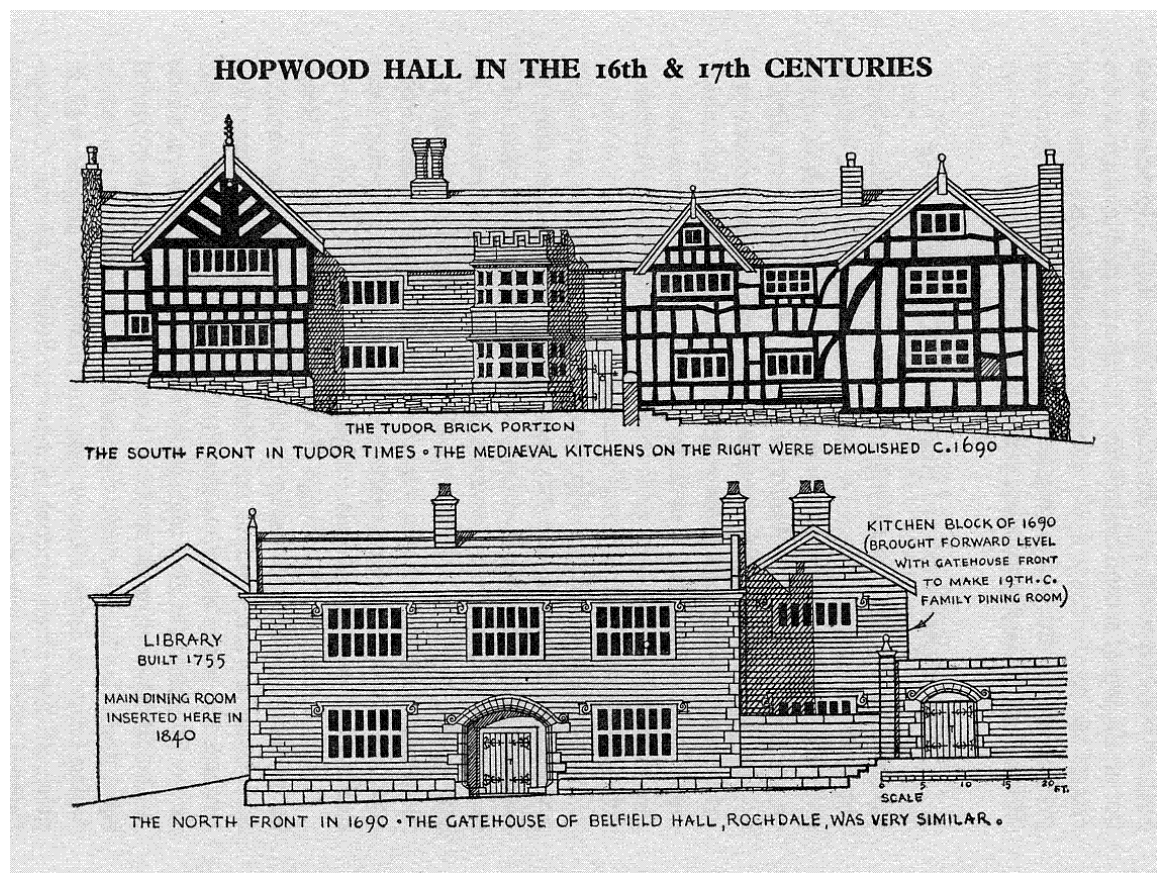
**Figure 3.1**

Historical Elevational drawings showing how Hopwood Hall evolved over the 16<sup>th</sup> and 17<sup>th</sup> Century  
(Source : [www.google.com](http://www.google.com))

The site continued to evolve during the 17<sup>th</sup> Century with the demolition of the medieval kitchens in 1690 and the construction of a new kitchen block. Figure 3.1 illustrates how Hopwood Hall developed during the 16<sup>th</sup> and 17<sup>th</sup> Century.

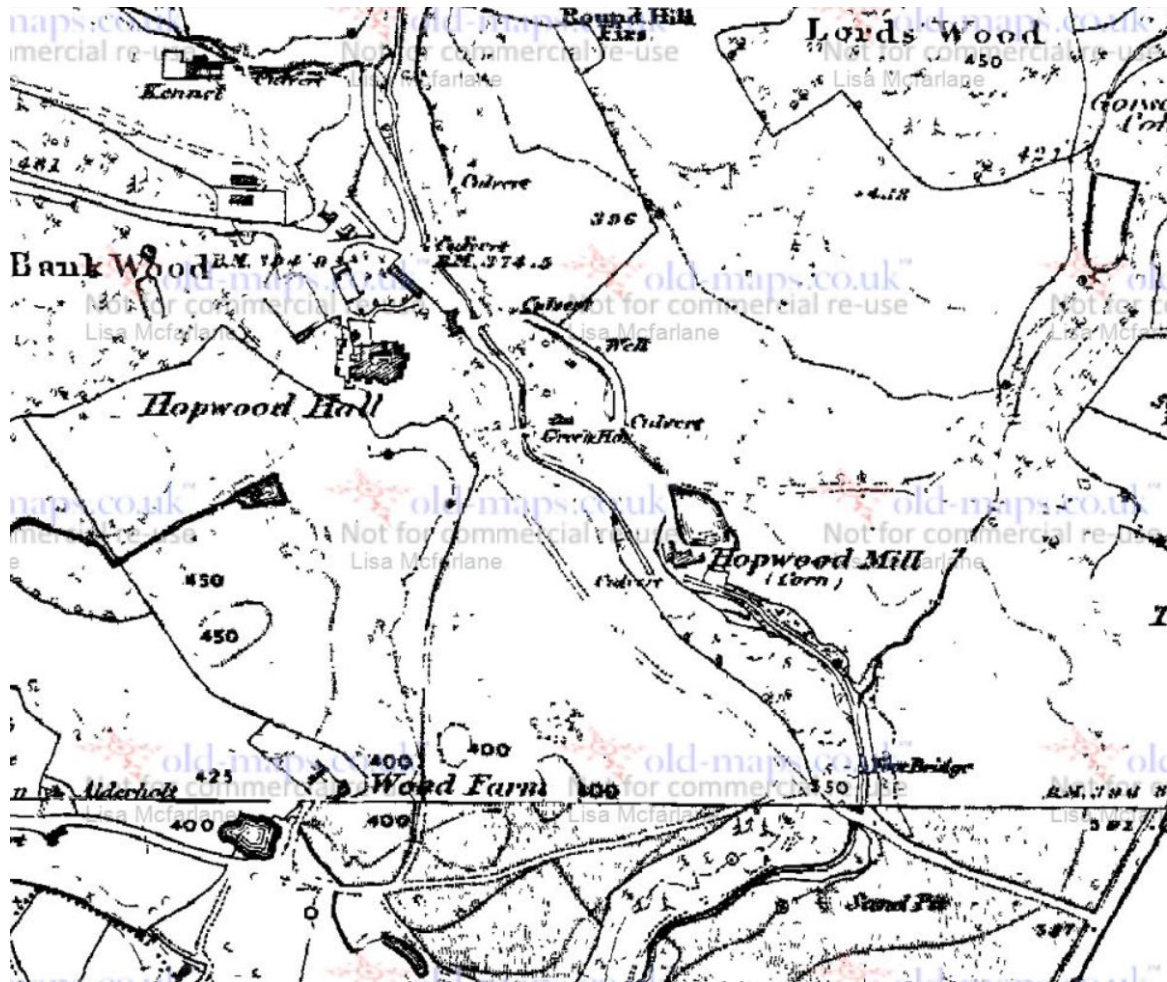
Figure 3.5

OS Map dating from 1848-1851

The earliest OS Map dating from the mid 1800's illustrates how the site had developed up to this period. The map shows how the Hall had expanded during the 18<sup>th</sup> and early 19<sup>th</sup> Century to the plan form that is evident today in 2022. The map also identifies the location of Hopwood Corn Mill which dates from as early as 1307 and continued to operate at this time. Wood Farm directly to the south of Hopwood Hall is also identified. The site at this time was surrounded by woodland with Lord Wood to the north-east and Oaken Bank Wood to the west of the Hall.

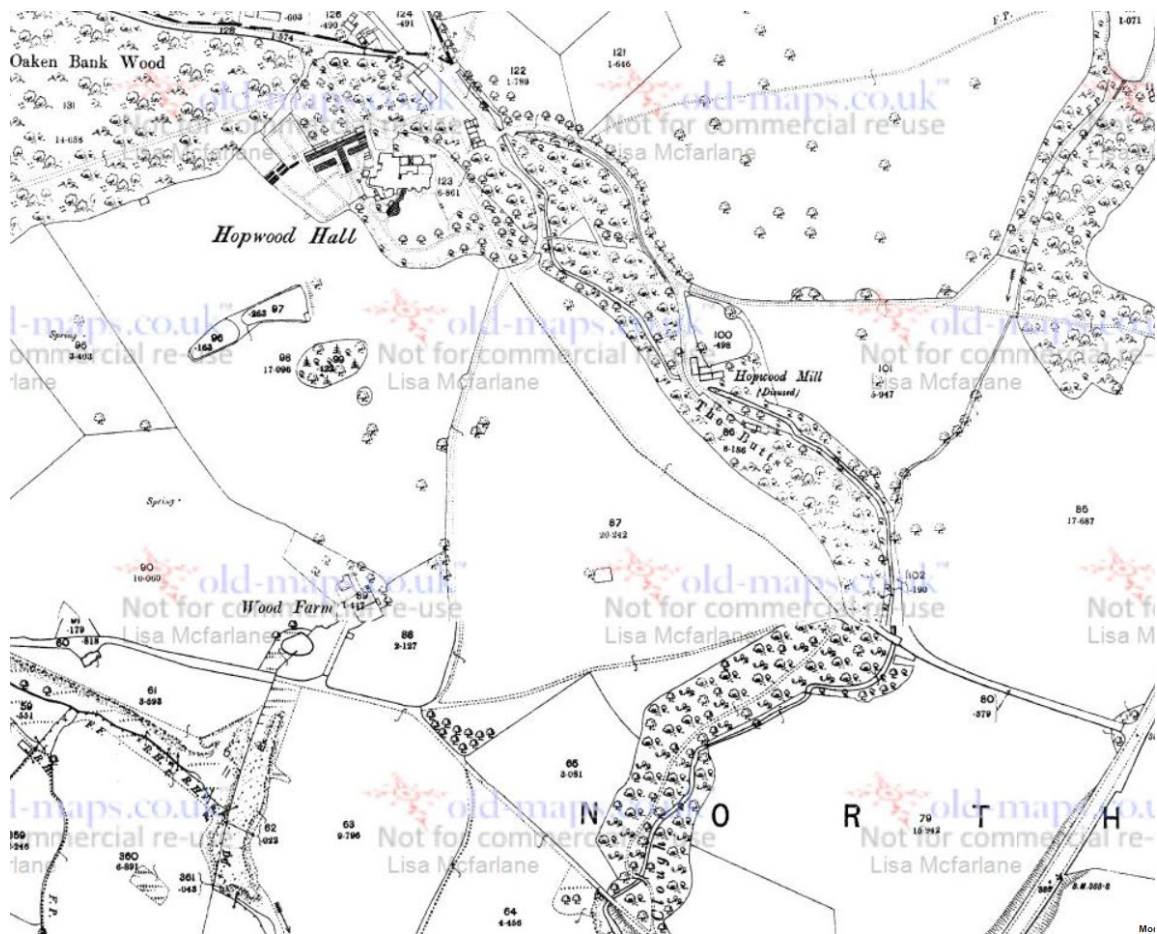
Figure 3.8

OS Map dating from 1893

The 1893 map illustrates how development had occurred during the late 1800's towards the north-west corner of Hopwood Hall. Although the Hall during this period hadn't undergone substantial change, single storey buildings were developed to the north-west of the Hall to support the growing Hall.

Hopwood Corn Mill and the associated Mill Pond is, at this time identified as being disused, after ceasing operation in the 1870's.

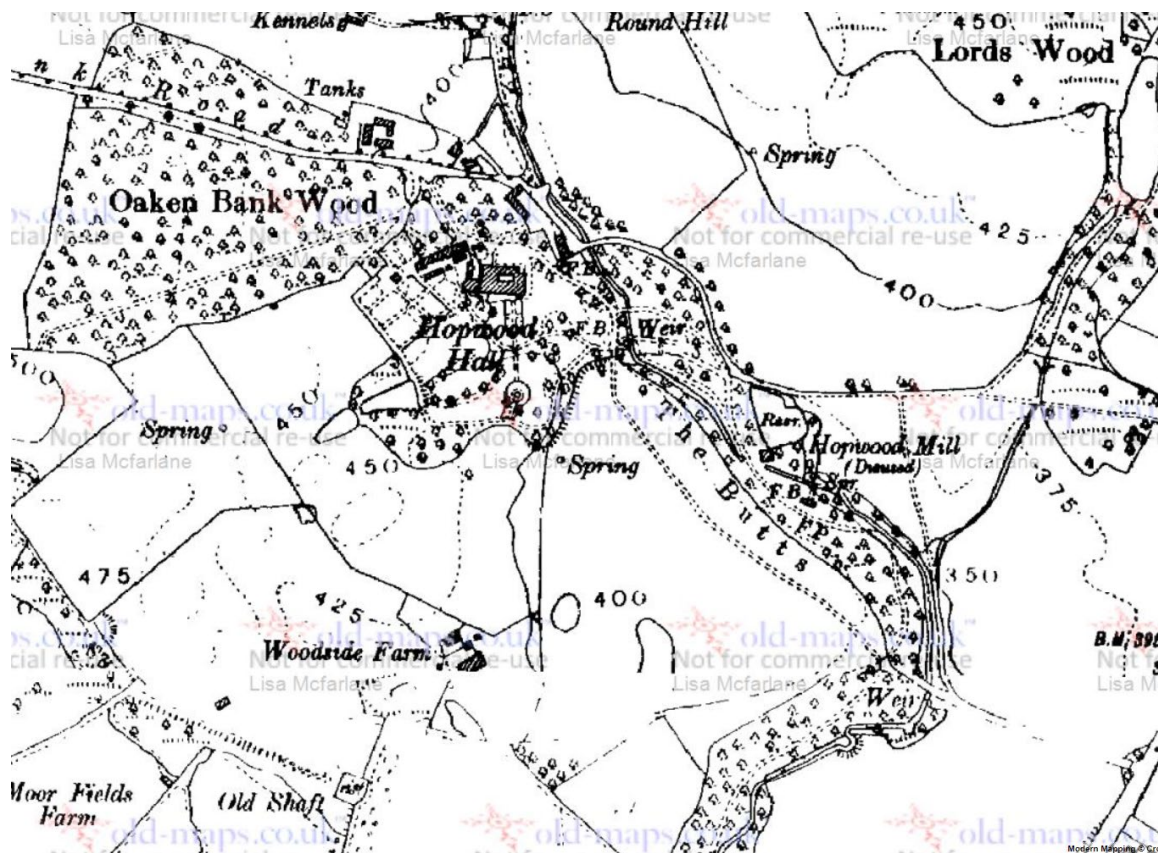
Figure 3.9

OS Map dating from 1932

The 1932 Map illustrates that very little development had occurred during the early 1900's. The development of further buildings serving the Hall to the north and north-east edge of the Hall are notable in 1932.

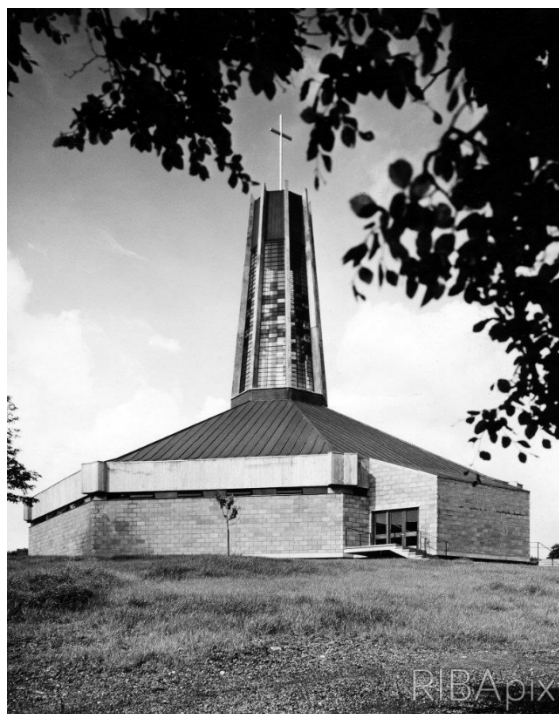
**Figure 3.11**

Photograph from 1965 towards the main entrance showing the overall building form and materials. (Source: [www.architecture.com/ribapix](http://www.architecture.com/ribapix), Ref RIBA11310, accessed 07<sup>th</sup> May 21)

The building was to be constructed using an in-situ concrete frame of concrete columns and pre-stressed concrete ring beams. The exterior walls were to be faced in functional concrete block, with a narrow clerestory window between the columns and below the eaves ring beam. The majority of the internal natural light was achieved through the dramatic coloured glass lantern at the centre of the structure. Glazed with clear, red, yellow and green glass, the lantern was designed by David Atkins. The design also incorporated underfloor heating.

The building was entered by a simple lean-to section to the south side of the building and was reached by a dramatic set of flying concrete steps.

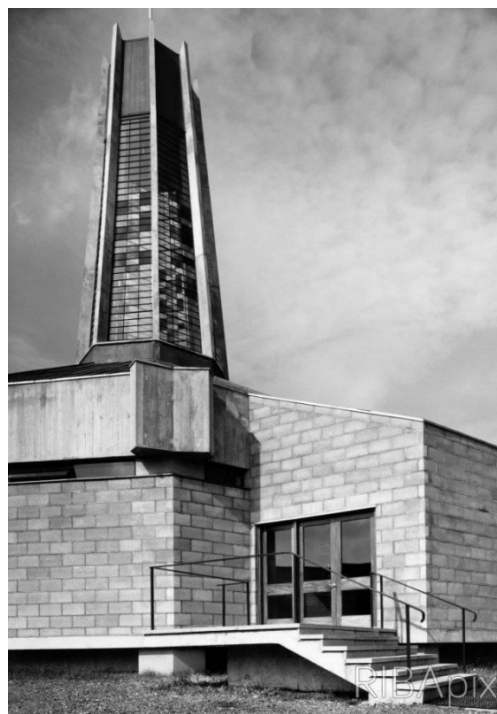
**Figure 3.12**

Photograph from 1965 towards the main entrance showing the entrance lobby and stepped approach. (Source: [www.architecture.com/ribapix](http://www.architecture.com/ribapix), Ref RIBA74990, accessed 07<sup>th</sup> May 21)

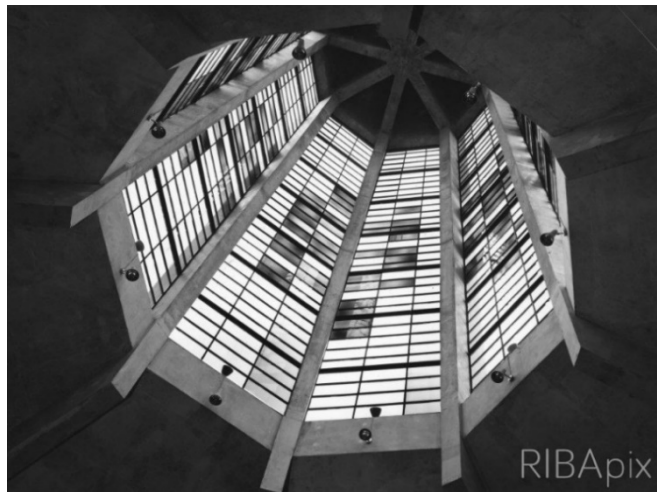
**Figure 3.15**

Photograph from 1965 showing the interior of the Chapel and the stained-glass lantern.

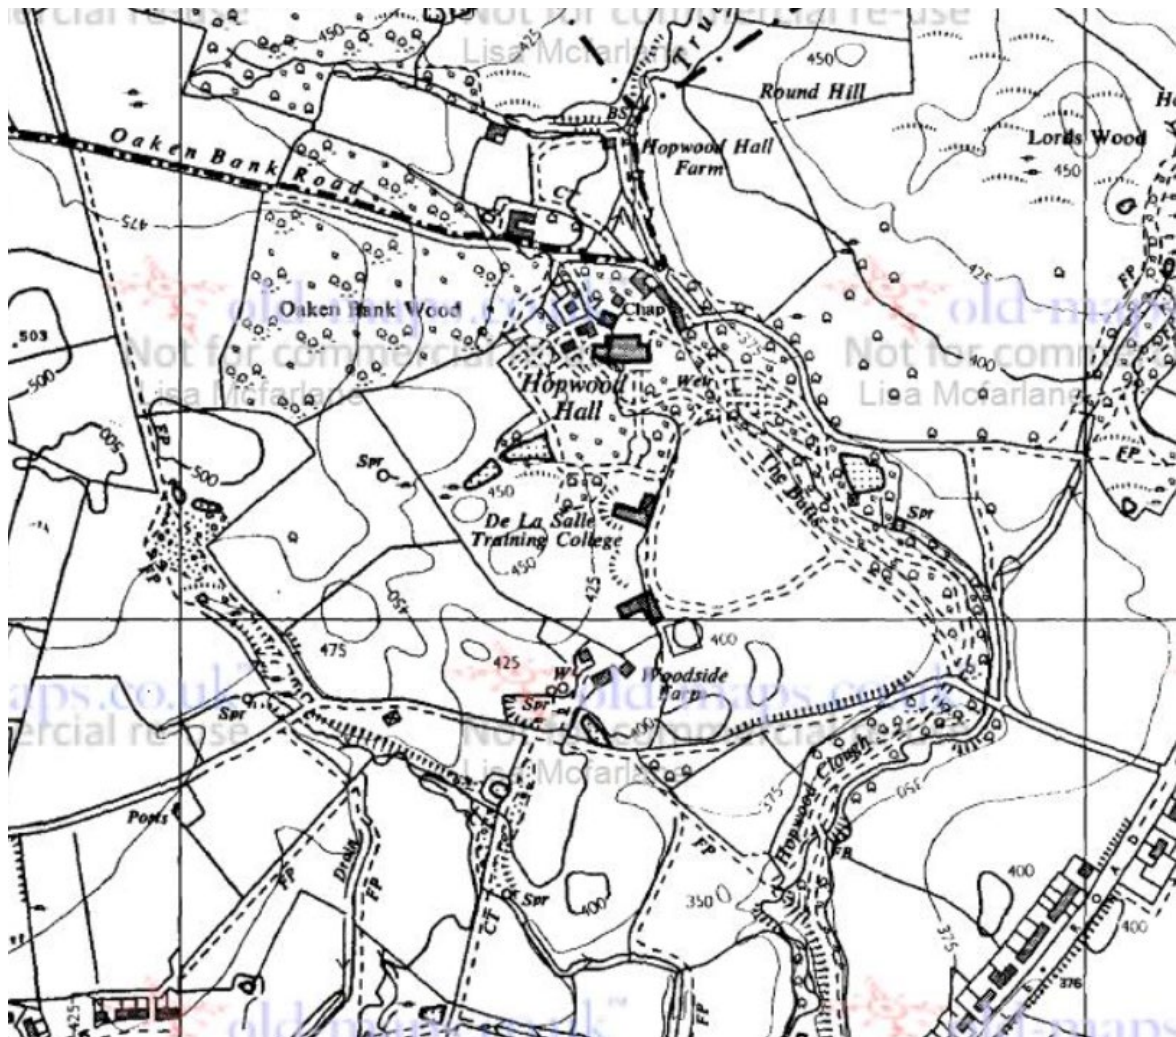
Figure 3.16  
 OS Map dating from 1965  
 (Source: [www.oldmaps.co.uk](http://www.oldmaps.co.uk), accessed 04<sup>th</sup> May 21)

The 1965 OS map shows the location of the two De Salle L-shaped residential blocks built in the late 1950's but does not yet illustrate the location of the new Chapel. Prior to this period, development was focused predominantly on the north-west edge of the site adjacent to Hopwood Hall. The below photograph (Figure 3.17) shows the development of buildings to the north-west of Hopwood Hall to serve the needs of the growing De La Salle College.

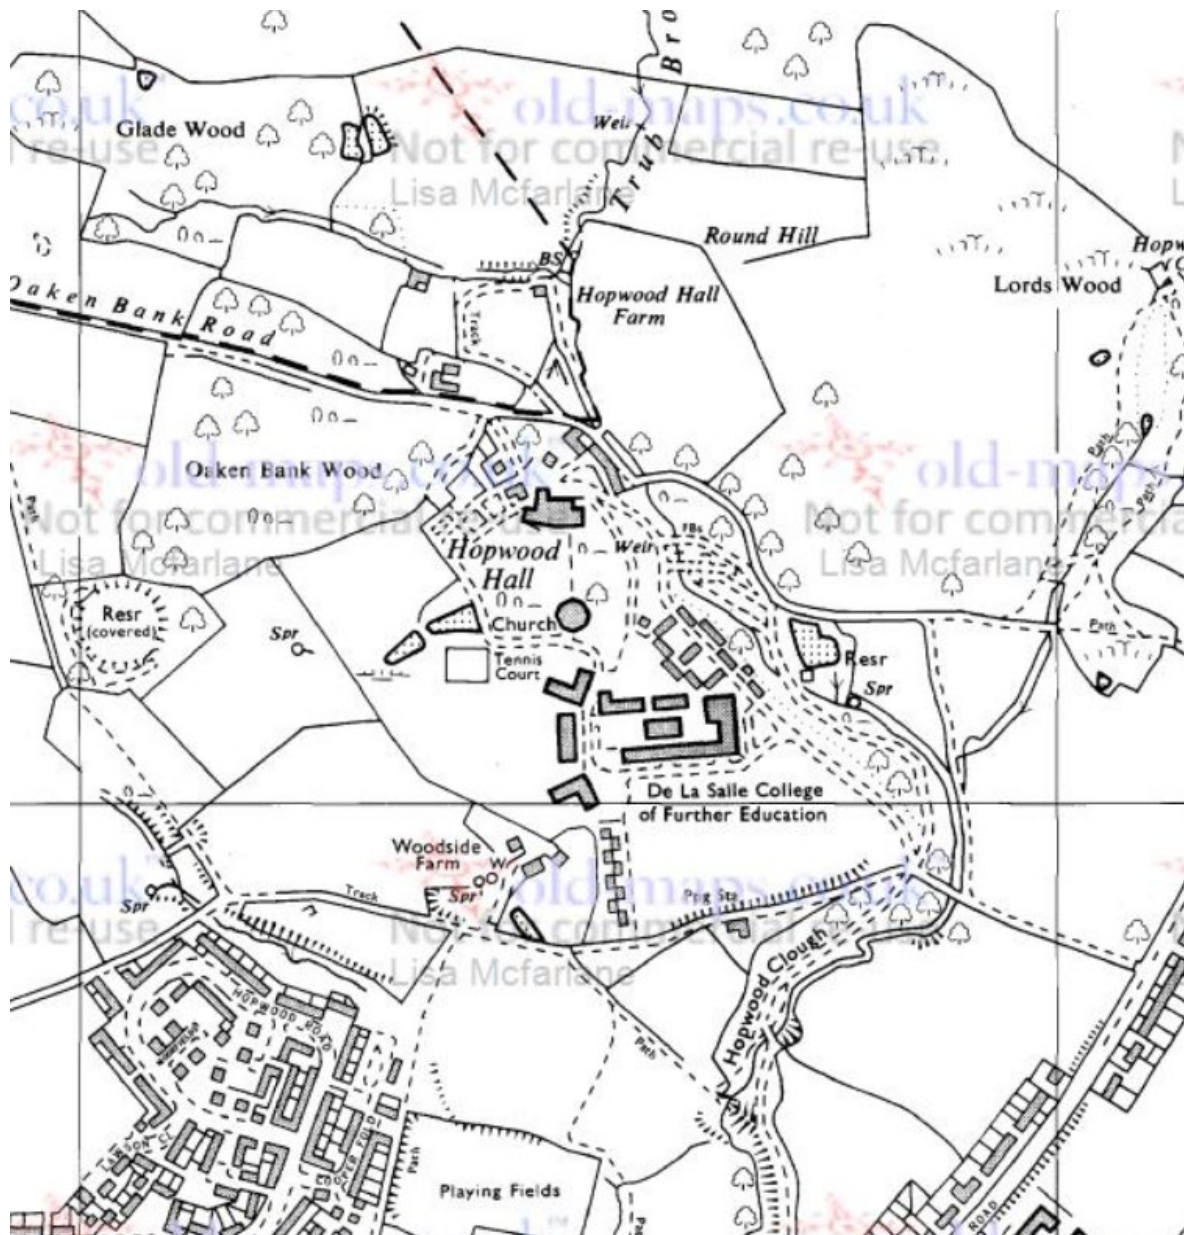
Figure 3.18

OS Map dating from 1984

The 1984 OS map illustrates how the College Campus rapidly expanded during the early 1980's with the creation of the courtyard of two storey teaching accommodation centred around the De La Salle Accommodation blocks on an east-west axis and the two-storey residential accommodation developed on a north-west/south-east axis alongside the Reservoir and woodland to the north-east boundary. The Chapel is located at the highest point of the hill overlooking the campus and creating a focal point to the site.

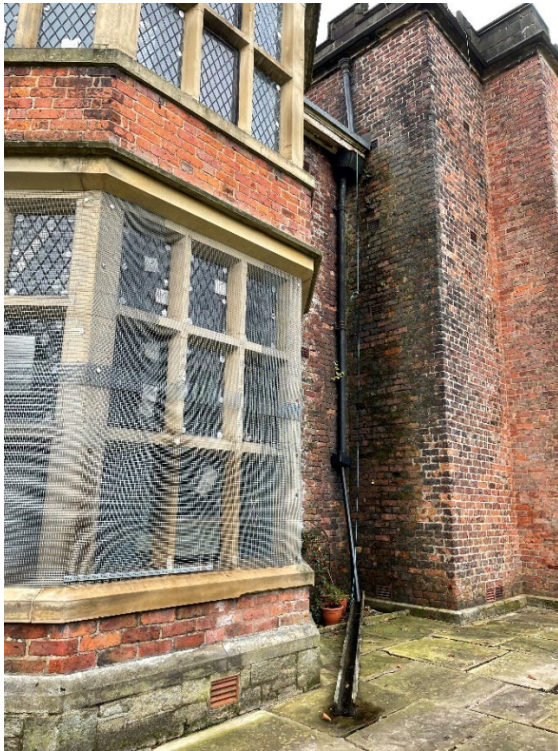
**Figure 02** Rainwater pipe failure affecting the brickwork to the south-east of the Hall.

There are multiple pressing issues contributing to the worsening condition of the Hall. One of the main substantial issues is the fact that the Hall is not watertight, with water ingress causing major damage to internal historic detailing as well as effecting the structural stability of the building. The West Wing of the building is currently in a very bad and unsafe condition, with some areas where the structure isn't sound and other areas where the stability of the structure is still unknown. It is assumed that the deterioration of the roof and chimneys over time, with the addition of lead being removed due to theft, has allowed for water ingress which has accelerated the decline of structural members. The wing is currently propped however is still deemed unsafe to access without guidance from the onsite maintenance team due to the precarious nature of the structure. On the South and South-East elevations there is widespread rainwater pipe failure including leaks. Some areas of the brickwork have therefore deteriorated more than others due to water saturation. The inability to shed water effectively has led to the general decline of the structure. The lack of access to the roof has rendered maintenance troublesome and over time has led to the growth of vegetation from elevations and chimneys.

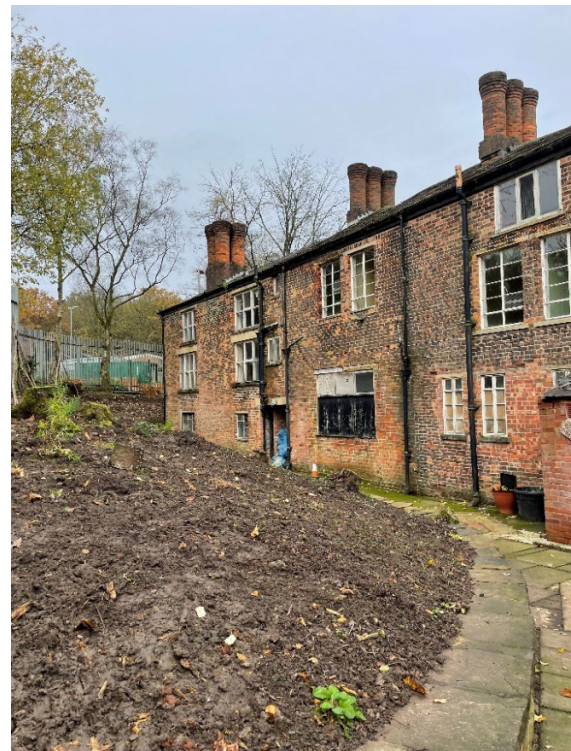
**Figure 03** West wing of the building which is in a very unsafe condition structurally.

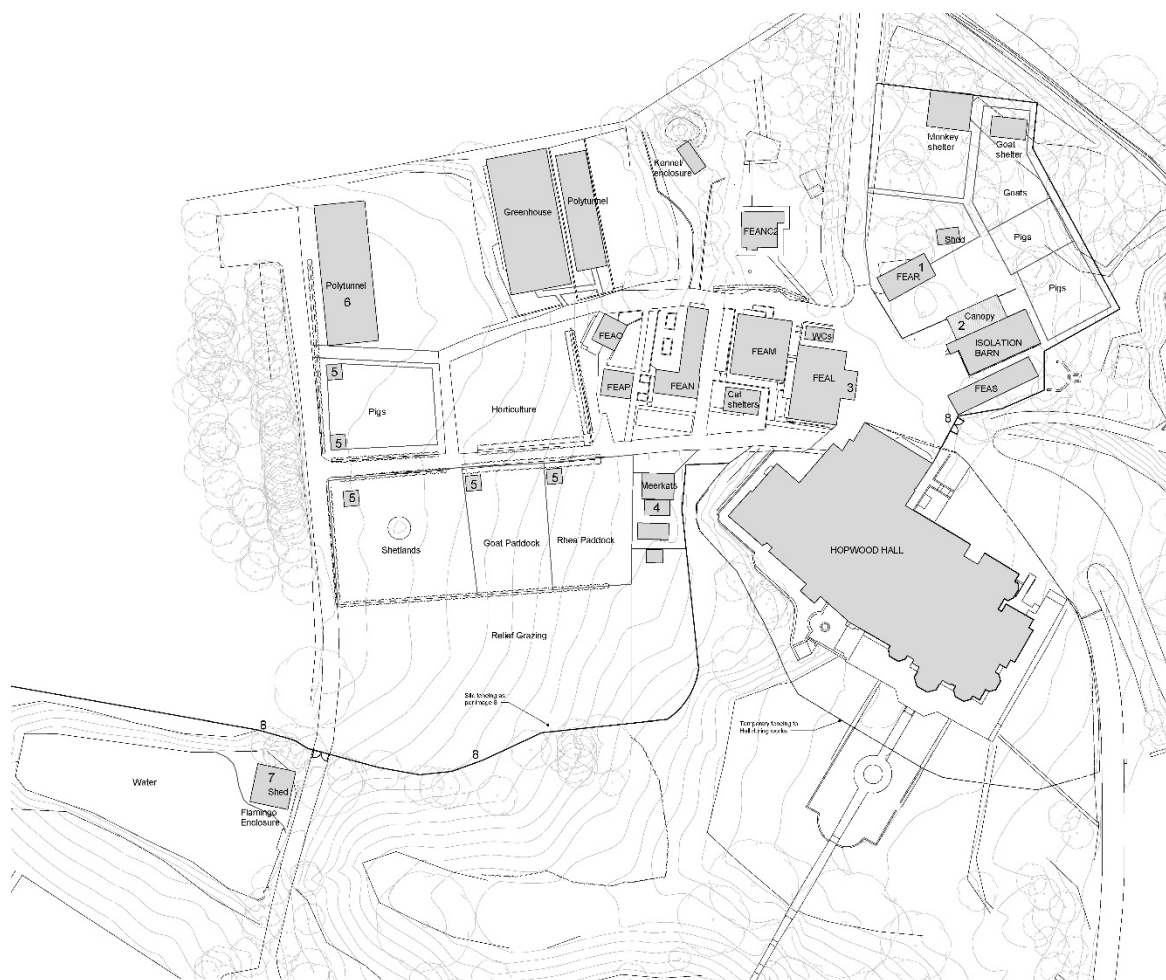
**Figure 6.1**  
Plan of the site in 2022.  
(Seven Architecture, 2022)

The development of the animal management facilities site had largely taken place within the last 10-15 years. The application looks to submit for a change of use planning application to allow for commercial use and altered
