## Littleborough Fire Station Drilling & Grouting Report

**Prepared for Greater Manchester Combined Authority**

| Report No. : | <b>2868/WSH/DGR</b> |
| Report Title: | <b>Drilling &amp; Grouting Report</b> |

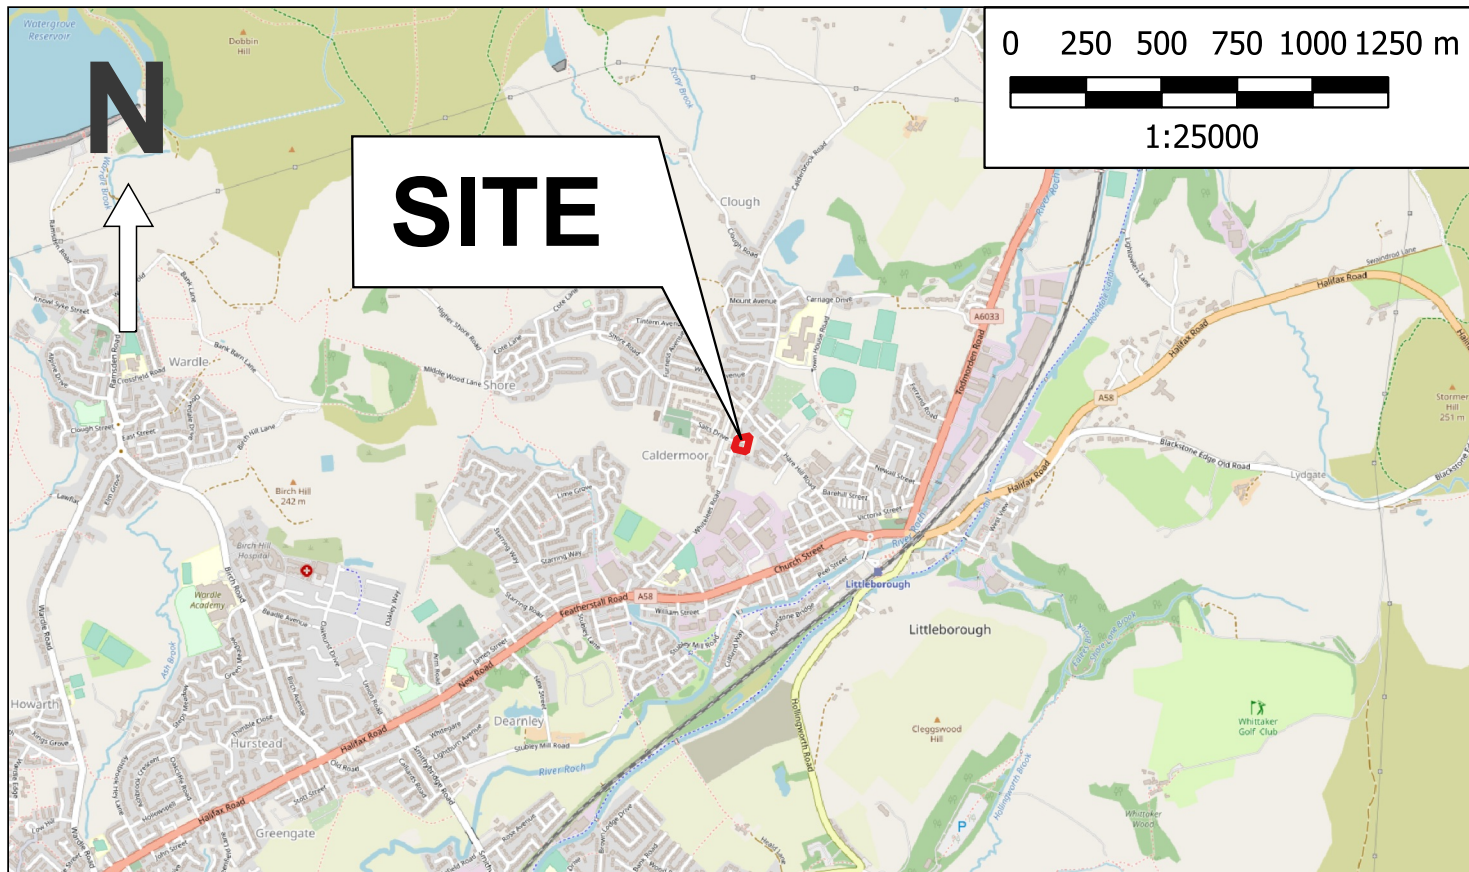
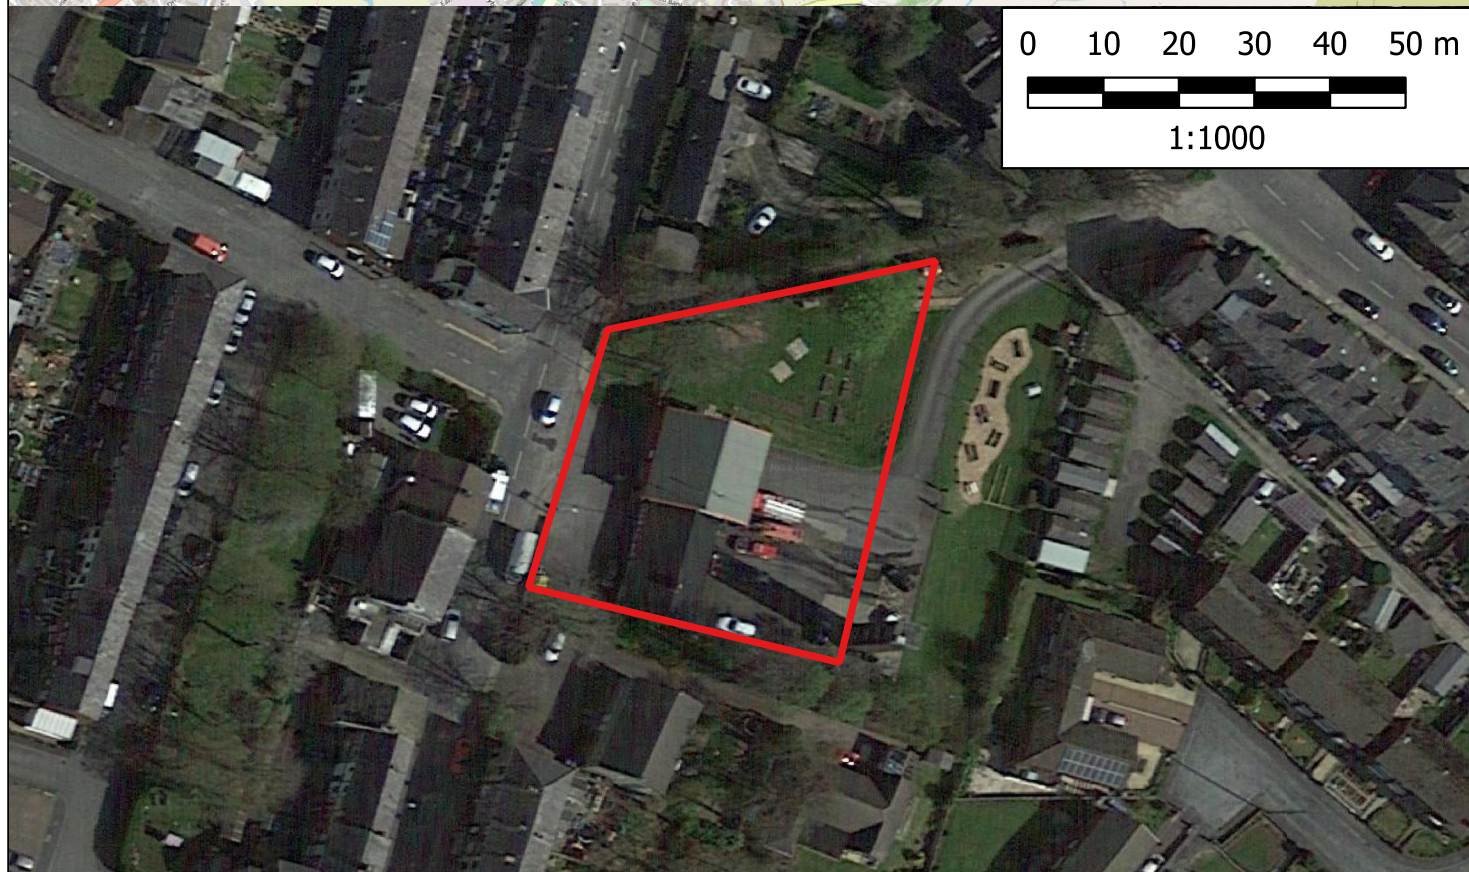
Figure:  
1

The site is located immediately to the southeast of Whitelees Road, across from Salts Drive, Littleborough as shown on **Figure 1**.

Title:  
Site Location and Boundary

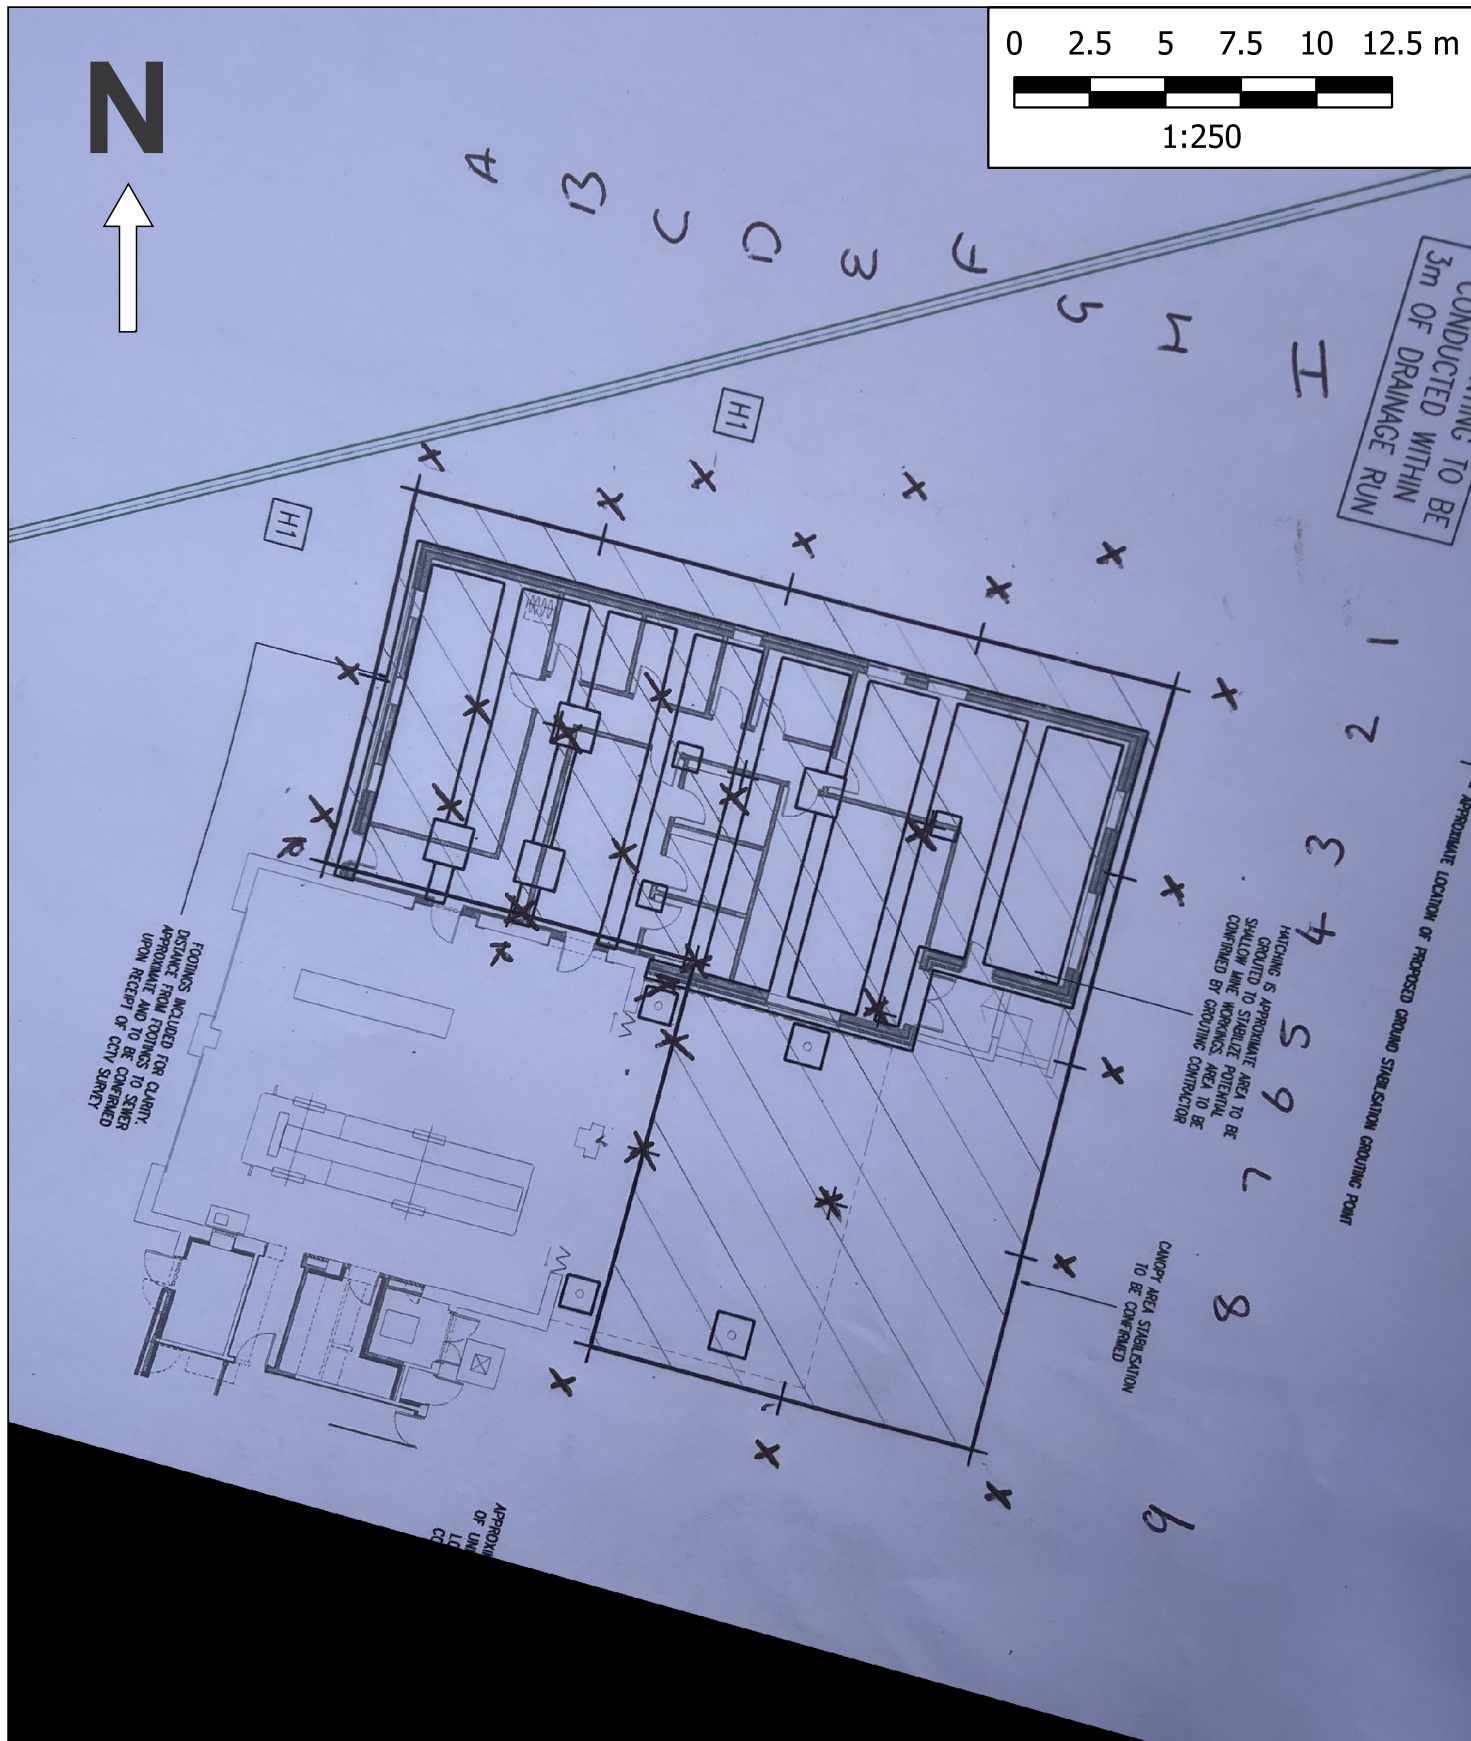
The development layout is presented on **Figure 2**.

The grouting borehole locations are presented on **Figure 3**, drilled on a 6m x 6m grid pattern across the entire extension area.

| Client:<br>Pennine Geotechnical Services Ltd | | | | Title:<br>Proposed Development and<br>Proposed Grouting Plan | | | <b>GroundSolve Ltd</b><br>Consulting Geotechnical Engineers |

Boreholes A2, A4, A6, B3, C2, C4, C6, D1, D3, D5, E2 and E4 were drilled to 20.00mbgl and did not encounter any coal seams.

Boreholes E7, E8, E9, F1, G2, G4, G6, G8, G9, H1, I2, I6, I8 and I9 encountered the target coal seam at depths of between 17.00m and 20.50mbgl, with a thickness of 0.50m to 2.00m.

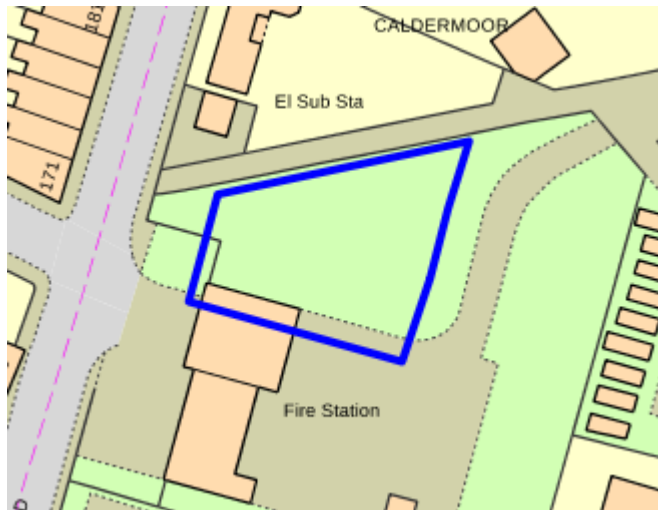
# Granted Permit Boundary

***Treatment of shallow mine workings by drilling and grouting to 20m on 6m grid***
