## Phase II Site Investigation Report

Further Red Lumb  
Rochdale

**Report Ref: M0981**

**June 2024**

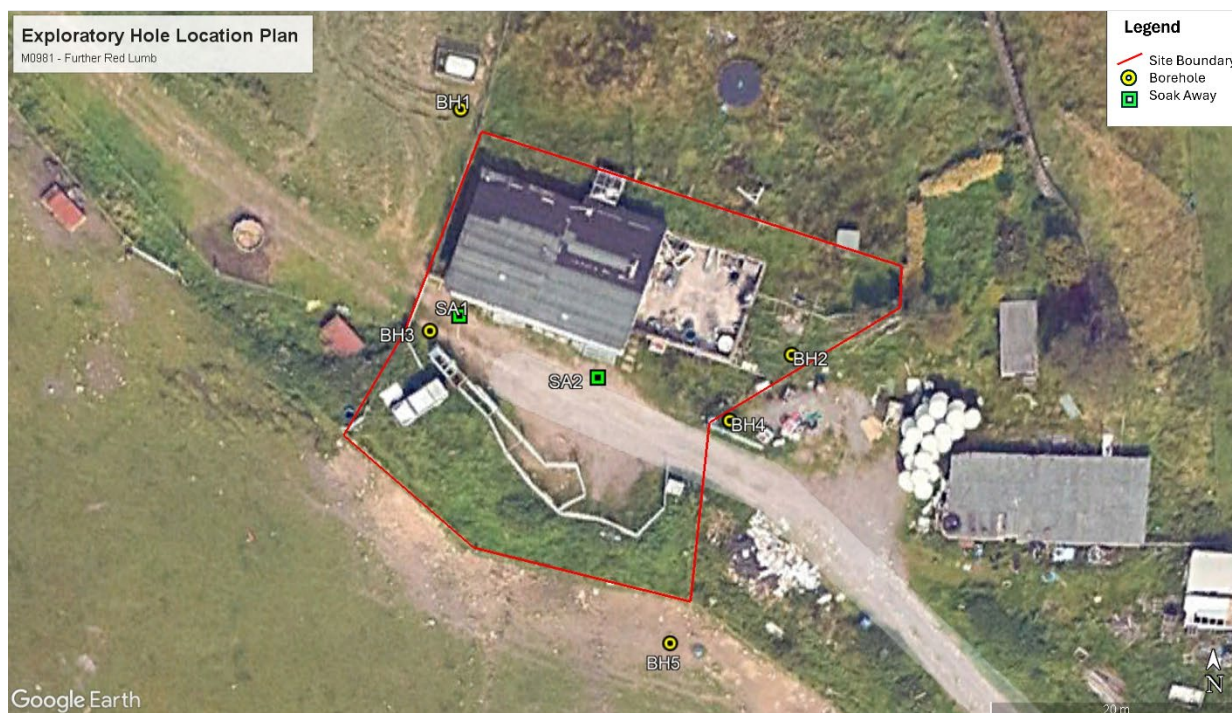
**Figure 4: Exploratory Hole Location Plan**

- Five window sample boreholes (designated BH1 to BH5) were each sunk to depths of between 1.20m to 4.00m below existing ground level. Due to restricted access, BH5 had to be excavated by hand to 1.20m. Window sampler boring is carried out with a small, track-mounted rig, which uses a chain-driven trip hammer to drive sampling tubes or penetrometers into the ground. These tools are coupled to the anvil of the hammer by solid drill rods. Sampling tubes comprise “windowless samplers”, which are plain sampler tubes in which a continuous disturbed sample is recovered within a semi-rigid plastic liner. In order to reduce friction within the borehole, sampling tubes of progressively smaller diameter are used as the borehole depth increases. Sampler diameters generally range from between approximately 90mm to 50mm. Standard Penetration Tests (SPTs) were undertaken in the boreholes in accordance with BS EN ISO 22476-3. Groundwater observations were noted where possible. These observations relate to the time of the investigation only, and do not necessarily reflect seasonal fluctuations. Exploratory hole logs are included in Appendix 1. Exploratory hole locations were selected on-site by an EEG engineer based on the proposed development layout and avoiding known services. BH1, BH2 and BH5 were backfilled using arisings/spoil, whereas BH4 and BH5 had ground gas monitoring pipes installed.

- Two trial pits (SA1 and SA2) were excavated in the centre of the site by use of a 3-tonne 360 tracked excavator to a maximum depth of 1.00m bgl. Soakaway tests were carried out in all of the trial pits in accordance with BRE Digest 365, the results of which are included in the Appendix 1.

Exploratory hole locations were selected on-site by an EEG engineer based on the proposed development layout and avoiding known services. Each exploratory location was scanned using a Cable Avoidance Tool (CAT) in order to locate unrecorded underground services, and the exploratory locations were repositioned if necessary.

An Exploratory Hole Location Plan is presented as Figure 4, below.

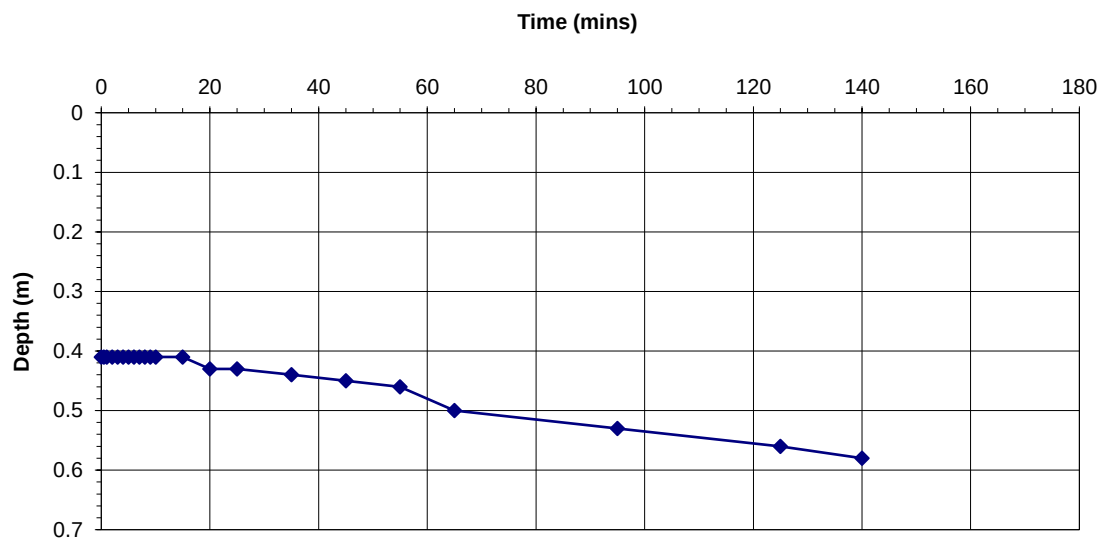
| 55 | 0.46 | Soil infiltration rate, f, (m/s) = | | 1.21E-05 | normal test |

Permeability testing was conducted in SA1 and SA2 in accordance with BRE Digest 365, a measured infiltration rate was at  $1.21 \times 10^{-5}$ m/s in SA1 and  $2.29 \times 10^{-7}$ m/s in SA2 which is presented in full in Appendix 1.
