# **Bat Survey Report and Method Statement European Protected Species (Bats)**

## **Reasonable Avoidance and Mitigation Measures**

**Yew Tree Farm South,  
Middleton,  
Manchester,  
M24 6XJ**

**23.09.2024**

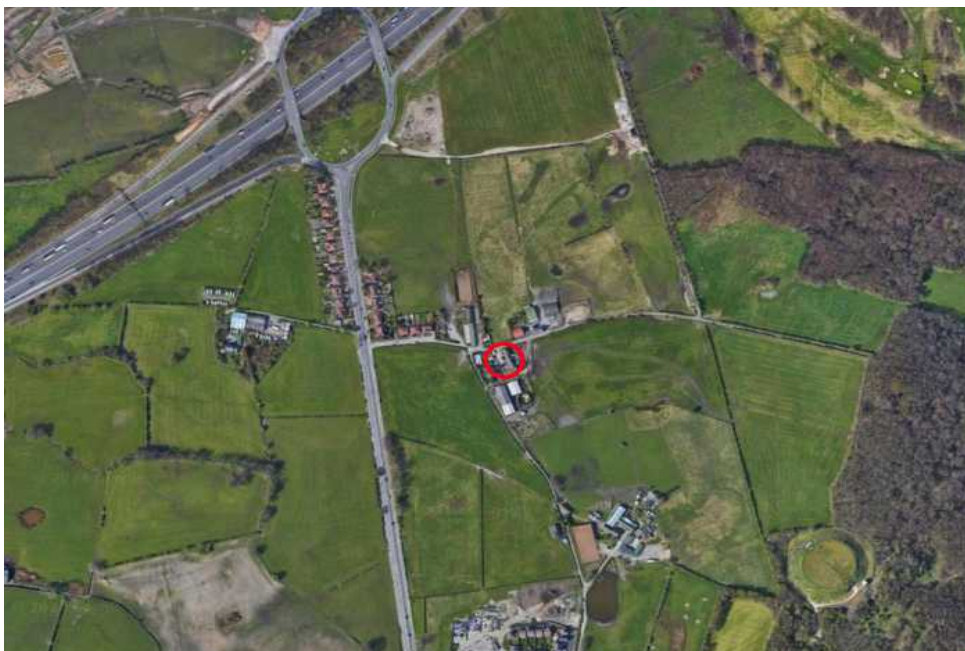
## Surrounding Habitat

The property is located in a semi rural position with surrounding habitat dominated by improved and semi improved grassland, with some hedgerow and scattered tree cover present on field boundaries, ancient and semi natural deciduous woodland is present to the east and south east of the site.

The presence of the M62 motorway (approximately 350m to the north) and associated traffic noise can be expected to have a negative effect on bat activity (*Berthinussen, A. & Altringham, J. (2012) The effect of a major road on bat activity and diversity. Journal of Applied Ecology, 49, 82-89.*).

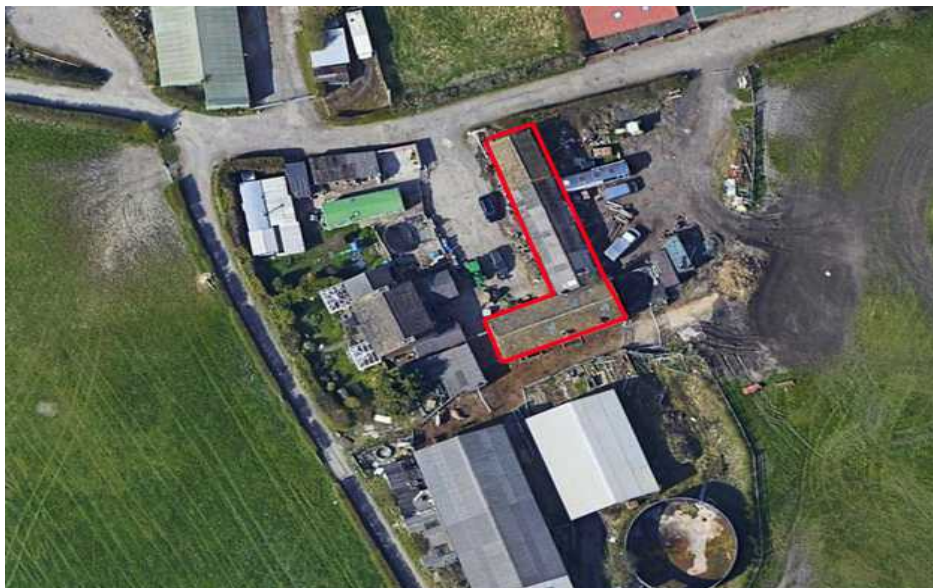
*Position of buildings within Yew Tree Farm South*

The property consists of a disused two storey brick built barn and associated agricultural outbuildings at Yew Tree Farm South. The main barn had a double pitched stone slate roof, and adjoins a series of single skin single storey outbuildings with corrugated fibreboard roofs which form an L shape to a two storey brick built barn at the northern boundary of the farm.

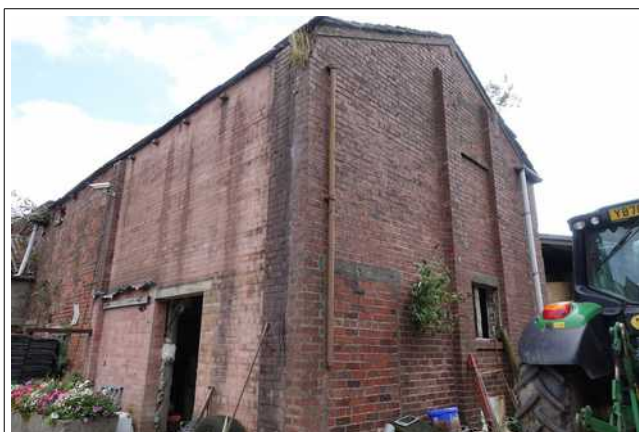
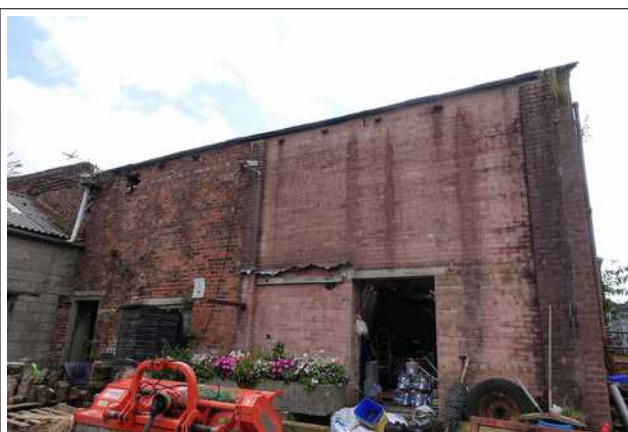
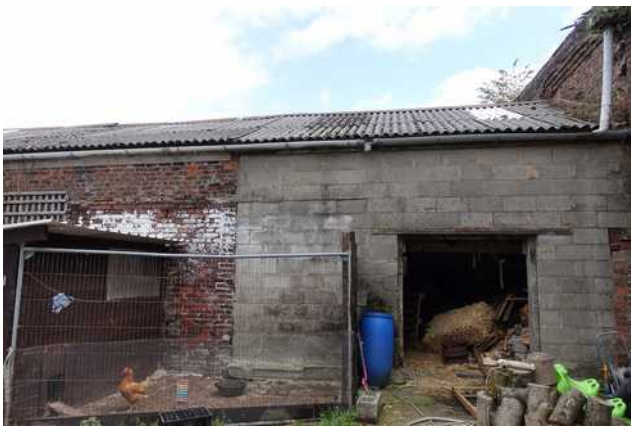
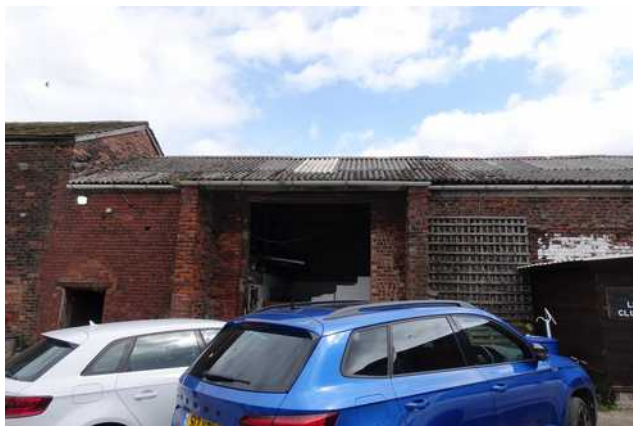
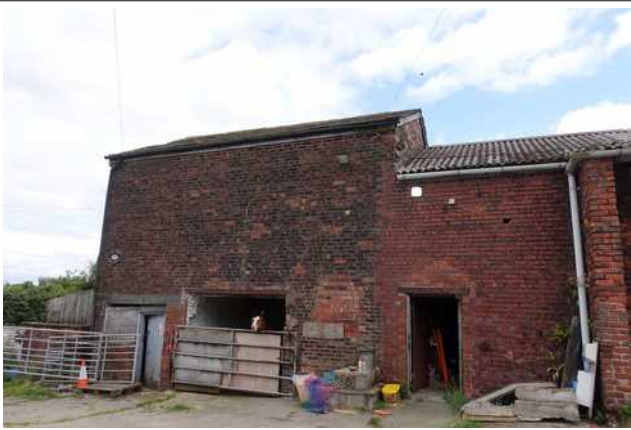
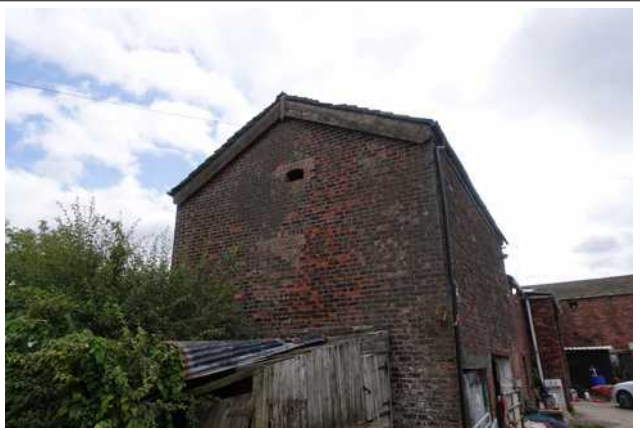
The buildings have a mixture of single skin and double brick walls without cavities and exposed wall tops to the interior. External walls are generally well pointed however, owl holes and open doorways and windows allow access to the interiors.

Corrugated panelled roofs are generally unlined and exposed to the interior, although some of the stone slate roofs have a ripped roofing membrane present. Gapes behind fascia boarding where present was wide and open and considered unsuitable for roosting bats.

Overall buildings were assessed as offering low potential for roosting bats.

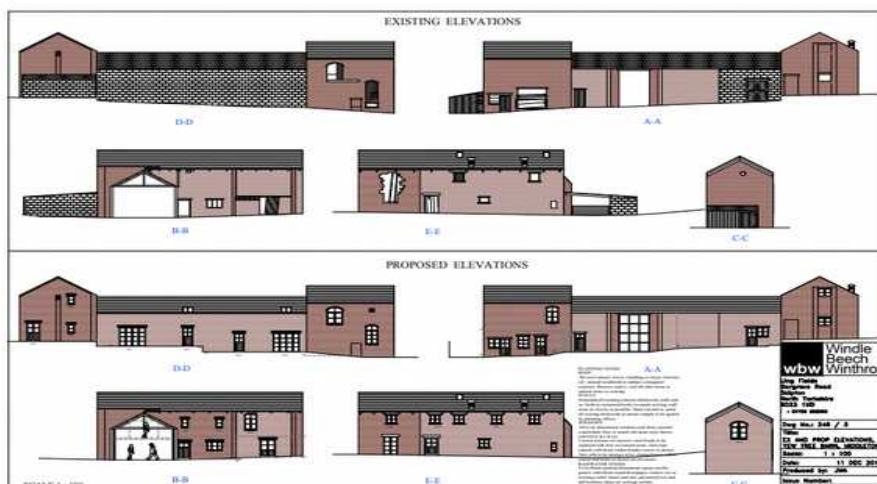
The proposed residential development will result in the conversion, partial demolition and replacement of existing buildings on site.
