# MARKET PLACE, MIDDLETON

## Preliminary Bat Roost Assessment Report

Project Name: Market Place, Middleton  
 Project Reference: CW20-3104  
 Report Title: Preliminary Roost Assessment Report  
 Report Reference: CW20-3104 PRA 001  
 Printing Instructions: Print at A4 Portrait, Double Sided.

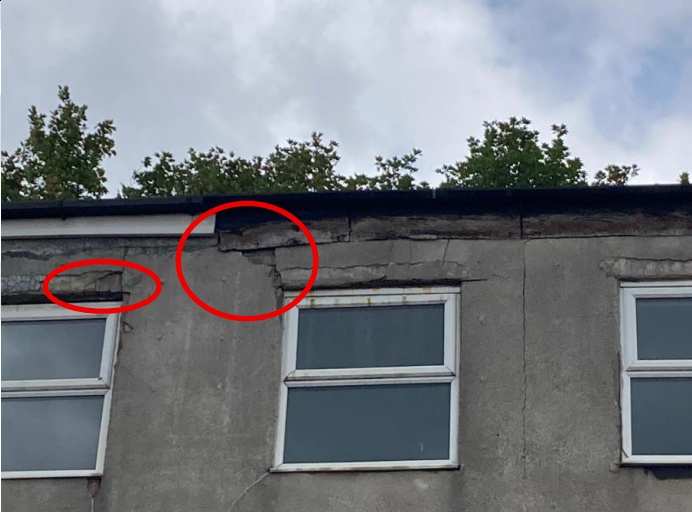
- The southern elevation offered potential roosting features (PRFs) for bats. Damage to the rendering and fascia boards was identified along the 2<sup>nd</sup> floor. Previous fascia boards have fallen off along the aspect leaving exposed wood which has become rotten over time, allowing for gaps to appear both within the wood and where it has begun to lift away from the wall. Furthermore, damage to the rendering has resulted in exposed brickwork and further damage to the mortar has created gaps along the aspect and around the 2<sup>nd</sup> floor windows.

| Feature | Photograph |
|---|---|
| Southern aspect – Fascia board damage and damaged rendering. | |

- 4.1.1 The building was found to provide bat roosting potential and therefore, in accordance with Best Practice guidance (Collins, 2023) further nocturnal surveys should be undertaken between May-September (inclusive) to determine usage by roosting bats. B1 was assessed as providing **moderate bat roosting potential**; therefore, a minimum of two further surveys are recommended, with at least one survey completed between May-August.

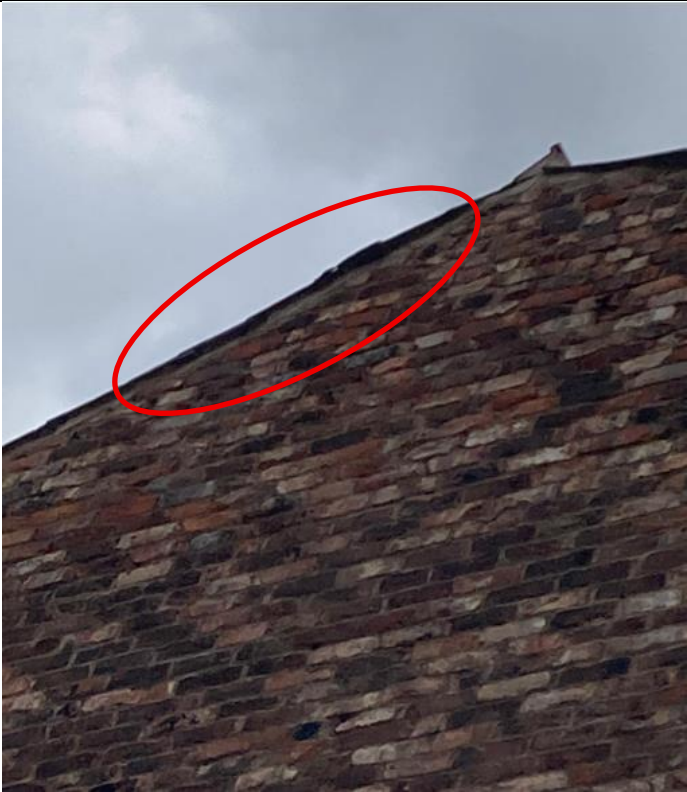
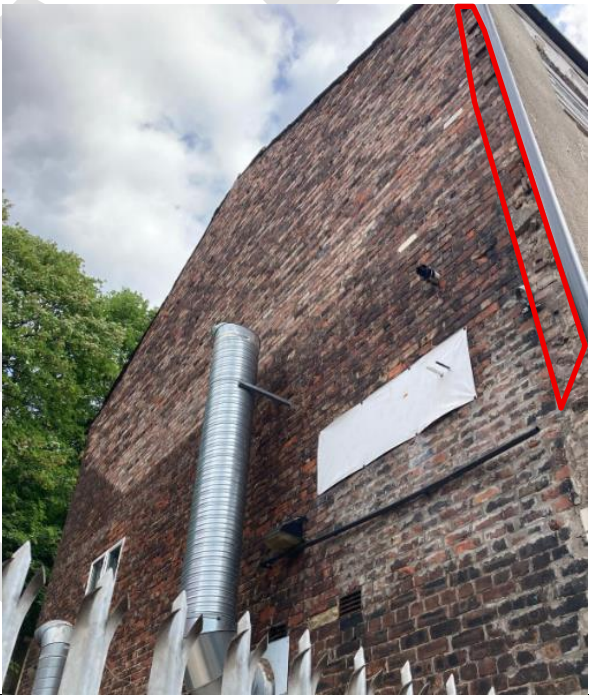
- The western elevation comprised solid red brick and external ventilation pipes. The brickwork displayed areas of damaged brickwork and missing mortar, with most of the damage isolated to the righthand side of the aspect. The damaged brickwork and mortar created small crevices that could be utilised by crevice dwelling species such as common pipistrelle which are known to be present within the surrounding area following the data search. The roof ridge also displayed several slipped tiles and missing mortar that has created small gaps underneath as a result.

Western aspect –  
damage to mortar  
and brickwork

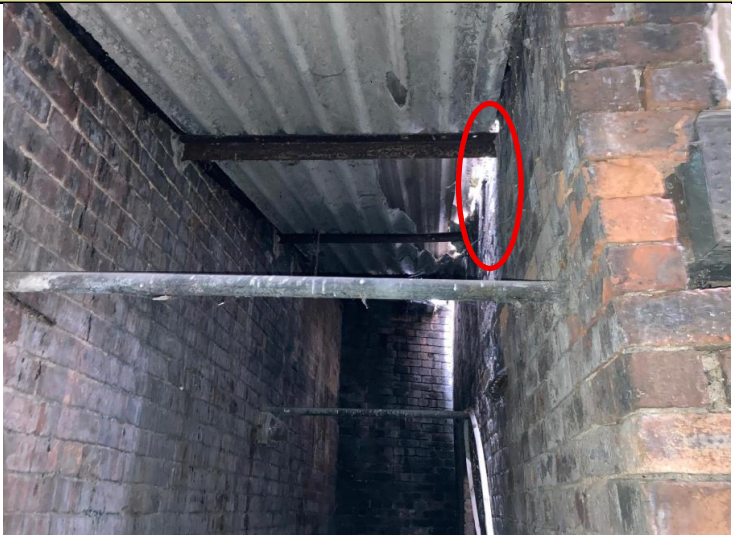
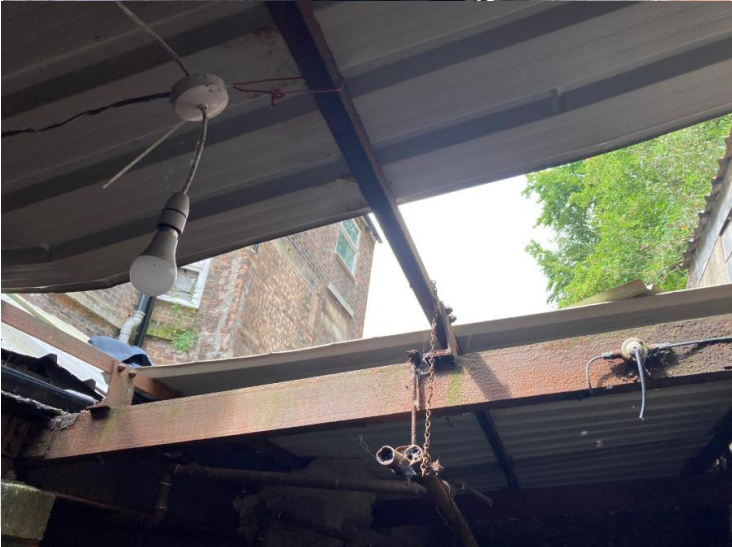
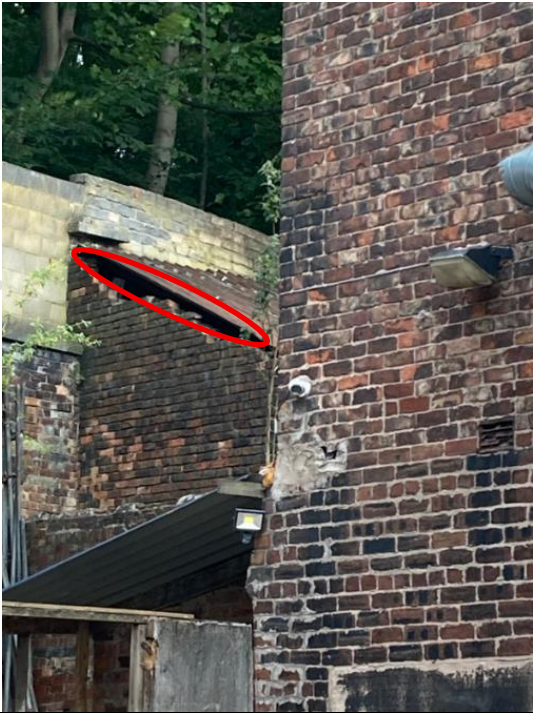
- The northern elevation of the main building comprised a solid red brick exterior and displayed areas of missing mortar along the brickwork. The missing mortar did create small gaps and crevices which bats could utilise as potential features. An extension is also present joining onto the northern aspect of the main building. The extension is currently utilised for storage. Externally there is damage to the brickwork as well as missing bricks that lead to internal access, missing areas of metal corrugated roof also allow for direct internal access to the ground floor extension.
- During inspection the eastern elevation identified gaps along the roof edge where mortar is missing between the verge tiles and the brickwork. This defect has resulted in small cavities allowing for access beneath the roof tiles that could be utilised by individual bats.

- 3.2.4. On internal examination of the ground floor rear extension/ storage area multiple internal access points were identified in relation to the missing and lifted sections of corrugated roof and damage to the external brickwork. Although no direct evidence of bats (e.g. droppings or feeding remains) were identified within this section during the survey the presence of structural gaps of this nature requires further investigation. The remainder of the internal inspection uncovered no further potential roosting features, internally.

Northern Aspect -  
Extension

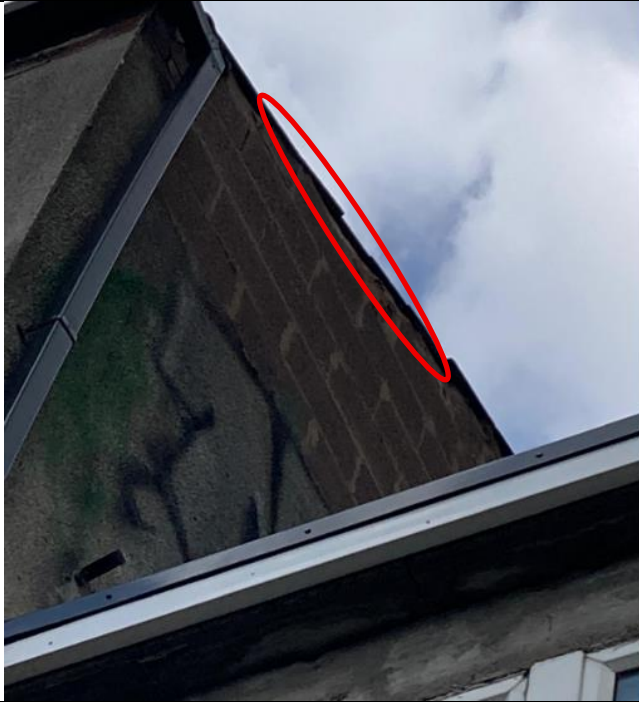
Eastern aspect

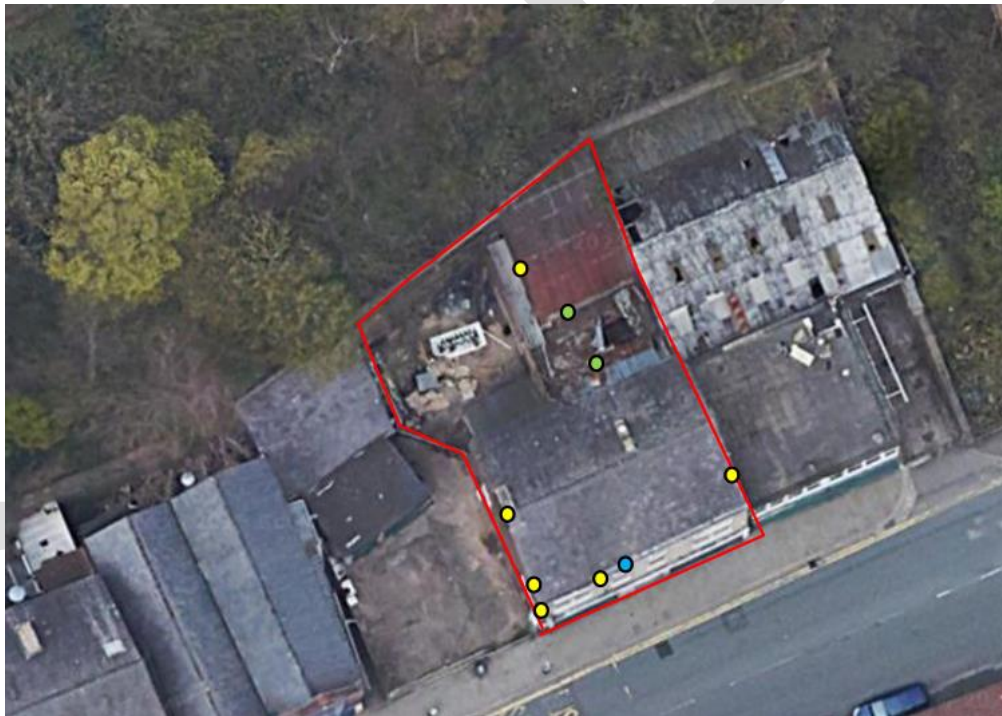
Figure 3.3.1 – Map of PRFs identified on the building

- Red line indicates boundary of the property at Market Place, Middleton.
- Green dots relate to gaps in corrugated roofing that lead to internal access
- Yellow dots indicate potential roost features relating to damaged brickwork/ missing mortar gaps identified externally.
- Blue dots indicate potential roost features relating to fascia boards externally
